The importance of structural monitoring as a diagnosis and control tool in the restoration process of heritage structures: a case-study in Portugal

Maria-Giovanna Masciotta^a, Luís F. Ramos^b, Paulo B. Lourenço^c

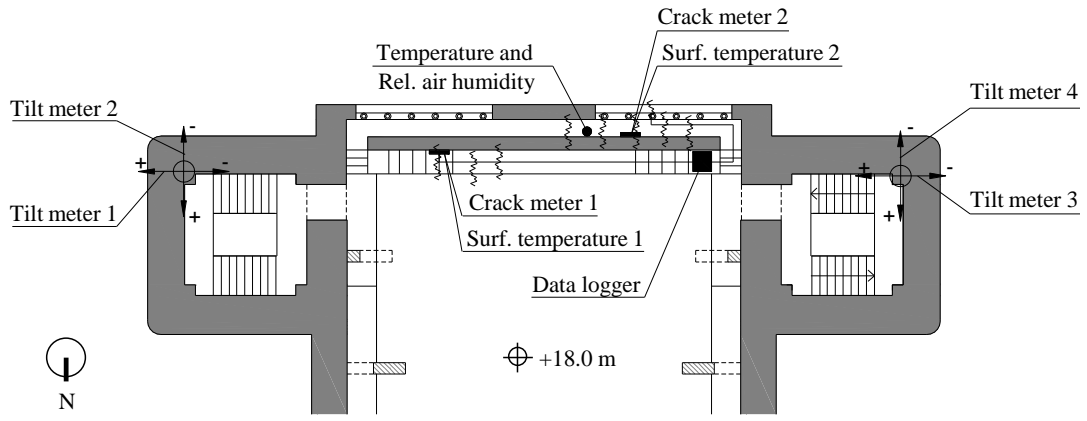
The location of the devices is schematized in Figure 3a. To catch daily temperature variations, all records were taken with a sampling rate of one per hour (24 events per day).

Figure 3 – Distribution of the monitoring systems: (a) static and (b) dynamic equipment.

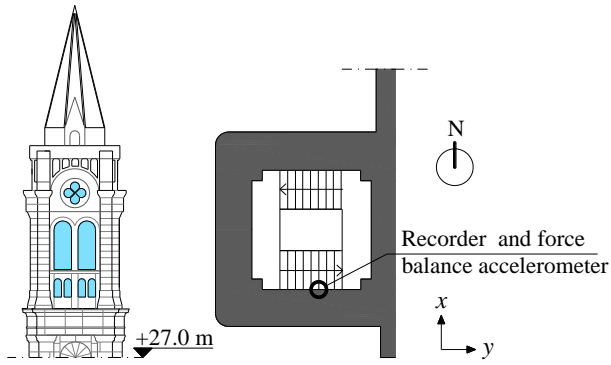
(b)

- One strong motion recorder (R) with 16-bit ADC analyser provided with batteries and installed on top of the western tower (Figure 3b);
- One tri-axial force balance accelerometer (A) with a bandwidth from DC to 100 Hz, a dynamic range ± 1 g, a sensitivity of 10 V/g and an operating temperature range of -20°C – 70°C . Accelerometer and strong motion recorder were connected by cable. The final resolution of both sensor and analyser was $8\ \mu\text{g}$.
