Evaluation of the masonry and timber structures of San Francisco Church in Santiago de Cuba through nondestructive diagnostic methods

Riccardo D. De Ponti¹ | Lorenzo Cantini² | Laura Bolondi¹

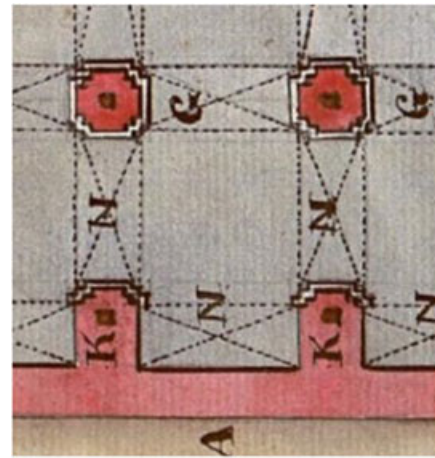
FIGURE 2 A detail of the pillars with the dark rectangular shape inside the structures

this area, permitting the monuments to resist both the strong winds (hurricanes and tropical storms are frequent) and the earthquakes. The pillars of San Francisco are now built externally with very regular and well-constructed brick masonry, but specific investigations were necessary to verify if it was possible to find a wooden structure inside the pillars.

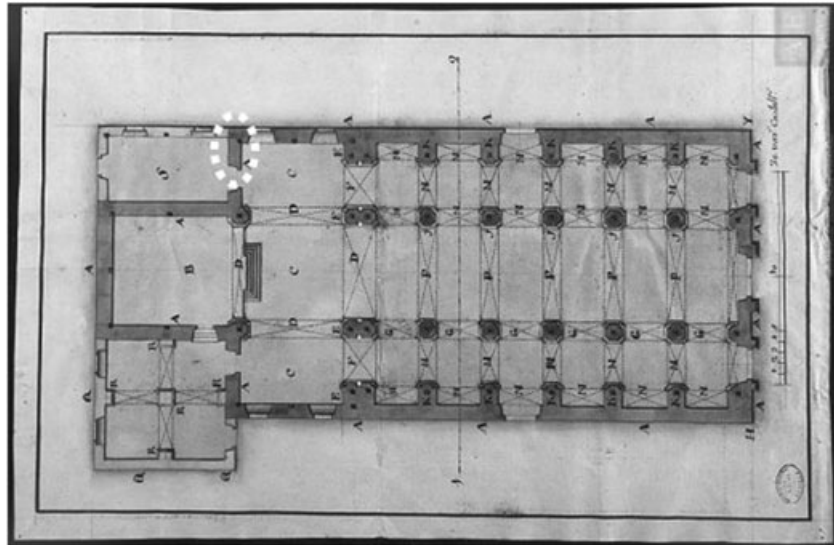
In the church of San Francisco, two samples of mortars were analyzed: a render (SF_r) and a fragment of bedding mortar (SF_b). They both were collected in the area of the church indicated as already built in the document of 1796 (see circle in Figure 12).

FIGURE 12 Mortar samples microscope analysis: localization of sampling area

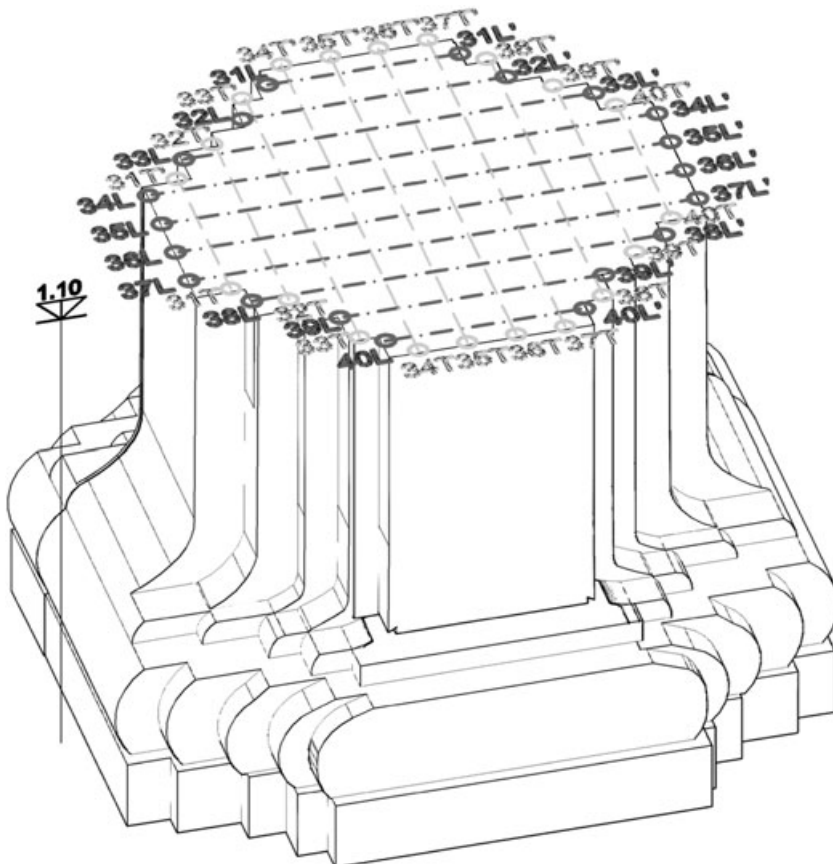
The common direct sonic tests carried out on the cross-shaped pillar were used for computing the average velocity in each intersection point between the propagation trajectory layouts (Figure 16) for the fourth row of the grid (at 110 cm from the floor). The same elaboration was carried out also for a higher level of the point grid (at 154 cm from the floor). As a result, the distribution of the average velocities on the horizontal section was obtained. The results were transposed in gray scale maps, reported in Figures 17 and 18. This computation of the sonic tests provide a more detailed indication of the position of the areas characterized by a low velocity range. This indication was later used for localizing the drilling core used for the inspection through the video endoscope.

FIGURE 16 The cross path used for the elaboration of the average velocity in each point formed by the intersection between the trajectories of the two sonic direct tests

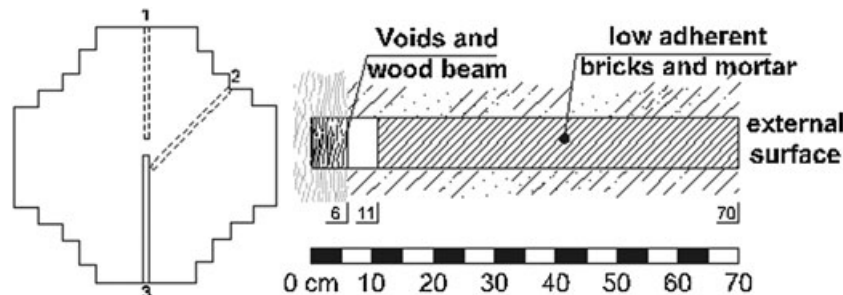
to low density of the structure). After carrying out a 70 cm drill in the area corresponding to low sonic velocity range, the video endoscope allows observing the masonry section stratigraphy (Figures 19). The pillars are formed by a brickwork structure containing a cavity (Figures 20) hosting a timber element (Figures 21). According to the historical analysis, the pillars contain timber columns.

FIGURE 19 Stratigraphic analysis of the pillar section

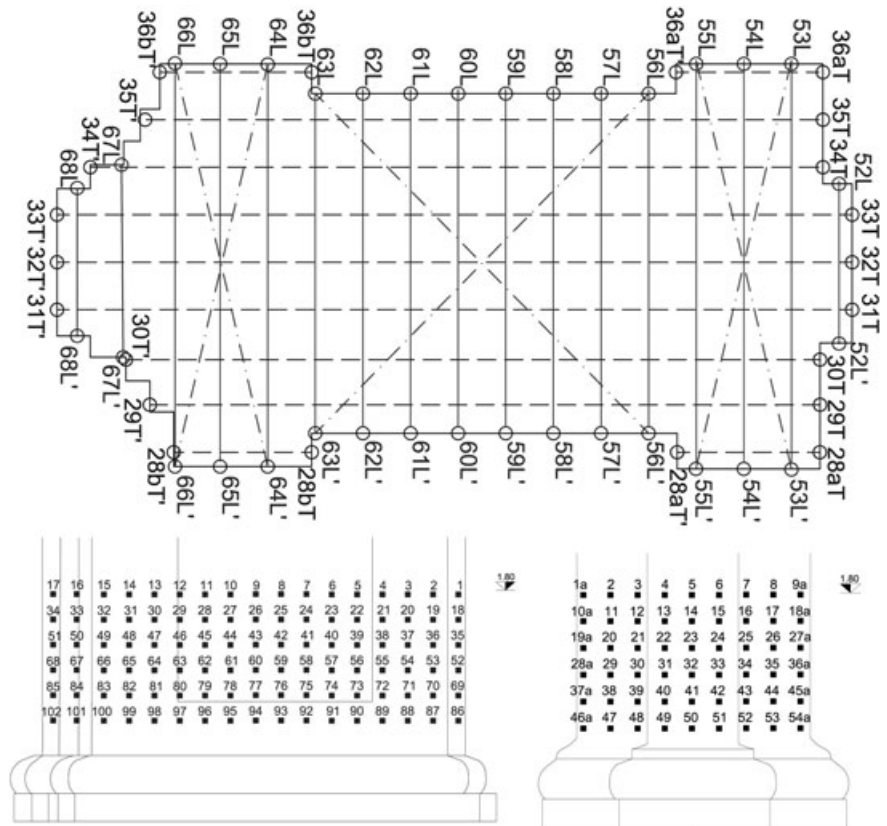
This combination of data obtained by the complementary use of different technique was useful for interpreting the characteristics of the large massive pillars (double cross-shaped pillars) facing the internal side of the facade of the church. As shown in Figure 24, several acquisitions were planned reporting many points along the surfaces of the structure. Compared with the velocity distribution obtained from the common direct sonic tests, the cross-path-based sonic computation provided a result that allows

FIGURE 24 The geometric grid of points set for the direct sonic tests carried out on the large pillar
