# INVESTIGATION OF RISING DAMP AND SALT ATTACK PROBLEMS OF HERITAGE BUILDINGS

**Md Azree Othuman Mydin<sup>1</sup>, Mohd Nasrun Mohd Nawi<sup>2</sup>, Muhammad Arkam Che Munaaim<sup>3</sup>**

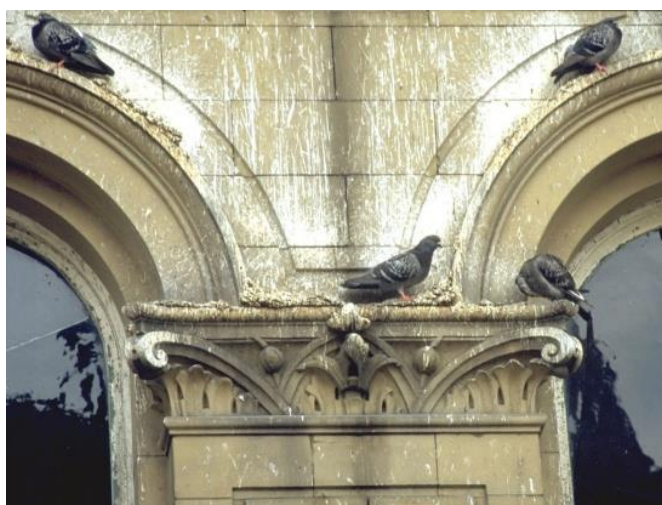
The damages that bird fouling causes to historic buildings can be extensive as been shown in Figure 1. Apart from the obvious unsightliness, the main problem is the acids released from their excrement. Studies have shown that the corrosive effects of the bird droppings can continue for a long time once the building fabric has been contaminated, even the fouling is removed or being washed away. The droppings from nesting materials can severely deteriorate the quality of virtually any roof. As time passes by, the acid contained in bird droppings will eat away the tar-based roofing materials and thus leading to leaks in asphalt roofs.

**Figure 1.** Bird damage on historical building

For those buildings especially historical building which is constructed of limestone or calciferous sandstone are most susceptible to the effects of the acids released from the bird excrements. The excrement from birds or any organisms is majority acidic nature (David, 2008). The method to reduce the building damage is to identify the location of the bird problems, treat and clean the affected area if any fouling found. Deterrents can be installed in order to avoid the bird from fouling in the same place. Another alternatives is, installing anti-perching devices such as anti-perching wire on the roof or the places where bird most likely to be fouling on.

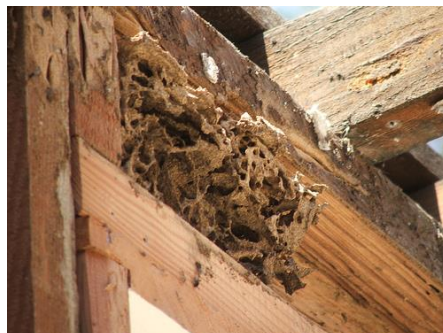
**Figure 2.** Termite damage on building structure

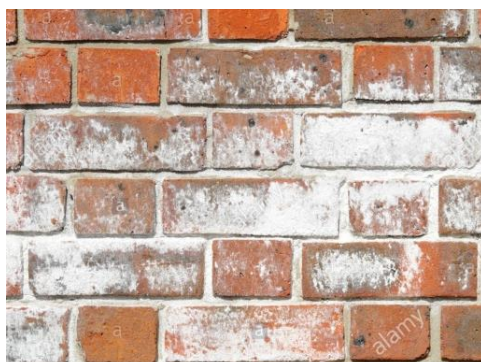
Salt crystallisation is used to describe the damage caused by soluble salt crystallizing within the pores of masonry materials as can be seen in Figure 3. Salts are brought into the porous masonry in solution in water by a variety means included rising damp. During the dry period, when the moisture evaporates from the masonry wall, the salts will be left behind due to salts cannot be evaporated and the salt solution residue in the wall will become more and more concentrated as time goes by. More and more salt solution will be brought into the wall and accumulated, thus the wall become more and more concentrated. At some point where the solution is reaching a condition which is saturation, or super-saturation, crystals will begin to form in the wall. When the evaporation rate from the wall surface is low, the evaporative front may be at or very the surface, in this case salt crystal will grow as long thin needles, extruding from the wall surfaces (Graham, 2002).

Figure 3. Salt crystallisation on brick wall

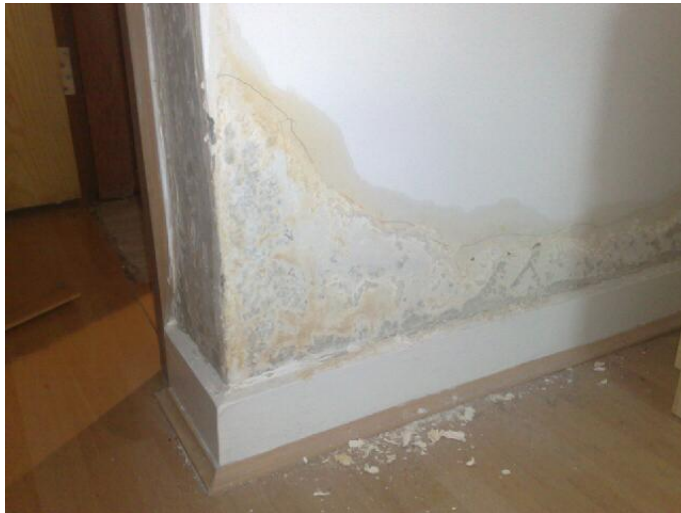
Rising damp is one of the most common yet severe damage that leads to decay and deterioration of many buildings especially heritage buildings as been shown in Figure 5. Rising damp is the upward movement of moisture caused by the capillary action which draws the moisture from the ground or the soil through the network of pores in the permeable masonry material. Capillary suction becomes stronger as the pore size gets smaller.

**Figure 5.** Rising damp on masonry wall

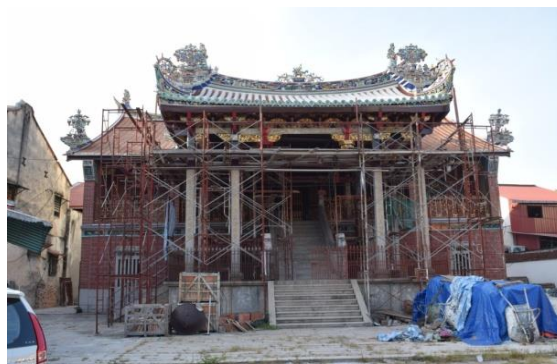
**Figure 7.** Boon San Tong Khoo Kongsi

Figure 7 shows the Boon San Tong Khoo Kongsi which is located at No. 117-A, Lebu Victoria, 10300 Georgetown, Penang. It was built in year 1878. The building of Boon San Tong Khoo Kongsi itself does not occupied by any occupant. However, there are few houses along the two sides of the building. On the left is the side office of the Boon San Tong Khoo Kongsi. On the right is the house of a family. Back in year 1907, the Lebu Victoria road previously was a sea before the creation of road. The current entrance of this building was changed into the newly created street in 1907. Currently, the building is under some renovation works included re-plastering, repainting, repair the traditional element in the building and so on.

From Table 3 above, the lower area of the affected column have very high moisture content until the reading is exceeding the scale. From Figure 12 above, the thermograph has captured that the temperature of the column is low. The moisture content in the wall is decreasing while further up to the column. However, the moisture content is still very high which is recorded as 5.0%. This shows the indications of rising damp. The possible cause of such high moisture content might be the location of the building which is previously a sea. Thus, the moisture of the ground is comparing high than others and the building is more susceptible to moisture.
