## MONITORING PROCESS OF THE RE-CONSTRUCTION OF AN ANCIENT STRUCTURE: THE BALUARTE DO CAVALEIRO

Jorge Pinto<sup>1</sup>, Humberto Varum<sup>2</sup>, João Guedes<sup>3</sup> and Anibal Costa<sup>4</sup>

Received 9 October 2009

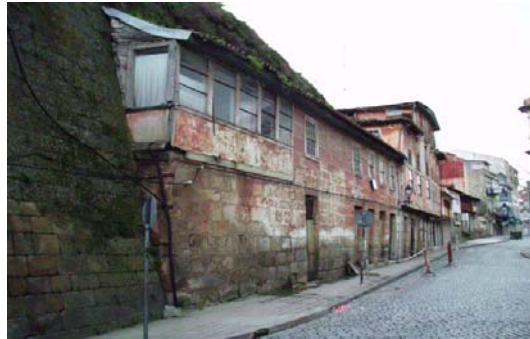
The SE wall has suffered two partial collapses recently. The first one occurred in March 2001 and the second one occurred in April 2002. Until March 2001, existed buildings attached to the SE wall all over its length, as can be seen in Figure 6.

Figure 6. SE wall of the Baluarte do Cavaleiro and the existing attached buildings before March 2001

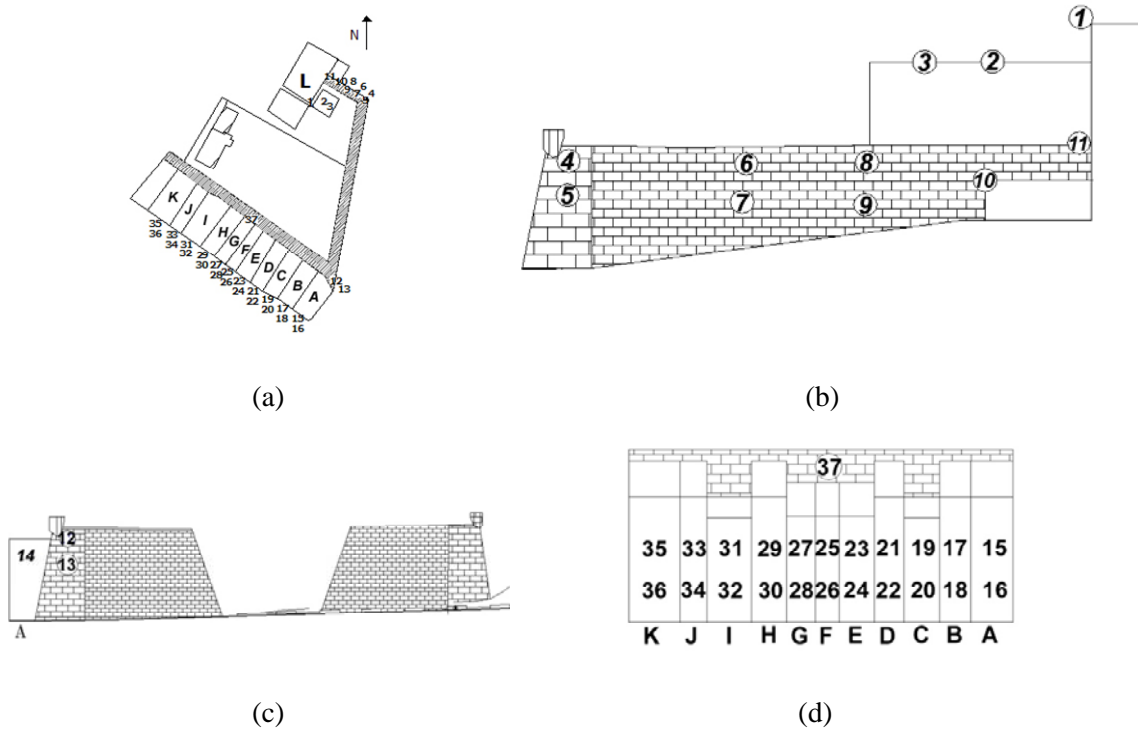
Figure 8. Key-points location and controlled buildings: a) Plan view; b) NE wall, Manas stair; c) SE wall, 25 de Abril road; d) SO wall and attached buildings (from A to K), Sol road

The location of the defined set of key-points (identified from 1 to 36) and the adopted notation for the controlled building (identified from A to L) can be seen in Figure 8. The coordinates of these points were measured using a pulse laser station NIKON-302 (Nikon 2007) and according to the traditional surveying techniques. Those coordinates were initially measured in a global coordinate system  $(x, y, z)$ . In order to simplify the analysis of the results those coordinates were then converted in a local referential ( $x'$  - direction perpendicular to the construction,  $y'$  - direction parallel to the construction,  $z$ , vertical), as represented in Figure 9.

According to the technical specifications of the used surveying instrument (Nikon 2007), its accuracy can be measured using the expression  $\pm(3+3\text{ppm}\times D)$  mm, in which:  $D$  is the distance (in km) from the surveying instrument to the reflector. Thus, the key-points of the NE wall had no expressive displacements during the reconstruction process of the SE wall, these displacements were mainly related to the normal behaviour of the NE wall as being a stone masonry wall structure. We may conclude that the tasks related to the reconstruction process did not affect the stability of the NE wall. In fact, as it was stated before, the key-point 8 was the one that had shown a higher value of displacement and, at the same time, it was the most far away from the rebuilding area, Figure 8(b).

The key-points 12 and 13, Figure 8(c), were defined to monitor the cunhal that connects the SW and SE walls. Their displacement evolution is shown in Figure 13. In this case, there was not a generalised increasing trend on the component displacement of these key-points either; the average value of these components was less than 2.0 mm. These facts indicate that this structural element was not affected by the reconstruction process of the SE wall.

A similar situation had happened for the cunhal that connects the SE and NE walls for which the related key points were 4 and 5, Figure 8(b). The displacement component evolution of these key points is described in Figure 15 where we can notice that until the 116<sup>th</sup> measurement (June 2006) there were not expressive value of displacement. However, from this measurement, the vertical component of displacement of both key points had increased which indicates that these key points went up. This evolution had inverted from the 158<sup>th</sup> measurement (November 2006) and the vertical component of displacement evolution converged to 0 mm, Figure 15.
