Survey on the main defects in ancient buildings constructed mainly with natural raw materials

In this context an early 19th century Portuguese watermill building is used as a study case to show how a roof leaking may lead to a progressive building collapse.

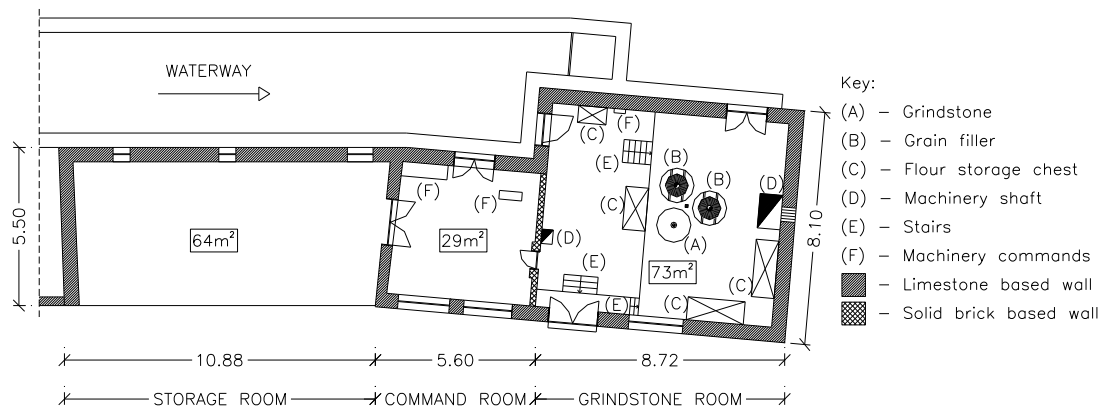
Figure 3. Ground floor Plant, 2009 (m)

The building has basically three rooms located in the ground floor. These rooms are the grindstone room, the machine command room and the storage room, Fig. 3. The grindstone room has a 73 m^2 area in which exist the grindstone, two grain fillers and massive wooden chests to retain the flour. The machine command room has a 29 m^2 area where the turbine's switching levers are located. Finally, the storage room has a 64 m^2 area and its purpose was for storing the grains and flour. Thus, the building has a total area of 166 m^2 .

According to Fig. 3 there are two types of walls. There are several limestone based masonries walls and one solid ceramic brick based wall. The function of the last one is partition. In contrast, the main ones have a structural function since they support the roof system.

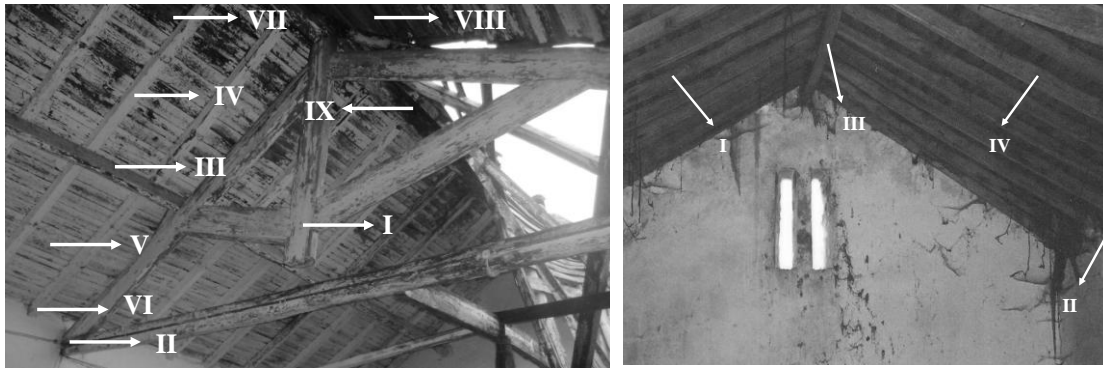
a. Trussed type roof structural solution
Figure 6. Roof structural systems

The roof timber structural solution comprises two types. In the grind stone and the command rooms (Fig. 6-a) it was adopted trusses (Fig. 6-a, detail I) directly supported on the limestone based masonries walls (Fig. 6-a, detail II), these trusses support beams (Fig. 6-a, detail III) which are supporting the purling (Fig. 6-a, detail IV). On the purling there are timber boards (Fig. 6-a, detail V) supporting the ceramic tiles.

The other type of roof timber structural solution was only applied in the storage room, Fig. 6-b, which includes timber beams (Fig 6-b. detail I) which were structures supported on the limestone based masonry walls (Fig. 6-b, detail II) and a central timber beam (Fig. 6-b, detail III). On these timber beams there were timber boards (Fig.6-b, detail IV) supporting the ceramic tiles.

The third roof structural failure occurred this year in the roof of the grindstone room (Fig. 8-c, detail I) in which its roof was partially lost. In this case, the purling (Fig 6-a, detail IV) collapsed in the zone of their support (the limestone based masonry wall (Fig. 6-a, detail VI) generating a load redistribution which resulted on the collapse of the beam (Fig. 6-a, detail III). This load redistribution was possible because the roof structural solution works as a structural system (CEN, 1998).

Meanwhile, Figure 8-a illustrates the roof's condition of the grindstone room before the above described third roof's structural collapse occurred in 2009 (Fig. 8-c). Some purling and timbers boards showed an advance stage of deterioration in the contact zone with the structural wall. Through Figure 6-a, detail I, it is also possible to notice that these timber elements had a darker shade than the similar ones located outside of the damaged zone which indicated a leaking problem. By doing a similar analysis, Figure 6-a, details VII, VIII and IX indicated that there were some cracked ceramic tiles or the ceramic tiles/timber board direct contact solution was not the appropriated one because may increase an undesirable water moisture in the timber structural elements.
