# The use of FRPs in seismic repair and retrofit: Experimental verification

A. Pinto, P. Negro, A. Colombo & H. Varum

*ELSA Laboratory, Joint Research Centre, EC, 21020 Ispra (VA), Italy*

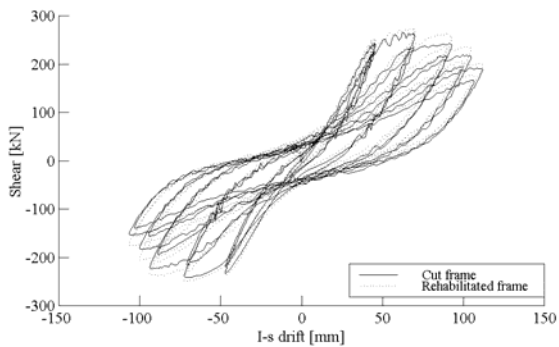
As a frame of low ductility, the building was characterised by a behaviour factor of 2.5. In spite of this value, the structure was able to sustain a maximum top displacement equivalent to a global ductility level of 6.5 without any major strength decay (see shear drift diagram in Figure 6).

Figure 6. Storey shear vs. interstorey-drift at first storey for the cut (after cutting the fiber strips) frame and the rehabilitated frame with composite material

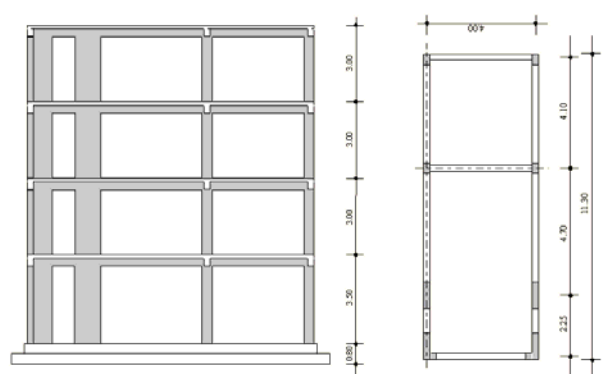
A full-scale reinforced concrete dual structure (Figure 7) was recently subjected to earthquake simulations at the ELSA Laboratory (Tsionis et al. 2001). The building consisted of two frames; one was designed according to Eurocode 8 and the other according to an innovative deformation-based design philosophy.

The structure was pseudodynamically subjected to an earthquake corresponding to the design intensity. The test was then repeated with the input increased by a factor of 1.5. During the second test, the building suffered extensive damage. Horizontal cracks typical of flexural failure were observed in the EC8 side of the building, whereas diagonal shear cracks appeared in the other part.

Figure 7. Layout of the dual structure elevation and pan-view)

The structure was then used to investigate the effectiveness of CFRP as a repairing technique. After the injection of all cracks with epoxy resin, monodirectional carbon fibre wraps have been glued around all the member (beams and columns) ends (see Figure 9). The shear walls have been wrapped throughout the height of the building (Figure 8). Being the damage in the two frames of the structure

caused by different phenomena, it has been decided to intervene in a different way in the walls of the two frames. In particular, four-directionally-oriented wraps have been applied to the shear walls of the deformation-based designed frame in order to recover the loss in shear resistance. In the other frame, the intervention has been limited to the increase of the confinement effects by using monodirectional oriented fibre wraps.

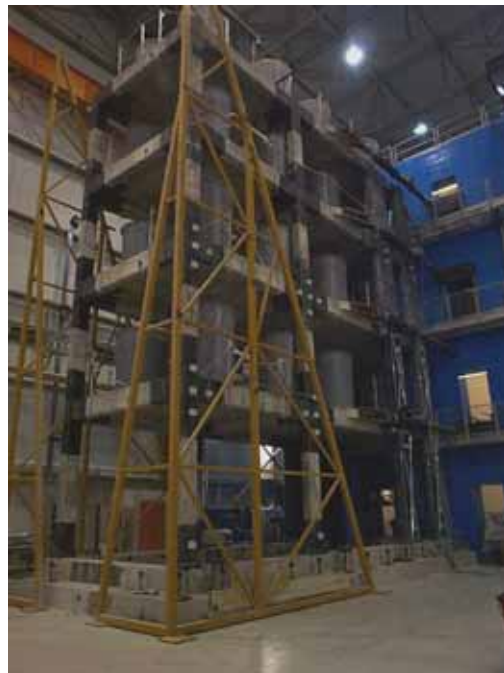
Figure 8. Earthquake tests at ELSA. Experimental set-up

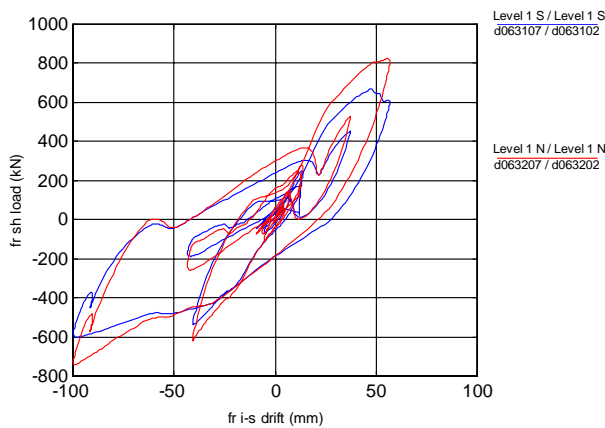
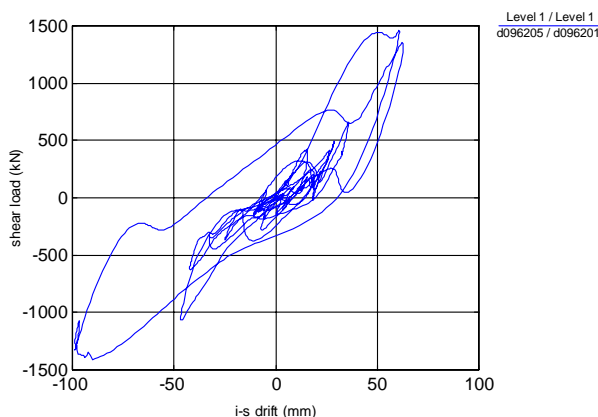
A preliminary analysis of the results seems to demonstrate that, thanks to the intervention, the loss in strength caused by the damage suffered during the previous tests was recovered. In addition, the capacity of the frame to behave in a ductile fashion appears improved (see shear-drift diagrams in Figure 10). The application of a quasi-isotropic wrap on the shear walls resulted in a local modification of the cinematic behaviour of the walls. The energy dissipation mechanism passed from the opening/closing of shear cracks to a rocking movement around the base of the walls.

Figure 10. First storey shear-drift diagrams for the high-level earthquake test for: a) the two original frames, b) for the repaired and strengthened frame

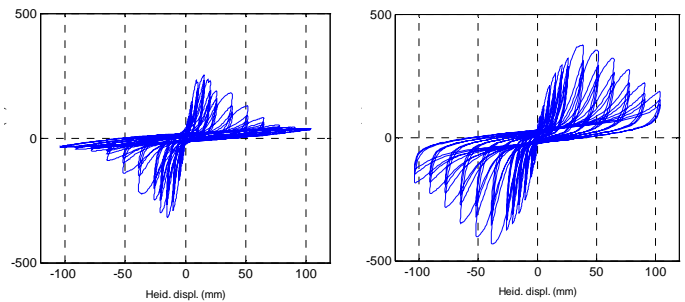
The difference in the responses of the plain and the confined panels was much more significant for the case of panels with non-symmetric openings (Figure 12). The unreinforced infill totally collapsed at a displacement corresponding to a storey rotation of about 0.03 rad. At this level of deformation, the panel with the plastic grid, even though dramatically damaged, was still able to provide 65% of its maximum strength. The effects of the confinement accomplished by the insertion of the net resulted in a significant shift of the yielding point up to larger forces (the difference on the shear resistance was about 40%) and larger rotations (from 0.006 to 0.015). This means that by the adoption of the proposed methodology, the panel could be able to dissipate an important amount of energy without major strength decay up to large storey rotations. This level of deformation is close to the limit fixed by the Eurocode 8 for the check of the serviceability Limit

Figure 12. Panels with openings: Shear (kN)-drift (mm) diagrams for plain (left) and reinforced (right) panels

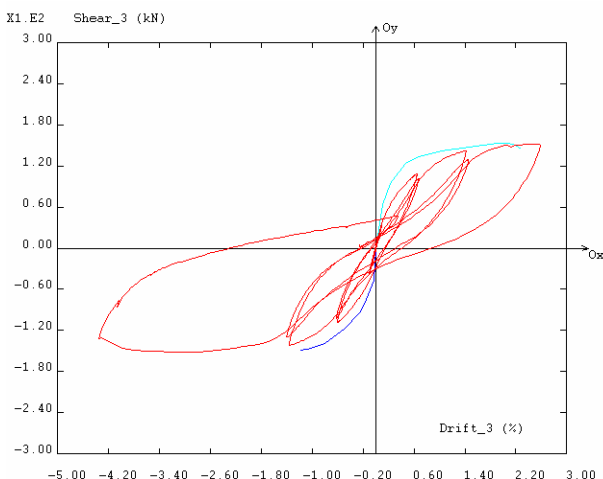
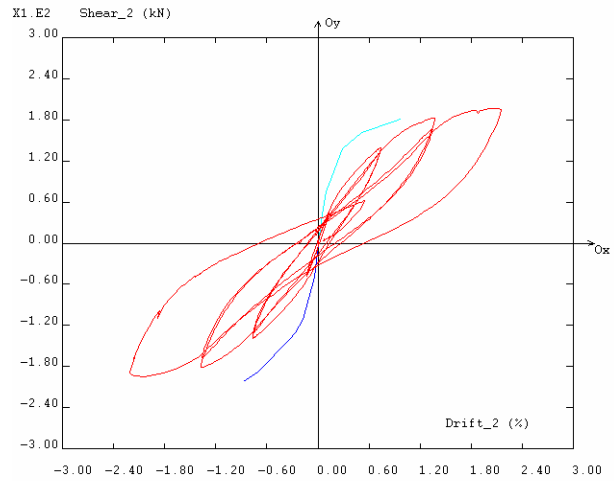
After repair and strengthening, the frames were subjected to a final collapse test consisting of an imposed top displacement cycles with increasing amplitude and assuming a triangular inverted force distribution. The shear-drift diagrams for the second and third storeys are give in Figure 16 together with the envelope of the earthquake response obtained from the earthquake tests.

It is noted that the repaired/strengthened frame was able to withstand storey deformations higher than the ones reached in the earthquake tests (these tests led to local failure of the column/joints) maintaining its load carrying capacity.

Figure 16. Shear-drift diagrams for the RC frame: 1) repaired/retrofitted frame - cyclic deformations; 2) envelope curves from the earthquake tests, which led to local column/joint failure
