Seismic vulnerability of churches in Faial and Pico islands, Azores

J. M. Magalhães, R. Vicente, T. Ferreira, A. Costa & H. Varum

SUMMARY:

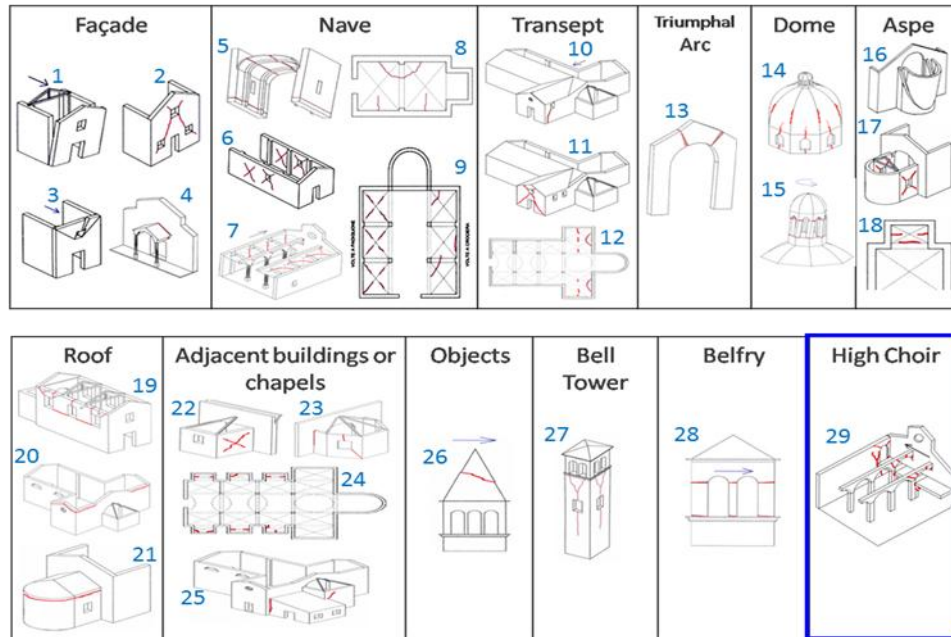
The study of this macro-element is extremely important due the register of serious damages (Figure 3) that may result from its interaction with other parts of the structure, for example, the sidewalls, arches that support the structure or the façade. For this reason it was introduced as the 29th damage mechanism on the methodology corresponding to this macro-element. Figure 4 presents all the damage mechanisms considered in this work.

Figure 4. Damage mechanisms (adapted from *Linee Guida*, 2006).
