## **HMS VANGUARD 100**

*Citation for published version (APA):*  
Rowland, C., & Hyttinen, K. (2018). HMS VANGUARD 100: Survey 2016-2017. HUSKYAN.

HMS VANGUARD 100  
SURVEY 2016-2017  
Survey Report

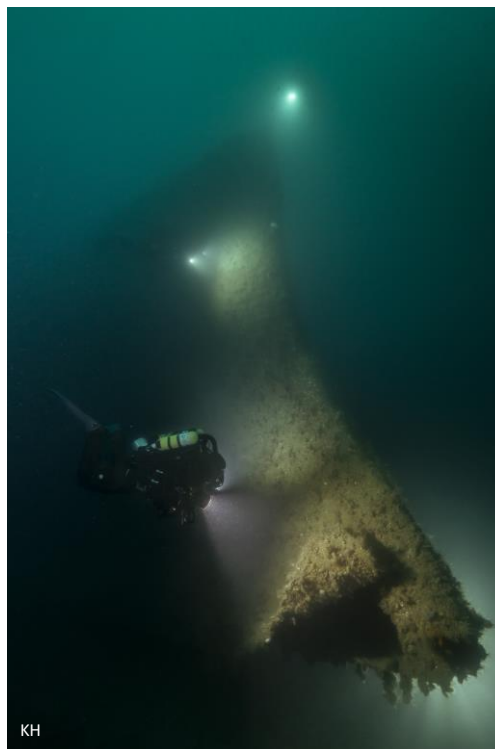
Figure 22: The Bow

Approximately 26m long and 11m proud of the seabed at its highest point, the Bow lies upright, pointing towards the north-northeast. It comprises of the hull structure above the Platform Deck up to the Forecastle Deck, and from the Wardroom skylight (frame 36 just forward of A Turret breakwater) to the bow post. The Forecastle Deck slopes downwards from the bow to the Wardroom skylight at an angle of approximately 25 degrees and is bent downwards at the hull break. The hull side plating is bent outwards on both sides at the hull break consistent with damage from an internal explosion and impact with the seabed. This has exposed the officers cabins on the port side of the main deck where white bed frames are visible.

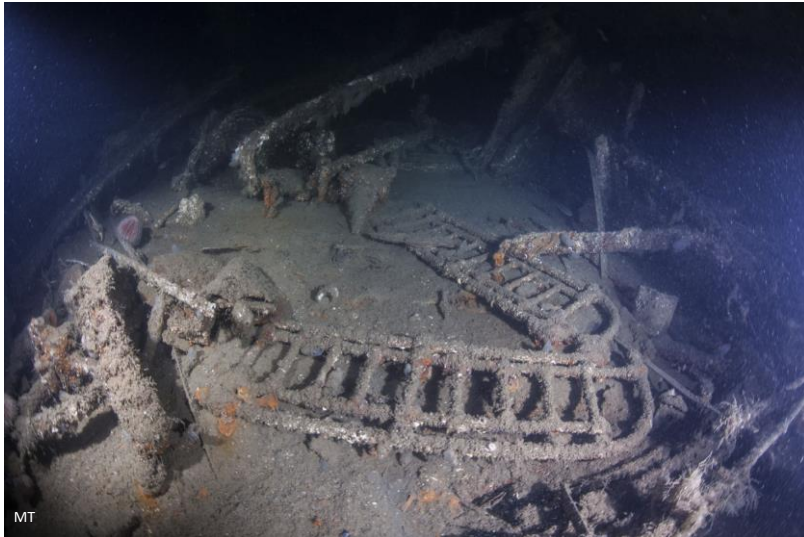
Figure 23: Officers bed frames

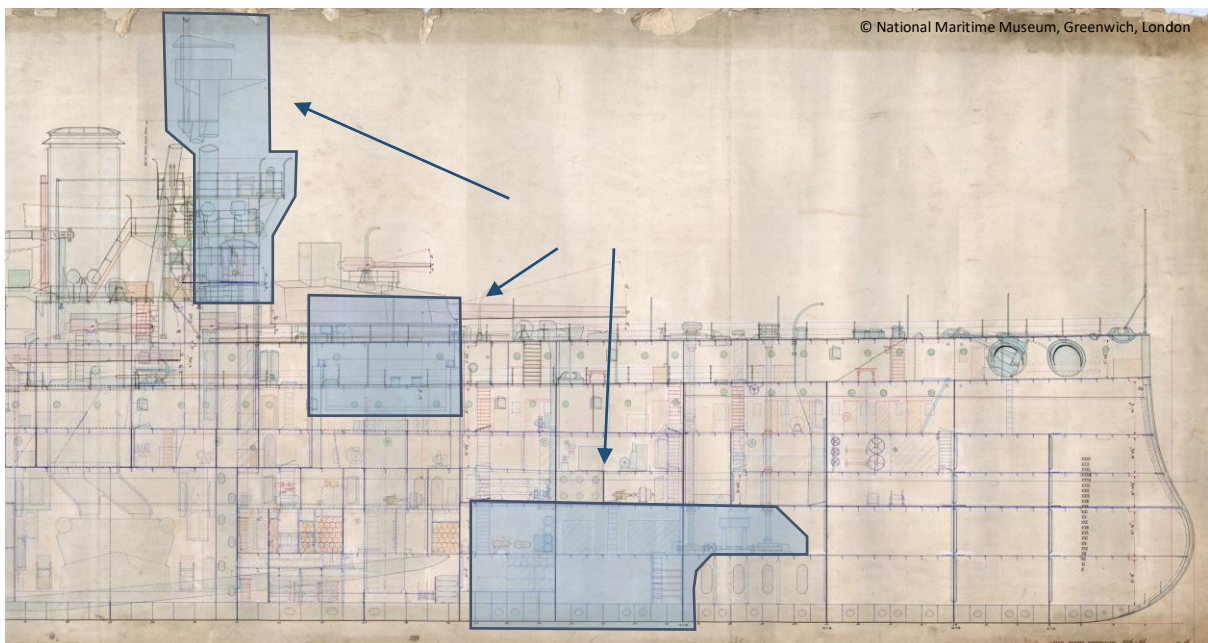
This is a substantial collection of wreckage covering an area of approximately 40m by 15m. A 12-inch turret, almost certainly A Turret, rests on its side. Aft of this is wreckage from the bridge area including the foremast, spotting top, fore bridge and compass platform, signal and conning tower. The wreckage also includes capstan machinery from the Platform Deck (frames 26-30) and the substantial double bottom hull plating on which it was mounted, and the submerged torpedo tube doors from the forward hull sides at Platform Deck level (frames 41-43).

Figure 27: Extent of wreckage at A Turret and Bridge

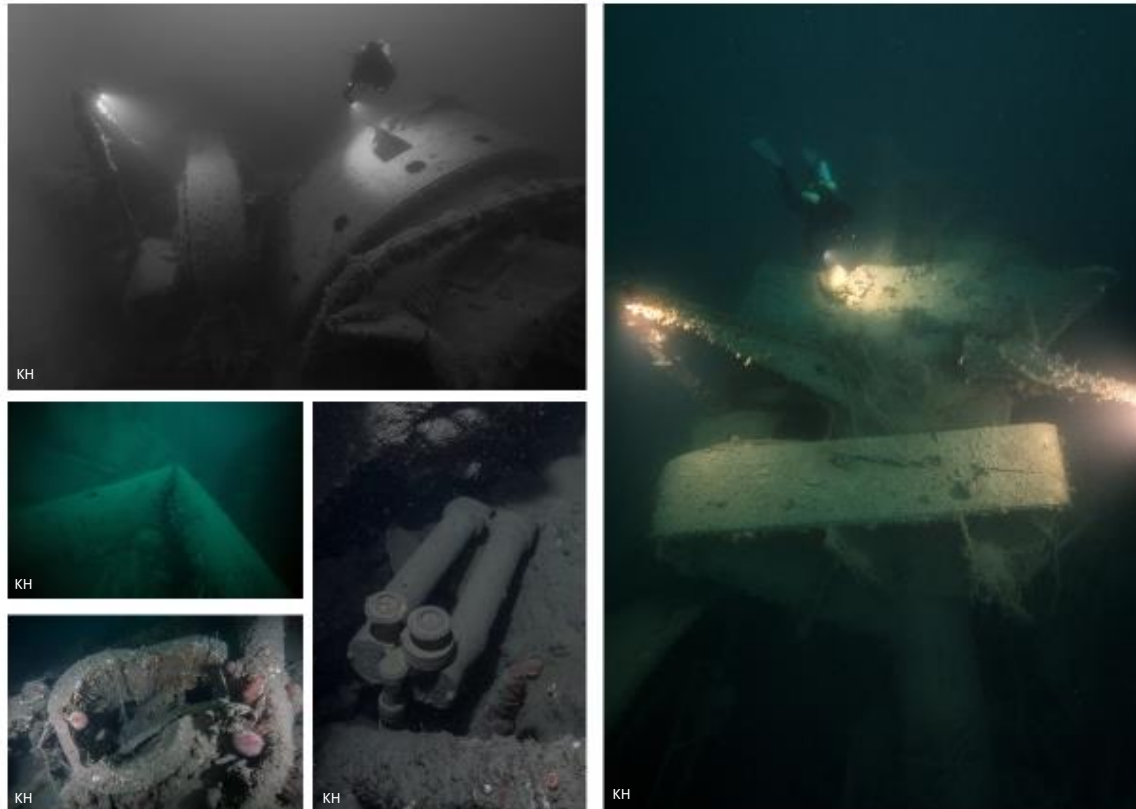
Figure 28: Clockwise from top left: A Turret and spotting top, foremast bent at 90 degrees, forward torpedo tube door, periscope binoculars, spotting top

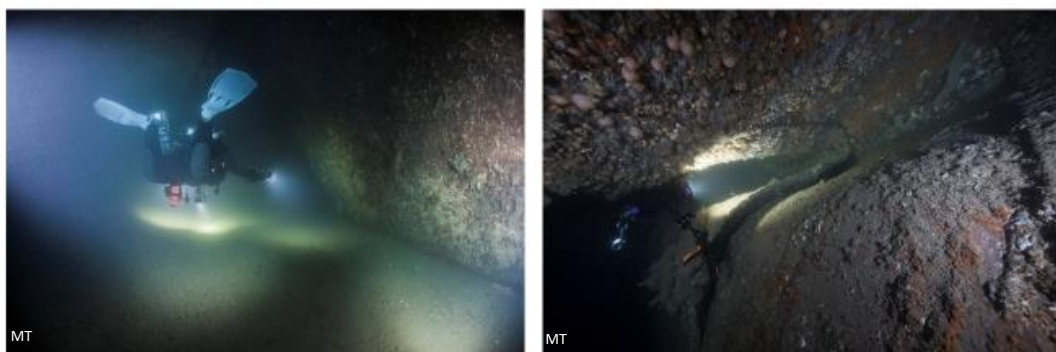
The decks and hull from above the Boiler Rooms and Engine Rooms are absent. The hull bottom throughout these sections is heavily distorted. It is severed to the west side of the wreckage forward of X Magazine in the vicinity of Boiler Room 3. Ostensibly, the lower hull is lying on her port side. Ten metres to the east of the datum line the double bottom stands up to 5m proud and is bent upwards in the vicinity of X Magazine forming a sharp bend at the apex and a "tunnel" beneath the hull approximately 5m wide that extends, with reducing width and height, almost the full width of the hull, emerging to the severed west side of Boiler Room 3 adjacent to the port side bilge keel. The westerly edge of the wreckage at this point lies approximately 15m to the east of the datum line and is in the vicinity of Boiler 1. Sections of the main outer 10-inch belt armour lies horizontally just off the seabed.

Figure 30: "Tunnel" beneath the hull and the sharp bend in the hull at the Apex

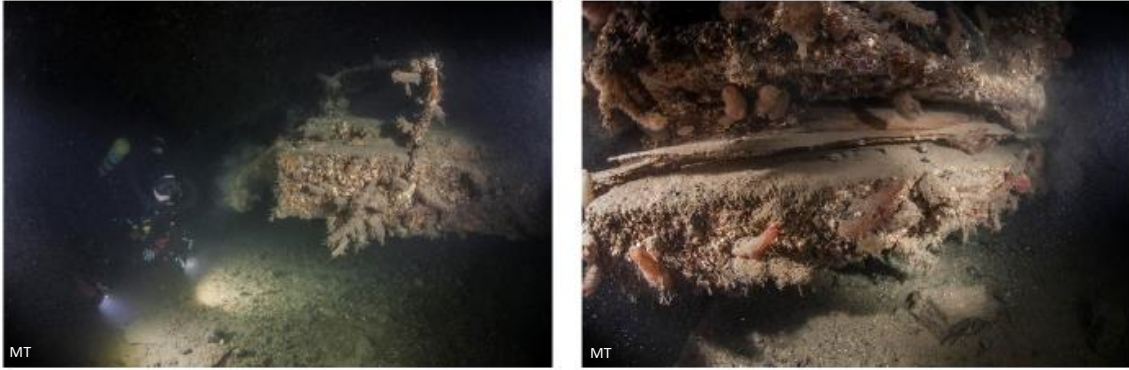
Figure 31: Sections of port side 10-inch armour belt and wooden lining

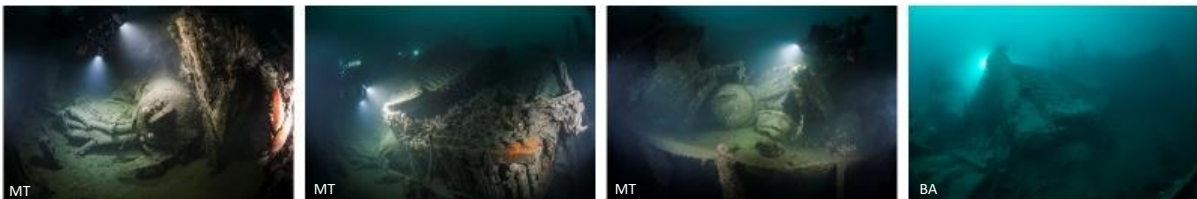
Eight boilers (survey numbers 1, 2, 3, 4, 5, 7, 8, 13) have been identified in this area, however, it is highly likely that more are buried beneath the visible boiler wreckage. Aft of the boilers and on the datum line is a circular ring structure likely to be deck structure for X Turret. X Turret is missing from this section and has been displaced towards the stern. To the west of the datum line is an area with a high concentration of 12-inch Clarkson cases. Four-inch propellant cases and 4-inch shells are also present. This is consistent with the X Turret Magazine and adjacent 4-inch Shell Room. To the east of the datum line is an area with multiple 12-inch shells, which appear to be 'stacked.' Based on location, this is highly likely to be the 12-inch Shell Room for X Turret (frames 139 to 148).

Figure 32: Babcock and Wilcox boilers

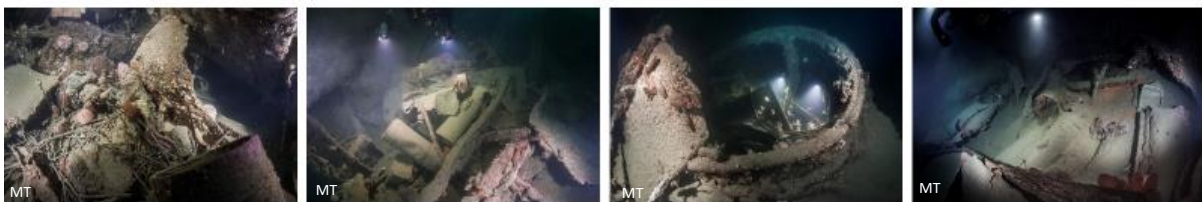
- A slight depression in the seabed of depth  $\cong 1\text{m}$ , absent of substantial pieces of wreckage.
- Randomly scattered sticks of cordite and small pieces of coal and shoe soles.
- 4-inch cordite cases heavily deformed and turned inside out by the effects of explosion, clearly identifiable by their corrugated case-form.
- 12-inch Clarkson cases empty of cordite, split open and with heat damage.

Figure 33: 4-inch shell & cordite; 12-inch Clarkson cases and 4-inch propellant cases; X Turret deck ring; X Turret 12-inch shell bin

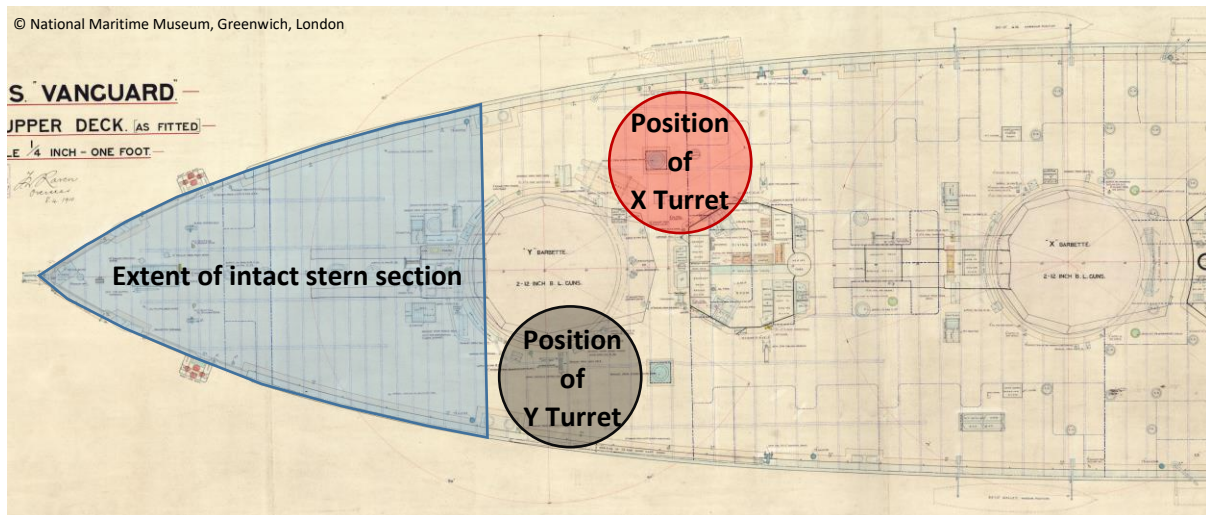
Figure 36: Position of X & Y Turrets in relation to the stern

The stern section is located immediately south-east (aft) of the Engine Rooms and Y Turret. It remains ostensibly intact abaft frame 206 (aft of Y Turret) and resting on its port side. The name "VANGUARD" can still be read on the port side. The Stern is orientated approximately east/west, with the sternpost to the east. The teak on the Upper Deck is in remarkably good condition and is bent downwards at approximately 90 degrees just aft of the barbette

aperture at the “break” in the hull. This bent section of upper decking contains a distinctive curved edge, that is almost certainly the deck aperture for Y Turret barbette (frame 200). Adjacent to this, Y Turret sits upright on the seabed. The gun house and barrels are missing. On the seabed sits the only 12-inch barrel located during the survey. It shows signs of salvage – the barrel is broken and the base of the barrel is stuck in the seabed, but has salvage chains wrapped around it. X Turret sits 10m to the northwest from Y Turret. It is also upright with gun house and barrels missing. The turret has been displaced from its original position forward of the turbine rooms.

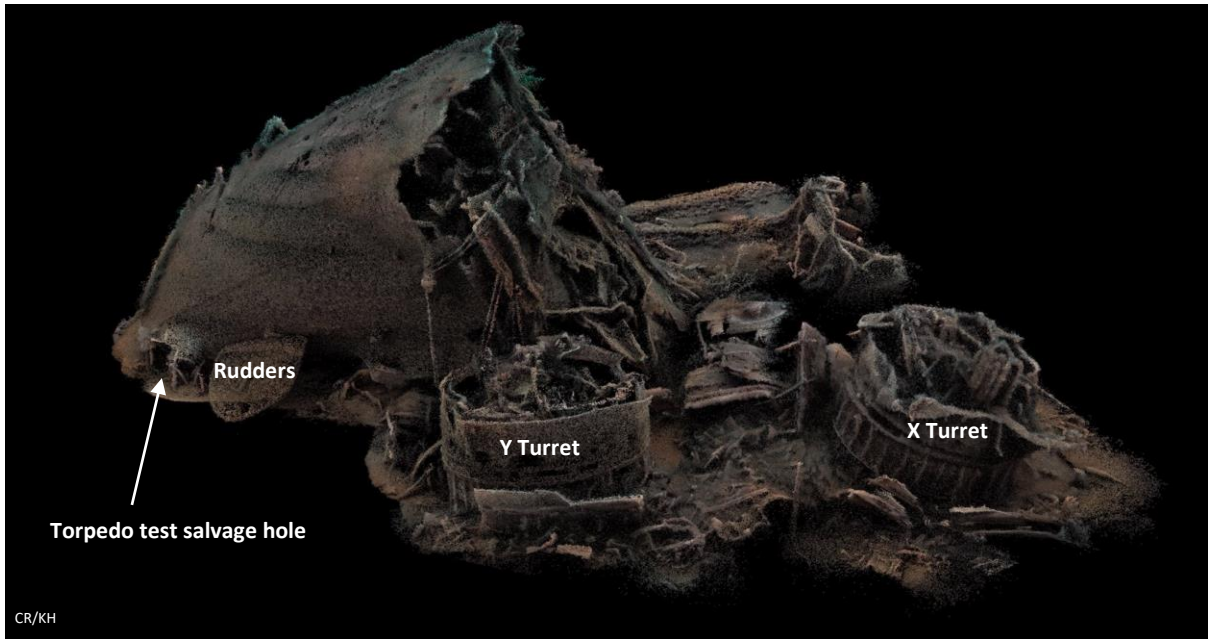
Figure 37: 3D photogrammetry stern image

Both rudders are visible, although the port rudder is partially buried in the seabed. None of the four propellers are visible. Severed A frame brackets for both starboard propellers and the port inner propeller are visible, attached to the hull and keel. The two inner propellers are known to have been salvaged by Nundy and Campbell, it is presumed that the third accessible (outer starboard) propeller was also salvaged by Nundy with the fourth propeller likely still buried under the stern section itself. Two guns are present on the Upper Deck of the stern section; a Hotchkiss gun located at frame 216 (not on the original plans, probably retrofitted for signalling and saluting) and a 3-inch 20 cwt Mk II quick firing high angle gun mounted on the very stern for engaging aircraft. The exit port for the rear torpedo tube is visible, with a large hole in the hull immediately below, which allows viewing into the Stern Torpedo Compartment. No torpedo tube or associated equipment is present. The larger hole is highly likely exploratory, made by the salvagers to locate the aft torpedo tube, but it would not have been large enough to remove the torpedo tube itself. It is therefore likely that the torpedo tube had already been removed from VANGUARD during a refit period. This is confirmed in the St Vincent Class Cover records held at Greenwich Maritime Museum.

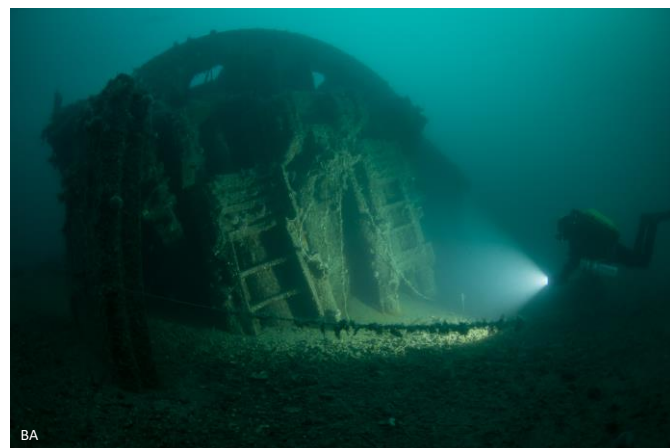
Figure 40: P Turret

**P Turret** is located on the seabed approximately 20m to the west of Boiler Room 3, approximately 35m south-southwest (aft-port) of its original position in the ship. P Turret lies on its side and some shield armour remains jutting out of the seabed.

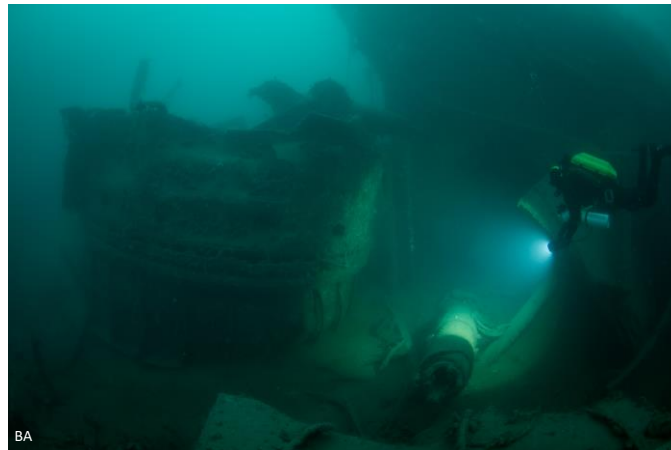
Figure 43: Y Turret & severed gun barrel

**Y Turret** is located in the Main Aft section. It is detached from the stern and lies upright immediately south of the Engine Rooms. It is in approximately the same position relative to surrounding wreckage as it was in the ship.

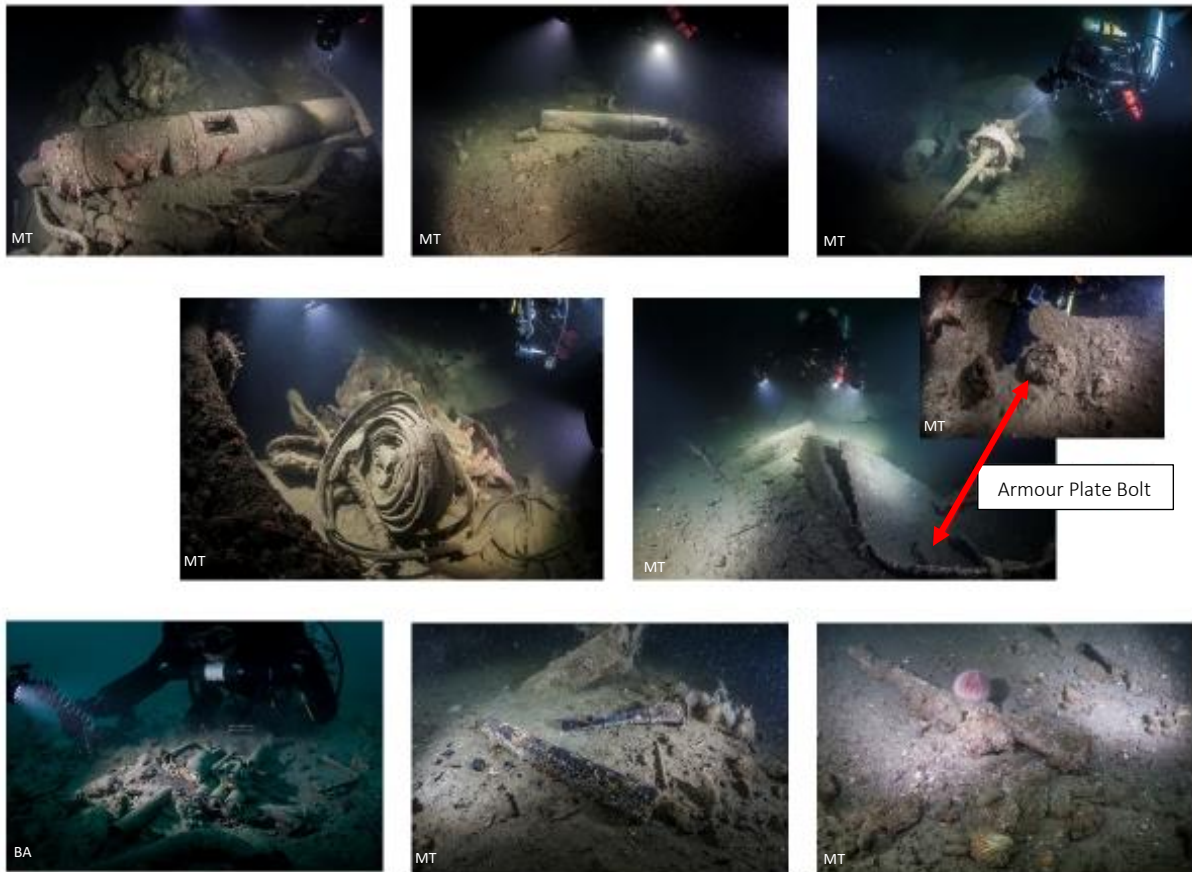
This area contains a very large section of wreckage, likely associated with the starboard hull between Q and X Turrets. The wreckage begins approximately 10m east of the datum line and extends a further 20m before bending at 90 degrees to the south for a further 30m. At the corner a section of 10-inch armour plating protrudes from the seabed. Evidence of coal bunker structures are present, including large amounts of coal. There is a 30.4m continuous section of bilge keel visible, providing evidence for this wreckage being hull section. Two

boilers (survey numbers 6, 11) are located here. Other features in this area include a range finder and a lay shaft from one of the engineers workshops. The remains of musical instruments were located on the seabed, specifically the body of an oboe and clarinet and the remains of a brass instrument, probably a euphonium given the size of the valve block. A rifle lies in the vicinity of the musical instruments.

Figure 45: Top: two sections of range finder; lay shaft. Middle: coil of hose; armour plate with armour bolt inset. Bottom: brass instrument; woodwind instruments; rifle

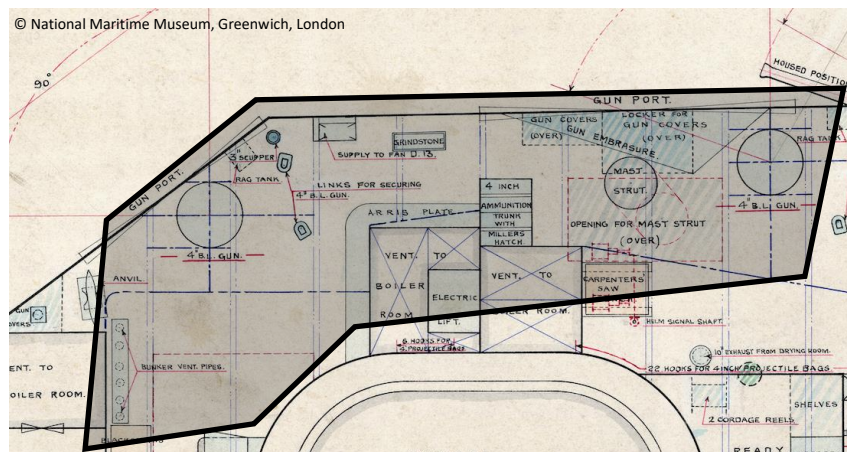
Figure 47: Extent of Debris 5 wreckage

A section of aft port side superstructure (Forecastle and Flying Deck) lying on its side on the seabed in the SW Outer area >50m beyond the stern section. One 4-inch gun sits mounted in its embrasure with splinter shield. Louvered vents for coal bunkers litter the wreckage and at the aft end a section of bunker vent pipes protrudes from the seabed. External domed bulkhead lights are present around the wreckage along with a bulkhead door with glass porthole. Lying off to the side off the main lump of wreckage is a section of plating containing a second 4-inch gun mount. An access ladder lies to the south of the wreckage.

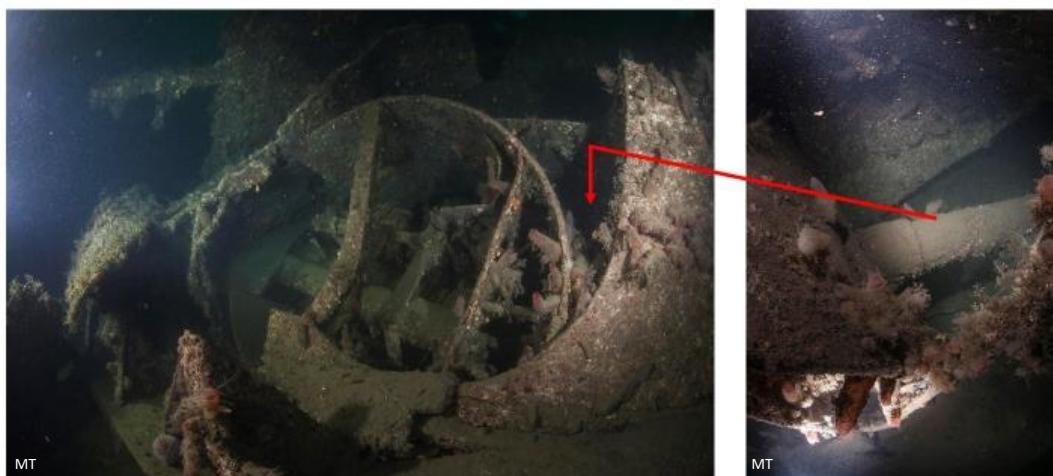
Figure 48: 4-inch gun with barrel visible

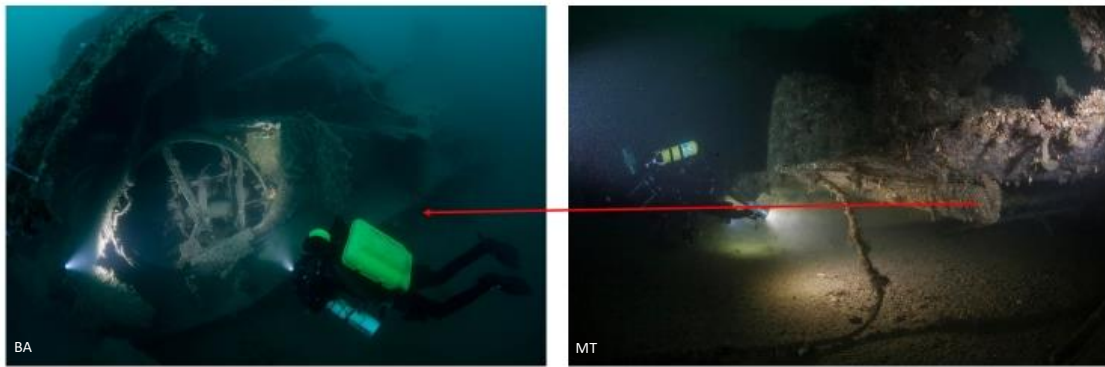
Figure 49: Debris 5: gun barrel visible under wreckage

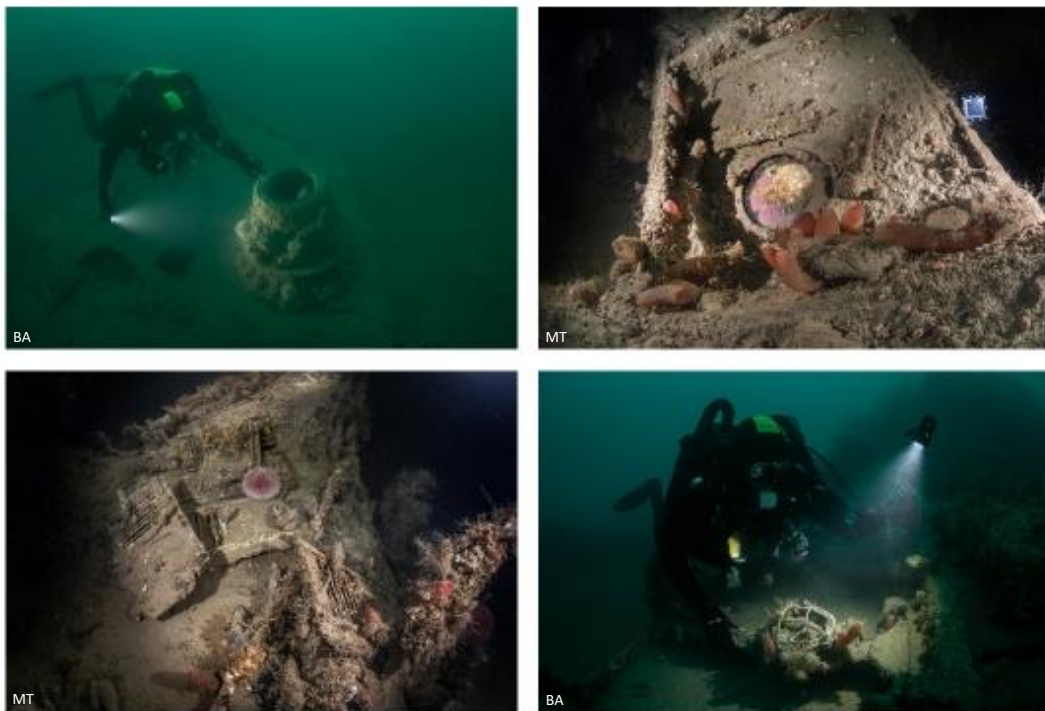
Figure 50: Debris 5: gun mount; door with porthole; air vents; bulkhead lamp

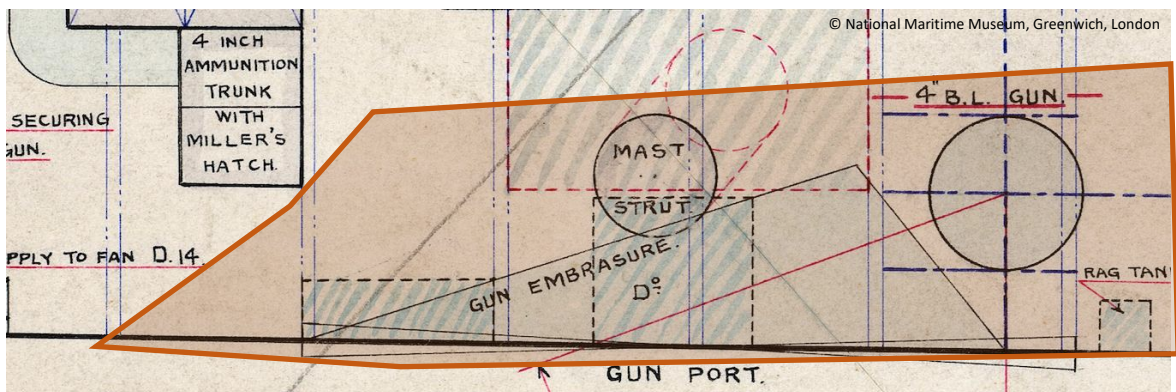
Figure 51: Debris 1

An isolated section of aft starboard side superstructure, including a 4-inch gun mount and embrasure and the base of the starboard main mast strut.

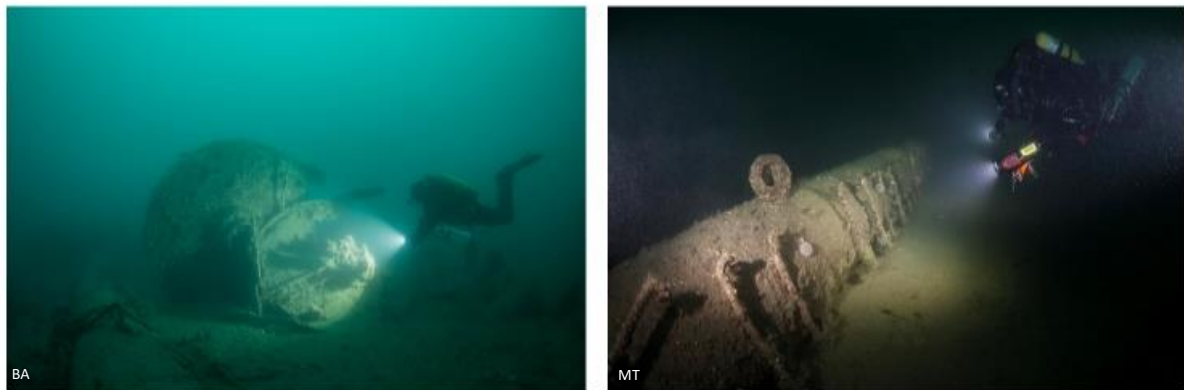
Three distinct pieces of the main mast lie on the seabed some 72 metres aft of the stern. The external ladder is visible on the north-most section. Spotting top platforms and part of a rangefinder were located on the other sections.

Visible are the remains of the uppermost platform and a short section of the main leg and approximately 10m of one of the mast struts, side unknown. The remainder of the main mast and struts are missing and were not located on the wreck site.

Figure 52: Main mast section and spotting top

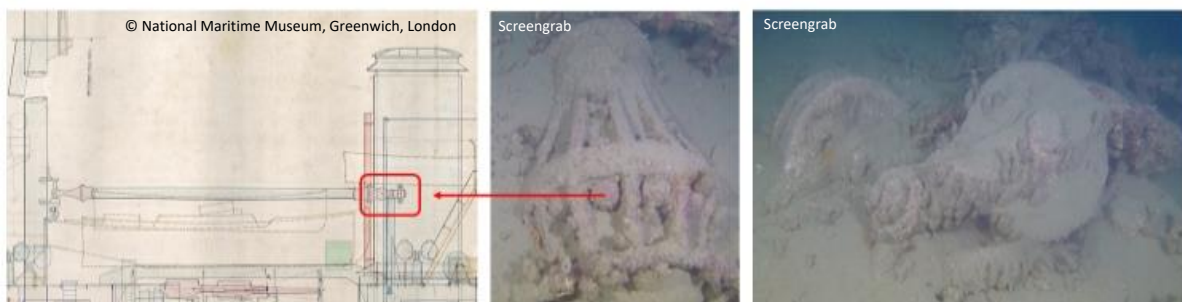
Figure 53: End of the main lifting boom and associated tackle

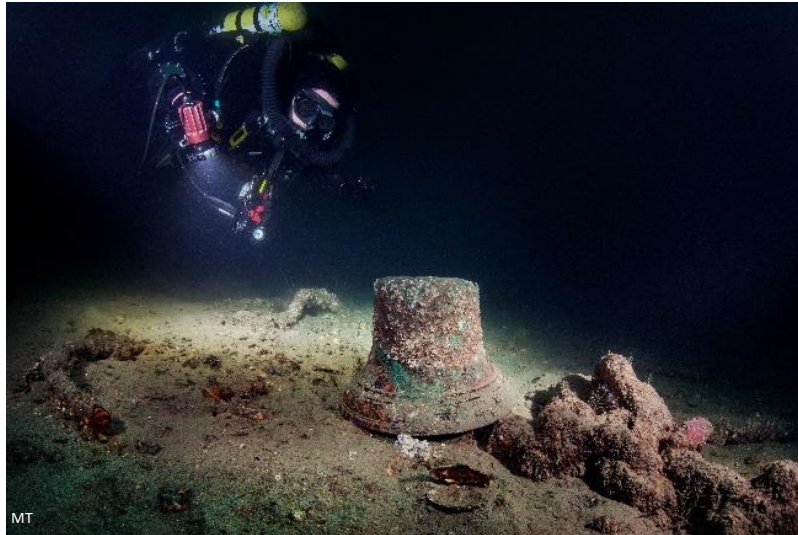
Figure 54: Ship's bell

Isolated and lying some 180 metres from the main wreck site and 60 metres from the aft superstructure is a ship's bell, presumed to be the aft bell from VANGUARD. No lettering was visible. There is damage to the top of the bell consistent with an explosion. The distinctive end of the ship's main boom with associated lifting tackle lies some 10m from the bell.

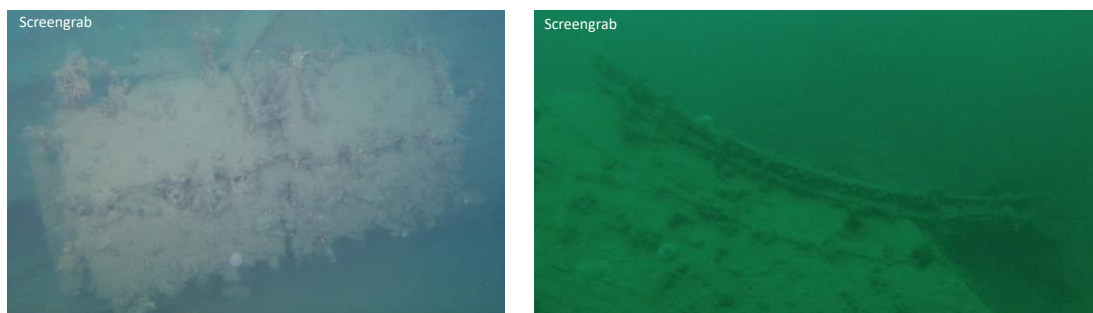
Debris 2 consists of a large piece of starboard side decking lying over the top of a smaller piece of decking. The larger piece contains a four-paned skylight adjacent to a small square vent which pinpoints this to the sick bay. Only two four-paned skylights are found on the ship's plans. The first is in the bow above the Gun Room, which is still in situ, and the second above the Sick Bay towards the stern on the starboard side. Also present is part of the curved deck aperture for X Turret. The smaller decking underneath is a piece of side decking with spurn water still intact. Brackets for stanchions, a small deck cleat and a scupper are all visible.

Figure 55: Debris 2: Sick Bay skylight and X Turret deck aperture

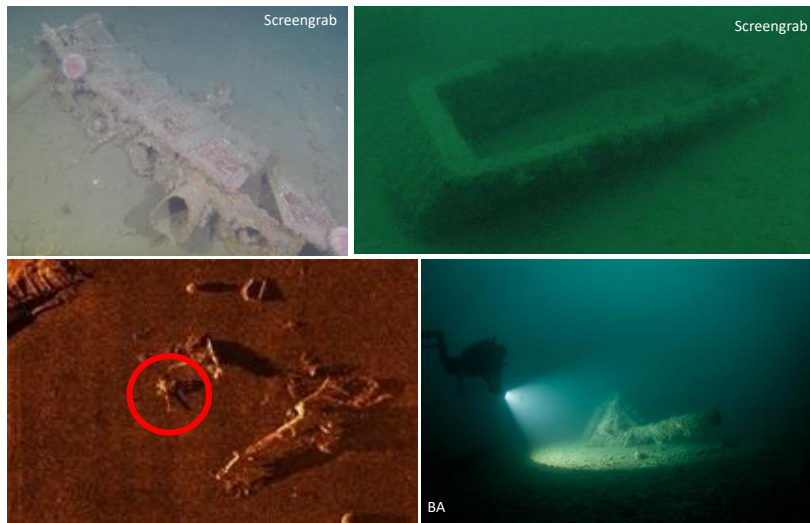
Approximately two metres to the north lies an intact section of bunker ventilation pipes and associated louvered covers. These lie adjacent to an intact 4-inch gun with splinter shield. The mount for this gun lies upturned attached to twisted decking just behind the gun. Five metres to the east is a very heavily built trough-like structure similar to a bathtub, but double the size. The thickness of the steel is approximately two inches.

Figure 56: Debris 2: Bunker ventilation pipe; heavily built trough structure; sidescan image of 4-inch gun; 4-inch gun;

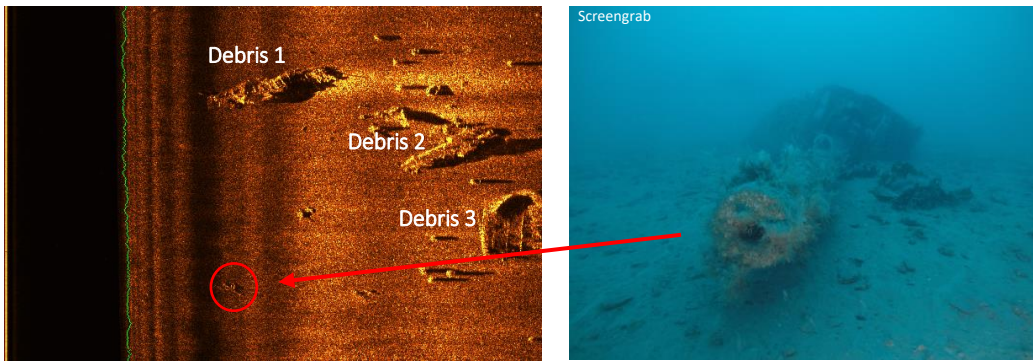
Contact 16 is an isolated 4-inch gun located some 40m from the SE corner of Debris 3.

Figure 58: Contact 16 Four-inch Gun

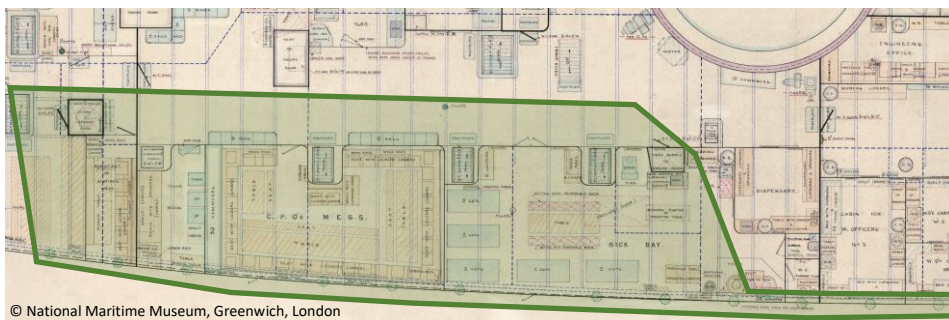
A large section of wreckage (approx. 30m by 10m), located 15m SE of the stern, being a combination of ship's side identifiable by side scuttles and teak deck. This section comprises two distinct parts. The first is a large length of ship's side from the main deck sitting upright with internal decking still attached containing several deck hatches and vents. The combination of square and round scuttles in the side, along with the main deck hatches and vents and the remains of bulkheads, indicates that this section of wreckage is from frames 130–187. Lying on top of this is a smaller section of Upper Deck. A fairlead and swinging boom bracket pinpoints this section to the Upper Deck, starboard side between X and Y Turrets, approximately frames 156–182. The two sections originate from the same place on the ship. However, the section of decking has been separated and turned through 180 degrees before landing on top of the main deck wreckage.

Figure 59: Debris 8 Main Deck wreckage showing visible hatches

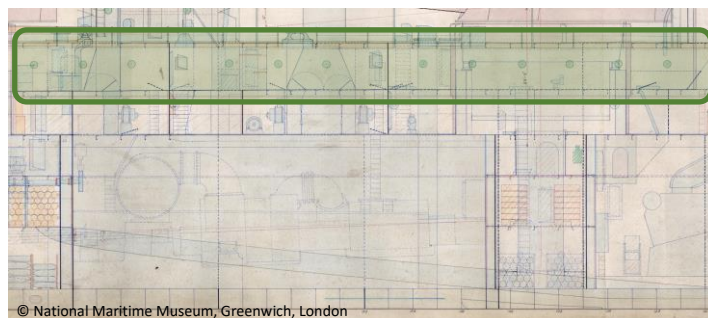
Figure 60: Debris 8 Main Deck wreckage profile of scuttles/portholes

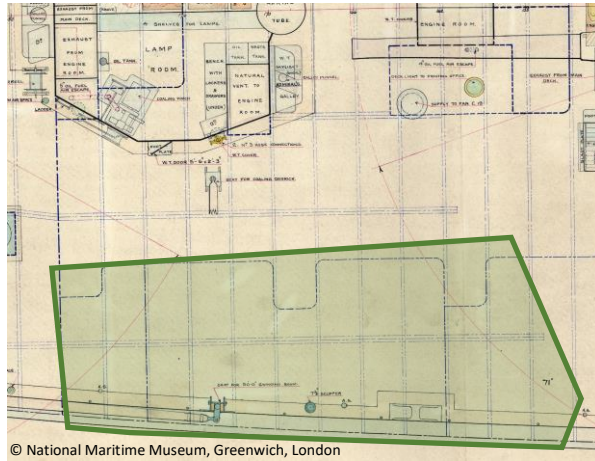
Figure 61: Debris 8 Upper Deck wreckage showing identifying fairlead and swinging boom bracket

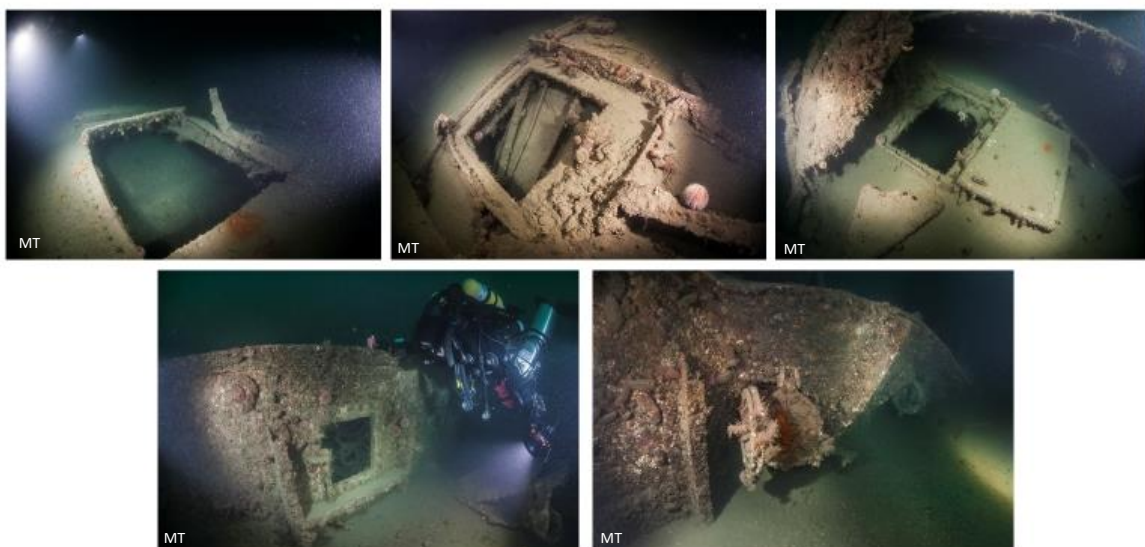
Figure 63: Debris 8: Top: Main Deck hatches. Bottom: square and round scuttles

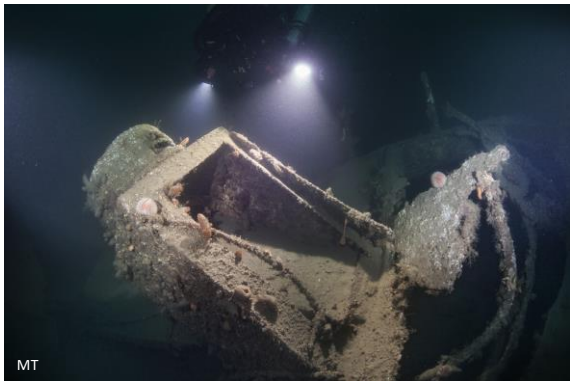
Also present is structure from the Flying Deck, including shelter decking with searchlight director tower, a 4-inch gun mount and a 4-inch propellant charge case or Clarkson case. The rectangular corrugated cases for the 4-inch guns appear to be copper or brass and designed to hold four or six propellant charges. This one is adjacent to the remains of one of the 4-inch gun mounts, and so would have been for “ready ammunition” for the first firings of an engagement (somewhere nearby would have been 4-inch projectiles/shells). This example is the same as an exploded one located in the Main Hull wreckage forward (see Figure 29), which would have been in the 4-inch Magazine adjacent to P/Q Magazines.

Figure 64: Debris 8 searchlight director tower

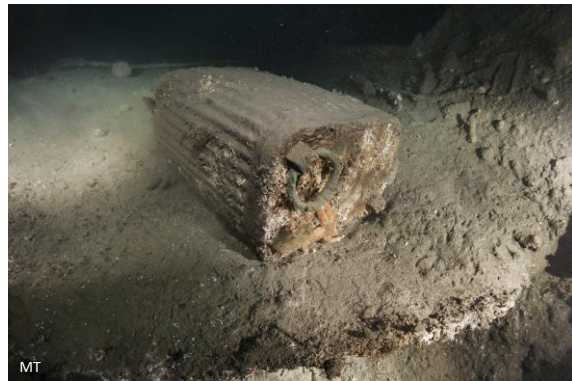
Figure 65: 4-Inch propellant charge case

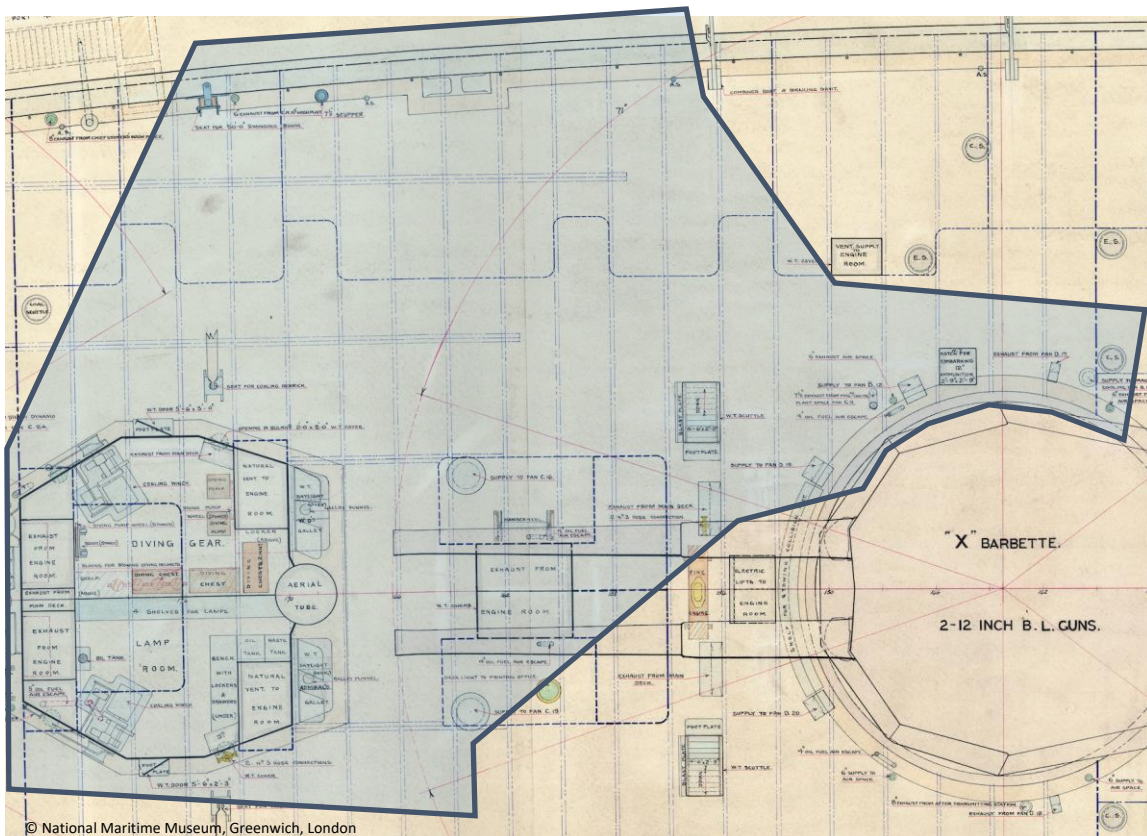
Figure 66: Debris 6

A large section of the Upper Deck from inbetween X and Y Turrets has been displaced to the south west. The wreckage lies upside down and extends from frame 140–180 (approx. 30 metres). At the east end visible under the structure are the Diving Gear Store and Lamp Room. Identifying features include two coaling winches. One is on the port side adjacent to the Diving Gear Store door, the other is on the opposite side adjacent to the Lamp Room door. The remains of the store appear largely empty but the remains of one diving pump and one wooden equipment chest are visible. The Lamp Room contains many different examples of ships lamps.

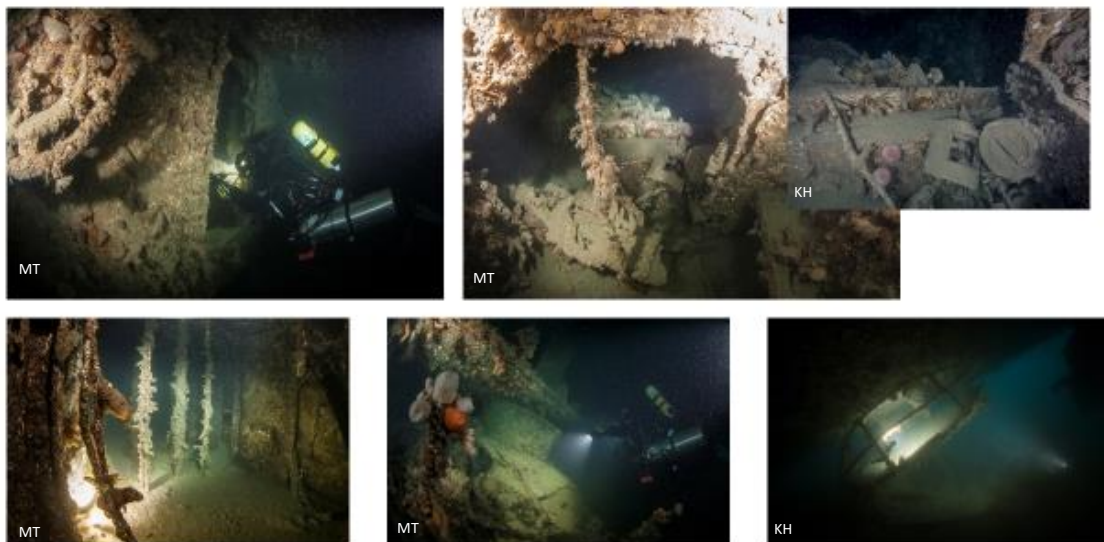
The room above the Diving Gear Store and Lamp Room labelled as the Painted Canvas Room on the ship’s plans is still in-situ, but rests partially buried in the seabed. The compass platform that should sit on top of this lies upright on the seabed approximately two metres away from the door to the Diving Gear Store. There is some research evidence to suggest that the compass was removed between May and July of 1917<sup>4</sup> and replaced with a 3-inch gun. A mount is clearly visible, although we found no evidence to suggest it is for a gun. The survey found no evidence of the original compass.

Figure 67: Debris 6: Top: Entrance to dive locker with coal winch; entrance to lamp room with lamps inset. Middle: Painted canvas room; 2 x different aspects of compass platform

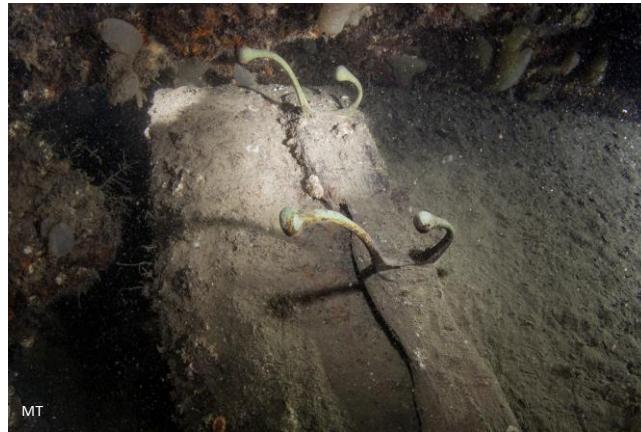
Throughout, the site artefacts directly linking the ship to the men who served are visible. At Debris 8 the most prominent of these was a set of brass coat hooks mounted on a wooden bracket. On the south west side is a nearly semi-circular curve, consistent with the deck aperture for a 12-inch barbette. This is most likely the X Barbette deck aperture. Several deck vents present in the structure are identifiable on the ship's plans.

Figure 68: Debris 6, brass coat hooks

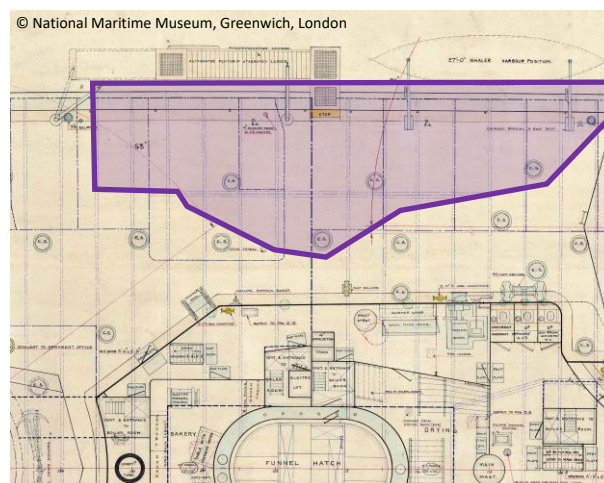
Figure 69: Debris 15

Debris 15 consists of a corner section of outer deck with spurnwater and small section of hull. Also present are two anchors with chain that wraps around the whole structure. The main locating features are the centre accommodation ladder bracket and a small brass numbered plaque for frame 120, which is the centre frame of the ship. Coal hatches and numerous deck fittings are also present, and portholes stick out of the silt.

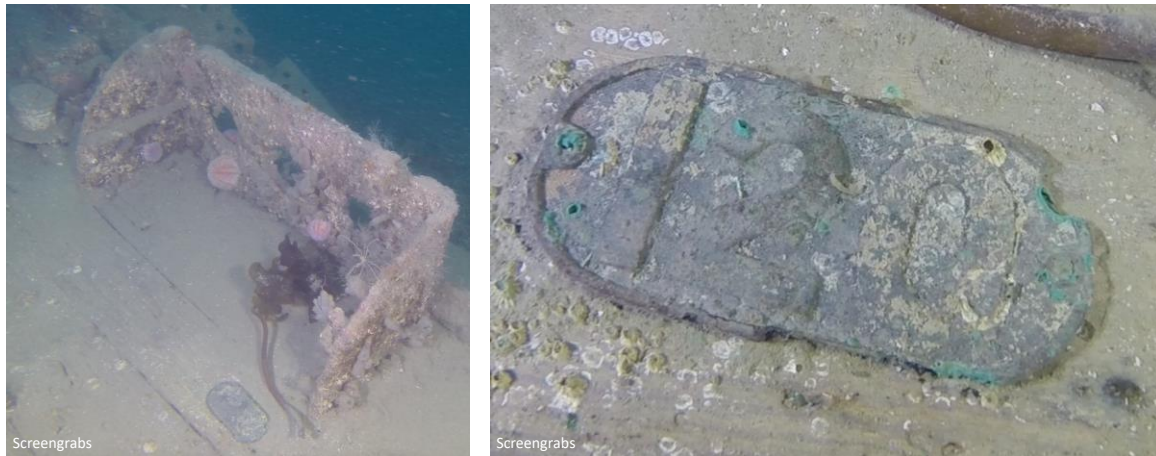
Figure 70: Debris 15 accommodation ladder step at frame 120

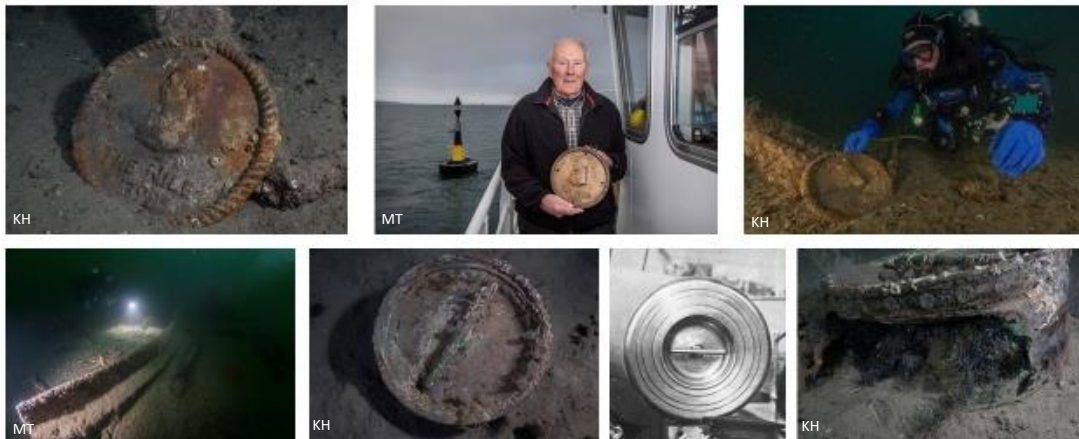
Three smaller lumps of wreckage consisting mostly deck and hull plating make up Debris 10. A section of deck plating reveals a barbette curve and 4-inch armour. It is likely that this deck plating is from Q Turret. Two important artefacts were located within the vicinity of Debris 10. The first was a 12-inch tampion with leather and “horse hair” innards, the second a decorative bronze crest/ship badge of Nelson from the twelve-inch guns. The ship’s badge for this HMS VANGUARD was of a bust of Nelson with the word *Nile* and date 1798. The 1787 built HMS VANGUARD was Nelson’s flagship at the battle of the Nile in 1798.

Figure 72: Debris 10: Top: HMS VANGUARD bronze ship’s badge; Dougall Campbell holding a bronze ship badge legally salvaged in 1975; Diver with bronze badge. Bottom: 4-inch deck armour showing curve; tampion images.

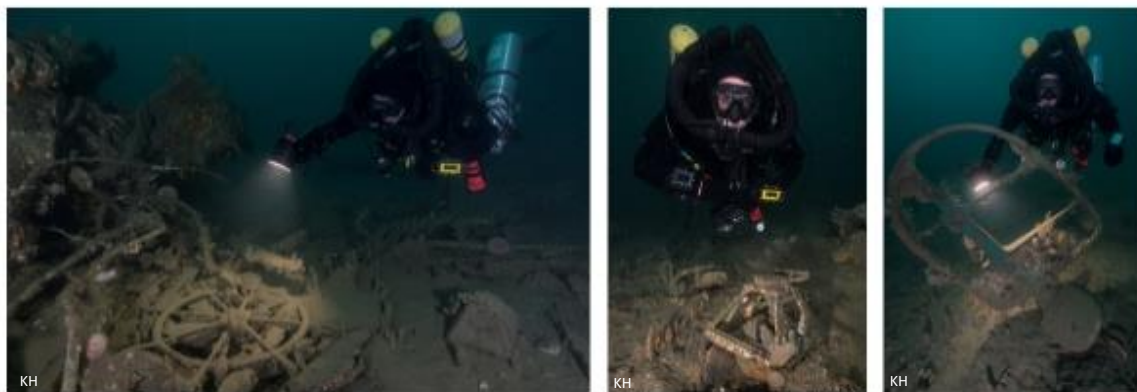
The central section is the most intact with helm and bridge fittings (including Dent's boat compass) still in situ. Moving forward, the steel engine and boiler stand clearly proud of the seabed, details like pressure and sight gauges still intact and in their original positions. Pipes and valves are evident aft of the boiler. The brass funnel sits off the wreck to the starboard side between the two. Moving towards the bow small bullets can be found, but the guns were not in position.

Figure 75: Pinnacle steering helm, Dent's boat compass and rudder

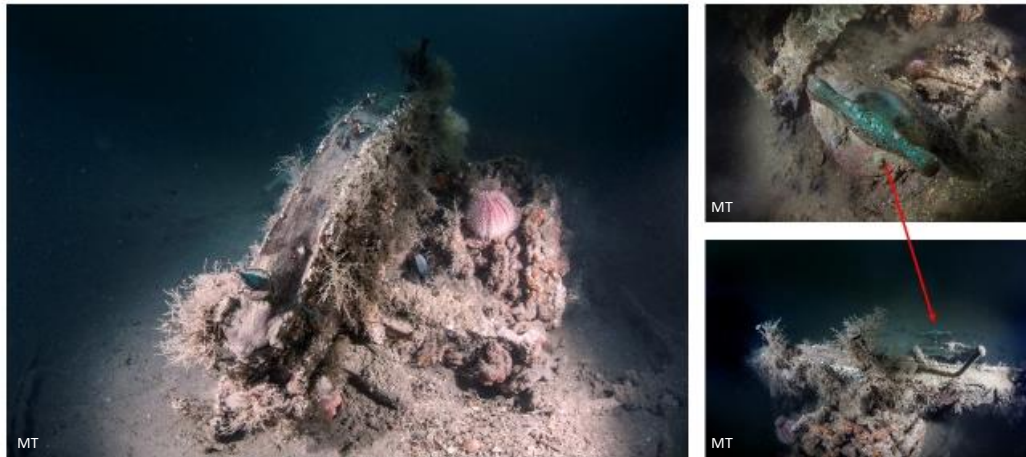
Further sections of latticed hull finally terminate in bow plating complete with cleats; chain locker and anchor; and the keel itself, original bronze bolts evident (Figure 76).

Figure 76: Wooden bow post with bronze bolts and a deck cleat
