## **HMS VANGUARD 100**

*Citation for published version (APA):*  
Rowland, C., & Hyttinen, K. (2018). HMS VANGUARD 100: Survey 2016-2017. HUSKYAN.

HMS VANGUARD 100  
SURVEY 2016-2017  
Survey Report

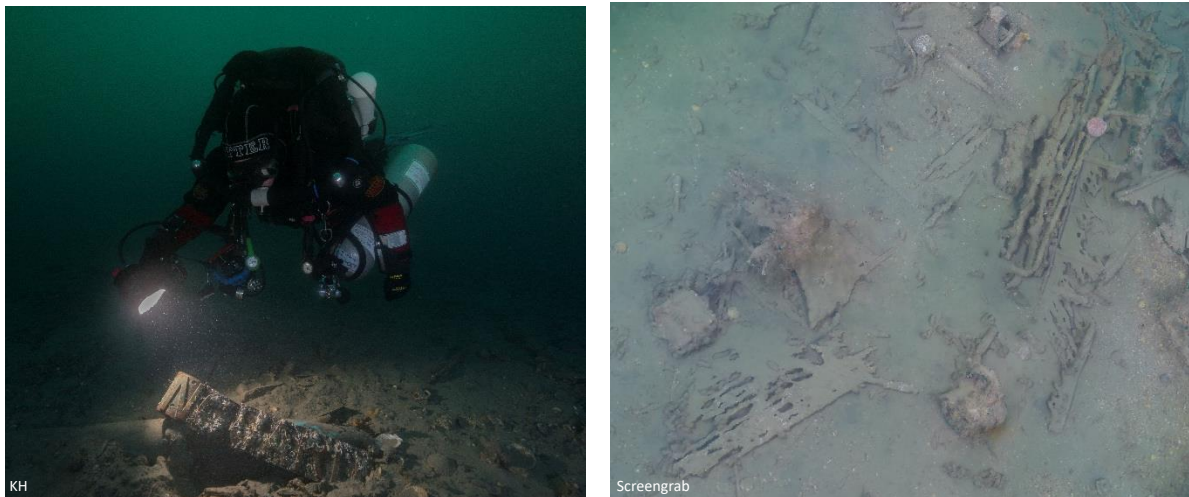
Figure 77: Nameplate and lattice frame hull

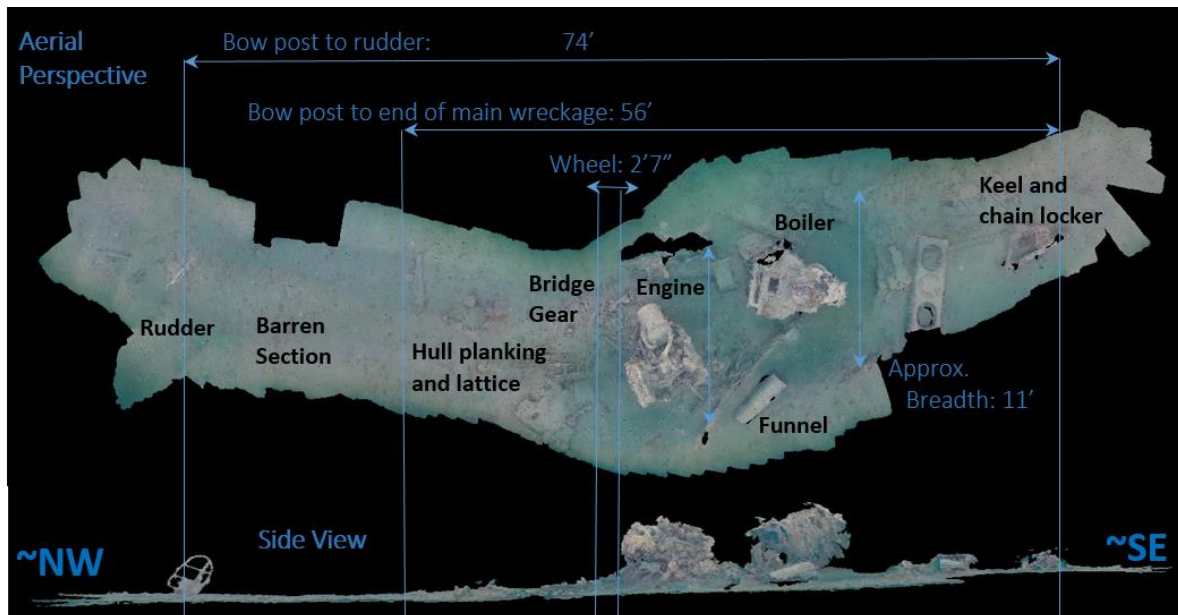
Divers found a site with low lying debris along most of the ~20m extent, but with areas of significant wreckage standing up to 2m proud of the seabed. From the basic sidescan available, remains appear to be oriented northwest (rudder) to southeast (bow).

Figure 78: Basic survey measurements of Pinnace 248 site visualised over aerial and side views of the site, created using structure from motion photogrammetric techniques (Fitzsimmons/Wade).

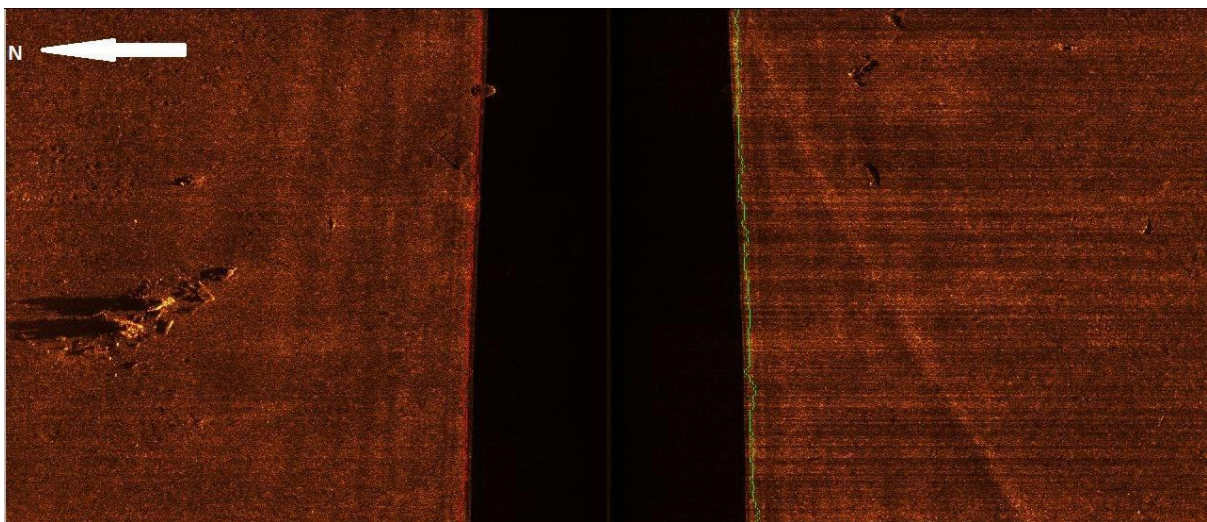
Figure 79: Sidescan sonar image of Pinnace 248

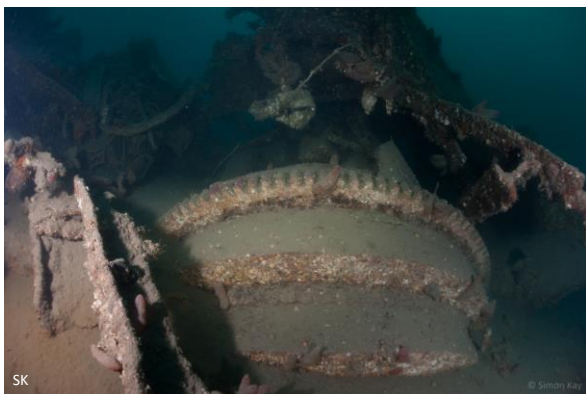
Figure 86: Q Turret shell bogie upper rack

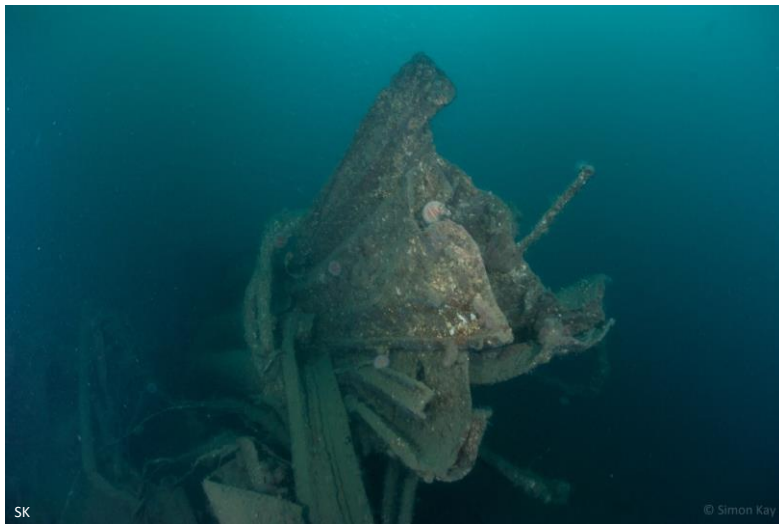
Approximately 30m west-southwest of Q Turret, on the south-east perimeter of the Forward Wreck Site “gap,” is its ammunition hoist tube, which shows substantial crush damage typical of pressure damage from an explosion.

Figure 88: Crushed and torn hoist trunk from Q magazine

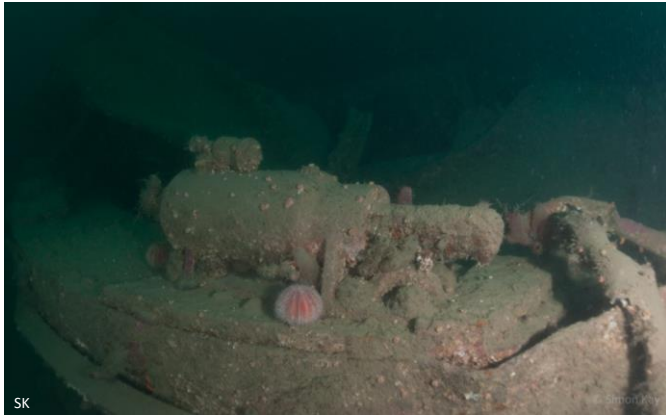
Figure 91: Q Turret training buffer

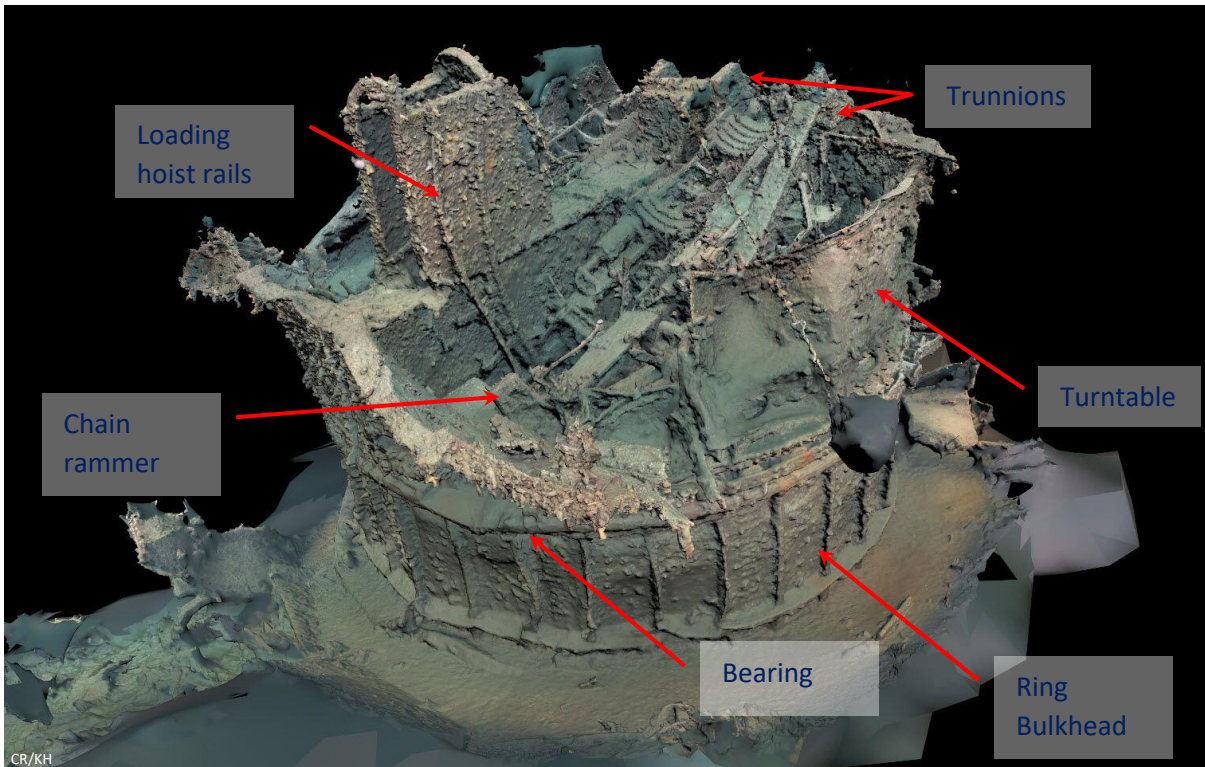
**X Turret** is in the best condition of the five turrets and lies upright on the seabed, approximately 10m to the west of Y Turret in the Main Wreck Site. X Turret lies approximately 25m south-southwest (port-aft) of its original position in the ship.

Figure 94: X Turret 3D photogrammetric model

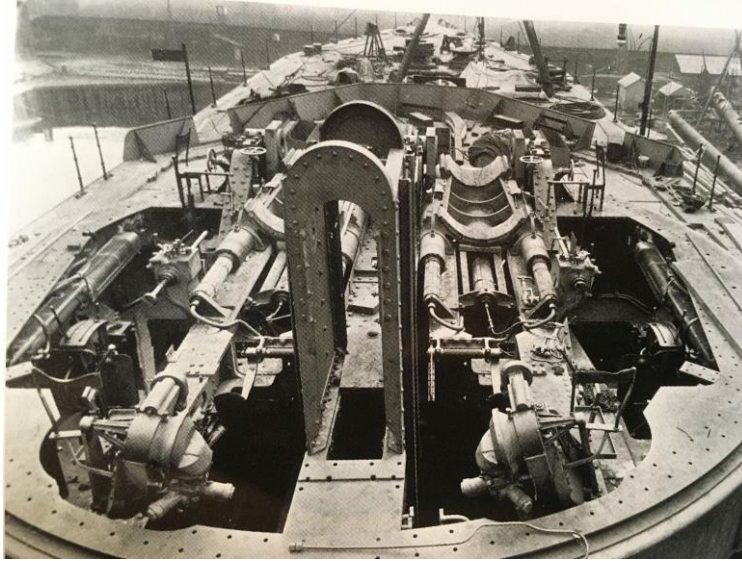
Figure 95: A turret under construction waiting for the guns to be lowered onto their cradles

Figure 95 shows the cradles and slides of A Turret during construction prior to fitting of the gun barrels. The interlocking grooves on the cradle have been covered to protect from damage. The buffers can be seen on each side of the right-hand gun slide, and the chain rammer mounted at the rear of the slide, behind where the barrel will be fitted.

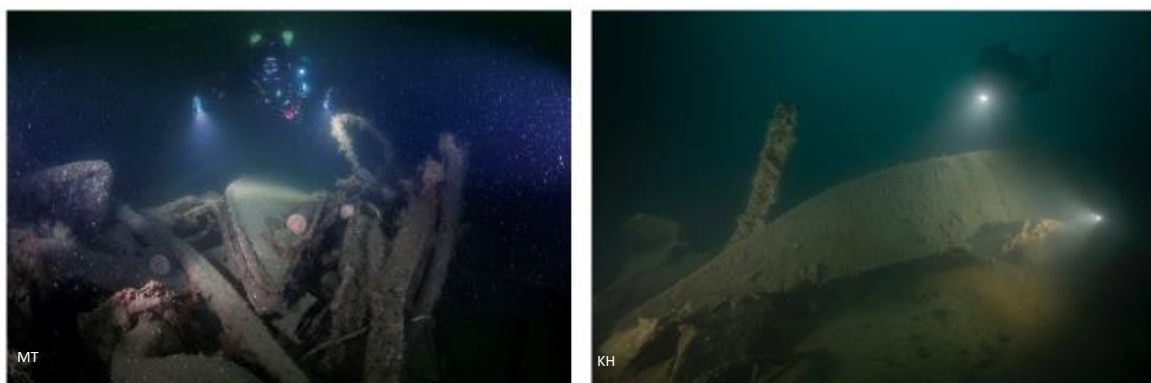
Figure 104: Port and starboard forward bilge keep ends

The fore and aft ends of the two bilge keels had a distinct tapering shape and were attached to the hull sides at Platform Deck level adjacent to A Magazine at the bow (frame 32) and Y Magazine at the stern (frame 128). All four bilge keel ends are now lying in the main wreck site with the two forward bilge keel ends lying at the northern (forward) end of the Main Hull Section, in the wreckage on the southern perimeter of the Forward Wreck site “gap.” They are approximately 25m apart in an east-west direction, and approximately 35m south-southeast (aft) of their original position in the ship.

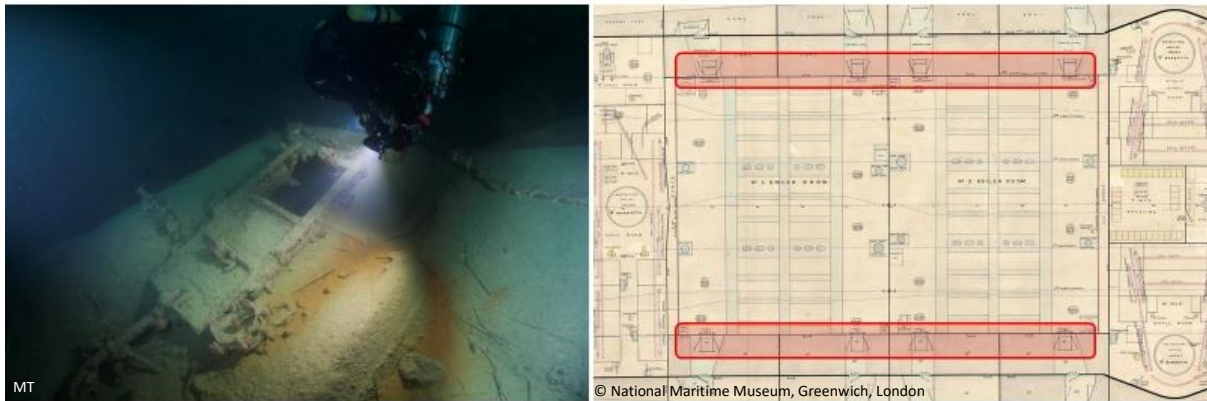
Figure 105: Coal Shutter Door and location on ship's plans

Adjacent to the forward port bilge keel end is a coal shutter door. These were fitted in internal longitudinal bulkheads between coal bunkers and Boiler Rooms. Noteworthy, this door is open. Two were located during the survey, the second is partially buried and is in the closed position.

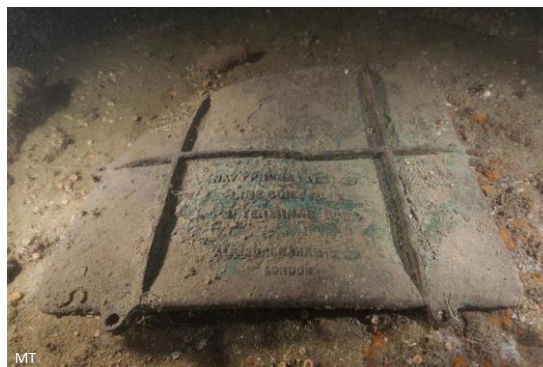
Figure 106: Navyphone Plate

There is a cast brass "Navyphone" cover-plate on wreckage to the northeast of the Main Hull section, close to one of the bilge keels and Q Turret ammunition hoist tube. In VANGUARD, the Navyphone switchboard was located in the telephone exchange on the Lower Deck starboard side, directly above A Magazine and adjacent to the Forward Fire Control Transmission Room and the Starboard Hydraulic Room. The plate is now approximately 50m to the southeast (aft-starboard) of its original position in the ship.
