Zekkos, Dimitrios and Athanasopoulos-Zekkos, Adda and Grizi, Athena and Greenwood, William (2016) The May 25th 2011 railroad embankment failure in Ann Arbor, Michigan, as a means for teaching geotechnical engineering. *International Journal of Geoengineering Case Histories*, 3 (4). pp. 234-245. ISSN 1790-2045

The May 25th 2011 Railroad Embankment Failure in Ann Arbor, Michigan, As a Means for Teaching Geotechnical Engineering

ABSTRACT: A 30-m long railroad embankment failure that occurred on May 25 2011 in the city of Ann Arbor, Michigan, is presented. Emphasis is given on the field observations of the failure, the characterization of the site conditions and the seepage and slope stability analyses, all of which represent important components of the training and practice of a geotechnical engineer. The failure occurred following a record wet season that resulted in ponding water against the embankment and high enough water pressures and exit gradients that resulted in instability of the railroad embankment. Detailed background material and the methodology for using the case history in geotechnical engineering education are presented.

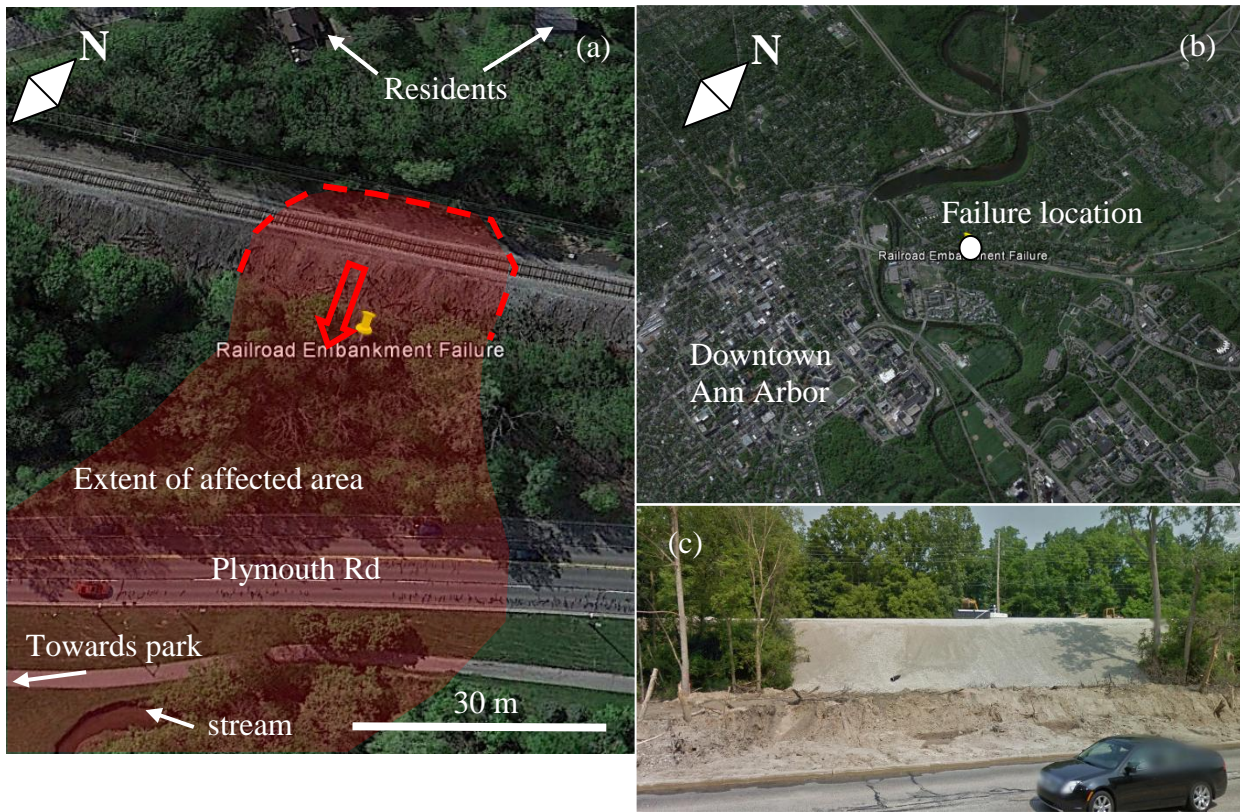
Figure 2. (a) Satellite imagery of the railroad embankment at the failure location; (b) location of the failure; (c) View of the repair works as recorded by coincidence by the Google Earth Camera.
