**The materials, technique, conservation treatment and after-care of
*Interior de um Convento***

Dissertação apresentada na Faculdade de Ciências e Tecnologia da
Universidade Nova de Lisboa para a obtenção do grau de Mestre em
Conservação e Restauro, especialização em pintura sobre tela

Dezembro, 2011

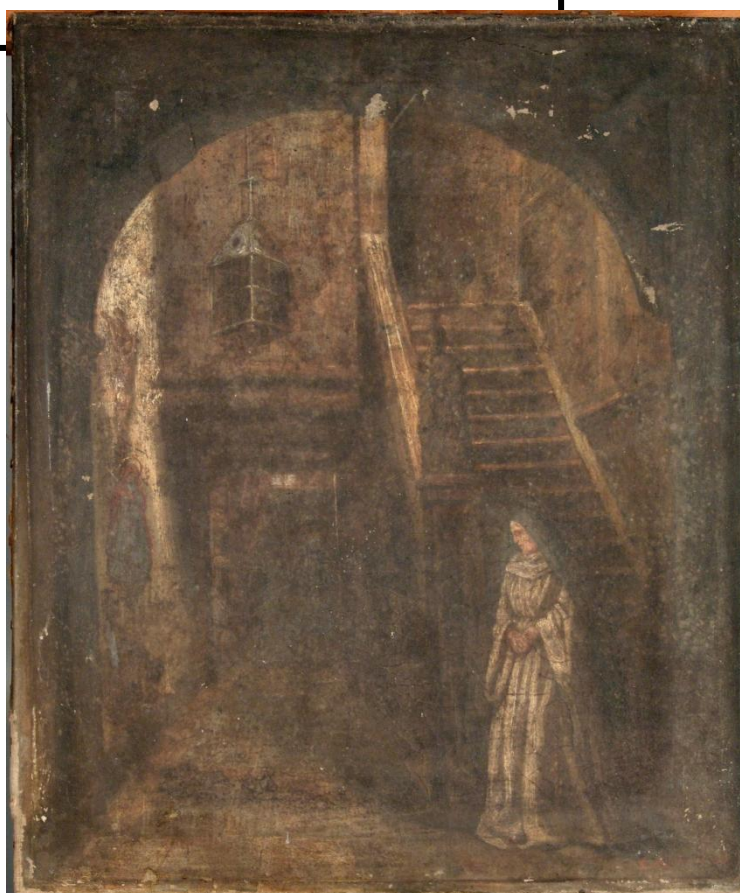
Fig. 1 - Normal light photograph of front of "*Interior de um Convento*" before intervention.

In relation to its condition, there is evidence of staining on the lower left and right corners likely due to previous water damage (**Ap. IV, Fig.IV.2, p.66**). There are also traces of mechanical damage, specifically some abrasion/incision marks over the top and bottom bars (**Ap. IV, Fig.IV.5, p.68**) and “exit-holes” in the wood, evidence of previous insect infestation. Otherwise, the stretcher was in good condition. The circular exit holes are characteristic of xylophagous attack, and their 1.5 to 2mm diameter size are typical of the species *Anobium punctatum*. [10] Another sign of insect infestation was the presence of wood dust and frass (mostly larvae fecal pellets). Therefore, it was decided to put the painting in quarantine: it was wrapped and sealed in a transparent sheet of Melinex® and left undisturbed for seven days, after which it was checked for traces of active infestation (wood dust and new exit holes). It was determined that the insects were not currently active.

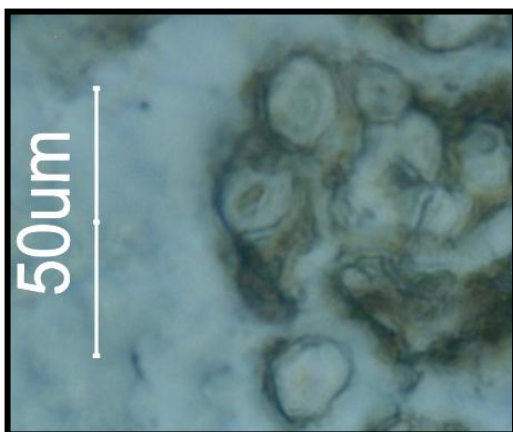
Fibres samples (T1) removed from a loose yarn in the left tacking margin of the painting (**Ap. I, Fig.I.1, p.53**) were examined through the Optical Microscope (OM). Transverse sections of the fibres show the hexagonal shape of the cell wall, slightly rounded in outline with a marked rounded lumen (Fig. 2 in text). In longitudinal section the fibres have a tubular shape with dislocations on the cell wall (cross like marks and nodes) and striations (Fig. 3 in text).

Fig. 2 - Transverse view photograph of the fibres under OM, visible polarized transmitted light, 50x.

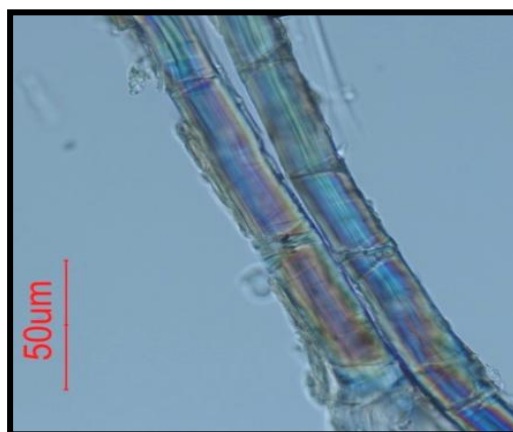
Fig. 3 - Longitudinal view photograph of the fibres under OM, visible polarized transmitted light, 40x.

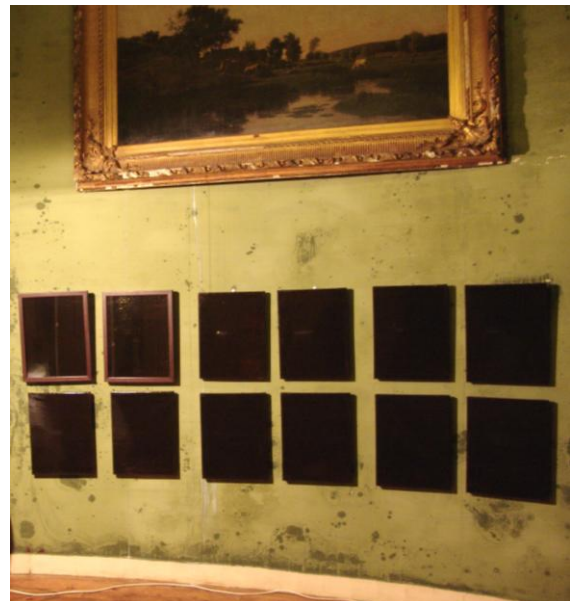
The location (the room adjacent to King Manuel II's chambers) for the backing board project at PNP was chosen based on the availability of an outdoor wall, to ensure maximum RH and T changes. The wall was made of plaster and showed

Fig. 6. Room at the PNP

signs of extensive mould growth (Ap. VIII, Fig. VIII.6, p. 85). Evidence of high levels of moisture present in the walls was gained by observing that any small scrape to the wall resulted in an immediate water mark in the wall's coloured surface. Another advantage is that the model paintings would not be disturbed as the room was being used as a temporary storage room closed to public.

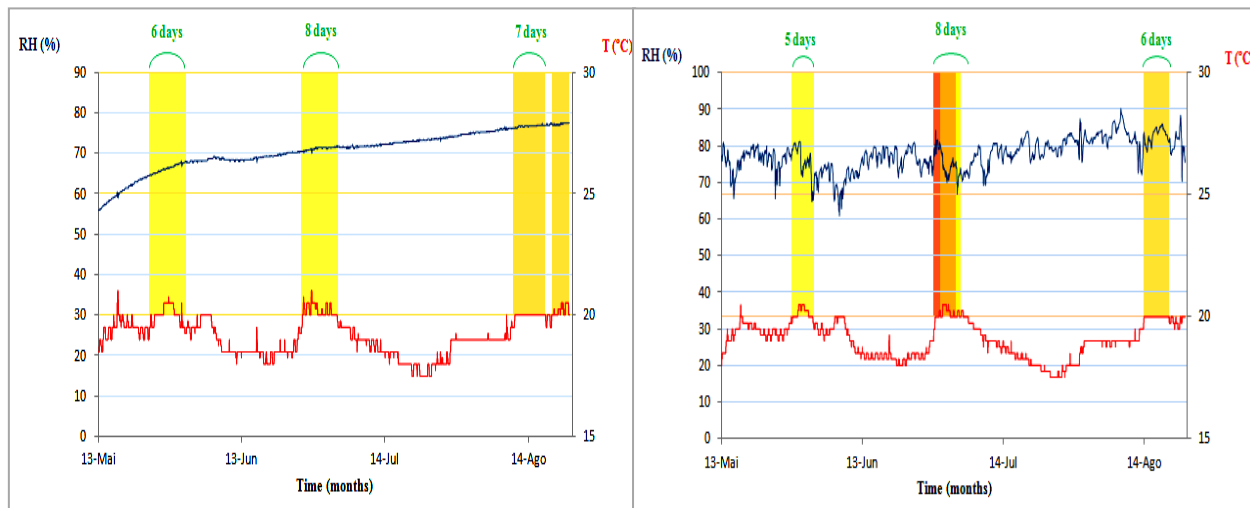
Graph 3 – RH and T of set 1. Yellow bars point out time periods in which the temperature was above 20°C and RH above 65%: conditions favorable of mould growth.

Graph 4 – RH and T of room. Even though RH exceeds 80%, it is not sustained long enough for mould growth.

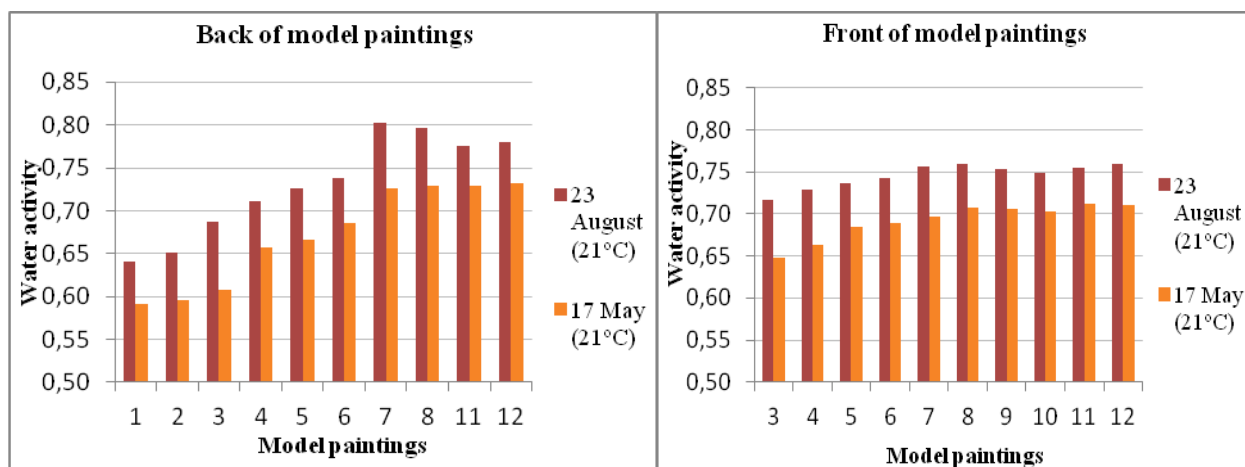
Water activity measurements of the wall from 13 of May to 23 of August showed that the wall had an increase from 0.6 a_w to 0.86. According to the literature, fungi need a range between a_w **0.70 and 0.98**. Growth cannot occur at a_w 1.0, which would be pure water without nutrients, and it rarely occurs below a_w 0.70 because enzymes and proteins are altered. [33] Fungi growth is also dependent

Graph 5 – a_w values of the back of the model paintings (1 to 12) from day 17th May (temp. rounded 21°C) and 23rd August (temperature rounded 21°C) Graph 6 – a_w values of the front of the model paintings (1 to 12) from day 17th May (temp. rounded 21°C) and 23rd August (temperature rounded 21°C)

Therefore, although the wall had increased its water activity to a level which favored mould growth, around 9th August this situation may have been interrupted due to the low temperatures (18 to 19°C). Water activity measurements made to the back of the model paintings revealed that it had an increase from 17 May to 23 of August of around 0.05 (Graph 5 in text). Set 4 (PCP board with cotton canvas) had the highest values maybe because the a_w measurement equipment was reading the fabric as well (that was folded over the back of the PCP board). Looking at the front of the model paintings (Graph 6 in text), the highest values measured also belonged to set 4 (and to set 6 - control). In August, all sets measured (except 1 and 2 that had glazing) had exceeded a_w 0.70, which means that the surface of the paintings were reaching suitable conditions for mould growth. Below 20°C, mould growth slows down but is not stopped (if RH/ water activity is high enough to sustain fungal activity. Of course it is important not to overlook the source of nutrients and the RH and T conditions: It is expected that the paint surface - primarily in unglazed paintings - will develop a dirt layer which may promote fungi activity in case of prolonged high RH conditions and temperatures below 20°C.

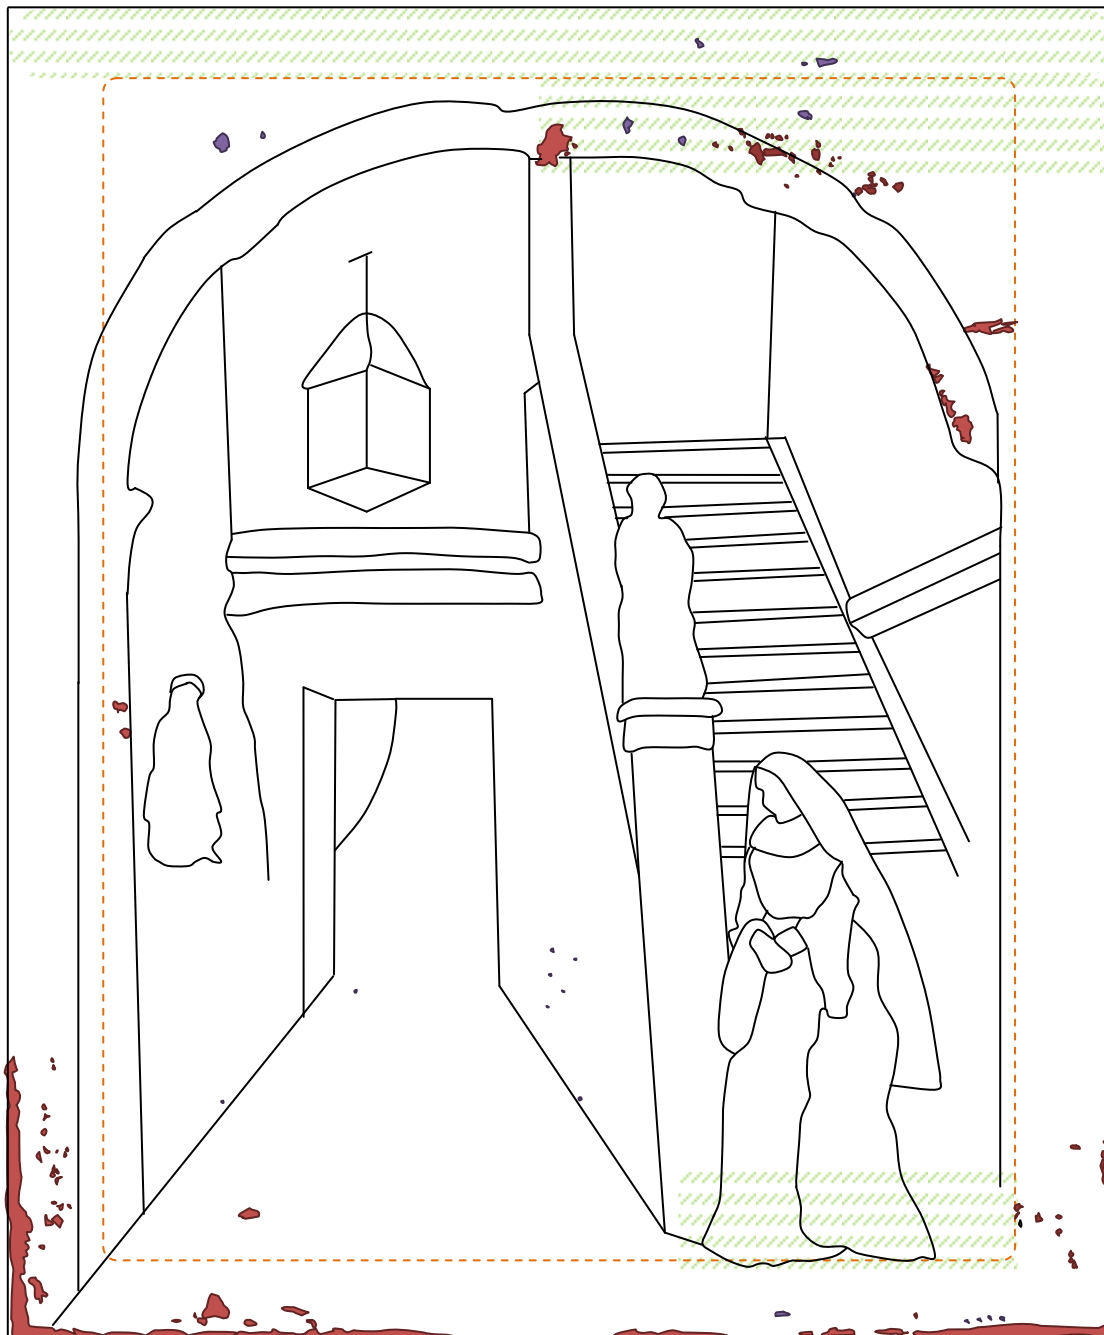
- Losses exposing canvas
- Losses exposing ground layers
- Stretcher mark
- Main deformations of fabric

Fig.IV.1. Schematic drawing of painting with coloured areas representing different condition problems.

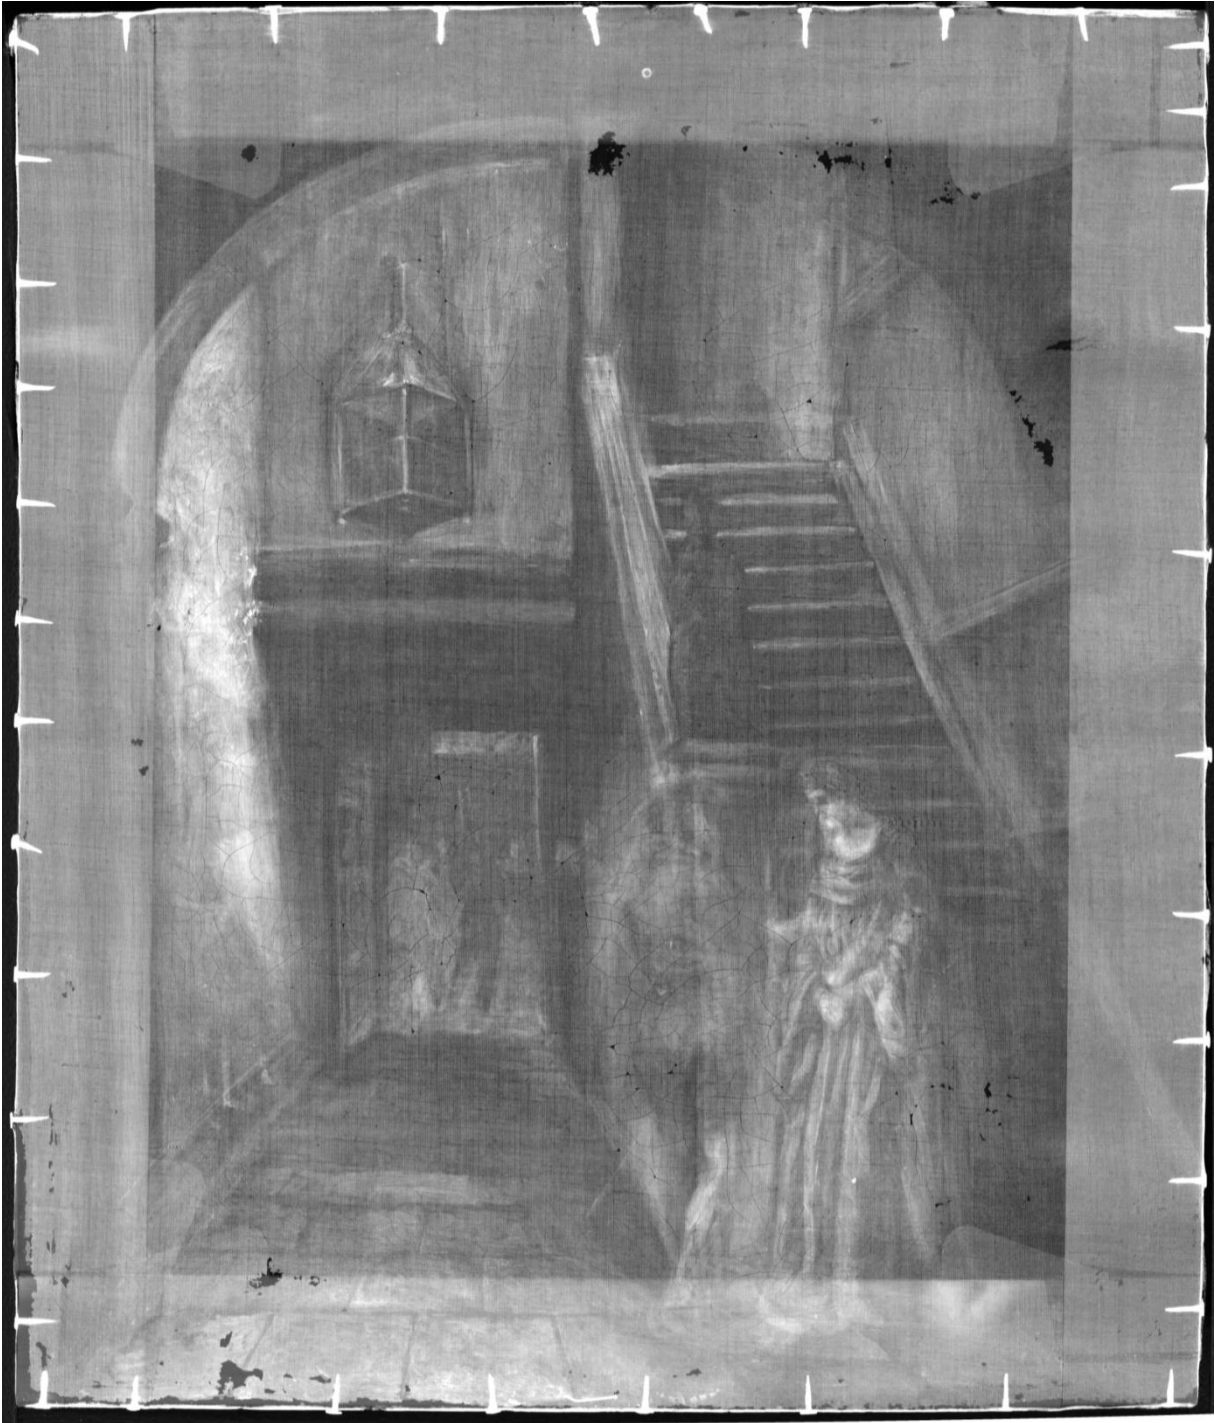
Fig.IV.3. Digital radiographic image of the painting showing the tack distribution and the underpainting (nun's area, staircase and at the end of the hallway).

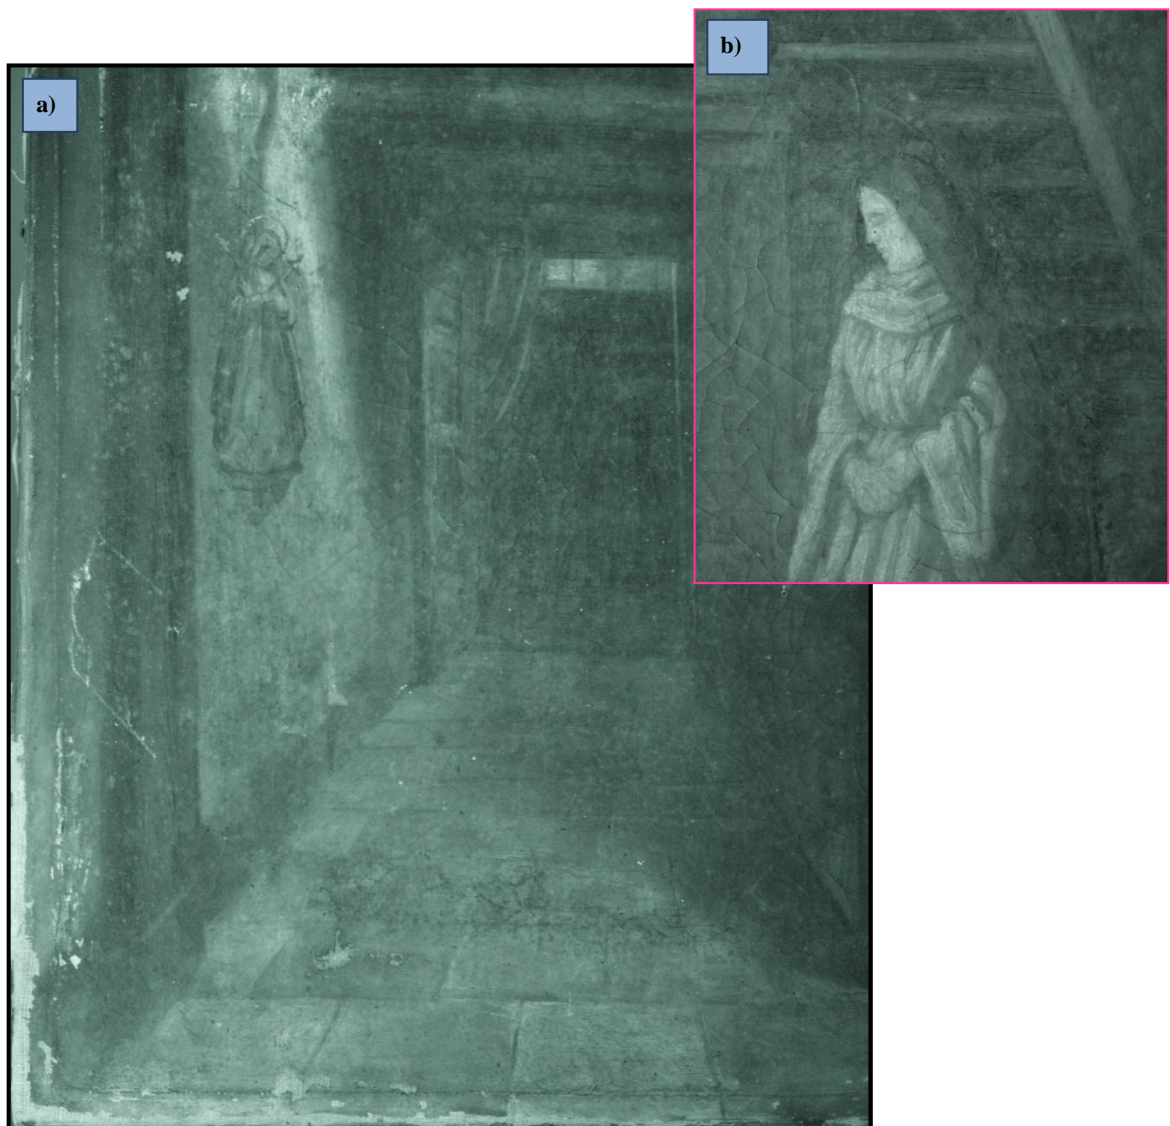
Fig.IV.10. a) Infrared (IR) photographic detail of front of the painting showing drawing lines in the floor; b) Infrared photographic detail of nun's face. Note that more detail of the image is visible using IR light than normal light due to extensive dirt/ mould incrustation on surface before treatment.

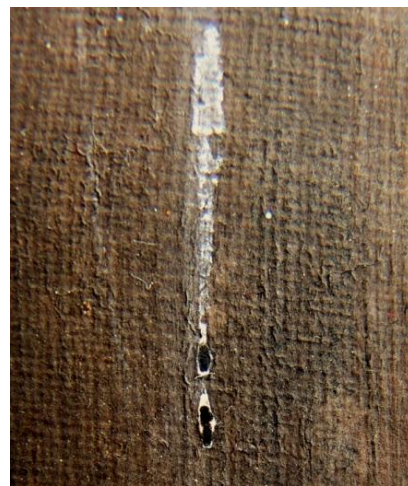
Fig.IV.15. Normal light photographic detail showing insect speck over the surface of the painting.
