***Reconstitution of the failure of the Fonte Santa mine tailings dam.
Modelling of the dam breaching process.***

Dissertação apresentada na Faculdade de Ciências e Tecnologia da
Universidade Nova de Lisboa para obtenção do grau de Mestre em
Engenharia Civil Perfil de Estruturas e Geotecnia.

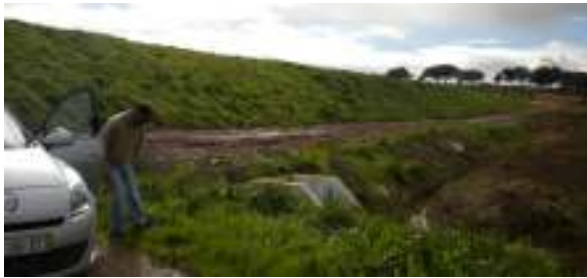
Figure 3. Herdade da Misericórdia dam after rehabilitation (2011).

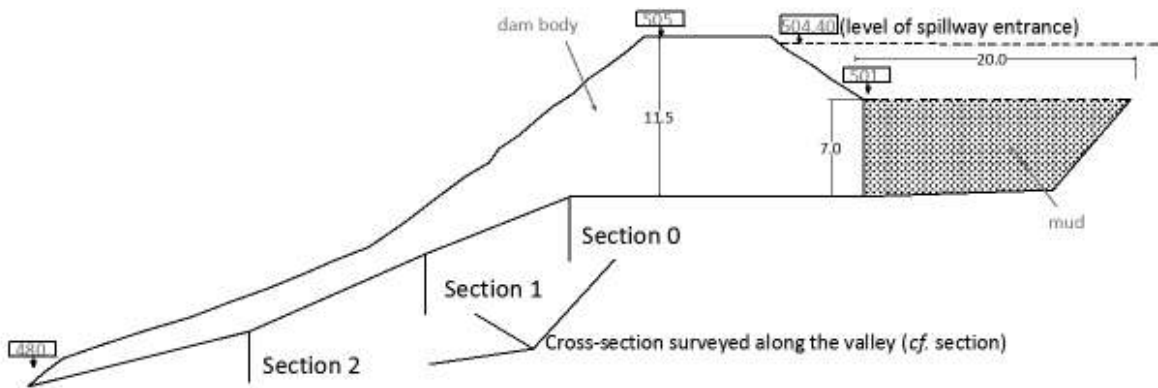
Figure 10. Central cross-section of dam body and the retained mud (with no specific scale).

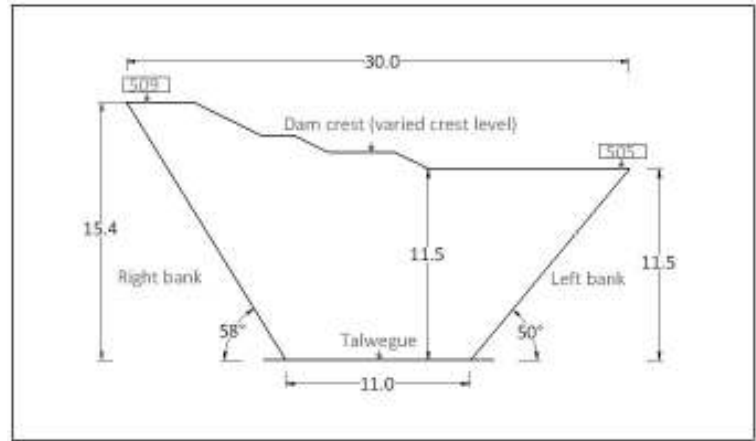
WAHL (1998) affirmed that the parameters of an idealized dam breach in an embankment are the width, the depth, the side slope factor and the formation time. During the survey the breach parameters were obtained. The dam did not have a symmetrical and homogeneous shape as mentioned before. The final geometry has a nearly trapezoidal shape. The main geometric characteristics of breach geometry are shown in Table 5 and Figure 16

Figure 16. Breach dam geometric (no specific scale).

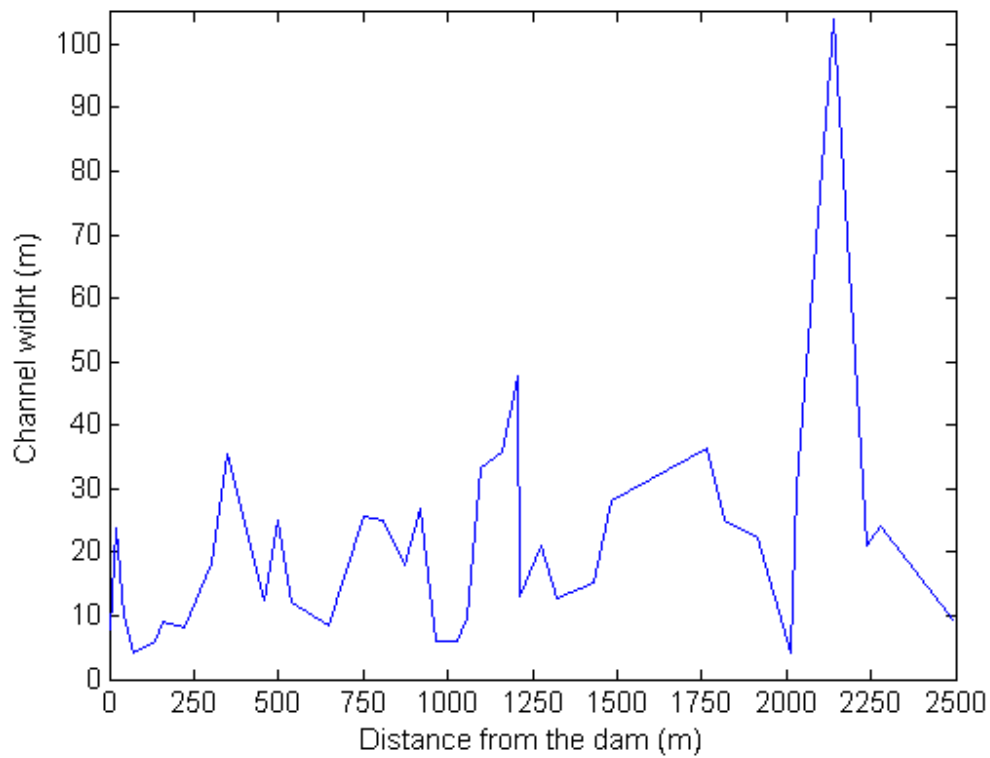
In Figure 20 the channel width is presented along the valley; this is herein defined as the locally observed lateral extension of the dam break reach, i.e. the width of the actual active channel during the passage of maximum flood discharge. After the first section, the channel width decreases; sections 9 (distance about 350 m after the dam), 10' (distance about 498 m after the dam) present an increase relatively to the adjacent sections (prior and after); those with a large increase were: 7 →9 (distance about 220 m and 350 m after the dam, respectively); 18→22 (distance about 1026 m and 1206 m after the dam, respectively); 29'→30 (distance about 2012 m and 2031 m after the dam, respectively). In section 20 (distance about 1097 m after the dam) it was observed an isle in the middle of the channel, eventually made by the flood wave which formed a channel near the left bank isolating a portion of soil and vegetation (cf. Annex IV).

Figure 20. Lateral extension of the morphological impacts of the flood wave.

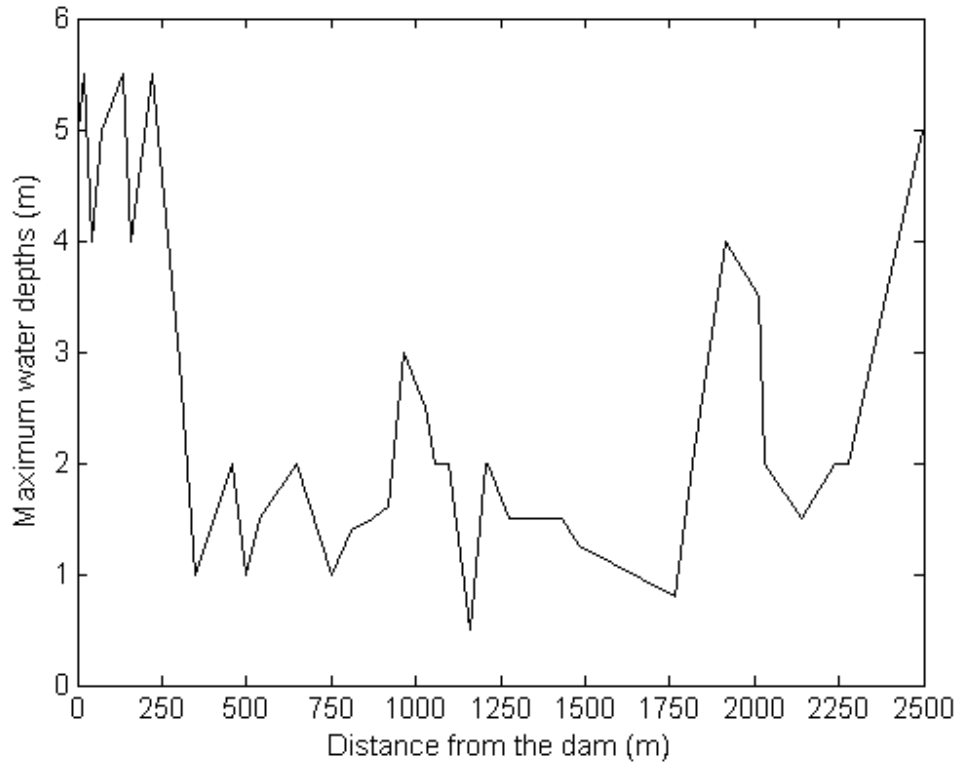
The largest width corresponds to section 31 (distance about 2138 m after the dam), where water level decreased (Figure 23) as downstream sections (32, 33, and 34) had a wall on the left bank

Figure 23. Maximum flood levels observed in field.

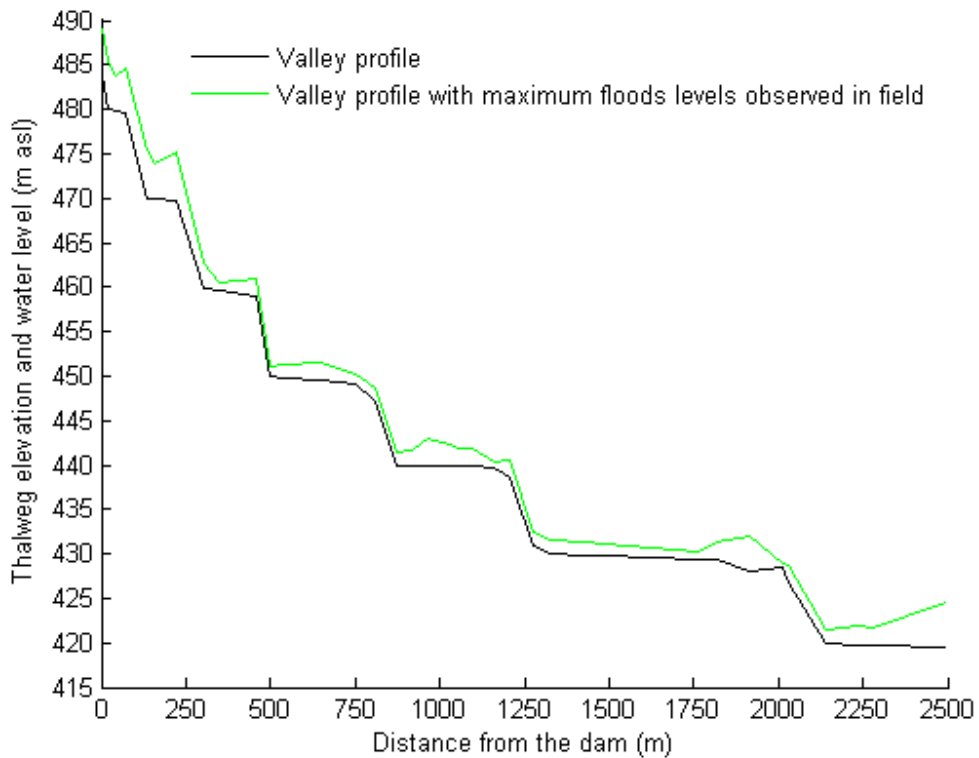
In Figure 24 the maximum water level along the valley profile and the thalweg elevation are shown. The thalweg elevation was calculated through 1:25000 topographic map. The water depths were as high as about 6 m and this occurred in the first sections, just after the dam where the valley is narrower.

Figure 24. Valley profile with the maximum flood levels observed in field.

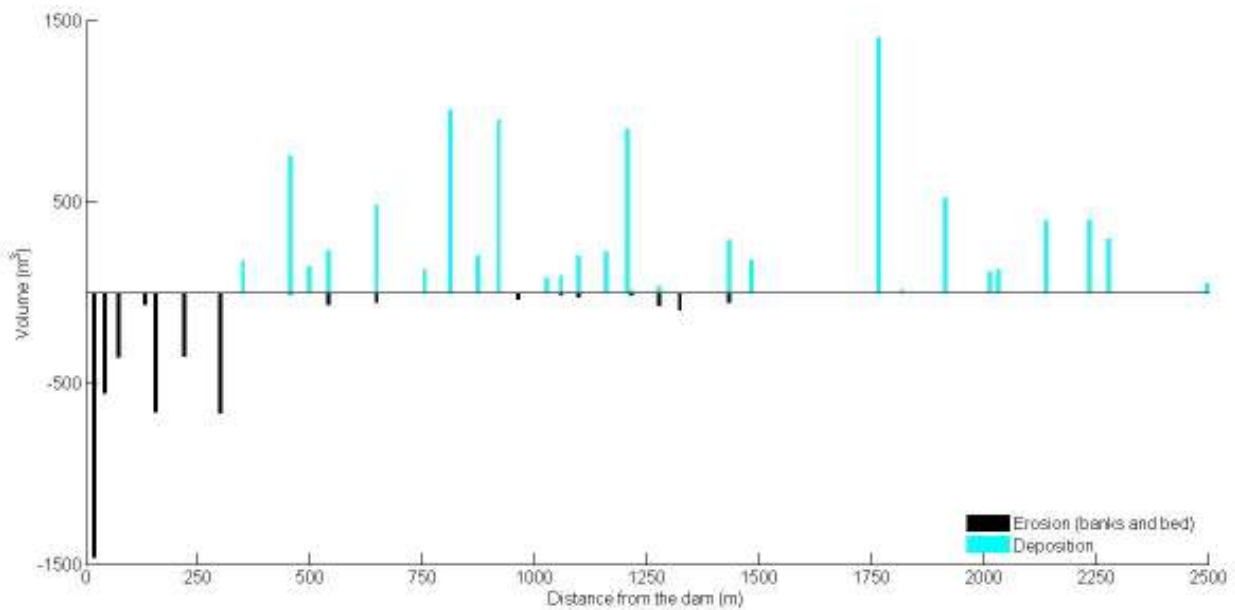
Figure 25. Estimated erosion and deposition volumes of the river bed and banks throughout the downstream valley (body dam and wedge mud are not included).

There is a difference of 9765 m^3 between erosion and deposition estimates (Table 11 and Table 12). Mud wedge volume was estimated by photos; this value can be unrealistic and it is possible that the sludge travelled downstream more than 2500 m. The greatest erosion, as seen in Figure 25 is concentrated in the first 300 m; probably these values obtained 'in situ' are overestimated. If one considers the distance between the study reach and Sabor river, roughly 15 km, and taking into account that fine sediments reached this river according to local accounts (a layer of roughly 0.10 m deposited along de valley), this could arguably represent this difference.
