Treatment of a nineteenth century male portrait in oil including the characterisation of materials, technique and a study of the lead soap aggregation in the paint composite

This project involved the conservation of a 19th century portrait in oils from the Ecomuseu do Seixal (Portugal). The painting of “*João Luiz Lourenço*” was in very poor condition. Because of the range and severity of the problems presented, it offered an opportunity to explore important aspects of painting conservation in-depth. The approach to its treatment required an empirical investigation of a number of materials and techniques used in the field of conservation/restoration. Of additional interest, the painting exhibits widespread evidence of metal soap (lead carboxylate) aggregates protruding through the paint from the ground layer. The painting’s materials and the metal soaps aggregates were studied and characterised with different analytical techniques: μ -EDXRF (*Energy Dispersive X-ray Fluorescence*), μ -Raman Spectroscopy, μ -FTIR (*Fourier Transform Infrared Spectroscopy*) and SEM-EDX (*Electron Scanning Microscopy with Energy Dispersive X-ray Spectroscopy*).

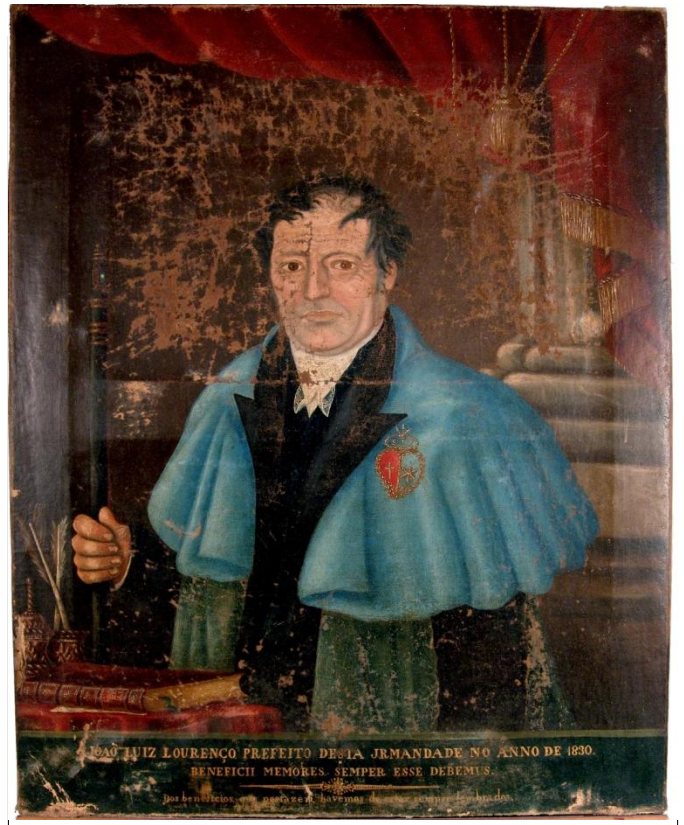
Normal light before treatment photograph of front of João Luiz Lourenço: belonging to ECOMUSEU Municipal do Seixal, Portugal). Artist: unknown.

The major problem that this painting presented was the severe distortions in the canvas and the extensive paint/ground losses associated with these distortions (appendix I&IV). Because the losses were particularly concentrated in areas of the greatest deformation in the canvas, this suggested that the severe distortions in the support (see below: Previous treatment) led to paint/ground losses as these more rigid layers were unable to conform to the upheaval in the fabric. It is likely that water and high humidity conditions led to mismatched movements of the materials presented.

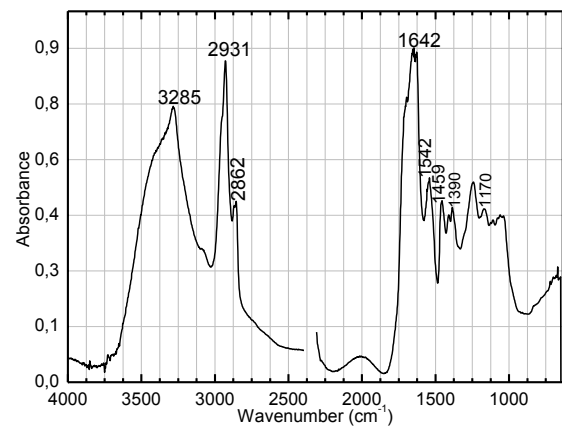
The lining adhesive was analysed by μ -FTIR. By observing the spectra obtained it was possible to identify characteristic bands related to animal glue and starch (Fig.1), a common mixture for lining adhesives used in the past.

Figure 1: μ -FTIR spectrum of the lining adhesive.

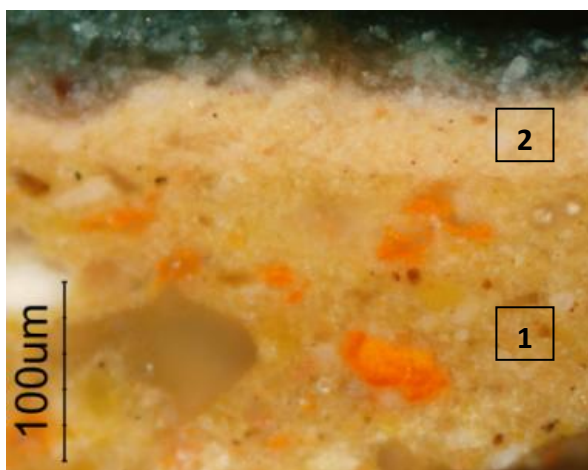
Observation of paint micro-samples under OM, indicate that the preparation is composed of two different formulations evident as visually different layers⁵ (appendix VIII.4). The first ground layer (identified in the Fig. 3 with the number 1) is thicker and more orange than the second. The next layer is thinner and lighter (identified with the number 2 in Fig. 3). Using SEM-EDX, it was determined that both layers are rich in lead, and are heterogeneous with particles of different shapes and sizes. However, the second thinner preparation layer has a higher ratio of lead and a finer particle size distribution (Fig. 4).

Figure 3: OM image of the X07 section: total magnification 200x, Vis-light - Polarized Light

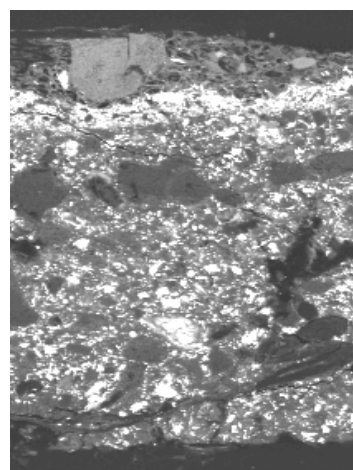
Figure 4: SEM BSE image of a cross-section (X15) showing heterogeneity of the particles and the differences in the ratio of lead in the two preparation layers.

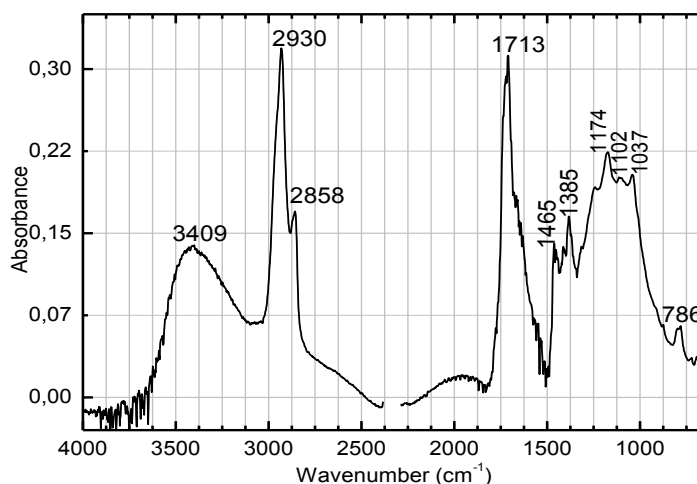
It is very difficult to distinguish natural resins. The bands in the spectra acquired are similar to those attributed to Dammar and Mastic resins (in use as a painting varnish from the early nineteenth century [24]): 3409cm^{-1} (O-H stretching band); 2930 and 2858cm^{-1} (C-H stretching bands); 1713cm^{-1} (C=O stretching band); 1465 - 1385cm^{-1} (C-H bending bands) and 1385 - 1037cm^{-1} (C-O stretching band) [5] (Fig. 8).

Figure 8: μ -FTIR spectrum of the varnish layer.

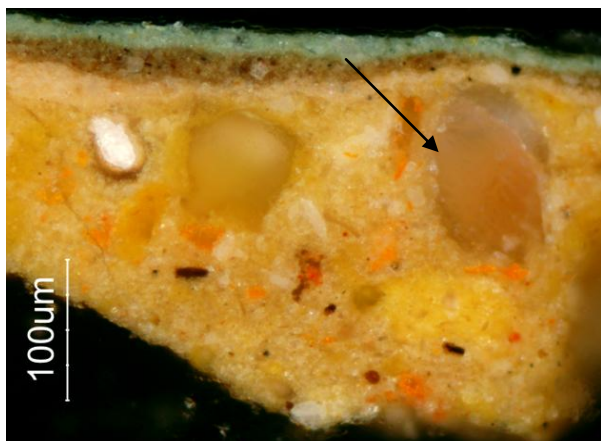
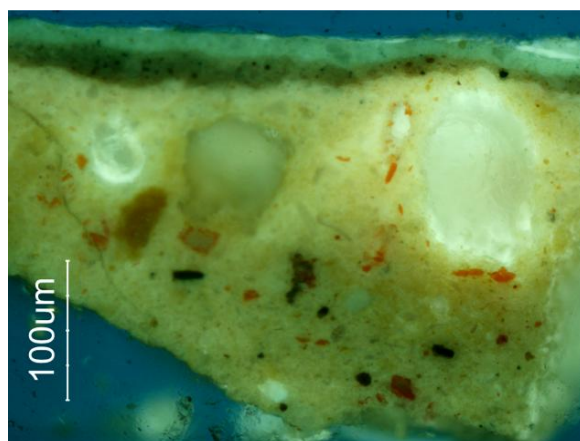
Under the microscope, lead soap aggregates in cross-sections appear transparent to whitish-opaque under visible light while they strongly fluoresce under UV illumination [23]. By OM differences between the aggregates (marked with an arrow) were detected in this painting: some aggregates were transparent (Fig.10 and 11), others completely white and some with a white centre surrounded by red particles (Fig.12 and 13), all these phenomena were present in the same layer (1^oground layer). As already mentioned the ground is oil-based and is composed of two preparation layers. The main difference between the two ground layers is the absence of minium (red lead) in the second layer. Of several articles consulted [15,23,25,27,31,58], only one showed a paint sample with both types together in the same layer, in the same painting [29].

Figure 10: OM image of the sample X10: total magnification 200x, Vis. light - Polarized Light

Figure 11: OM image of the sample X10: total magnification 200x, UV light-Filter set5

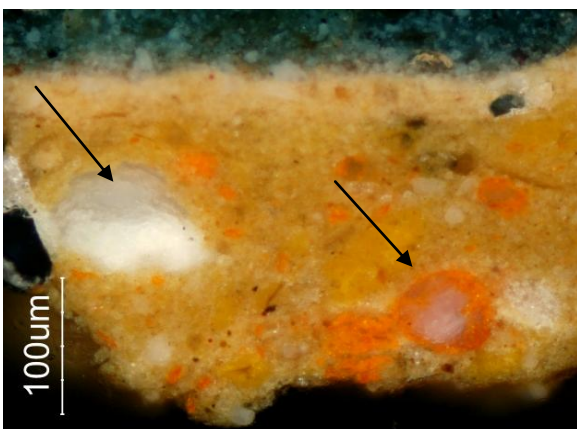
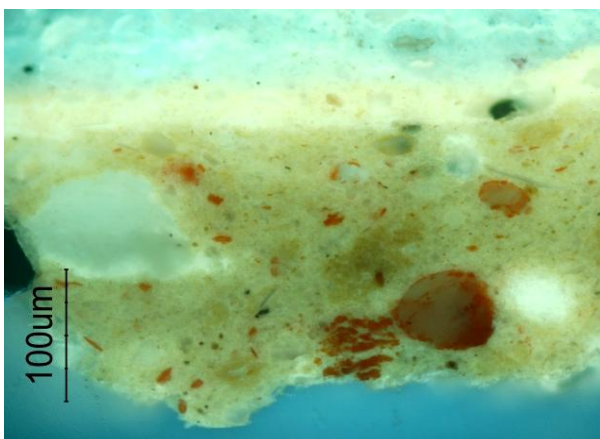
Figure 12: OM image of the sample X07: total magnification 200x, Vis. light - Polarized Light

Figure 13: OM image of the sample X07: total magnification 200x, UV light- Filter set5

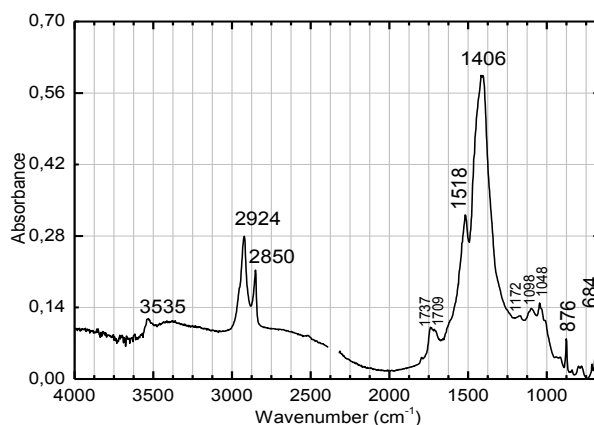
Through this analysis, it was possible to conclude that the protrusions on the surface are actually lead soap aggregates. The IR bands for lead carboxylates and lead carbonates overlap in the 1400 cm^{-1} region. The presence of lead carbonate is proved by the absorptions at 3535 , 1050 and 680 cm^{-1} [30]. The presence of the O-H stretching band indicates that the lead carbonate is present in the hydrocerussite form (basic lead carbonate), $2\text{PbCO}_3 \cdot \text{Pb}(\text{OH})_2$ [26,30]. The presence of free fatty acids was only detected in sample FL3 by the band at 1709 cm^{-1} (Fig.14) (see appendix VII.2). Often, a heterogeneous structure with lamellar bands (enriched in lead) is seen in the centre of aggregates [23,31]. The striations are interpreted as precipitation bands of a new lead compound - lead carbonate [31]. It is assumed that the lead soaps formed react with atmospheric carbon dioxide (CO_2), the carbonate source [15,28]. The aggregates analysed with μ -FTIR were limited to those that protruded at the surface, perhaps indicating that they were already in an advanced stage of the mineralization [15,23,28,31,32]. This could be the reason why basic lead carbonate is detected in all spectra.

Figure 14: IR spectrum of a lead soap aggregate on a green area (sample FL3).

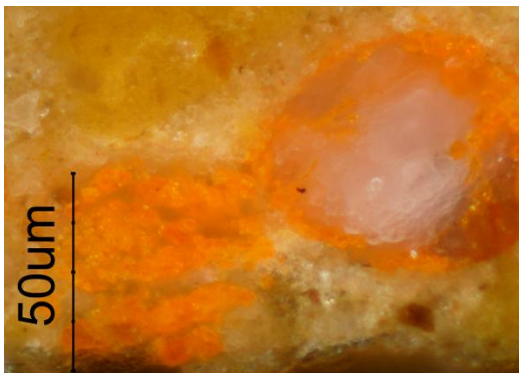
Figure 19: OM image: 500x mag. Polarized Light (right) and BSE image (left) of the sample X7

In the BSE images of the orange aggregates (Fig. 19 and 20), it is possible to observe that these are a light-greyish large mass with dark-grey cracks. The bright and strongly scattering particles inside and around the aggregates correspond to the orange particles (red lead) seen in the visible light image. Tiny highly scattering particles around the soap mass on the Figure 20 seems to indicate the occurrence of dissolution of the pigment.

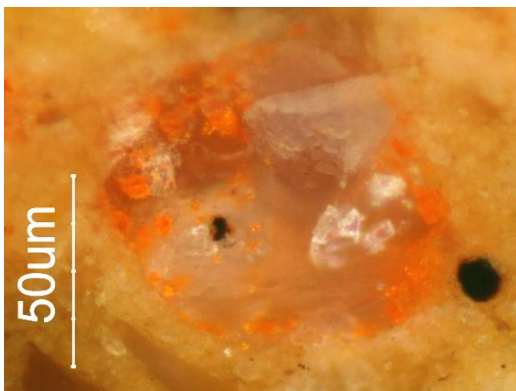
Figure 20: OM image: 500x mag. Polarized Light (right) and BSE image of the sample X13

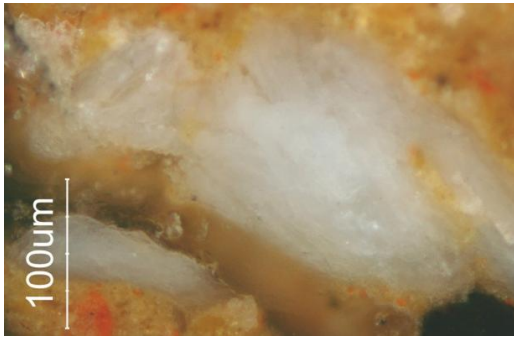
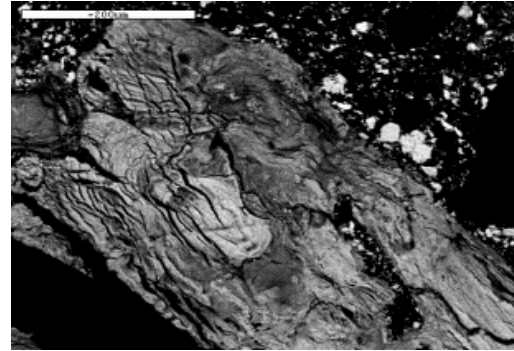
Figure 21: OM image: 200x mag. Polarized Light (right) and BSE image of the sample X13

The white aggregate (Fig. 21) presents a lamellar structure: it has cracks, and it seems to have a high degree of remineralisation. The areas that strongly scattering indicates a higher lead density, which can indicate the presence of lead carbonate (precipitation bands) rather than lead carboxylates [30,31].

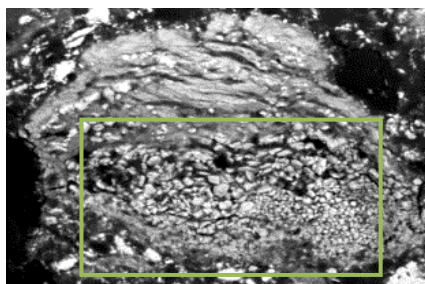
Figure 24: BSE image of the sample X7

The BSE image of the white aggregate in Figure 24, shows rounded particles in the aggregate. By comparison with BSE images of intact white lead (not saponified) in the literature (Fig.25) [O], it is possible to see that the images are similar. Therefore, it is supposed that these particles are intact white lead which have not reacted with free fatty acids to form a soap. In other words, only a partial reaction has occurred.

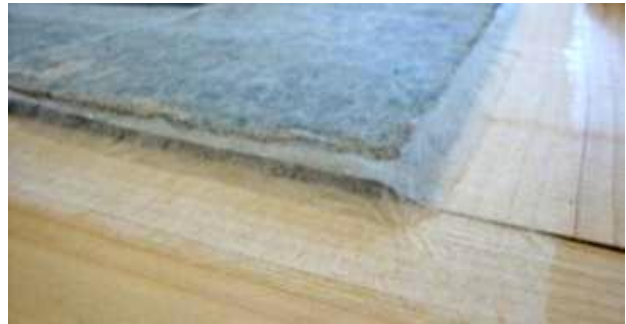
Figure 32: facing tissue was adhered to wood planks.

edges, where the painting was no longer attached to the lining the facing tissue was adhered to wood planks to keep the edges stable as the facing dried²¹ (Fig. 32 & 33).

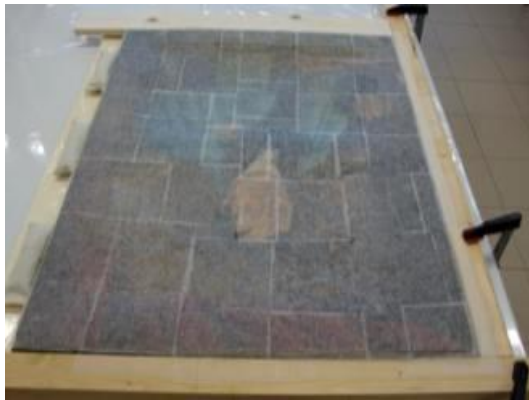
Figure 33: Painting with the facing.

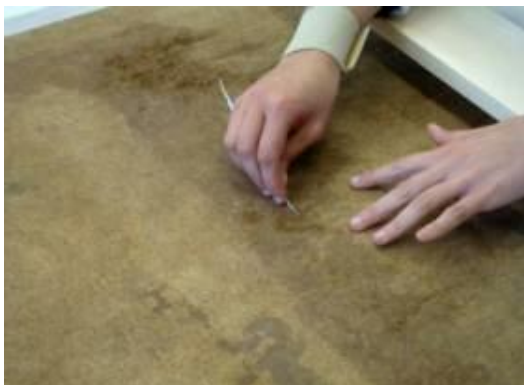
Figure 34: Removal of the glue-lining adhesive.

Removing an old glue lining involves risk to the painting due to the pressure applied and the possibility of any moisture used disrupting adhesion between the ground and the canvas (e.g. allowing the size layer to swell and detach), as well, it can be very time consuming. The methods used to remove the lining adhesive are detailed in appendix X.2 and as previously noted, depended on the state of the lining adhesive. This process did not allow a complete removal of the adhesive as part of the glue had penetrated between the threads in some places. However, this system did not damage the original canvas. Removal of the glue on areas with more extreme deformation is detailed in the chapter 4.4 and was achieved by supporting the distortions underneath locally such that pressure applied during adhesive removal did not damage the paint layer (Figs. 34 and 35).

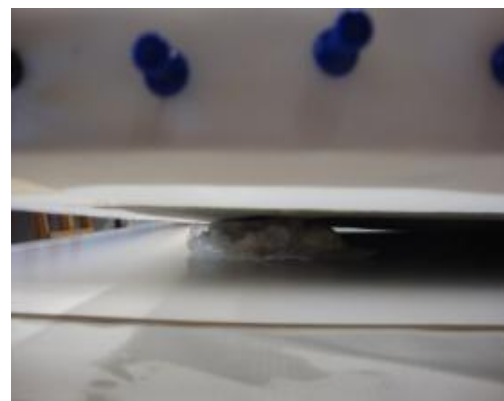
Figure 35: Mould supporting the distortions underneath.

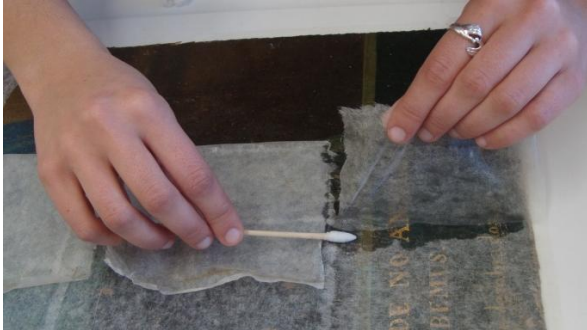
Figure 36: Removal of the facing with moistened cotton swab.

After the lining adhesive was removed, the facing was taken off using moistened cotton swabs (Fig.36). Excess water was rapidly absorbed with dry cotton. After removing the square tissue paper, the paint surface was cleaned with a moistened cotton swab.

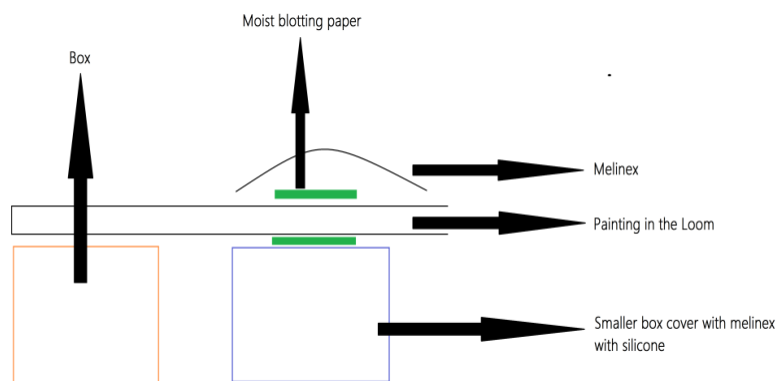
Figure 37: Diagram showing the systems used during the flattening.

The procedure was as follows (see Fig.37):

2. Pre-conditioned²⁶ slightly moist blotting papers were torn²⁷ to size, slightly smaller than the deformation/distortion. They were attached to the top of the boxes and secured with tape, then the boxes were slid underneath the painting with the moist blotter immediately below the deformation. A piece of Melinex was placed over the paint surface to hold the moisture within the paint composite (Fig.61, appendix XIII.3).

3. The moist blotter was allowed to remain in contact with the painting until the distorted canvas or paint surface became flexible (monitored constantly with finger pressure), usually within 2-5 minutes (up to 10 minutes). Once plasticity was obtained, the blotter was removed and replaced with a larger dry blotter, then mild pressure was applied over the Melinex covered distortion. Initially small lead weights were applied, followed by sand bags, and then after approximately an hour, those were replaced by large flat lead weights

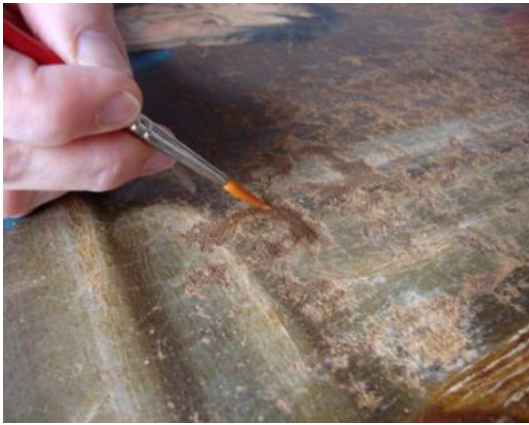
Figure 38: Isinglass being applied on canvas exposed.

Two tests were performed with a 4% solution of isinglass: 0.125 g of isinglass to 5.5 ml of water³⁰. The first, on piece of stretched linen canvas, the second: on the painting *João Luiz Lourenço*, in both it was applied by brush. On the linen canvas two strategies for flattening were explored: the first to apply weights while the isinglass was drying, the second using a vacuum table during the drying process. In both cases the canvas became flat and somewhat stiff, with the best results from the vacuum table. For the test on the painting the vacuum table was used. The isinglass was applied on a 2x2cm area of exposed fabric (Fig.38). To enhance air flow a sheet of non-woven fabric (Reemay) was placed immediately below the painting, with a sheet of blotting paper covering the perforated table top. The painting was covered with a thin flexible sheet of plastic (Fig.39 and appendix XII) to create the top of the vacuum system. To prevent this plastic from sticking, a sheet of silicon-coated Melinex was placed immediately above the paint surface. While under vacuum the Melinex did not conform perfectly to the surface, therefore, after approximately four hours when the fabric/isinglass was partially dry, the Melinex was removed so that the soft plastic sheet could follow the contours of the paintings surface and the areas of paint loss.

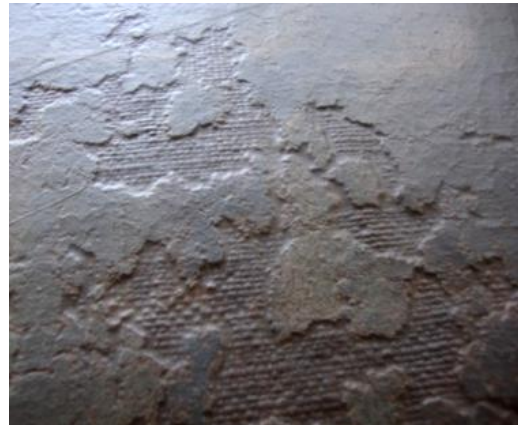
Figure 39: João Luiz Lourenço under vacuum after the isinglass has been applied with a soft plastic sheet on top.

After seven hours, the vacuum was turned off and the test area appeared completely flat; the day after it continued to remain flat. In view of this success, the same treatment was carried out on all exposed fabric in areas of loss, taking care to not to wet the area too much. The same treatment was carried out for the remaining deformations in painted areas, by applying the isinglass to the canvas on the back. In this case, a silicone-coated Melinex sheet was left over the painting during vacuum treatment to enhance flattening of the painted surfaces. Flattening was achieved after six hours of vacuum pressure (Figs. 40 and 41).

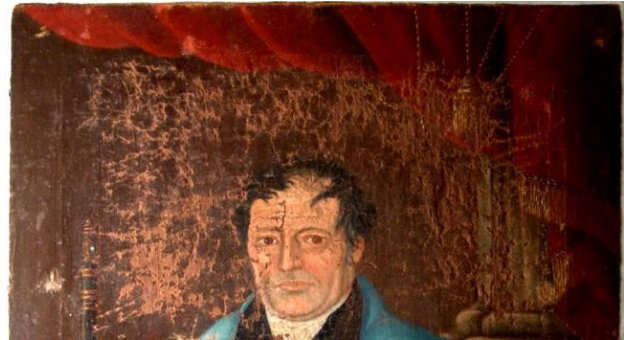
Figure 41: During treatment (after flattening), detail, raking light showing less evident deformation.

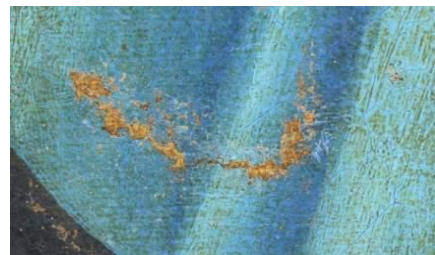
Figure 43: The tear after the realignment of the threads.

Effective tear repairs for paintings on fabric involve ensuring that the torn threads are completely re-aligned, a delicate procedure since they are usually displaced and the edges of the tear can overlap. This was the case for the tear on *João Luiz Lourenço*. Realignment was achieved by first opening up the tear using a small raised lump of Melinex-covered plasticine placed underneath the painting immediately below the tear (Fig.42). As the painting was gently lowered over the mound of plasticine the tear opened, allowing access to the threads which, with the help of the 4% isinglass solution to increase their flexibility and to hold them in place, were successfully realigned (Fig.43). This operation was performed under a stereomicroscope.

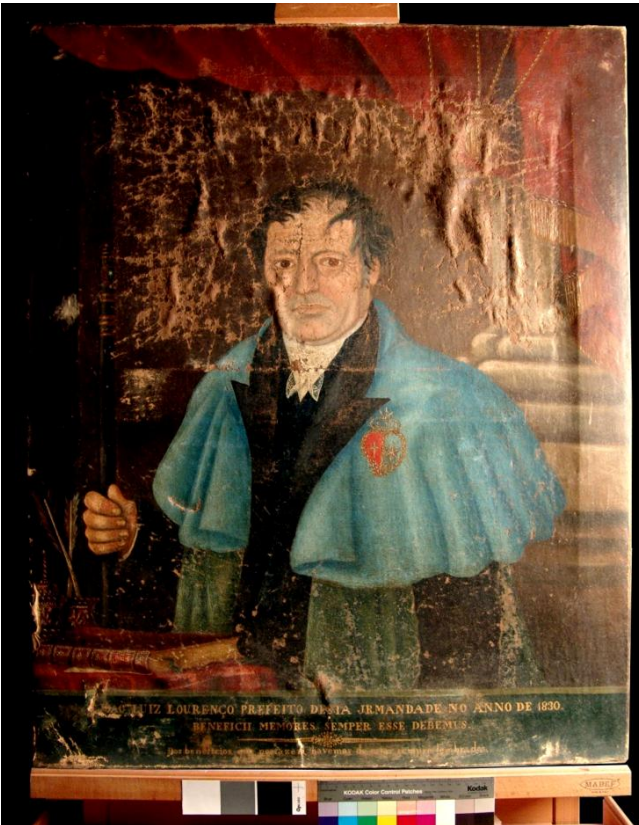
Before Treatment: Raking light photograph.

The original fabric appeared to be in good condition, but was badly distorted. There are several different types of deformations: undulations, sharp depressions, stretcher-bar creases, and bulges (see appendix I, Before Treatment: Raking light photograph). The areas protected by the stretcher bars are significantly less damaged, probably due to the buffering effect of the wood moderating fluctuations in relative humidity and because the fabric was supported beneath by the stretcher bars (the extreme distortions in the canvas related to stretcher bar creases suggest that the painting was left in a horizontal position while in a plastic state induced by water and moisture- e.g. it was laid flat after having stood in water).

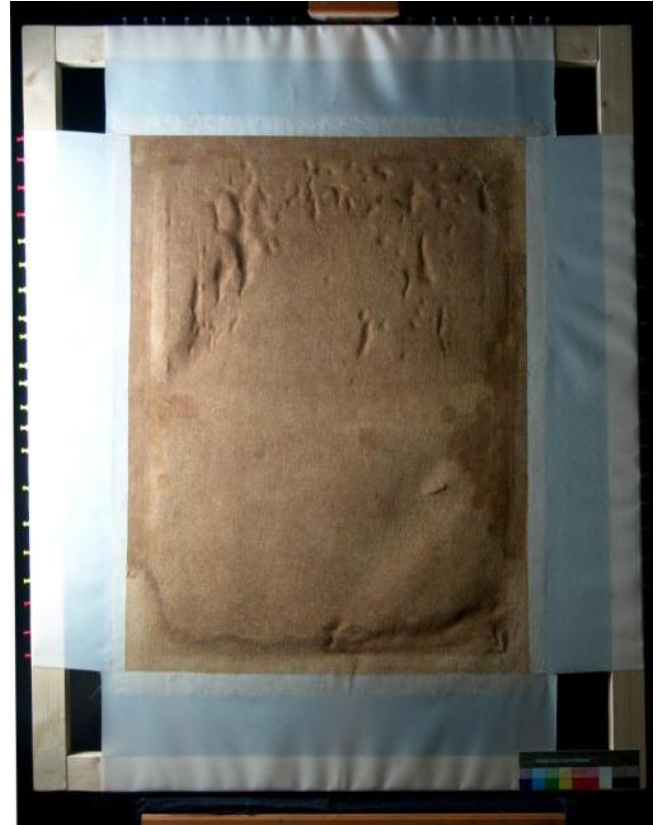
During Treatment: Raking light back, after the removal of the lining canvas, before flattening.

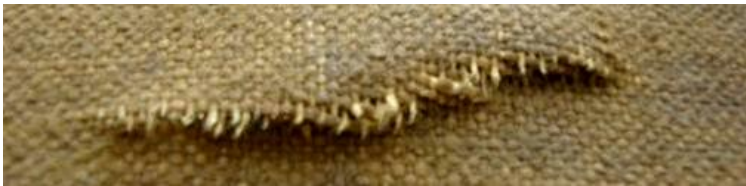
Figure 2: Small tear (4cm) through original and the lining canvas.

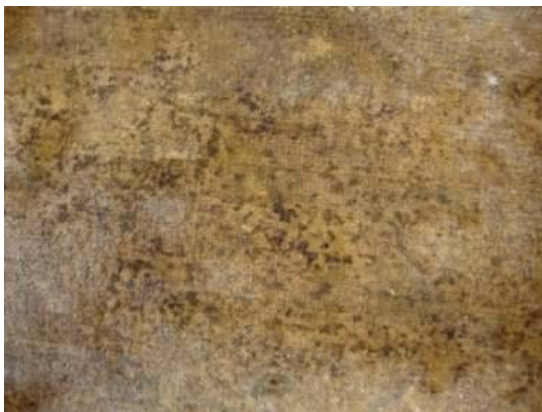
Figure 4: After removing the lining canvas, it was possible to see that the adhesive had been severely affected by microorganisms.

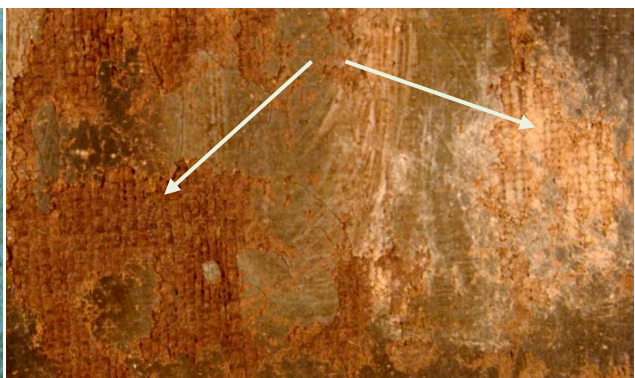
Figure 10: Difference in colour of the original canvas between old and more recent losses.

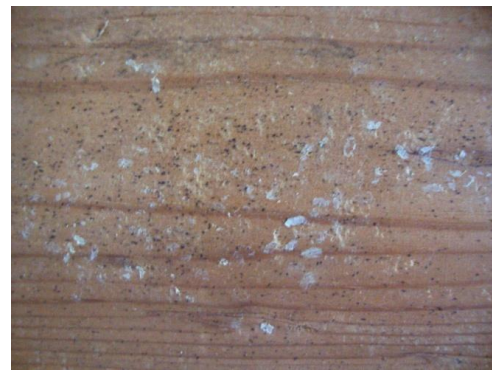
The stretcher is in good condition overall, the wood is sound and the corners are well secured (although part of the bar is slightly protruding at each corner, a fault of this type of corner design). On the back of the stretcher, there are several small circular holes (1 mm) distributed randomly that indicate the presence of an insect infestation (no longer active), (Fig. 20). On the front, there is evidence of previous mould growth and insect infestation (carcasses from insects are present) (Fig. 21).

Figure 21: Signs of fungi and insect debris (carcasses) on the surface of the stretcher.

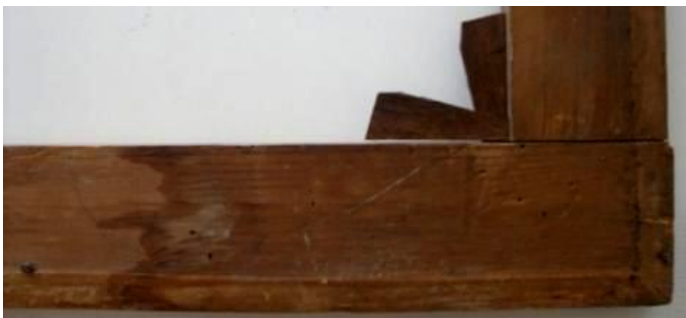
As in the case of the lining canvas, the stretcher has a tide line, visible signs that this was in direct contact with water (Fig.22).

Figure 22: Tide line on the stretcher

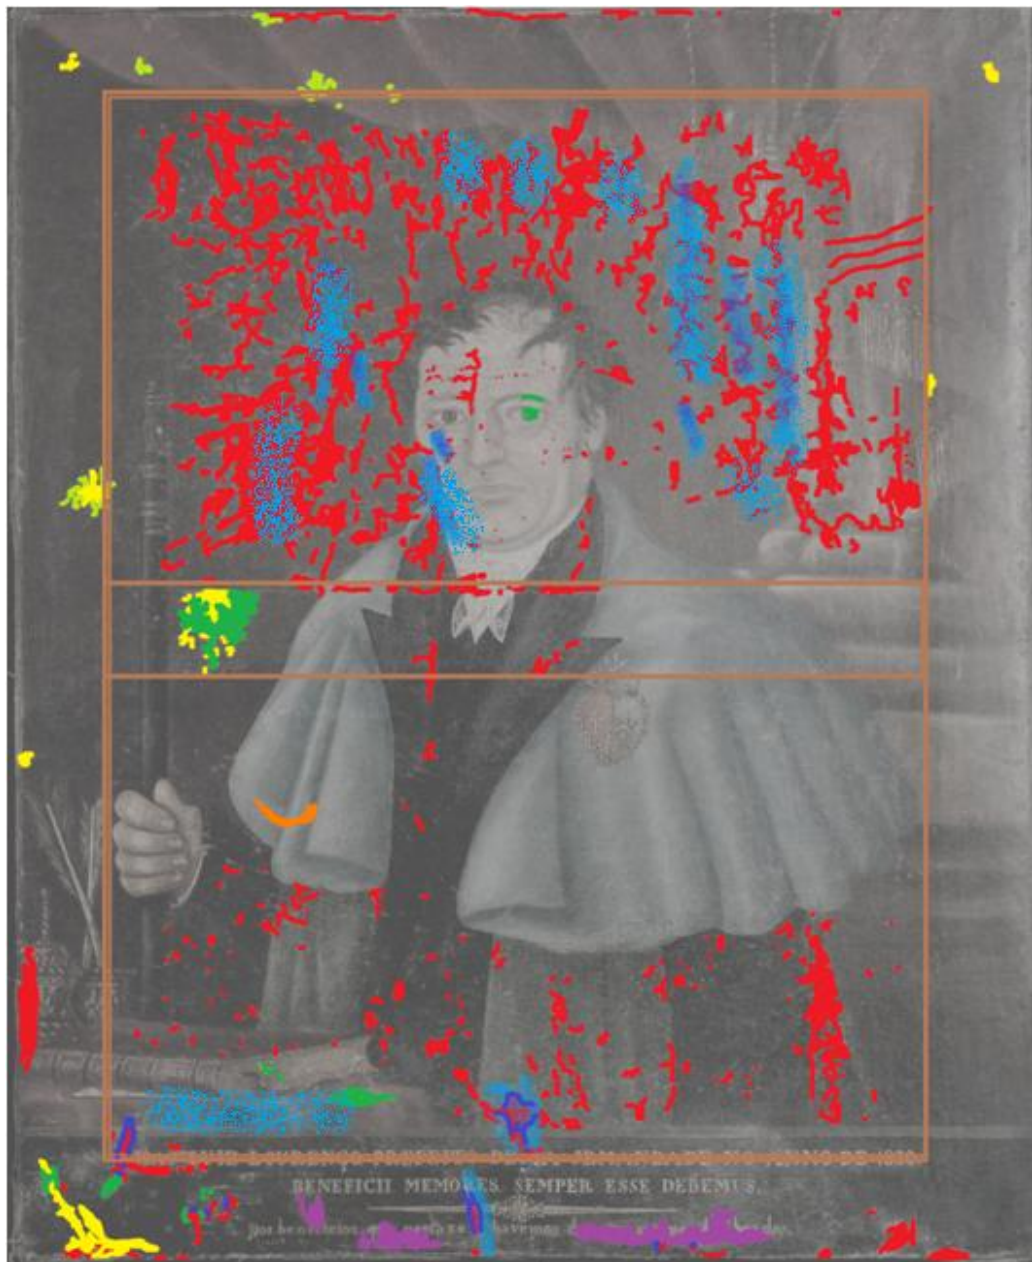
Appendix IV –Map of damages

Paint composite loss

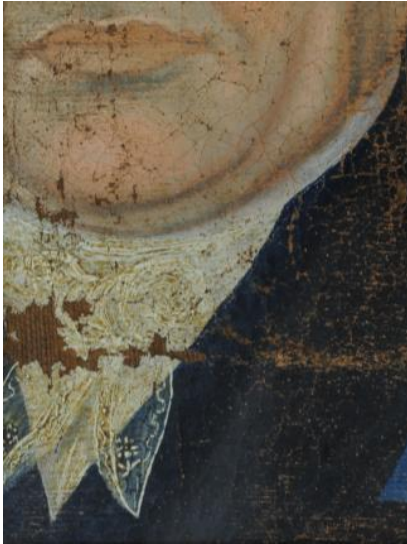
Figure 32: Initial efforts to document the distribution of the protrusions at the surface of the painting. Problems with discriminating lead soap protrusions from other surface defects was encountered, so that imaging did not provide exclusive evidence of lead soaps for the mapping desired.

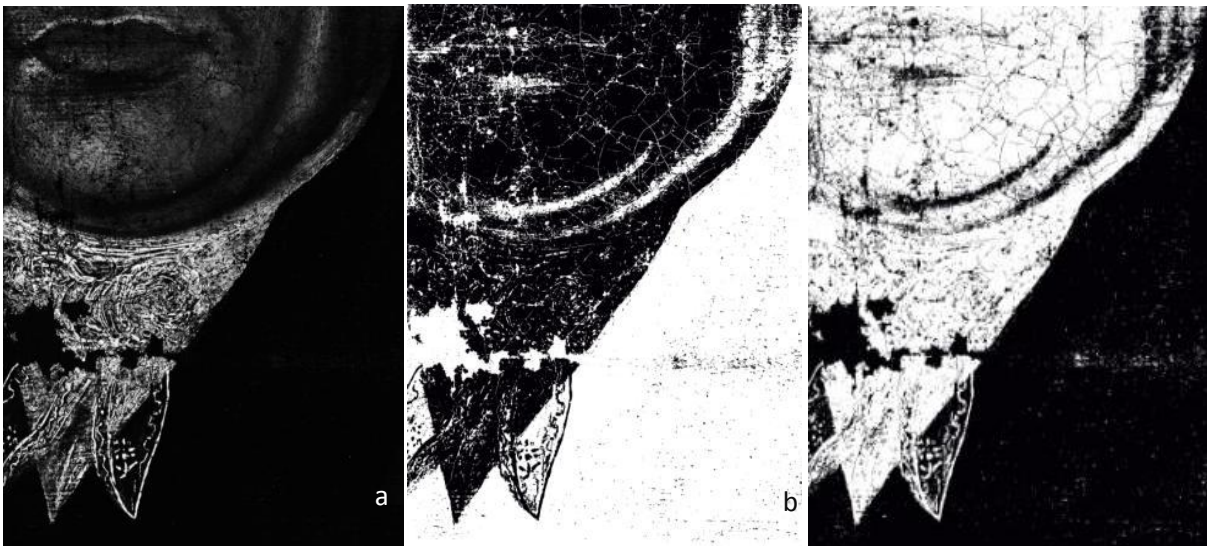
Figure 33: Application of a series of Photoshop filters, in an attempt to highlight the protrusions.
 a) Black&white image with increased contrast. b) Filter "Torn&Edges" c) Filter "Torn&Edges" (inverted)

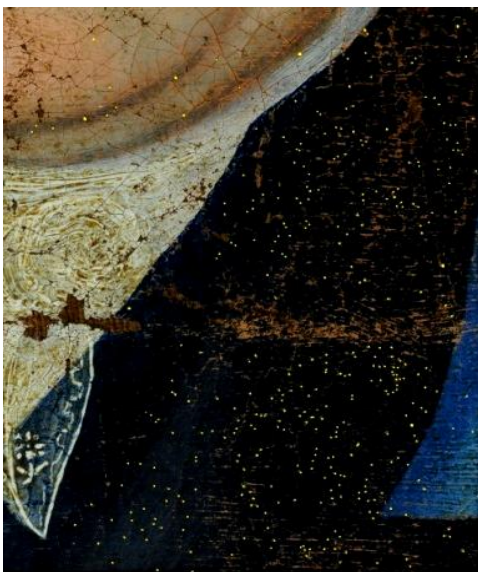
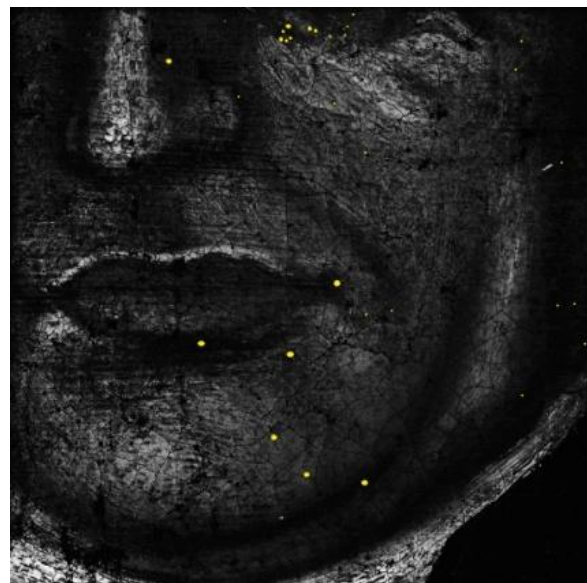
Figure 34a: Highlighted protrusions with yellow dots on the surface without a filter (left image) and Figure 34b: black&white image with increased contrast image (right)

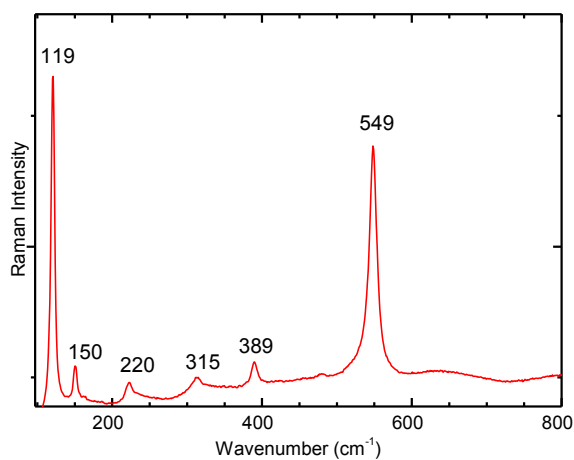
X07: the first ground layer showing the main peaks of red lead (minium): 119, 150, 220, 315, 389 and 549 cm^{-1} [33, 60].

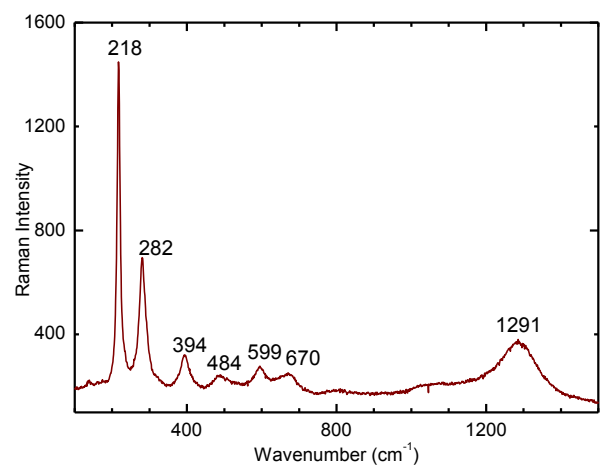
X05: the first ground layer showing the main peaks of an iron oxide: 218, 282, 395, 484, 599, 670 and 1291 cm^{-1} [20, 33,61].

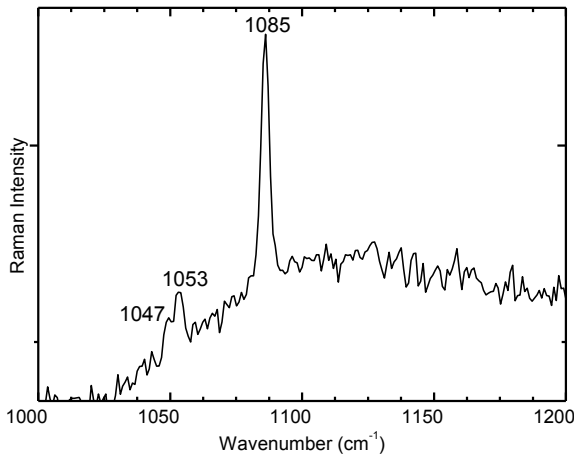
X07: the first ground layer showing the main peaks of lead carbonate (1047 and 1053 cm^{-1}) and calcium carbonate (1085 cm^{-1}) [33,34].

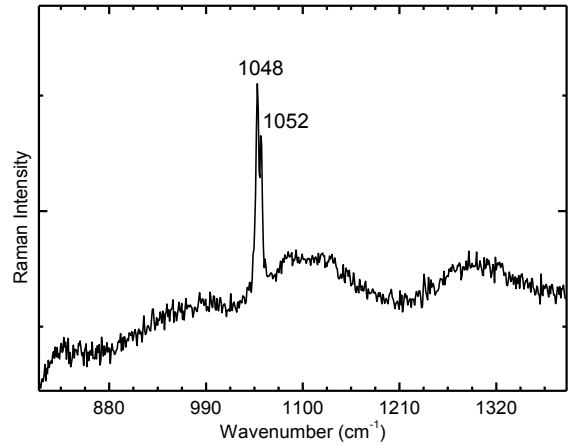
X05: the first ground layer showing the main peaks of lead carbonate (1048 and 1052 cm^{-1}) [33,34].

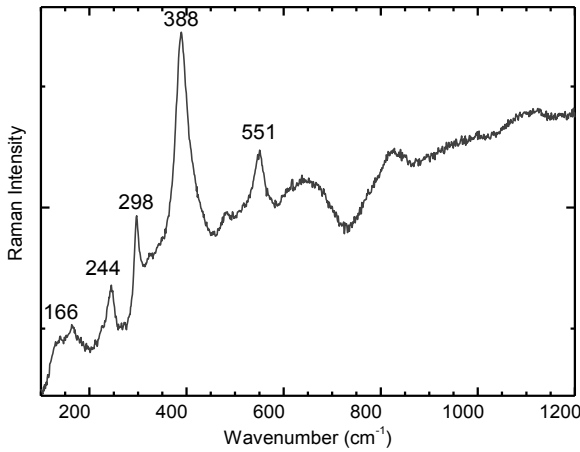
X03: the second ground layer showing iron oxide (goethite): 166, 244, 298, 388 and 551 cm^{-1} [61].

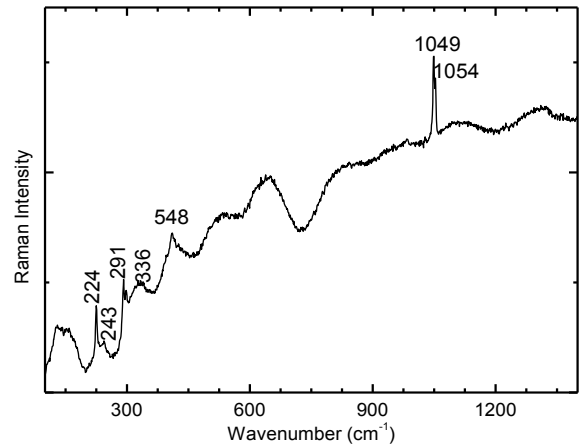
X05: the second ground layer showing the main peaks of an iron oxide (haematite): 224, 243, 291, 336 and 548 cm^{-1} [E1,E4] and lead carbonate (1049, 1054 cm^{-1}) [20].

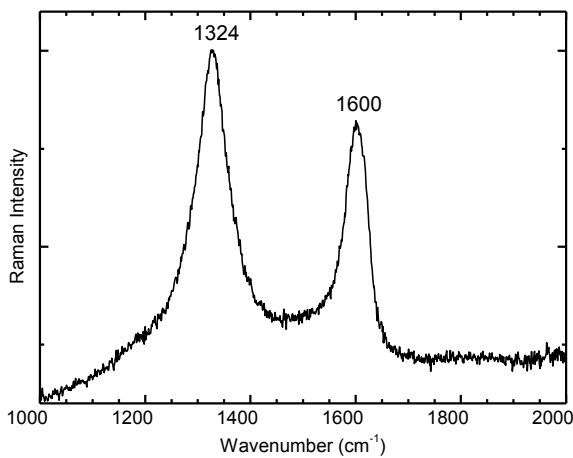
X11: Black pigment. Showing characteristic peaks of a carbon-based pigment: 1324 and 1600 cm^{-1} [33,34]

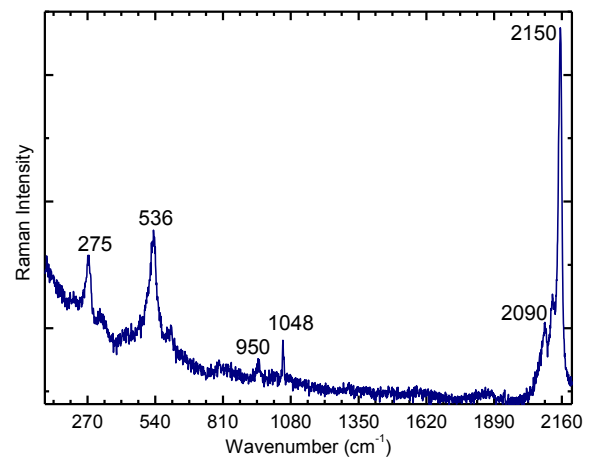
X3: Blue pigment. Showing peaks associated to Prussian blue (275, 536, 950, 2090 and 2150 cm^{-1}) and lead white (1048 cm^{-1}) [33,34]

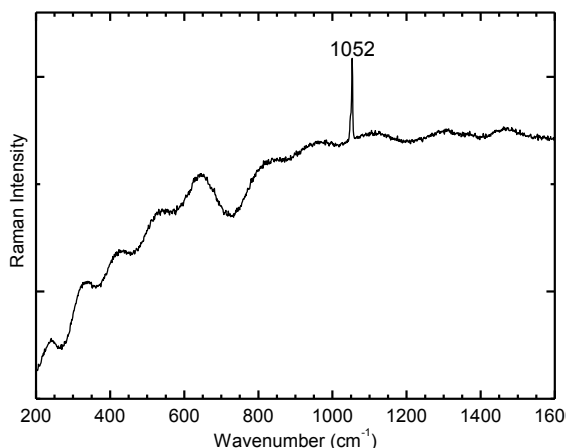
X12: White pigment. Showing the main peak associated to the presence of lead white pigment at 1053cm^{-1} [33,34].

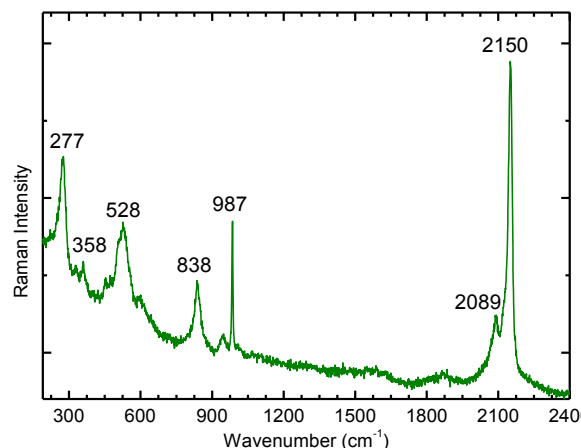
X4: Dark green pigment. Showing characteristic absorbance for chrome yellow (lead chromate) at 358 and 838cm^{-1} . The strongest band is at 838cm^{-1} is associated to vibration of CrO_4^{2-} (symmetric stretching) [59] and to Prussian Blue (277, 528, 987, 2089 and 2150cm^{-1}) [33,34].

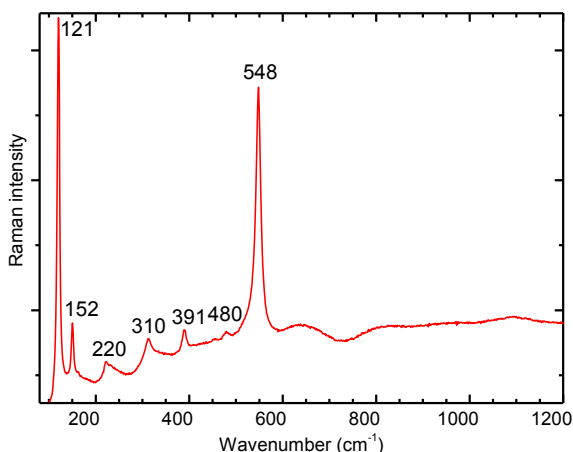
X6: Red pigment. Showing the presence of minium: 121, 152, 220, 310, 391, 480 and 548cm^{-1} [33, 60]

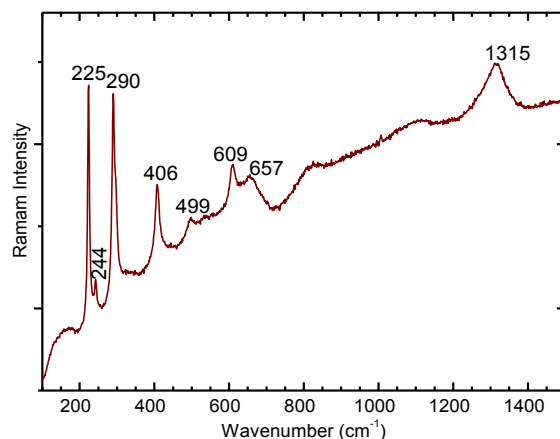
X13: Brown pigment. Showing the presence of an iron oxide (haematite): 225, 244, 290, 406, 499, 609, 657 and 1311cm^{-1} [61].

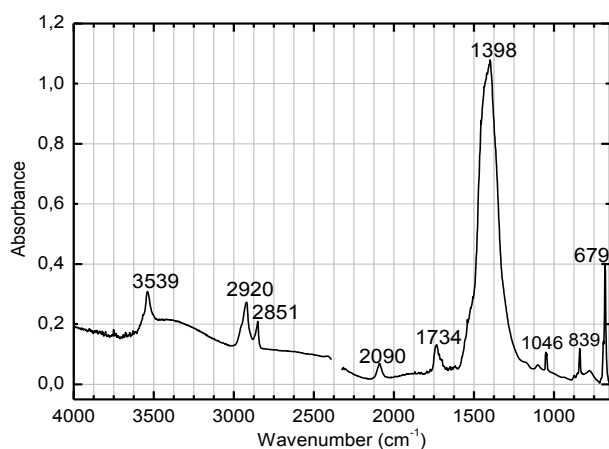
F2: Blue pigment. A mixture of Prussian blue and lead white. The μ -FTIR indicates the presence of the ion $[\text{Fe}(\text{C}=\text{N})_6]^{3-}$ (Prussian blue) stretching band at 2090cm^{-1} [5] and the main peaks of lead white at 3530cm^{-1} (OH stretch), 1734cm^{-1}

(C=O stretch), 1398 cm^{-1} (C-O stretch), 1046 cm^{-1} (CO_3 symmetric stretch), 839 cm^{-1} (CO_3 out of plane rocking) and 679 cm^{-1} (CO_3 in plane rocking)[22].

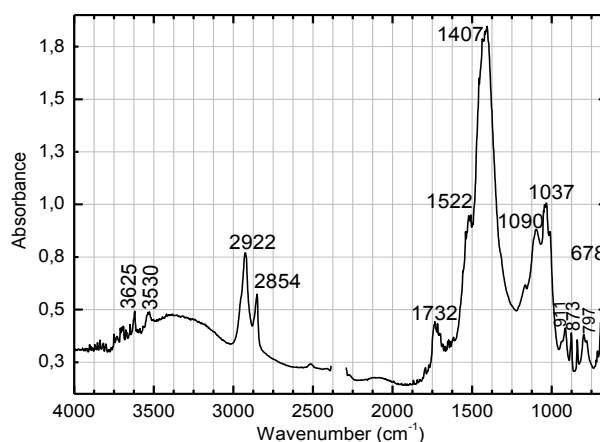
F3: Brown pigment. A mixture of lead white ($3530, 1732, 1407, 1037, 873$ and 678cm^{-1} [22]), aluminosilicate kaolinite (3624cm^{-1} (hydroxyl ion bands), 1037cm^{-1} (Si-O-Si) and 911cm^{-1} (Al-O-H) [21]). Normally, low amounts of quartz are found

with kaolinite, which is identified by the bands at 1090 and 797 cm^{-1} [21]. It was not possible to verify the presence of an iron oxide. In this spectrum the metal carboxylates' peaks at 1407 and 1522 cm^{-1} (COO^- symmetric and asymmetric stretch, respectively) [14-16,23] are detected.

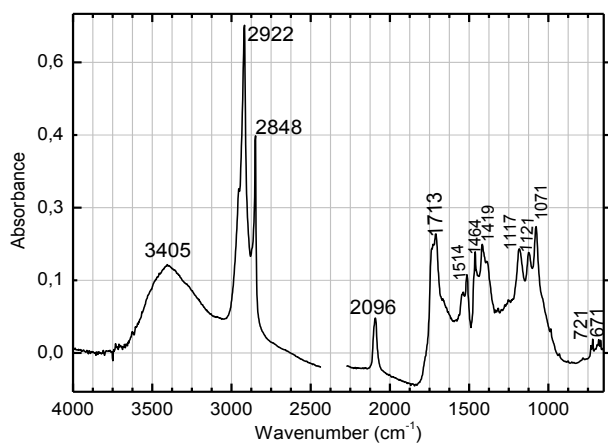
F4: Green pigment. Confirmed the presence of Prussian blue through the band at 2096 cm^{-1} and barium sulphate (BaSO_4) by the IR bands at 1117 , 1121 and 1071 cm^{-1} [E2].

It is possible to observe a peak at 1713 cm^{-1} , associated with the presence of carboxylic acids [A], and peaks related with metal carboxylates at 1464 and 1514 cm^{-1} (COO^- symmetric and asymmetric stretch, respectively) [14-16,23].

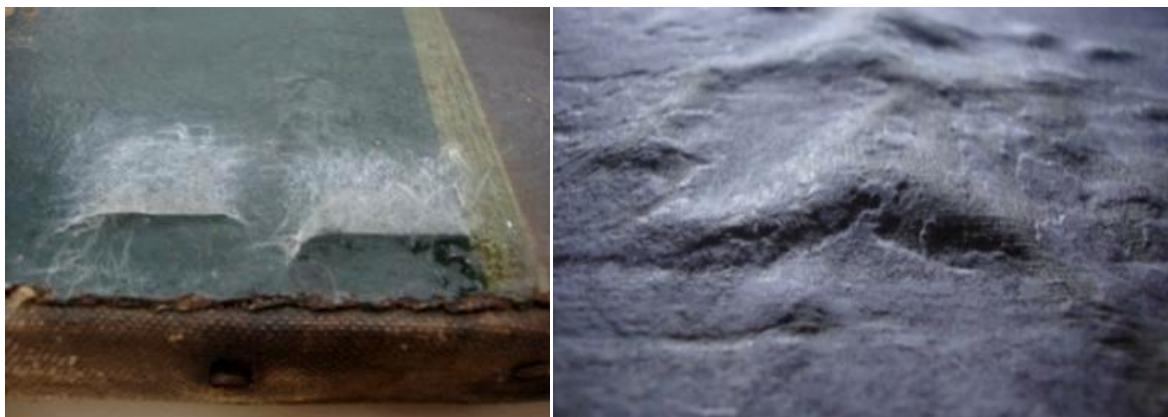
Figure 37: Two facing papers were considered, one thin³⁴ (left) and one thicker³⁵ (right). Rectangles (3cm x 4cm) of each tissue were applied with the 3% CMC solution.

Figure 38: Painting after facing. The thick tissue still provided good conformation to all deformations.

Two facing papers were considered, one thin¹² and one thicker¹³. Rectangles (3cm x 4cm) of each tissue were applied with the 3% CMC solution (Fig.37, appendix X.1.2) and allowed to fully dry. The thicker tissue was chosen since the thinner tissue left more fibres on the surface after removal than the thicker one. The thick tissue still provided good conformation to all deformations (Fig.38, Appendix X).

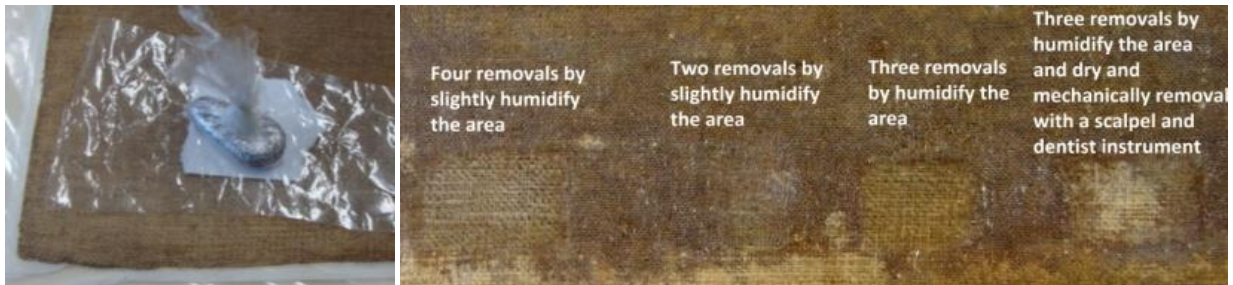
Figure 39: A light weight was placed over the Melinex to obtain better contact between the glue and the blotting paper.

Figure 40: Aspect of the canvas after the removal (with moisture) of the lining adhesive.

Moistened blotting paper: This method avoided damaging the canvas fibres and allowed good control of the level of moisture introduced to the back of the painting. A square of slightly moist blotting paper was placed on top of the glue and covered by a piece of polyester film (Melinex) to slow moisture loss. A light weight was placed over the Melinex (Fig. 39) to obtain better contact between the glue and the blotting paper and left for ten minutes. After this time, the glue appeared dark and was soft, but the canvas did not appear to be significantly wet. The blotting paper was then removed and a dental instrument followed by a scalpel blade were used to gently scrape the adhesive. The process was repeated two to three times, removing two to three layers of adhesive (Fig. 40).

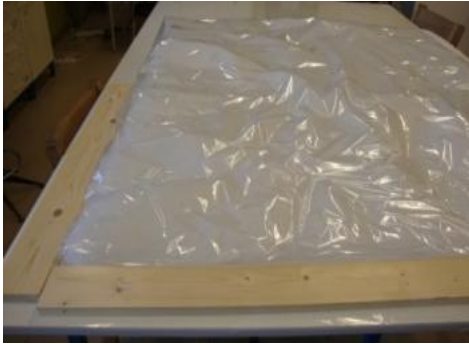
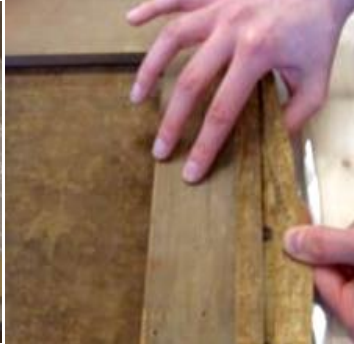
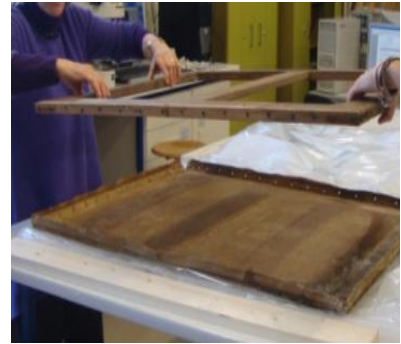
Figure 53: Cushioning material to accommodate and provide some support to the badly distorted painting while face down.

Figure 54: Lining canvas being pulled away from the stretcher along the tacking margins.

Figure 55: The stretcher being lifted off the back of the lined painting.

To remove the stretcher and the lining canvas the painting was laid face down on cushioning material to accommodate and provide some support to the severe out of plane distortions.²² The lining canvas was gently pulled away from the stretcher along the tacking margins, and the stretcher lifted out (Fig.53-55, appendix XI.1). After removing the stretcher, a surface cleaning of the lining canvas with a soft brush and a vacuum cleaner was performed. The canvas was extremely dirty (Figs. 56 & 57, appendix XI.1).

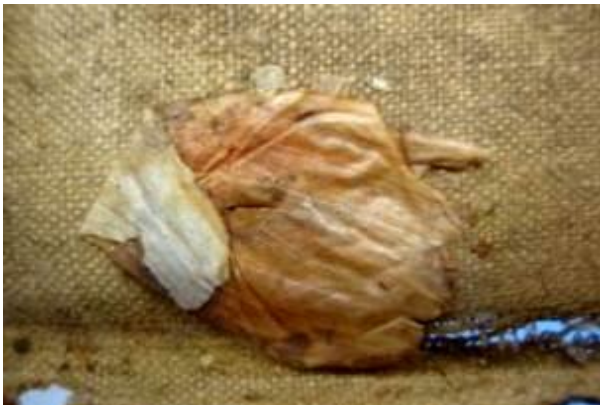
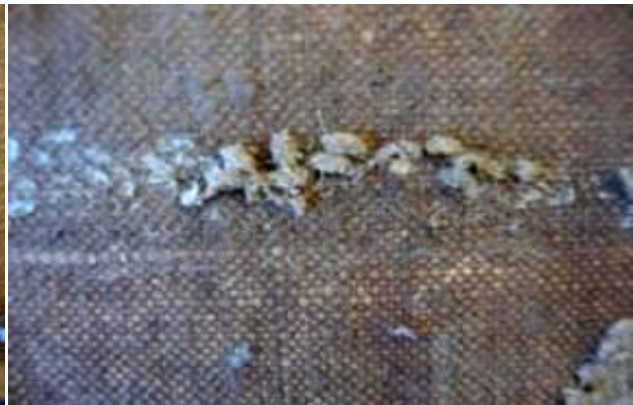
Figures 56a & 57: Lining canvas debris- a: a piece of old onion skin, and b. insect casings
