Treatment of a nineteenth century male portrait in oil including the characterisation of materials, technique and a study of the lead soap aggregation in the paint composite

This project involved the conservation of a 19th century portrait in oils from the Ecomuseu do Seixal (Portugal). The painting of “*João Luiz Lourenço*” was in very poor condition. Because of the range and severity of the problems presented, it offered an opportunity to explore important aspects of painting conservation in-depth. The approach to its treatment required an empirical investigation of a number of materials and techniques used in the field of conservation/restoration. Of additional interest, the painting exhibits widespread evidence of metal soap (lead carboxylate) aggregates protruding through the paint from the ground layer. The painting’s materials and the metal soaps aggregates were studied and characterised with different analytical techniques: μ -EDXRF (*Energy Dispersive X-ray Fluorescence*), μ -Raman Spectroscopy, μ -FTIR (*Fourier Transform Infrared Spectroscopy*) and SEM-EDX (*Electron Scanning Microscopy with Energy Dispersive X-ray Spectroscopy*).

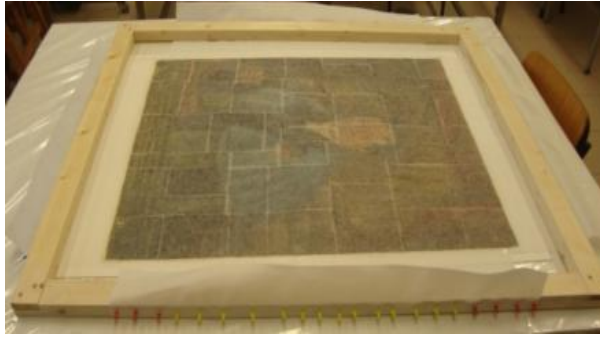
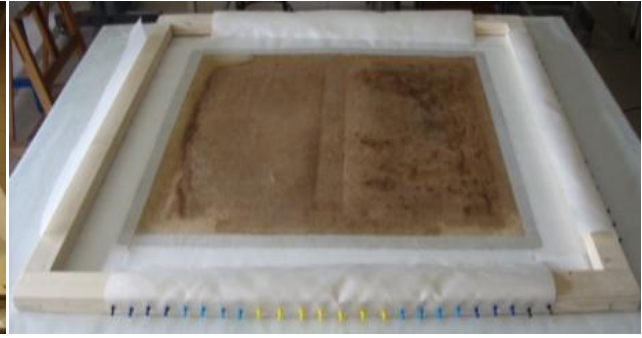
Figure 59: The painting is attached to the loom such that it is face up with the canvas back flat on the table.

Figure 60: The painting is attached to the loom such that the canvas is face up with the paint surface flat on the table.

Strips of 3 cm wide BEVA film were applied to polyester fabric strips with a hot spatula (around 70°C). The strips were then adhered to the back of the painting using a hot spatula (about 60°C). Prior to this it was necessary to remove the lining adhesive in these areas. This operation was performed with moist blotters and scraping. Once in place the strips were attached with pushpins to the loom - a pine wood frame²⁵ with lap joint corners. Pushpins were used because they are simple to remove thus the tension applied could be easily adjusted during the flattening treatment. The orientation of the fabric on the loom and thus the relationship of the face of the painting to the loom-bars was changed according to the stage in treatment (Figs. 59 and 60, appendix XI.2).

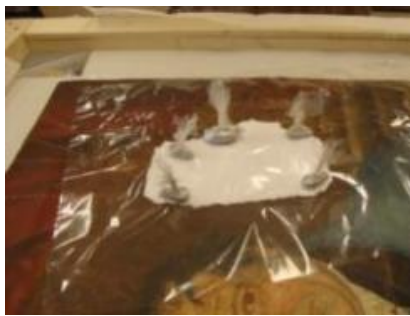
Figure 61: A slightly moist blotter on the surface of the painting to plasticise the paint/ground composite. Blotting paper had been moistened with water spray and left to equilibrate 3 to 24 hours before use to ensure uniform moisture delivery.

2. Pre-conditioned²⁶ slightly moist blotting papers were torn²⁷ to size, slightly smaller than the deformation/distortion. They were attached to the top of the boxes and secured with tape, then the boxes were slid underneath the painting with the moist blotter immediately below the deformation. A piece of Melinex was placed over the paint surface to hold the moisture within the paint composite (Fig.61, appendix XIII.3).

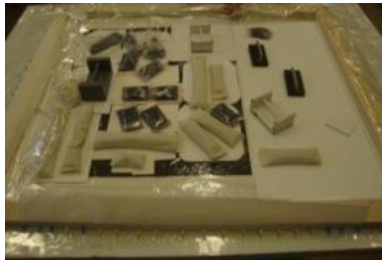
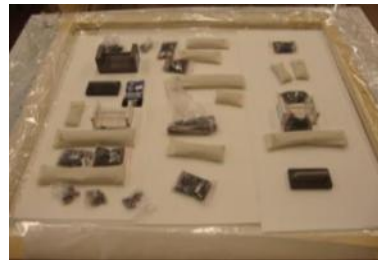
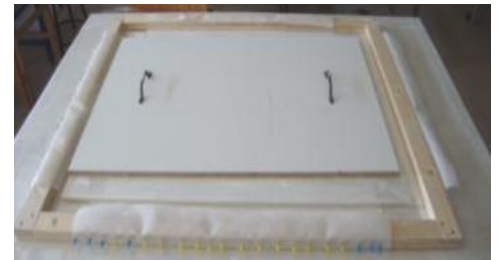
Figure 62: The painting protected with a Melinex sheet and with a series of small flat light-weight boards placed on top covered with weights

Figure 63: Three light-weight flat boards covering the entire painting with weights on top.

Figure 64: In the last phase of the flattening a card-board (heavier than those used before) was placed on top of the painting. Above this, a very flat and heavy particle board was used.

After the main deformations were minimized with local flattening as above, an overall moisture treatment was performed. Two sheets of moistened blotters were placed under the painting with a Melinex sheet suspended over top (to create a moisture chamber). After two minutes the painting started to relax. The blotting papers were removed and new dry blotting papers were placed under the painting. On top (with a Melinex sheet protecting the paint surface), a series of small flat light-weight boards were placed on top and covered with weights (Fig.62, appendix XIII.3). Eventually, as the worst distortions flattened, it was possible to replace the smaller boards with three light-weight flat boards that covered the entire painting (these also had weights on top) (Fig.63, appendix XIII.3). Finally, when the deformations were reduced, a card-board (heavier than those used before) was placed on top of the painting. Above this, very uniform wooden board was used with weights on top in order to apply a heavy uniform pressure (Fig.63, appendix XIII.3). The painting was then left is under these boards and weights between flattening treatments.

After the overall moisture treatment a sequence of weights were applied on top of the painting.
