Troia Roman Baths (Portugal) – Assessment of history of interventions

SUMMARY: *This paper presents a study of one of the roman architectonic complexes from Troia archaeological site: the Roman Baths. The first archaeological excavations campaigns and the different Roman monuments that constitute the whole site are presented, as well as the historical past conservation and restoration interventions and the most important decay factors. The Roman Baths are one example of a complex that has been intervened in, at least, two different periods of time. An assessment was made in order to understand and document its actual state of conservation, to help planning a future coherent conservation operation.*

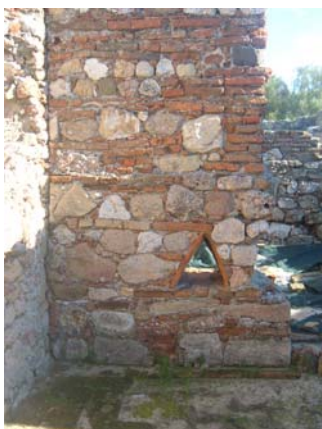
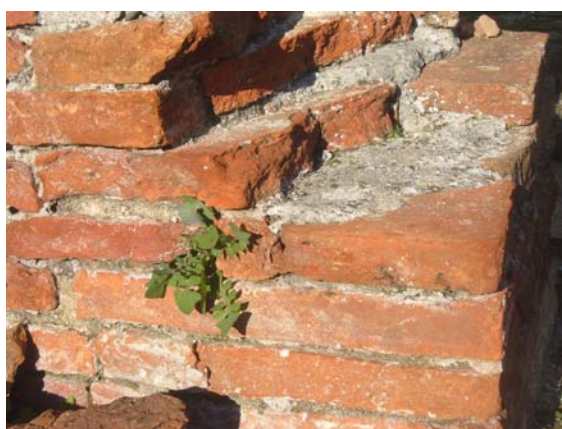
There is evident a good construction technology using various local stone and brick (*opus incertum*, *opus testaceum* and *opus mixtum*). Wall's basements are made on masonry, more or less prepared. About each 0,42m stone masonry height of the walls is intercalated and leveled with a line of bricks and roofing tiles fragments. Irregular stone and brick fragments

are used in the walls masonry, with a coarse and sandy mortar. The *caldarium* walls (except the N wall, adjacent to a *cetariae*) are 0,60m thickness and are rendered, so that its verticality is assured.

Figs. 4 and 5 - *Caldarium*: *opus incertum* and *opus mixtum* wall and a detail of an *opus testaceum* pillar

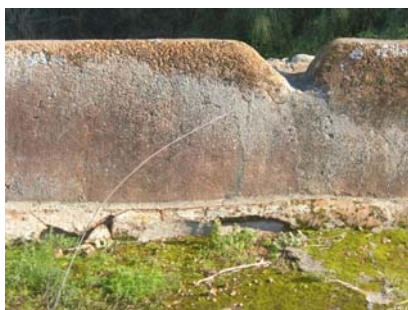
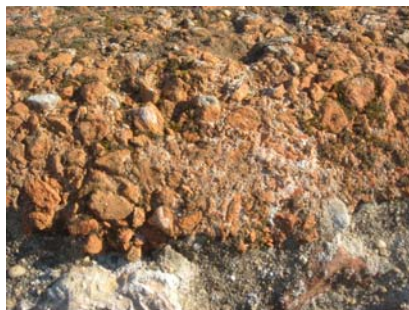
Fig. 6 and 7 – Cistern render (*frigidarium*) and detail of the *opus signinum*
