Analysis and Treatment of a Nineteenth Century Portrait, Study of Artsorb® and a Proposal for a Microclimate Frame

Dissertação para obtenção do Grau de Mestre em
Conservação e Restauro, especialização em pintura

PART 1: ANALYSIS AND TREATMENT OF THE PORTRAIT OF DOMINGOS AFFONSO	1
1. INTRODUCTION	1
1.1. Description of the Image	1
1.2. Historical Context	1
2. EXAMINATION: CONDITION, MATERIALS AND TECHNIQUE	3

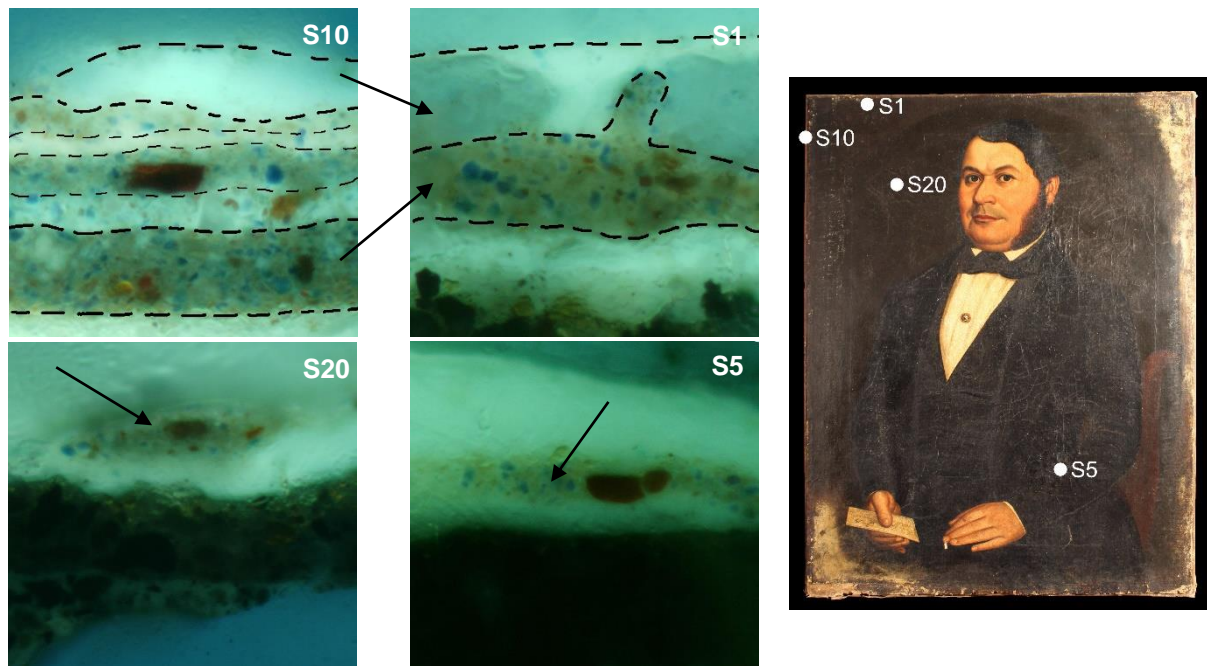
Current findings show that this overpaint corresponds to the same paint used on top of the filling material applied by a previous restorer. This layer is very distinctive: in normal light it is an orange translucent colour with some darker particles, but under UV it has a brownish translucent appearance and some of the particles fluoresce in blue (Figure 6). Further observation made in the course of this thesis preparation showed that the overpaint layer on the male portrait is not only on top of the background but also on the figure's jacket. Figure 6 shows details of four cross-sections: S10 was taken from the painting's margins and corresponds to the filling material, S1 and S20 were taken from the background and S5 was taken from the figure's jacket. Images of cross-sections S1, S5 and S20 show that the paint layer sandwiched between the two layers of varnish is very similar to the paint layers applied during a previous restoration treatment alongside the painting's margins. The dashed lines on cross-sections S10 and S1 enhances the layer division, and the arrows indicate a possible

correspondence of the layers on top of the putty to the overpaint and final varnish on the painting's surface. Although only three cross-sections are represented here to show the overpaint layer, this also appeared in the other cross-sections taken from these areas.

Figure 6 - Left: OM details from cross-sections under UV light, where the overpaint layer is seen, 500x magnification. Cross-section S5 was taken by Marques in 2014 and S1 by a DCR student in 2012. Both were photographed by the author of this thesis. Cross-sections S10 and S20 were taken and photographed by the author. **Right:** Map of sampling for the cross-sections showed on the left.

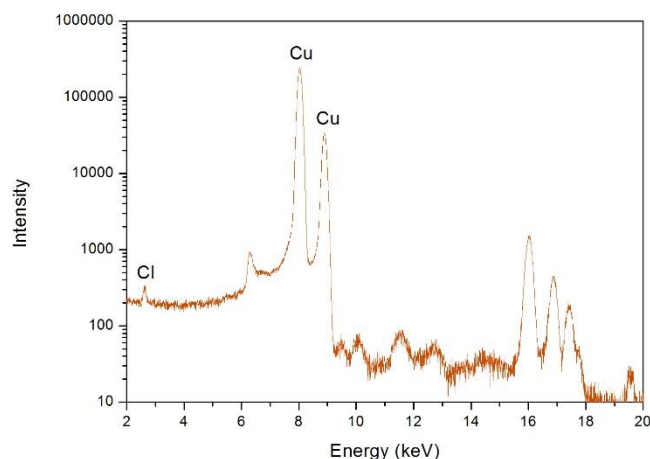
μ -EDXRF analysis of the copper coupons revealed the presence of chlorine on those exposed to Artsorb® and Tyvek® covered Artsorb®, although chlorine appeared in lesser extent in the one with Tyvek® (Figure 13) (silver and lead coupons were eliminated

Figure 13 - μ -EDXRF spectra from the copper coupon with Artsorb® (first Oddy test).

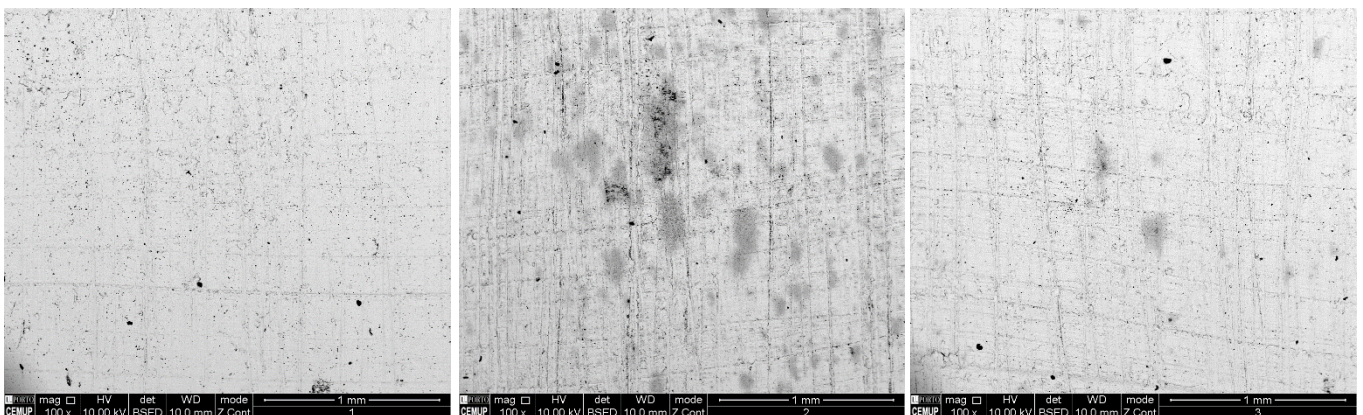
Figure 14 - SEM-BSE micrographs, 100x magnification of silver coupons from the first Oddy Test. **Left:** Control; **Centre:** Artsorb®; **Right:** Artsorb® with Tyvek® cover.

on the metal. Results of the silver coupons from the first Oddy test were consistent with μ -EDXRF on the copper coupons: the control showed no presence of chlorine while the coupon from the Artsorb® environment had a significant amount. This was seen as dark stains in the SEM-BSE micrographs and EDS analysis confirmed the presence of chlorine on these spots (Figure 14) (see Appendix VII.4, Figure VII.3). These stains are likely to be reaction products of the metal with the chlorine. The coupon from the environment of Artsorb® with Tyvek® cover revealed some stains but to a much lesser extent (Figure 14). These findings support that a Tyvek® cover over Artsorb® reduces but does not eliminate chlorine contamination from the Artsorb® sheets.

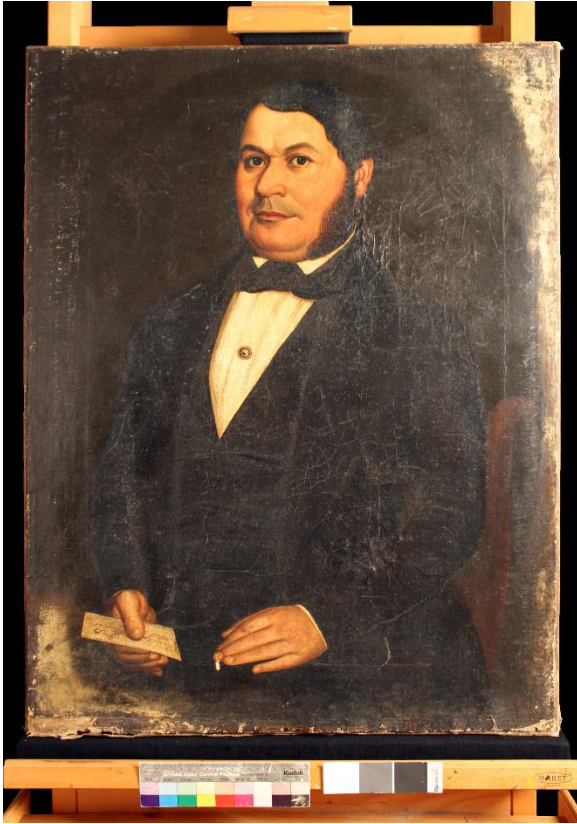
Figure I.1 – Normal light, front.

The painting exhibits mechanical cracks overall. As noted above, there are two major areas of significant cupping associated with tenting (Figures I.1, II.1 and II.15). The paint cohesion is generally good but in some areas there are losses of paint and ground/paint (see map of damages Appendix III). In these areas there was significant flaking at the interface of the paint/ground and at the interface of the paint & ground composite which is also seen along the bottom edges of the painting. The losses along the bottom edge of the painting are significant and likely associated with the water damage described above. On the surface of the painting and in between cracks, it is possible to see small white dots that appear especially on top of the black paint (on the figure's hair and jacket). Those dots were thought to be mould growth (Figure II.16) (for the fungi identification see Appendix VI).

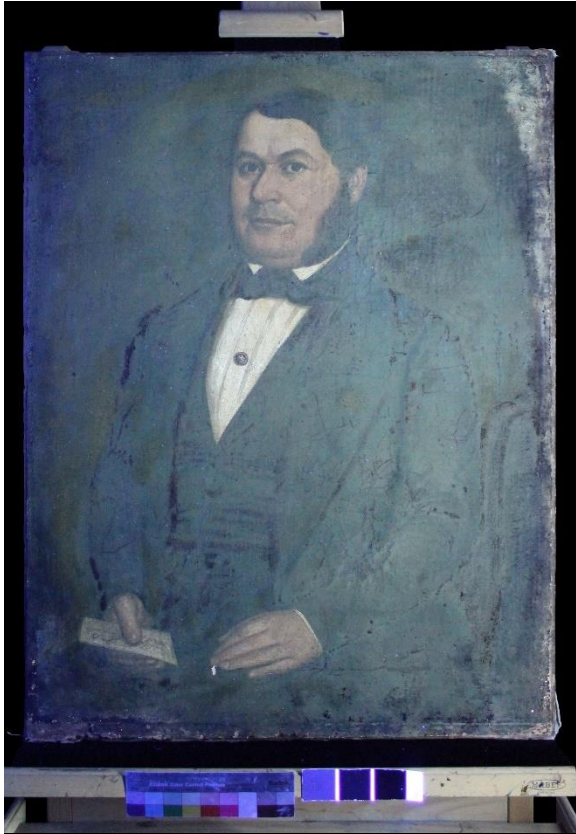
Figure I.5 – Ultraviolet light, front, showing varnish fluorescence.

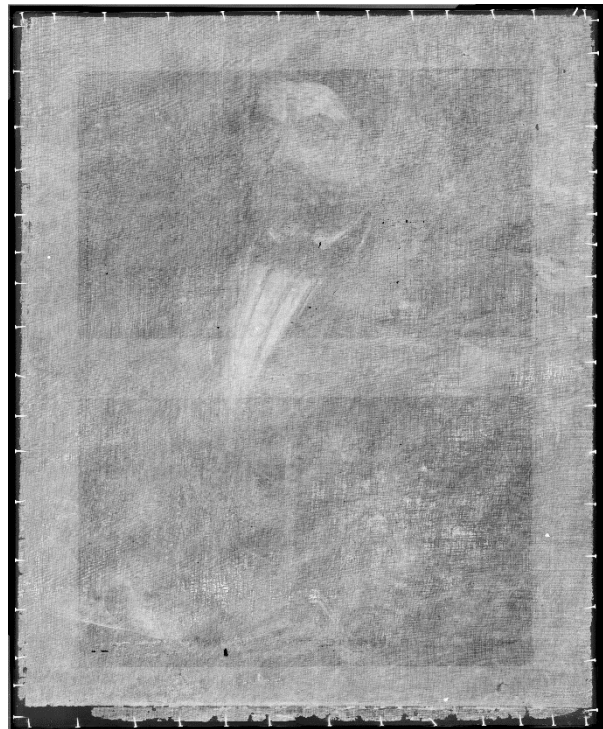
Figure I.8 –X-radiograph.

The current image area is 65.5 x 84.8 cm. Although it seems that the tacking margins were cut off at the time of the lining, as previously mentioned, through observation of the x-radiography of the painting it was possible to conclude that the left and bottom tacking margins are still present, due to the evidence of holes (likely tacking holes) and a turnover edge partially infilled (Figure II.9). Although slightly visible in raking light, due to an elevated wrinkle, the old tacking margins are currently covered with dark paint

for the areas of tenting and water damage, where small losses of paint indicate delamination in the ground as well. There are also some areas with local mechanical cracking that are evident in the x-radiograph (Figure II.10).

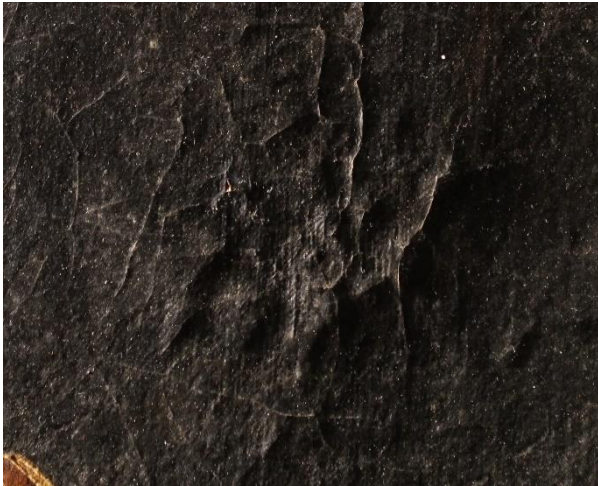
Figure II.1 – Tenting and cupping paint in the figure's arm.

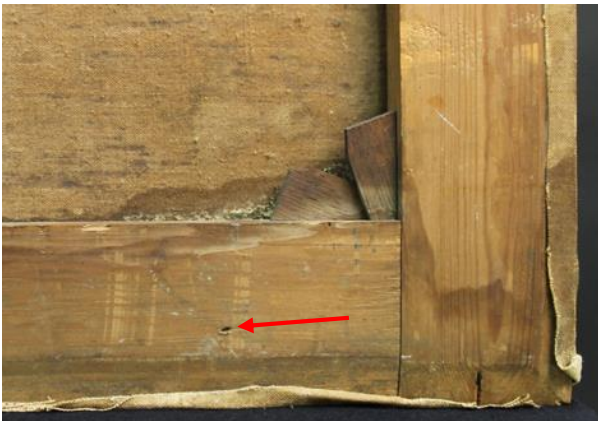
Figure II.3 –Water mark in the stretcher and canvas and mould growth on the canvas. The arrow indicates one of the insect exit holes present in the stretcher.

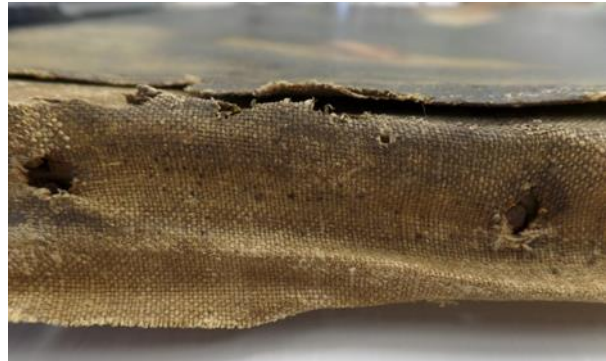
Figure II.4 – Oxidized tacks and torn lining canvas. The lining canvas was completely detached in the bottom.

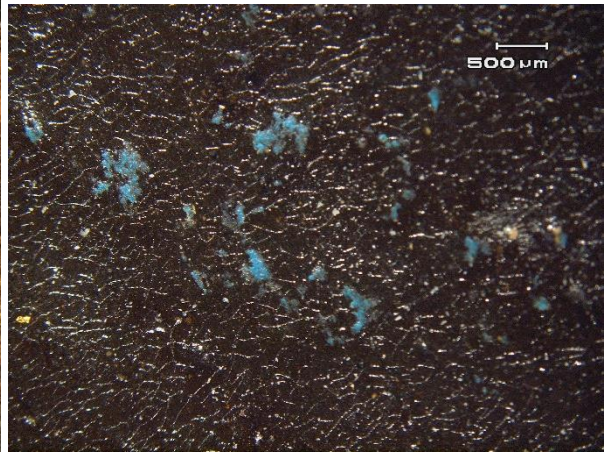
Figure II.7 – Stereomicroscopic image of abrasions and green and white deposits on the painting's surface (see Figure II.17).

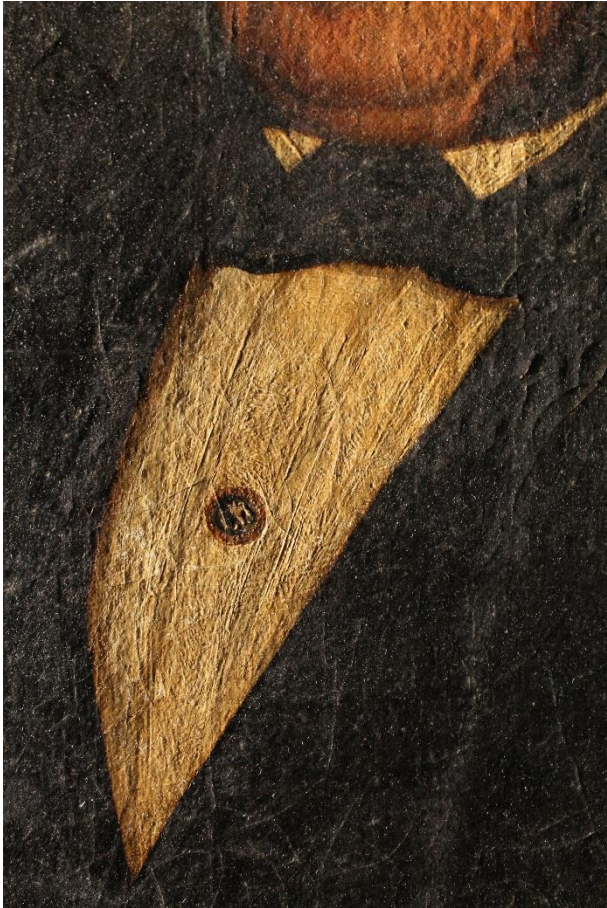
Figure II.12 – Raking light detail, textured white paint.

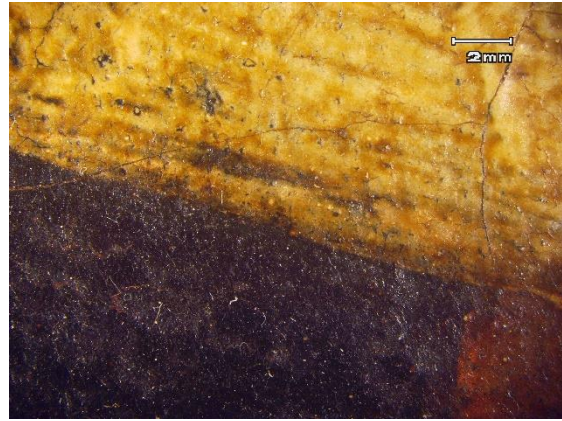
Figure II.13 – Stereomicroscopic image of transparency of the white paint (see Figure II.17).

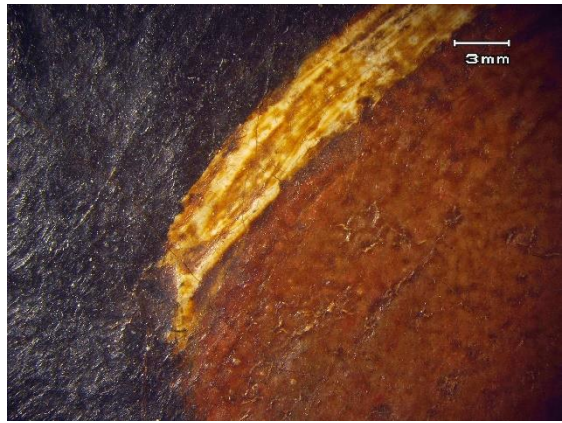
Figure II.14 – Stereomicroscopic image of white buttery paint (see Figure II.17).

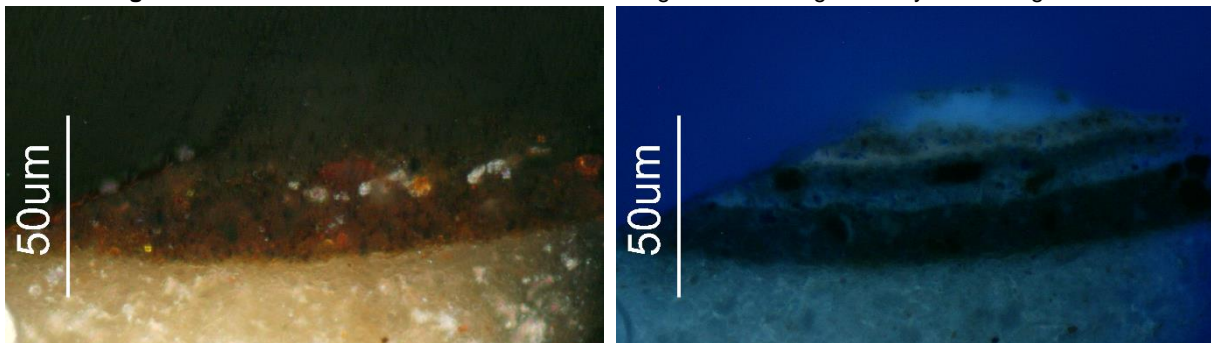
Figure IV.3 – Cross-section S10 taken from the infill in the painting's margins, showing 6 layers of paint and varnish above the putty.

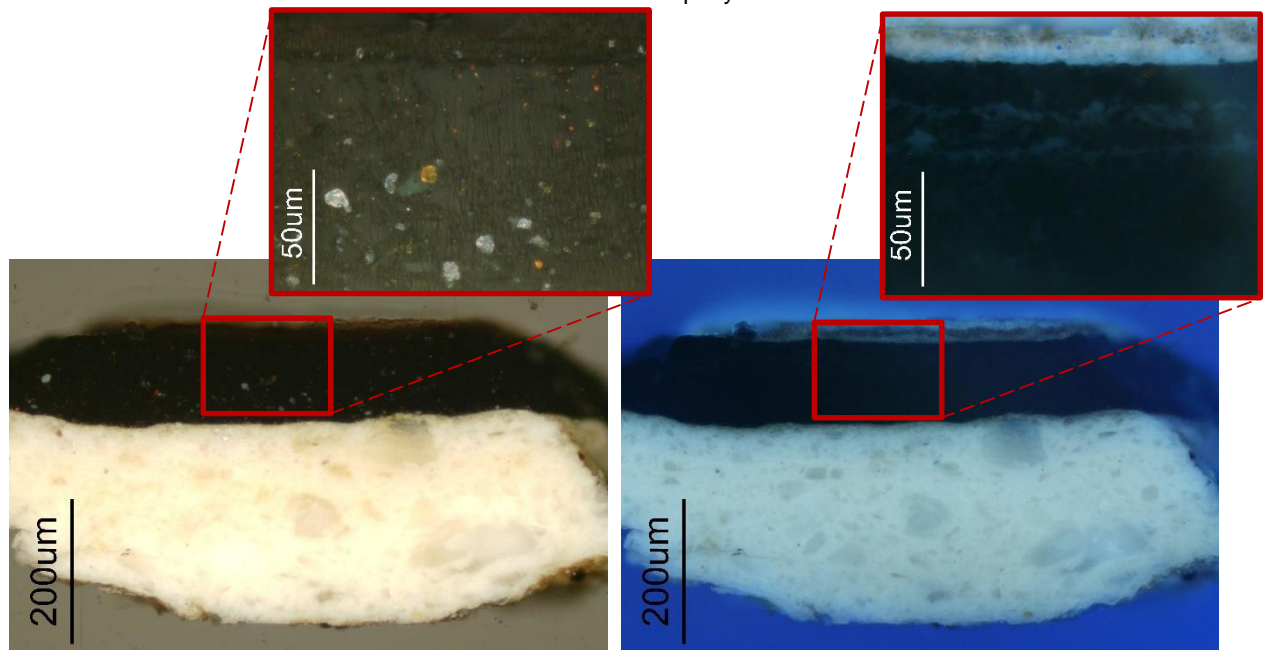
Figure IV.4 – Cross-section S13 taken from the figure's jacket showing the overpaint sandwiched between two layers of varnish. Note the particles in the bottom of the sample. The detail images show the three layers of paint with what is thought to be a layer of resin/varnish between the paint layers.

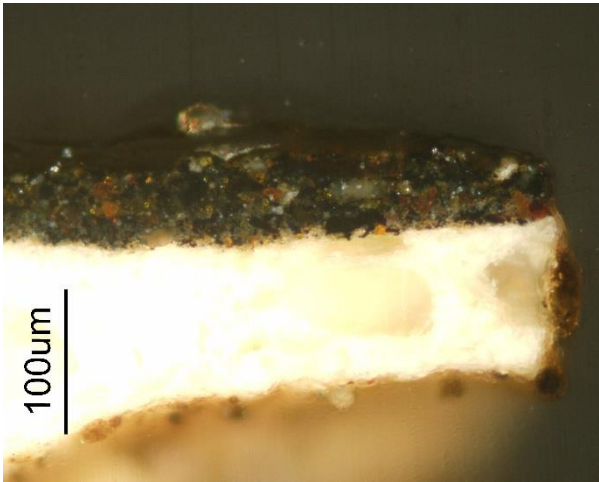
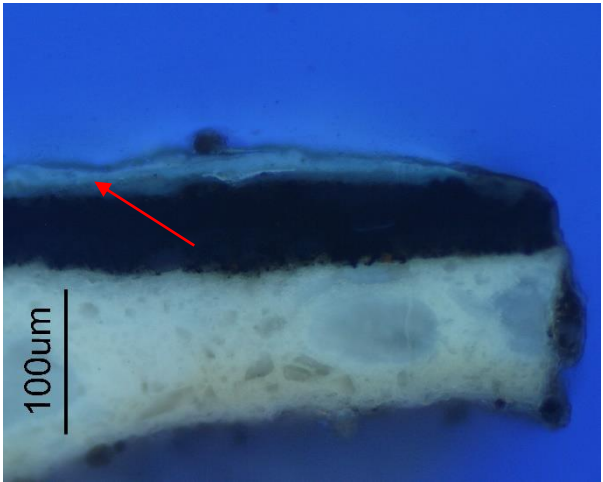
Figure IV.7 – Cross-section S21 taken from the background showing the overpaint sandwiched between two layers of varnish. The arrow indicates the overpaint layer. Note the particles in the bottom of the sample.

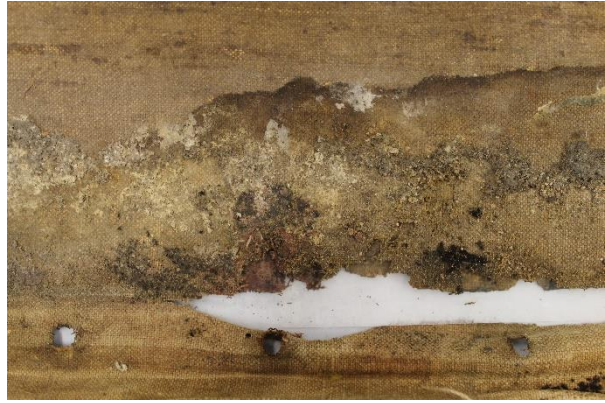
Figure V.7 – Bottom of the lining canvas exhibiting severe disintegration of the material and extensive mould growth.

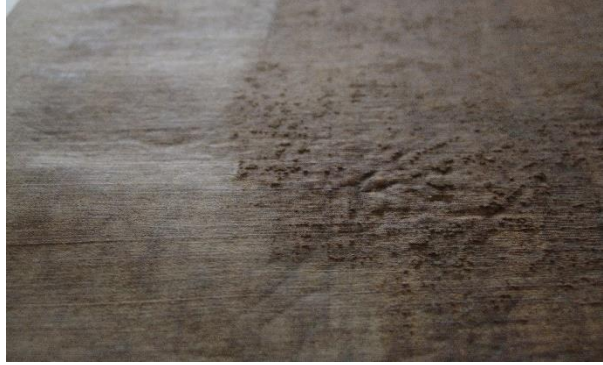
Figure V.14 – Lining adhesive with a melted appearance.

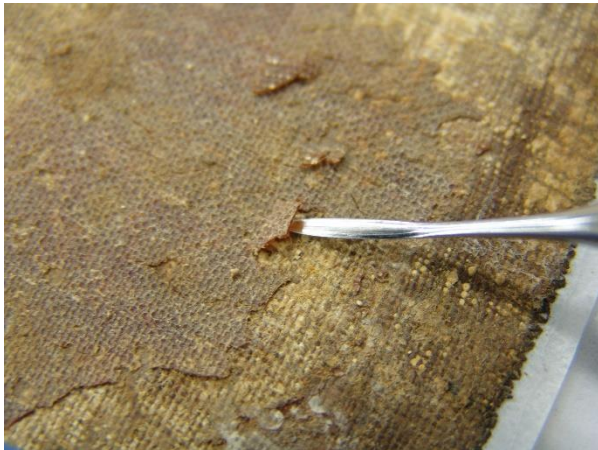
Figure V.15 – Cleaned area on the left (after the lining adhesive was scrapped off) contrasting with the still-uncleaned area on the right side.

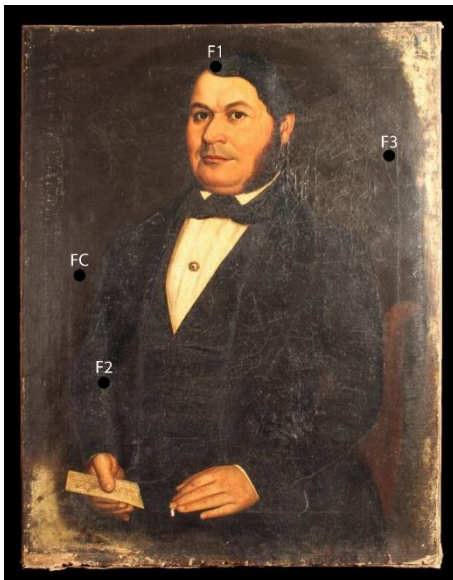
Samples were taken from the painting in areas where there were visual signs of possible microorganisms’ activity. Three samples were taken from the front, from areas that showed the presence of small white dots (F1 to F3) (Figure VI.4) and one was taken from an area with no sign of biodeterioration, as a control (FC) (see map of sampling Figure VI.1). As for the back of the painting six samples were taken from areas that showed possible signs of biodeterioration (B1 to B6). Since not all

Figure VI.1 – Map of the fungal sampling areas from the front of the painting.

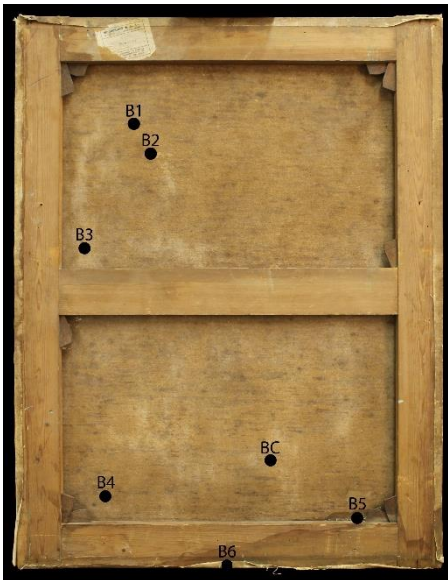
Among the samples taken from the back of the lining canvas only B2 and B6 showed fungal growth (no yeasts or bacteria were observed). Both fungi identified belong to the genus *Cladosporium*. Sporulation was not possible to obtain in one of the fungi from sample B6 (Table VI.1). Fungi that did not give spores in the PDA formulation described above were cultivated in the diluted medium. Even in these conditions some samples did not sporulated. Since the identification of fungi is mainly based on the morphology of spore-bearing structures, the way in which the spores are produced and on the spores themselves, the fungi that did not give spores could not be identified [56].

Figure VI.2 – Map of the fungal sampling areas from the lining canvas.

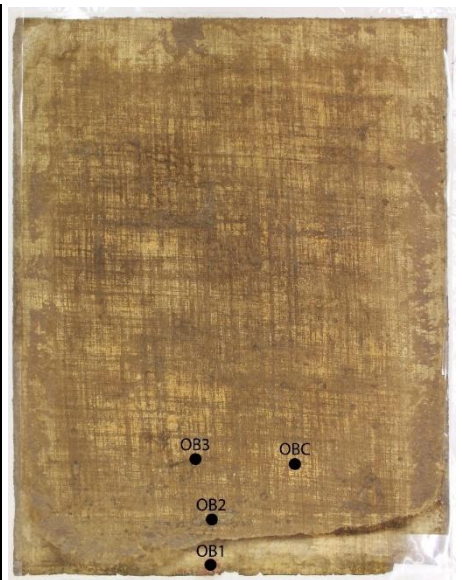
of the visual phenomenon at the surface of the paint and canvas offered clear evidence of biological activity, samples were taken to see if they could be related to the action of microorganisms. These areas consisted of black dots, whitish stains and areas with a brownish or white UV fluorescence (Figures VI.5 to VI.9). One sample was taken as control from an area where the canvas did not seem to have signs of biodeterioration (BC) (see map of sampling Figure VI.2). After the removal of the lining canvas it was seen that the original canvas also exhibited mould growth (Figures VI.8, VI.9), therefore new samples were taken (OBC and OB1 to OB3) (see map of sampling Figure VI.3).

Samples OB2 and OB3 taken from the back of the original canvas exhibited the presence of two yeasts and fungi of the genera *Cladosporium* (possibly two different species were identified in each sample due to the different features, such as colour of the colony, observed among them). Sporulation did not occur in one of the fungi from sample OB3 (Table VI.1).

Figure VI.3 – Map of the fungal sampling areas from the original canvas.

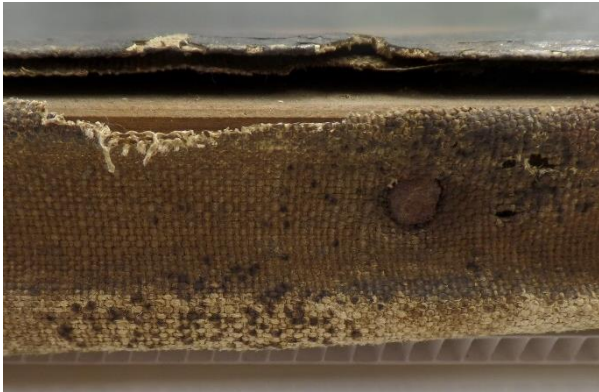
It is important to underline that although some samples of microorganisms did not grow, this does not mean that they were not active in the past. A clear example for this is the sample B5 that was taken from the visible mould on the lining canvas where nothing grew in the culture. In future work of this kind, more focused on the identification of the microorganisms, the samples should be inoculated in more than only one culture media since some fungi may not grow or sporulate in PDA.

Figure VI.5 – Mould growth between the stretcher and the lining canvas.

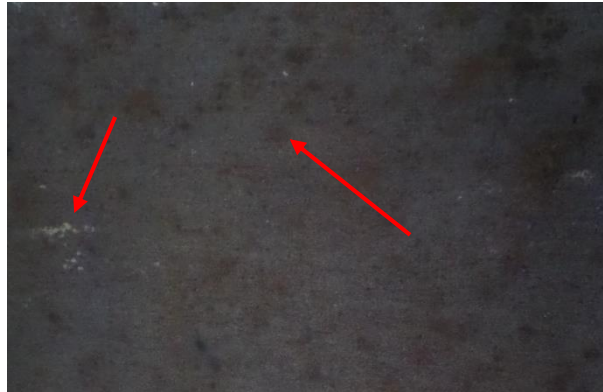
Figure VI.6 – Black dots from mould growth on the lining canvas.

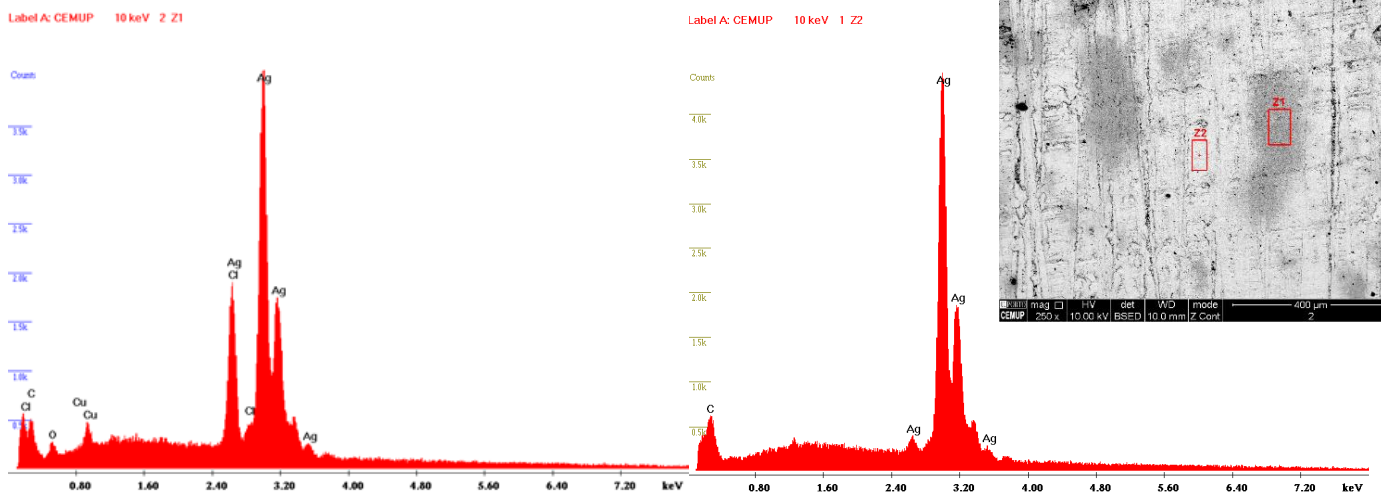
Figure VII.3 – EDS analysis on the coupon in the Artsorb® environment. **Left:** spectra from a dark stain associated with chloride corrosion products. **Right:** spectra from an area with no signs of corrosion. The red squares on the SEM-BSE micrograph indicate areas of analysis.
