SWS Contract Report 375

**AN ASSESSMENT OF BOTTOM SEDIMENT CONDITIONS
IN THE ILLINOIS RIVER
IN THE VICINITY OF PEKIN COMBINED SEWER OVERFLOWS**

Prepared for the City of Pekin
in cooperation with Randolph & Associates, Inc.

December 1985

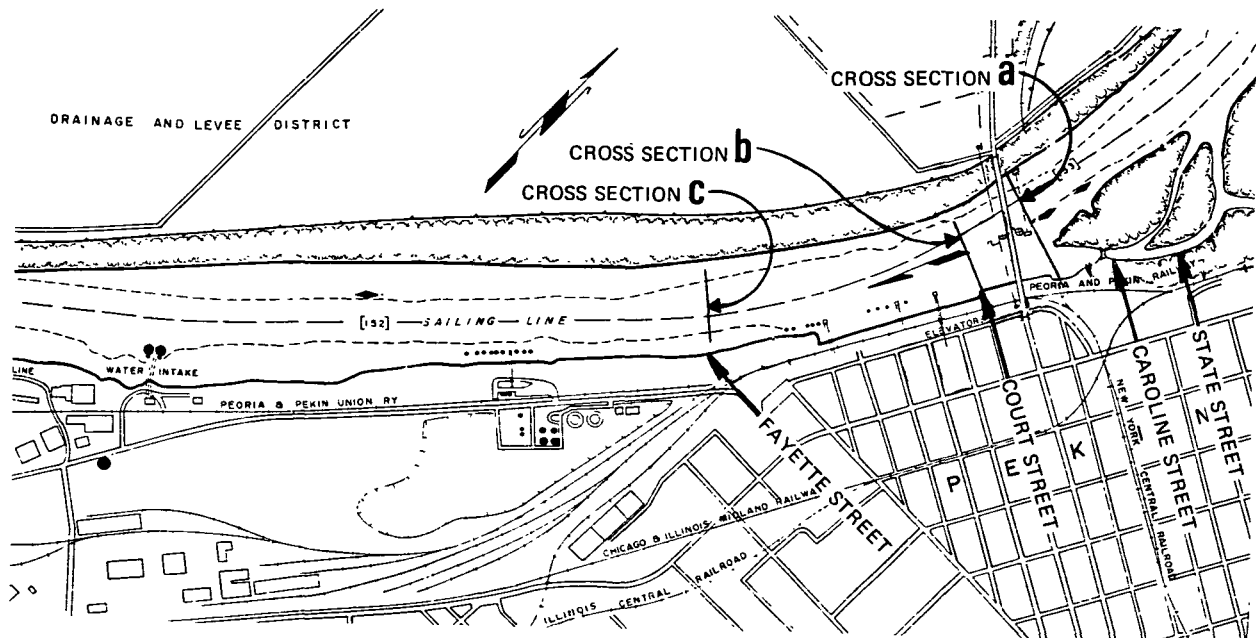
Figure 1. Pekin combined sewer outfall locations examined and evaluated

The four outfall areas located above the wastewater treatment plant which were examined and evaluated are shown on figure 1. The outfalls are identified by the street locations at which the discharges occur. In downstream sequence, they are State, Caroline, Court, and Fayette Streets. State and Caroline discharge into a common side-slough off the river proper, Court discharges about 50 feet back from the river, and Fayette discharges into a "dog-legged" drainage channel at a point approximately 250 feet back from the river bank. Photographs of the respective outfalls and discharge areas are presented as figures 2 through 7. All four sewer outfalls discharge within a 3700-foot reach of the Pekin City river front.

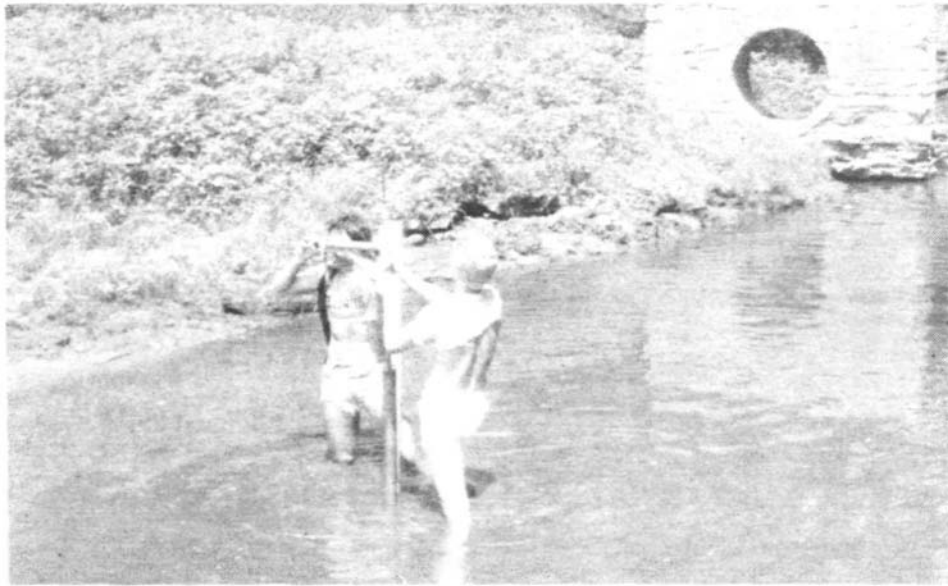
Figure 9. Core sediment sampler and range finder in use

The Fayette Street outfall area is shown in figure 7 and depicted diagrammatically in figure 12; its areal location is shown on figure 1. The outfall pipe terminus shown on figure 15 is over 250 feet back from the river shoreline. The outfall channel bottom is lower than the river water surface and is therefore always flooded with about 2 feet of water (figures 9 and 15). An old headwall and attendant pipe opening

stand isolated about 100 feet back from the river (figures 7 and 9). The bottom and sides of the outlet channel are relatively firm and free of sludge. The water in the channel, however, shows evidence of pollution. The water appears somewhat black and septic and contains wastewater-related material such as floating solids and condoms. The outfall pipe terminates at the edge of a railroad track, and the area in the vicinity of the pipe is choked with debris and fallout from the tracks (figure 15).

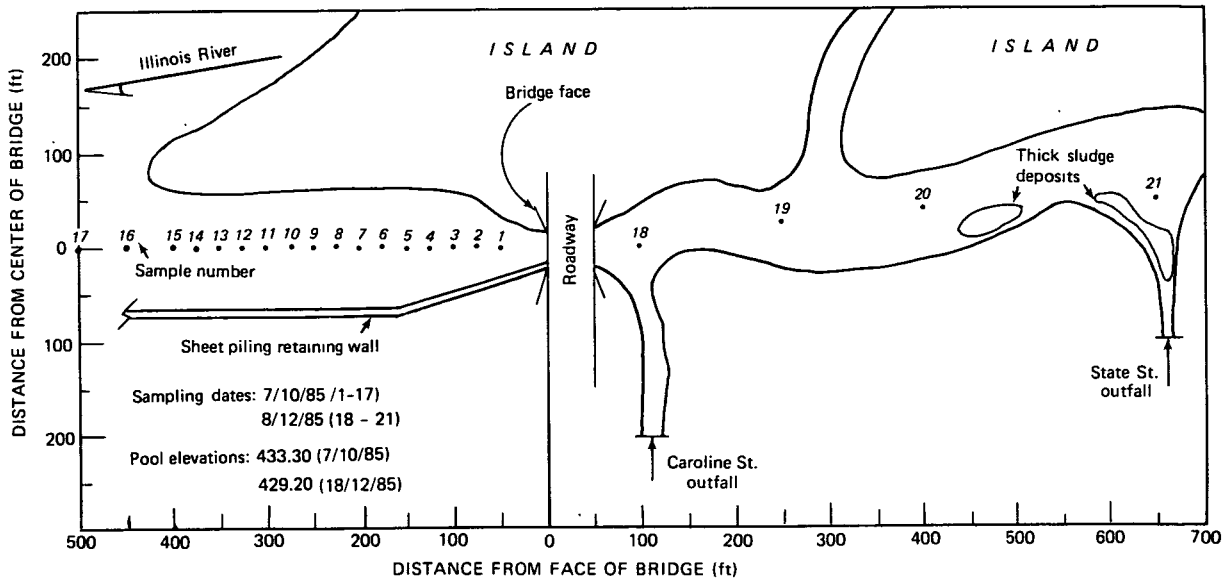
Figure 10. Sampling stations in the State Street and Caroline Street outfall areas

This is the upstream-most of the four overflow sewers. It discharges into a very shallow off-channel slough (figures 1, 2, and 10). At the time of the survey, only a few stagnant pools existed in the slough above the point where the sewer

overflow channel empties into the slough. Figure 2 shows the outfall viewed at sampling station 21 (figure 10). The overflow channel is lined with watery sludge and muck which supports a lush stand of arrowhead along the banks. Figure 4 shows the slough viewed downstream of station 21. Sludge deposits were observed in the slough below the outfall channel in the localized area shown on figure 10. These sludge deposits were approximately 30 to 36 inches deep, smelted septic, and emitted gas bubbles when disturbed. The State Street overflow channel was free of trash and debris often associated with CSOs. The slough below station 20 is free of any significant sludge deposits. This may be an indication that the observed sludge deposits in the State Street outfall area are residual from historical dry weather overflows which frequently occurred prior to extensive lift station rehabilitation during 1972 and 1973.

The sampling locations in the outfall area common to these two overflows are shown on figure 10. Dredge samples were collected at stations 1 through 17; core samples were collected at stations 14, 18, 19, 20, and 21. Figures 17 through 21 show the core samples, and Appendix A shows 6 dredge samples which were selected for illustrative purposes for this area. Samples were collected for water and volatile solid content at stations 19, 20, and 21. Descriptions of the core and dredge samples are presented in tables 1 and 2, respectively.

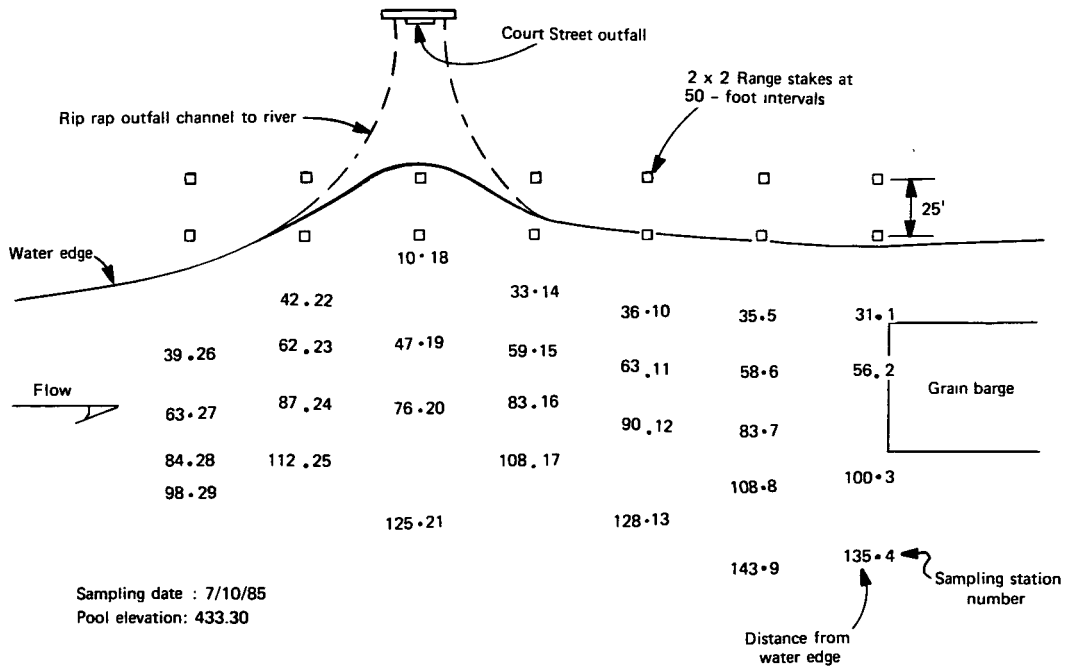
Figure 11. Court Street sewer outfall area sampling stations

The Court Street outfall area is shown in figure 6 and depicted diagrammatically in figure 11; its areal location is shown on figure 1. Figure 13 shows a close-up view of the outfall channel. The course to the river is short, elevated, and lined with riprap. This rough trace causes trash and debris to hang up in the stones and concrete fragments during overflow periods (figures 13 and 14). Immediately downstream of the outfall is a grain elevator barge loading dock, the upstream-most mooring pier of which is shown on figure 6. The spillage of grain in the loading area appears to affect localized bottom conditions.

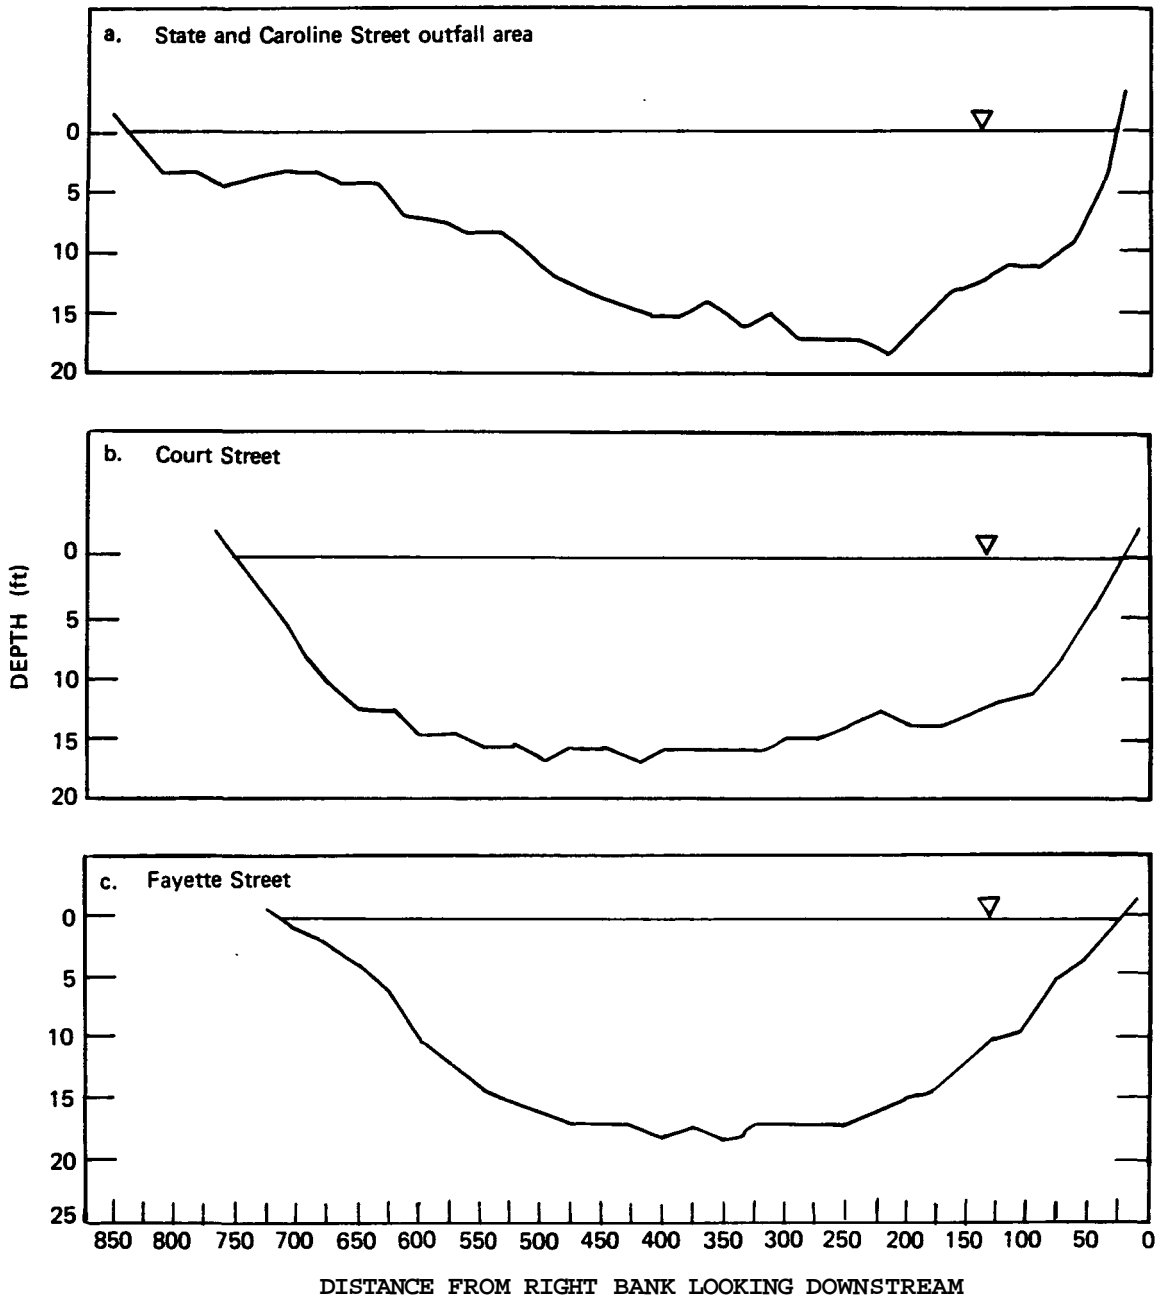
Figure 16. Illinois River cross sections at Pekin combined sewer overflows (pool elevation: 433.20)

The cross sections taken at the centerline of the outfall areas for Court and Fayette Streets and the one taken essentially perpendicular to the State-Caroline slough outlet are shown on figure 16. The shallow nature of the State-Caroline transect on the left bank side reflects entry into the bay-like area into which the slough terminates. The deep sloping bank in the Court Street outfall probably reflects past dredging in the area to establish deep water for the barge loading operations.
