SWS Contract Report 411

**AN ASSESSMENT OF ILLINOIS RIVER BOTTOM SEDIMENTS  
IN THE VICINITY OF HAVANA COMBINED SEWER OVERFLOWS**

*by Thomas A. Butts*

January 1987

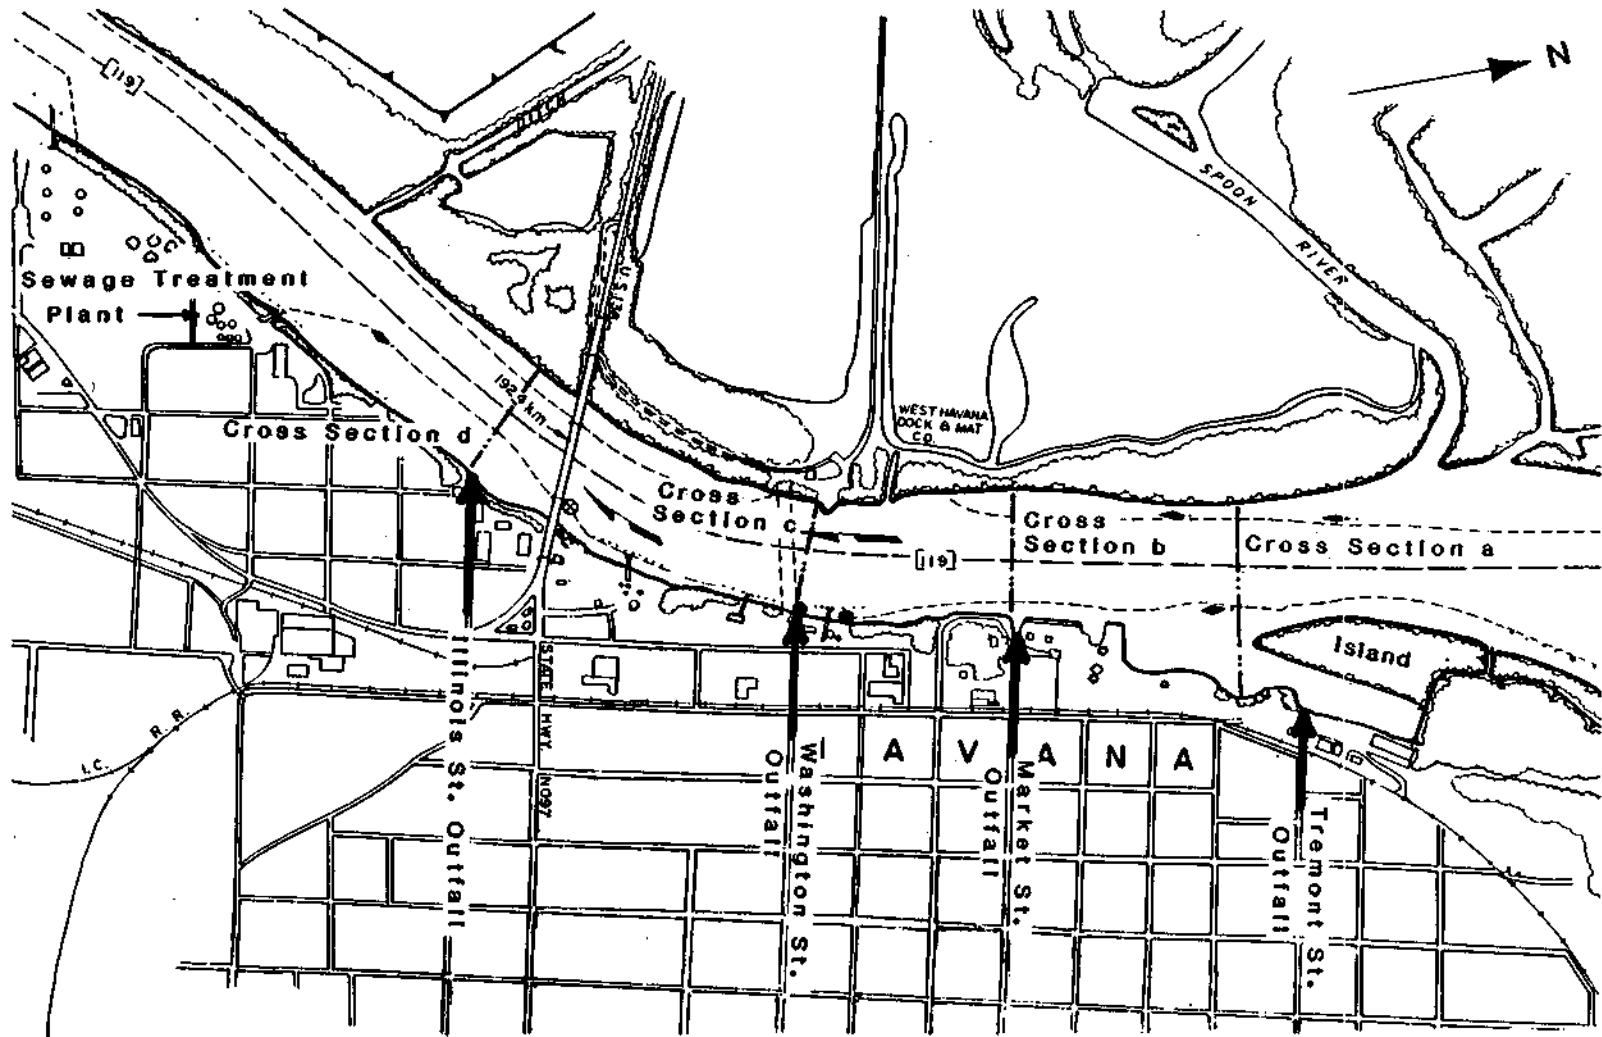
Figure 1. Havana combined sewer outfall locations

This is the upstream-most of the four overflow sewers. It discharges into a shallow off-channel slough or bay-like area (figures 1, 2, 3, and 14). At the time of the survey, the shoreline of the bay was very wet and "mucky" due to the rapid drop in high pool levels caused by recent high-water conditions. The area around the outfall had grown up in willows, weeds, and bushes and had to be cleared to be examined (figure 3). No evidence of sludge or pollutional depositions of sewage origin existed on the bank above the edge of the water. The outfall area was totally free of undesirable odors and overflow trash and debris such as rags and paper products.

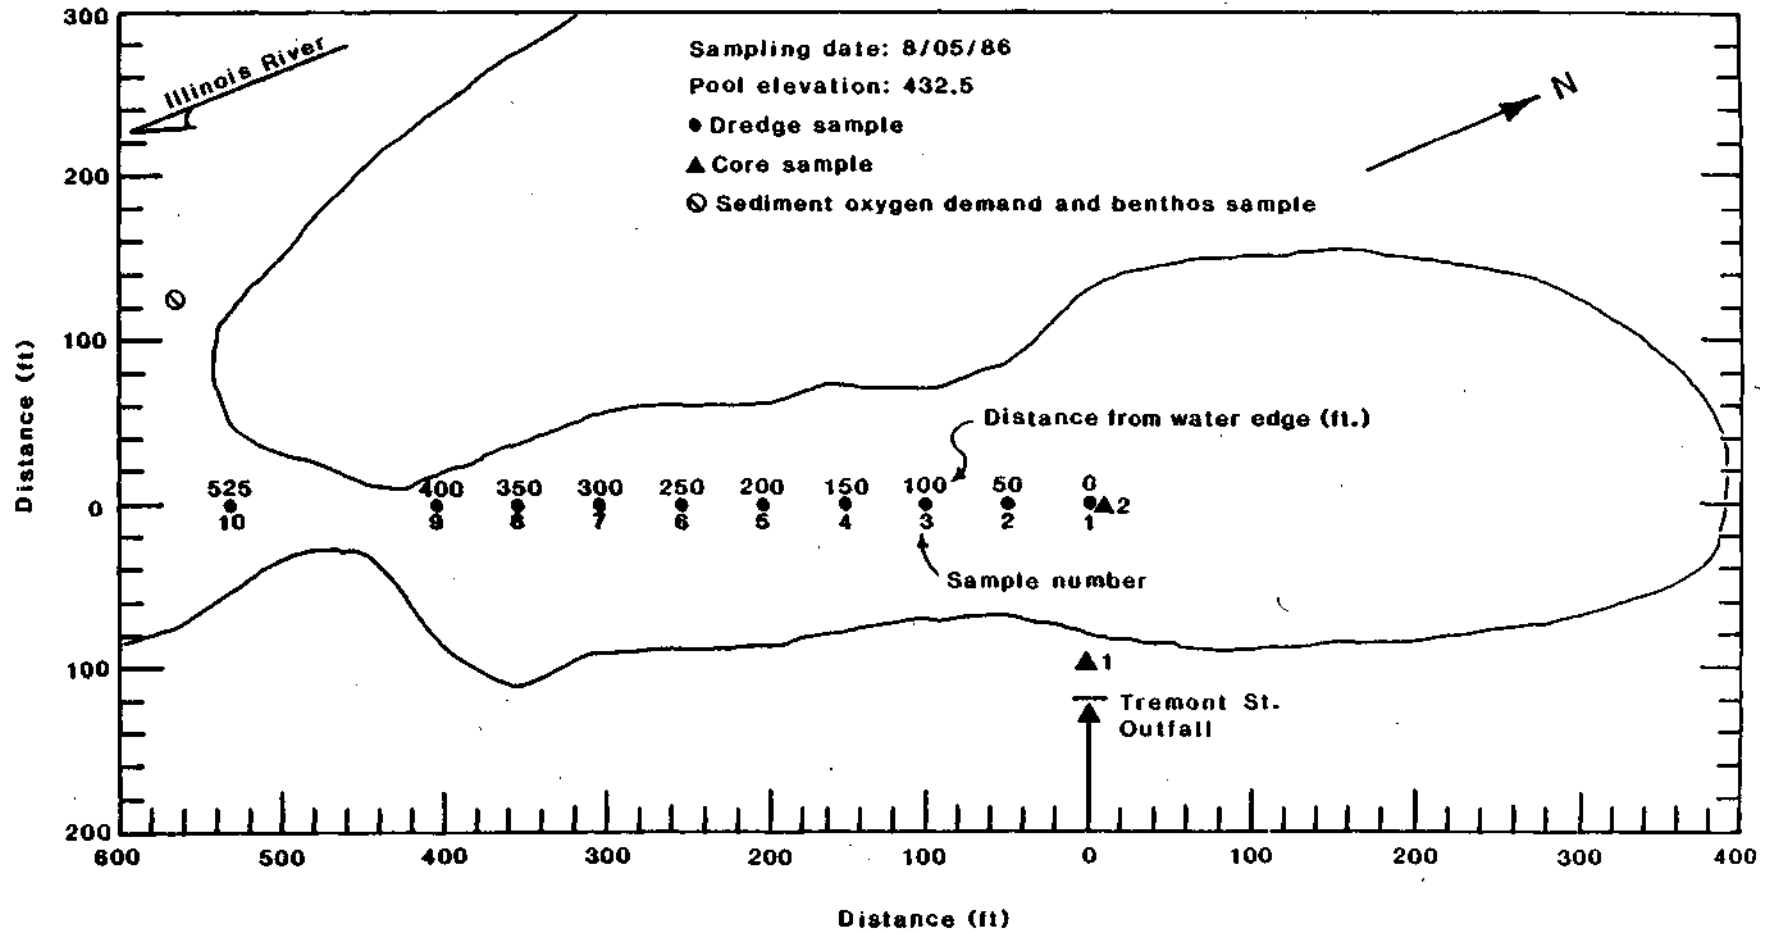
Figure 10. Sampling stations in the Tremont St. outfall area

The sampling locations in the Tremont Street outfall area are shown on figure 10. Core samples were collected at station 1 and at the water's edge in line with the outfall. Figures 17 and 18 show the core samples, and Appendix A shows two dredge samples which were selected for illustrative purposes for this area. Descriptions of the core and dredge samples are presented in tables 1 and 2, respectively.

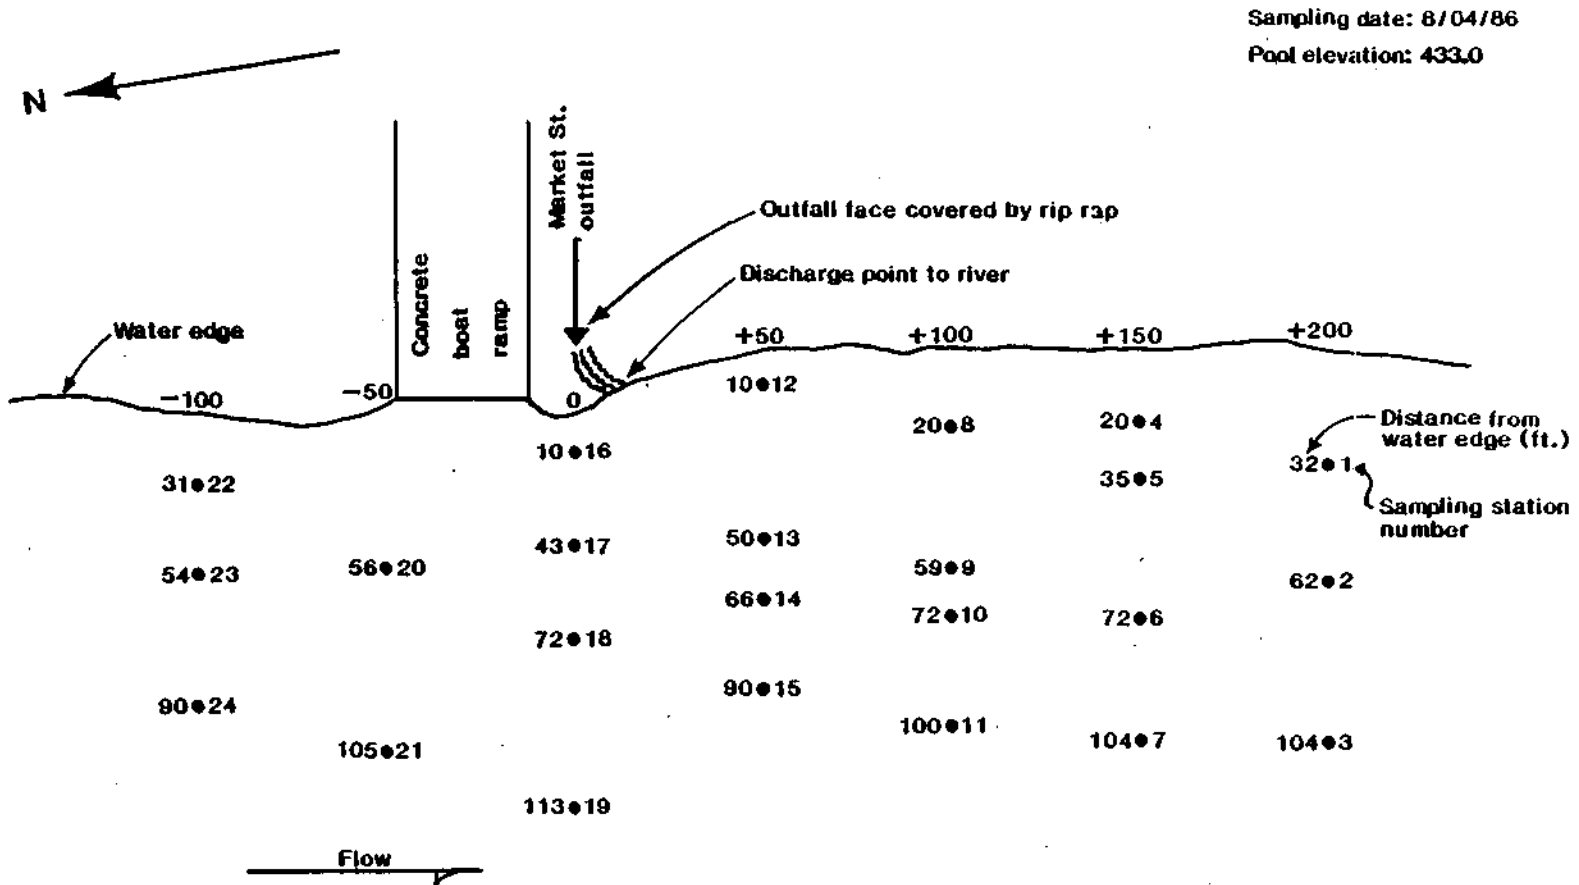
Figure 11. Market Street sewer outfall area sampling stations

The sampling locations in the Market Street outfall area are shown on figure 11. Dredge samples were collected at all 24 locations shown except at station 4, where large riprap fragments prevented the sampler from closing. Photographs of 14 selected samples are presented in Appendix B and descriptions of all the samples are given in table 3. Core sampling was attempted here and at Washington and Illinois Streets but was unsuccessful because a major portion of the sediments consisted of loose, watery sand and gravel which could not be retained in the core sampler.

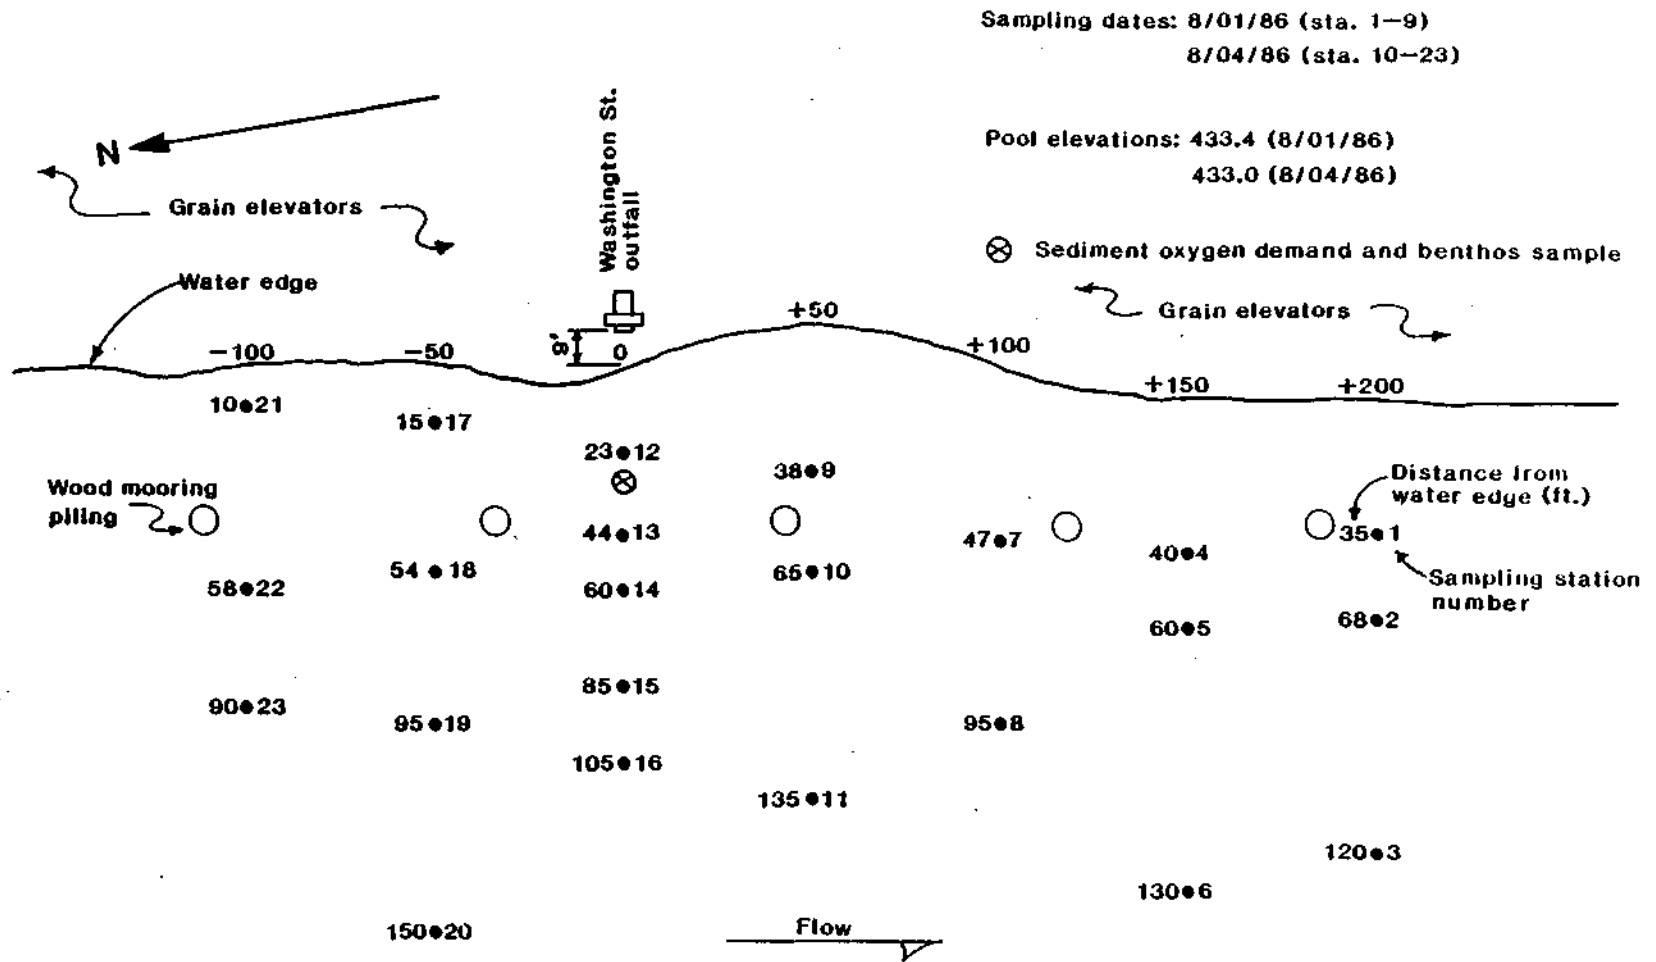
Figure 12. Washington Street sewer outfall area sampling stations

The sampling locations in the Washington Street outfall area are shown on figure 12. Dredge samples were obtained at the 23 locations shown except at station 4 where large riprap fragments made dredge sampling impossible. Photographs of 16 selected samples are presented in Appendix C, and descriptions of all the samples are given in table 4.

The results of the two SOD runs given in table 7 indicate that some degradation of the bottom sediments may be occurring in the area around the Washington Street outfall, albeit probably not from combined sewerage overflow. The degradation is more likely due to grain which has settled to the bottom during grain-loading activity and exists in various states of decay. The background SOD rate measured upstream of the city (figure 10) was 1.35 grams per square meter per day ( $\text{g}/\text{m}^2/\text{d}$ ) of dissolved oxygen usage compared to a value of  $3.02 \text{ g}/\text{m}^2/\text{d}$  in the Washington Street outfall area (figure 12). Also, the volatile solids content in the Washington Street measurement area was 2.5 times as great as that observed at the background measurement location (table 7).

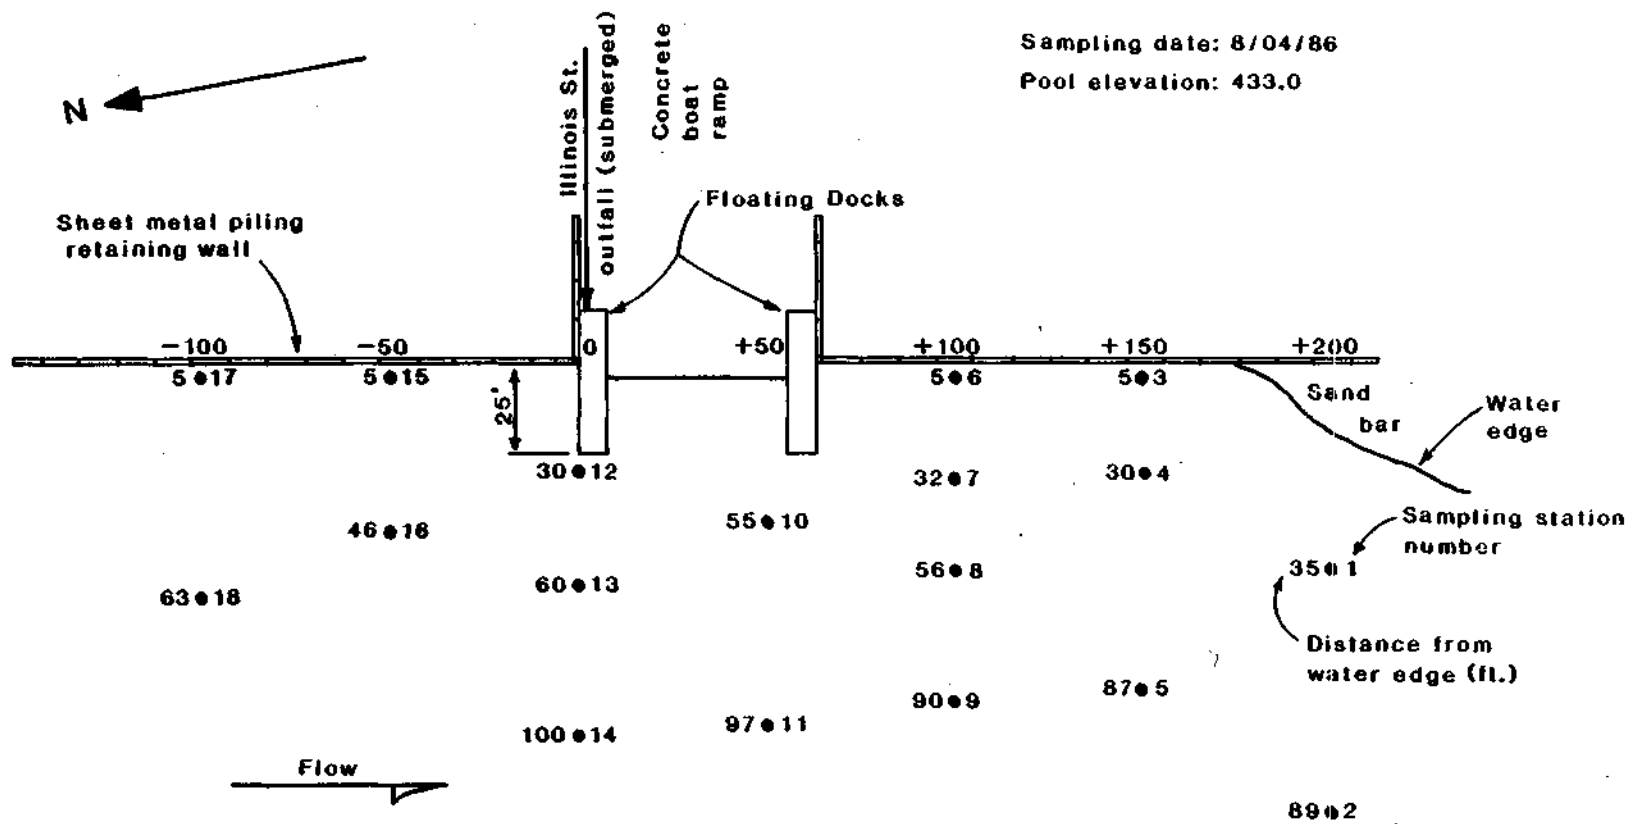
Figure 13. Illinois Street sewer outfall area sampling stations

The fact that the sediments in the area below Illinois Street are very clean and free of even sterile silt and clay particles, except in the quiet water near the sheet-metal-piling retaining wall (figure 13 and table 5), is significant since this area is downstream of all four outfalls.

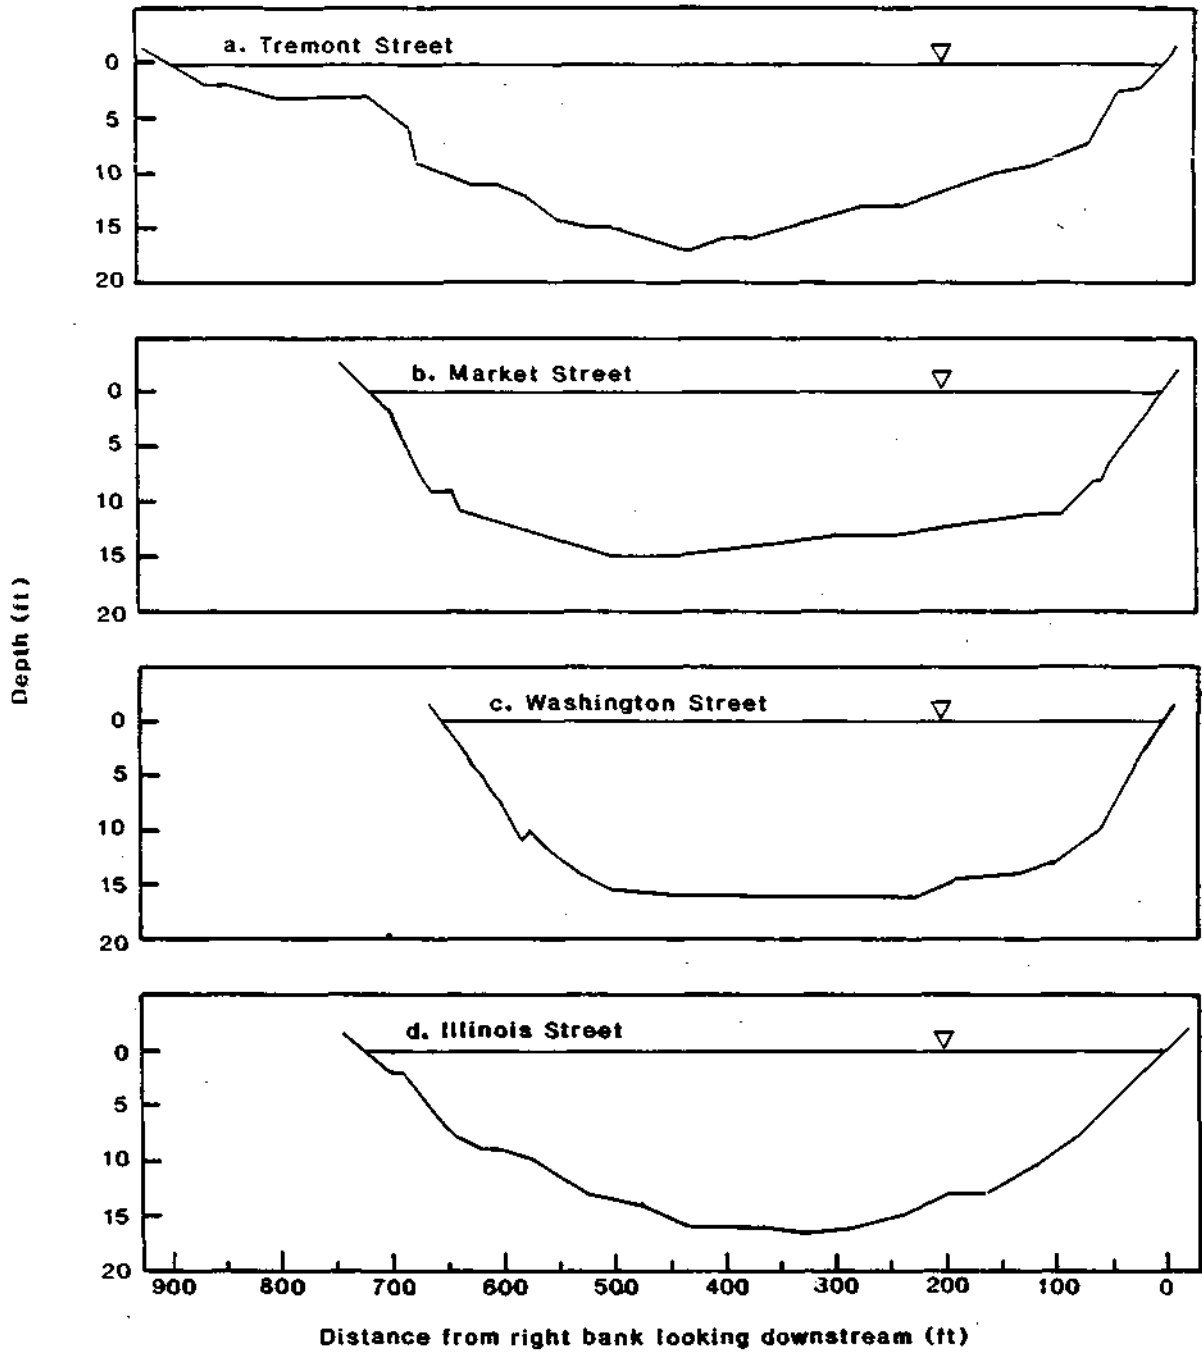
**Figure 16. Illinois River cross sections at Havana combined sewer overflows at pool elevation of 432.5**

The cross sections taken at the centerline of the Market, Washington, and Illinois Street outfalls and the one taken at the entrance to the bay into which the Tremont Street outfall discharges are shown on figure 16. All the cross sections were typical of debris- and snag-free sections occurring along the navigational channel in the lower Illinois River. The shallow 200-foot-wide left portion of the Tremont Street section represents the silted-in entrance to the bay area. The left bank of the Washington Street section drops off slightly more rapidly than those at Market and Illinois Streets because of the barge-docking facilities centered around the Washington Street outfall.
