Reduction of Non-Revenue Water through Continuous Acoustic Monitoring

David M. Hughes
American Water

RR-132
February 2016
www.istc.illinois.edu

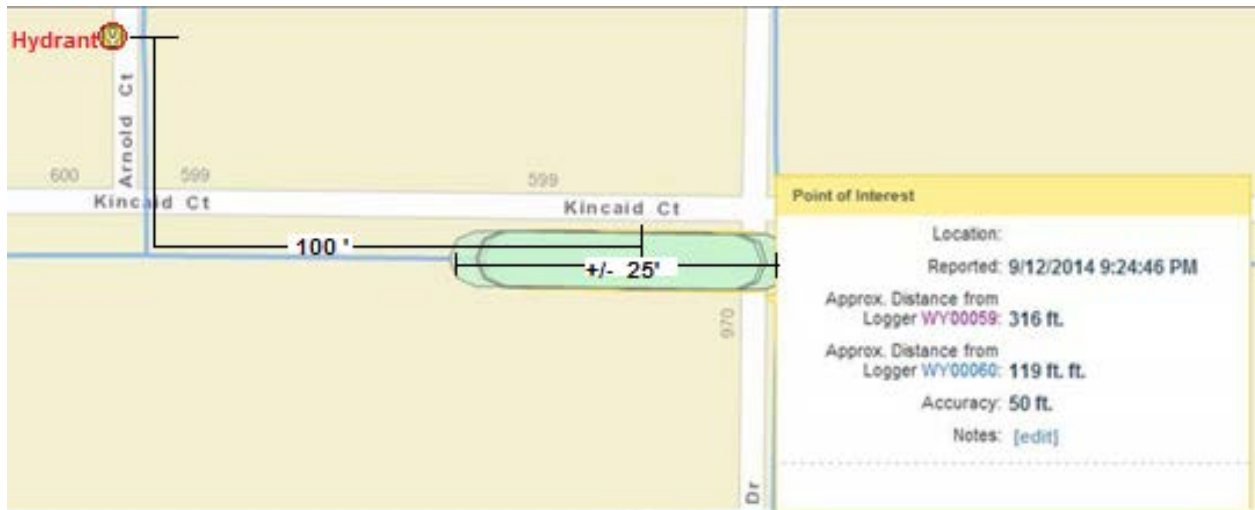
The Kincaid Court leak location was approximated by the Echologics unit as 100 feet \pm 25 feet from one of the sensors (Figure 3.2); the 50 foot location window allows for variation in correlation timing and for structural variations in the pipe. The leak was quickly found 82 feet from the hydrant/sensor (Figure 3.3); the 18-foot difference was within the expected range.

Figure 3.2 Echologics software display of suspected area of interest for Kincaid Court leak.

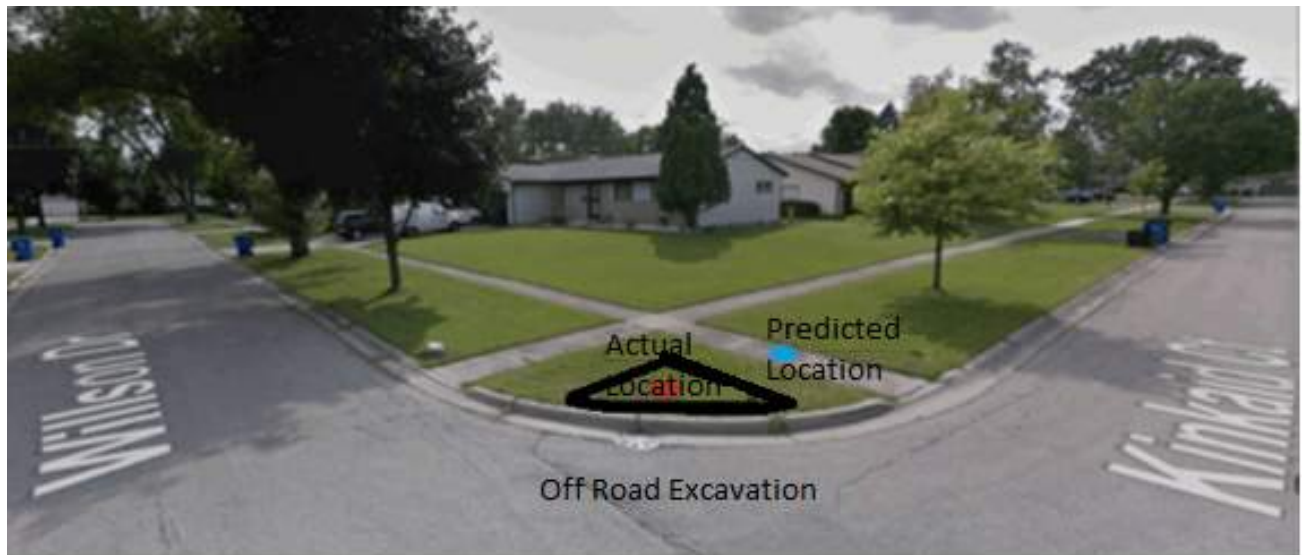
The leak continued to flow for twelve days without surfacing. The leak was allowed to run to help verify that the leak would not have surfaced even in a grass area. American Water’s

Figure 3.3 Location of hidden leak showing predicted location (blue) versus actual leak location (red).

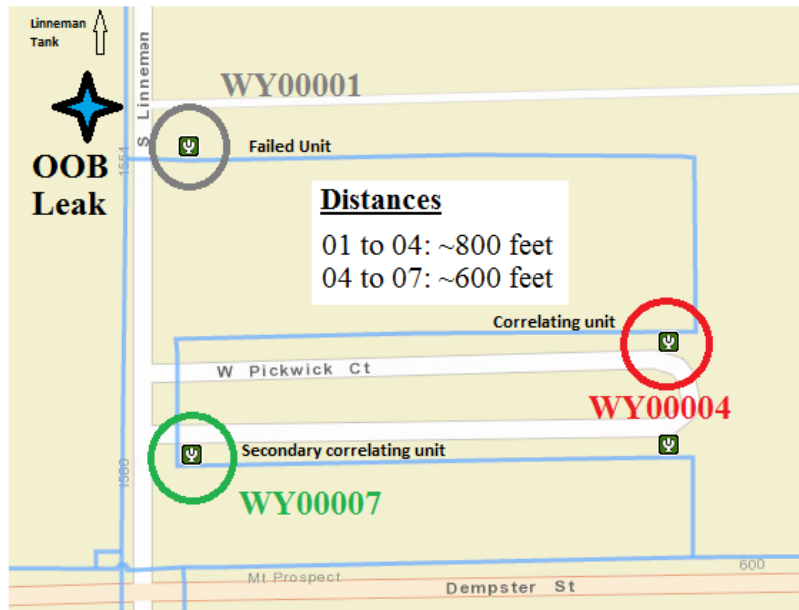
The leak on Linneman Road was reported the moment it started on Friday, October 31, 2014. The leak occurred when a shutoff valve was operated on a service line in the meter pit (Figure 3.5). The leak continued overnight and was reduced by a plumbing adjustment on November 1 and resolved on November 3. The Echologics alarm system did not respond to the leak because one of the two units that would have correlated the leak had a dead battery. A glitch in the prototype software caused the units' batteries to run down prematurely. An investigation into what was heard by the Echologics system confirmed that the leak was detected by another nearby unit and would have been reported the night after the leak started, if the failed unit was operating. The leak ran for about 3 days at an estimated average flow of 4 gallons per minute (higher at the start of the leak), expending about 13,000 gallons.

Echologics performed a high-sensitivity correlation with the working primary unit and a secondary unit more distant from the leak and confirmed that the system was able to find the leak through the local asbestos cement pipe. Figure 3.6 shows the location of the closest three units. The unit closest to the leak (WY00001) was the failed unit. Note that the closest working unit (WY00004) was more than 800 feet from the leak and the secondary correlating unit (WY00007) was more than 1,400 feet away. Leaks can be detected even from distant units such as these (Figure 3.7) if sensitive enough; however, too much sensitivity can lead to distracting data from multiple sources, including false positives. Had the failed unit been working, the leak would have been identified immediately. In any event, the time required to find this leak would not have changed the time required to repair it.

Figure 3.6 Acoustic monitors near Linneman Road leak.

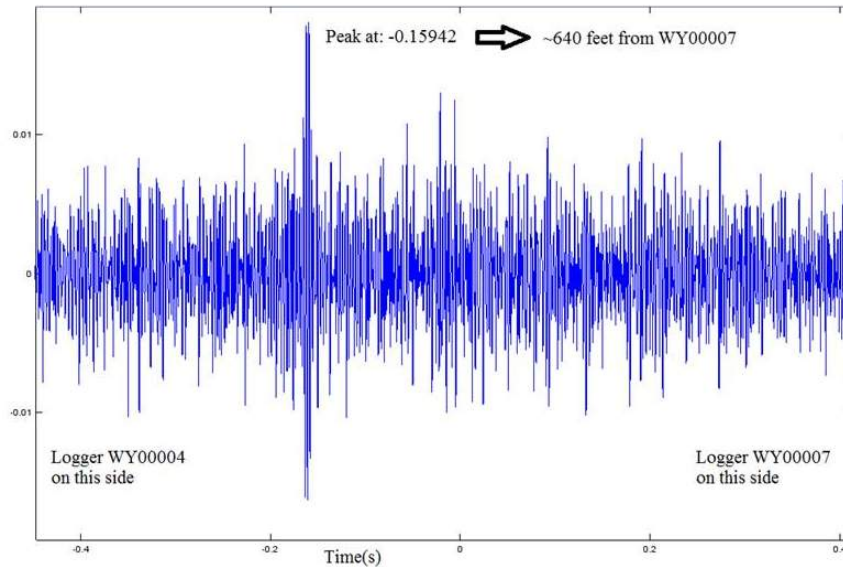
Figure 3.7 Correlation from more distant WY00004 and WY00007 acoustic monitors.

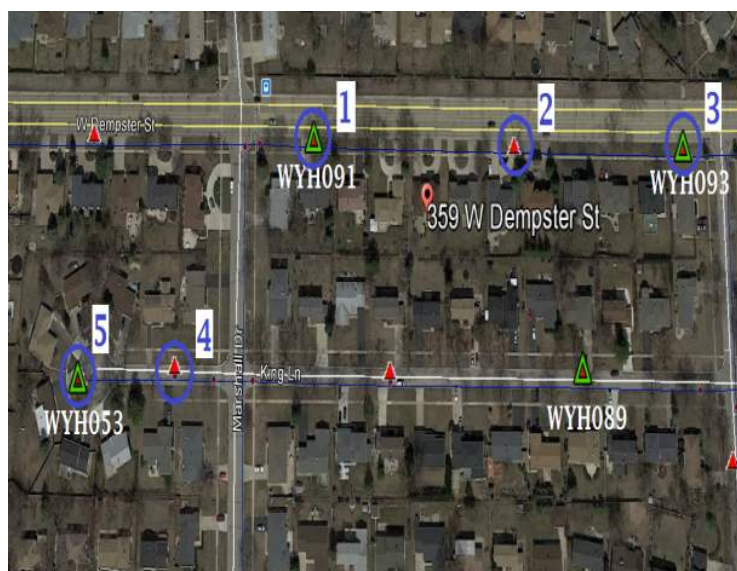
The location of this small leak was between the two logger units, WHY091 (200 feet from leak) and WYH093 (675 feet from leak), but it did not trigger an alarm from the correlating CAM system. WHY091, the closest unit, was inactive due to a failed battery. The next nearest loggers, WYH089 (1650 feet) and WYH053 (950 feet) (see Figure 3.8), were too far away from the leak for the noise they received to correlate or result in an alarm.

Figure 3.8 Acoustic loggers near 359 Dempster Street leak.

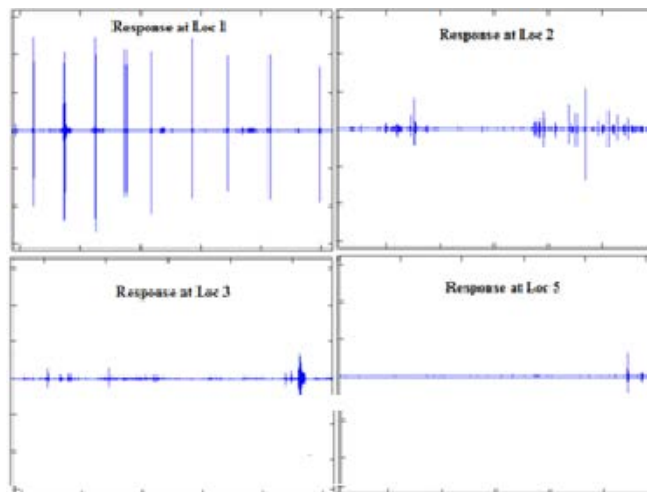
After repair, the Echologics team performed an acoustic investigation by inducing sound to verify that a properly operating unit would have heard the leak. This exercise is done by striking a valve near the leak with an impact hammer (Figure 3.9). Figure 3.10 displays the manual correlation responses of the replaced monitor (location 1, WYH091), as well as other units (location 3, WYH093 and location 5, WYH053)). According to these results, the sound source could be readily detected at the closest unit and one hydrant away from the source (location 3). Although the noise was barely noticeable at the units two hydrants away (location 3 and 5), it was concluded that, if the acoustic network was fully operational (WYH091 active), an alarm would have sounded and pinpointed the leak. It is not clear from the available data if the leak ran for any extended time prior to surfacing on January 1. Consequently, no economic value could be placed on this leak prior to surfacing. The leak – detected on a holiday – would not have been repaired any sooner than the following Monday. It would be unrealistic to assume a faster response time in this instance. The surfaced water caused road ice in the vicinity of the leak. Had the leak been detected earlier than January 1, the hazardous condition and the water loss could have been minimized, but this statement is hypothetical because it is not known if the leak started prior to the holiday.

Figure 3.10 Responses at locations 1, 2, 3, and 5 from sound created at location 1 (diminishing sound with distance).

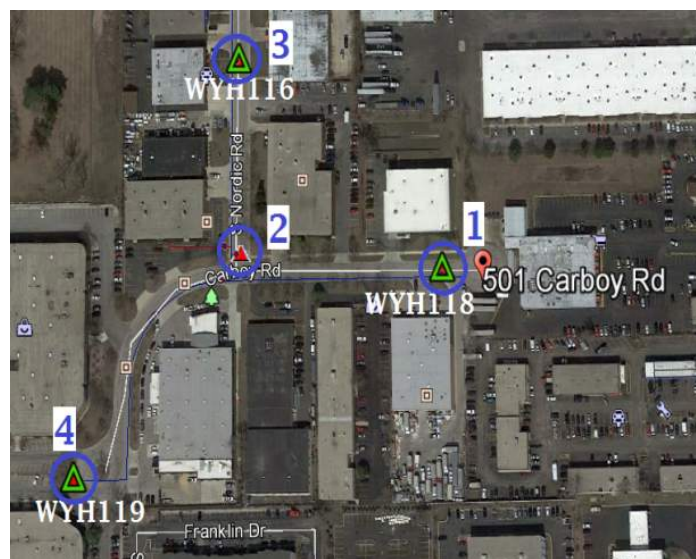
The Echologics alarm system did not respond. Figure 3.11 shows the location of the closest three units. The unit closest to the leak was location 2 WYH118 (50 feet) and the two next closest monitors were WYH116 (550 feet) and WYH119 (600 feet). The proximity of three sensors that appeared to be working suggests the leak should have been detected. There were several possible causes of the Echologics system failure: (1) the close sensors may not have been properly connected with the pipe network, (2) insufficient energy (noise) was generated by the leak, (3) the leak was very short term, or (4) there was a sensor issue. Under normal circumstances, if the energy from a leak is strong, it can be detected by the neighboring unit even if the unit closest to the leak has failed. Echologics performed a high-sensitivity correlation with the working primary unit and a secondary unit more distant from the leak and confirmed the ability of the system to find the leak.

Figure 3.11 Location of acoustic monitors near 501 Carboy leak.

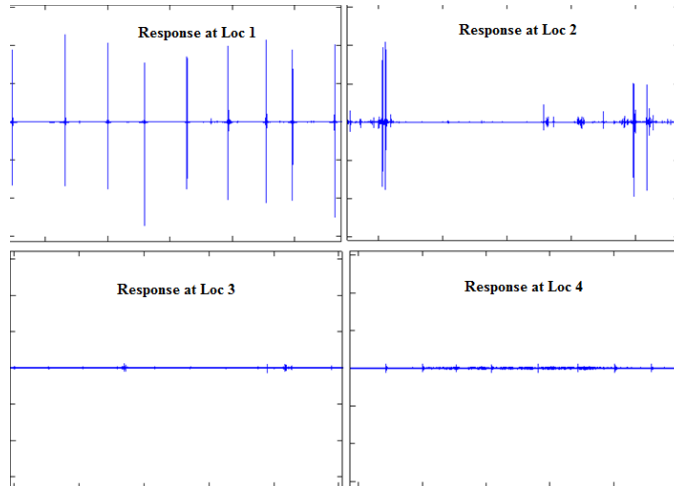
The correlation responses to hammer blows at different locations are shown in Figure 3.12. According to these acoustic propagation results, the sound was detected one hydrant away from the source (response at Location 2). The sound dissipated noticeably at more distant locations (Locations 3 and 4), as expected. Even though the attenuation (noise dissipation) was significant, some minimal sound propagated through the pipes to the more distant hydrants. With a noise source at location 1 (hydrant WYH118), it was possible to clearly see the impacts on location 4. Because the leak could be found at a distance, the best theory is that the pipe break was a sudden surfacing leak.

Figure 3.12 Responses at locations 1, 2, 3, and 4 from sound created at location 1 (diminishing sound with distance).

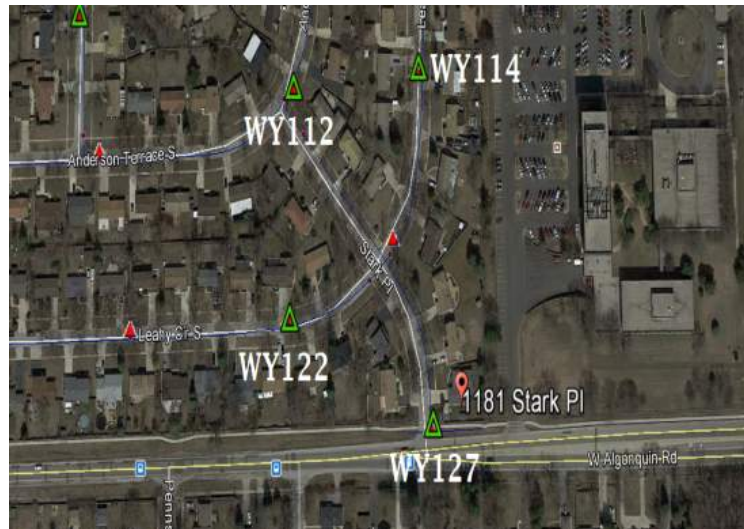
Unfortunately, the logger closest to the leak location (WY127) was inactive due to the duplication of serial number with another device that was reporting in the system. The location of the leak was next to the driveway of a residential customer. If the leak, estimated at 150 gallons per minute (gpm), began running after it surfaced, about 54,000 gallons were lost. If it started smaller, the leak might have run a few more days. However, this would be atypical for a circumferential break, especially over a driveway that would not tend to hide the leak. Figure 3.13 shows the leak repair at Stark Place, and Figure 3.14 shows the layout of Echologics units in the area and the leak location. If the noise spectrum is strong from a main break like this one, an alarm would be triggered at the closest logger. The location of the leak occurred at the end of the network, so no acoustic unit was on the other side of the leak. The next closest units were WY122, WY112, and WY114. These distant loggers could not be counted upon to capture small changes that occurred due to this leak. A field spectrum investigation was conducted by Echologics to determine whether a fully functional system (with duplicate serial number loggers corrected and in active status) would have detected the leak. They found that the large leak with its strong leak energy spectrum could have triggered correlation with the next closest logger and would have confirmed the location of the leak.

Figure 3.14 Locations of acoustic monitors near 1181 Stark Place leak.

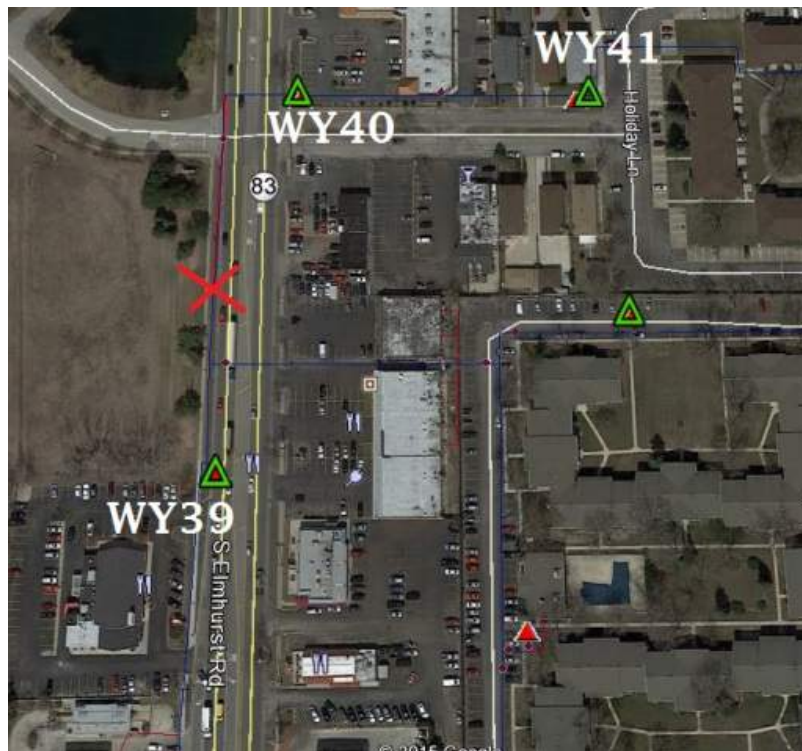
The leak at Elmhurst Avenue was spotted on February 17, 2015. The leak appeared shortly after the installation of second generation Echologics units. The units close to the leak location, WY039 and WY040 (Figure 3.15), were still being commissioned at the time of the leak, which means that the alarm mode was not activated. To validate that the system would have found the leak, Echologics performed high sensitivity manual correlation on February 18 and was able to spot the exact leak location. The circumferential leak was repaired later in the day on February 18. The leak occurred at about a 150 gpm rate for 18 hours, wasting 162,000 gallons. Circumferential breaks are generally categorized as sudden breaks, so it is likely the leak surfaced quickly with little advanced warning. Consequently, no theoretical economic benefit can be gleaned from detecting this break..

Figure 3.15 Acoustic monitors near 1101 Elmhurst leak.

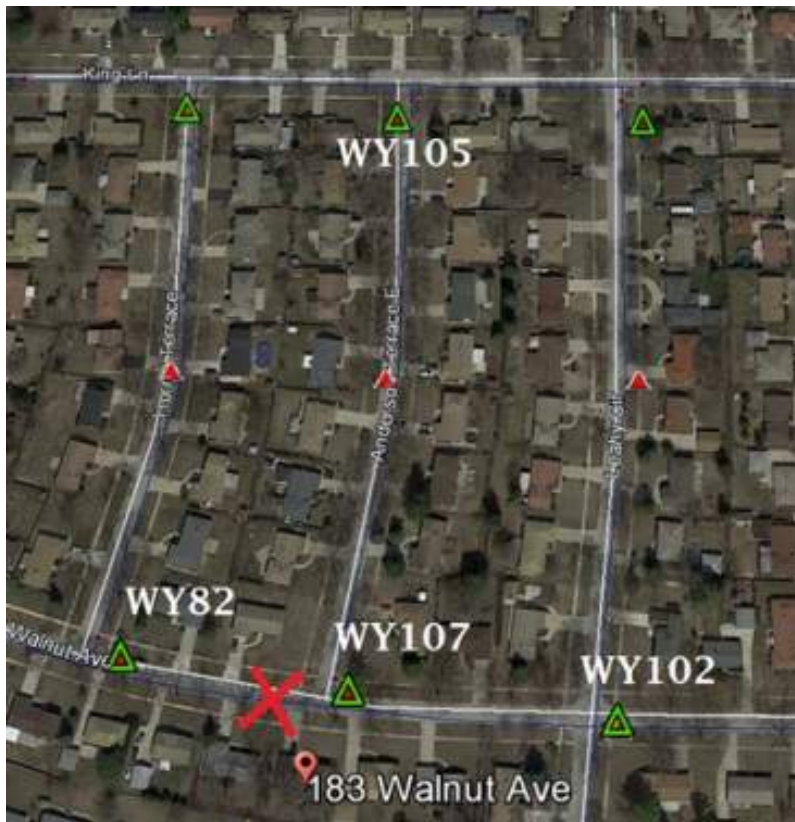
The leak near 183 West Walnut Street was reported on February 25, 2015, and was estimated to be a 100 gpm circumferential break. The leak occurred next to the customer's driveway in a grassy area. The leak did not trigger the Echologics alarm system. At the time of the leak, the closest unit (WY107) (Figure 3.16) was inactive due to the duplication of serial number of the logger units. The subsequent field spectrum investigation by Echologics confirmed that the complete system (with duplicate serial number loggers corrected and in active status) would have detected that leak. But the Echologics system would have found a large leak another way; a strong leak energy spectrum could have triggered correlation between other working loggers (WY82 and WY102), had the leak run during an overnight period. The crew arrived at 3:00 PM on the day the leak surfaced, repaired the circumferential break, and restored service by 8:00 PM. It is estimated that the leak ran 16 hours and wasted 96,000 gallons. The combination of a circumferential break, fast repair, and absence of sound the previous night served to convince the researchers that the leak was sudden and could not have been detected sooner.

Figure 3.16 Acoustic monitors near 183 West Walnut leak.

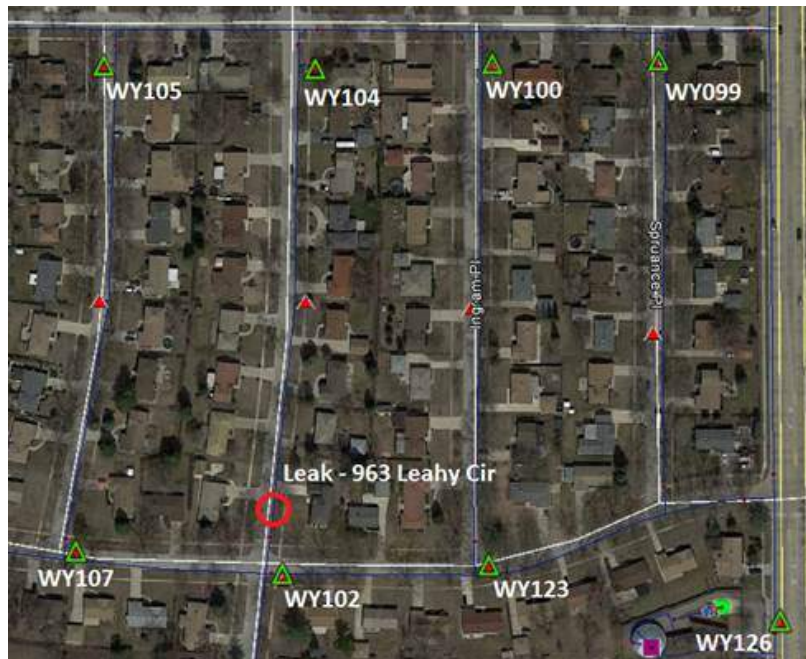
The leak at 963 Leahy Circle was reported on March 1, 2015. This was a blowout leak on a 6” cast iron main adjacent to the customer’s driveway. The crew arrived on site at 11 PM, arrested the leaks using two clamps on the cast iron main, and discovered that a corroded section of pipe had to be removed. Service to 25 customers was interrupted for nearly three hours. The leak flow was estimated at 400 gallons per minute for 4 hours, losing 96,000 gallons. The loggers did not trigger leak alarms at this location, due to the short time window of the leak. The Echologics system reported 4 POIs the night before, but at different locations. The POIs were reported between the following pairs of nodes (Figure 3.17):

Manual correlations were run between five nodes (WY99, WY100, WY102, WY126 and WY123). The results pointed to a potential leak near node WY123. This hydrant was used during the repair to flush the line clean. It is possible that the flushing or a minor leak in the hydrant might have triggered the alarm. The leak took place on a Sunday, and was repaired by early Monday morning.

Figure 3.17 Acoustic monitors near 963 Leahy Circle leak.

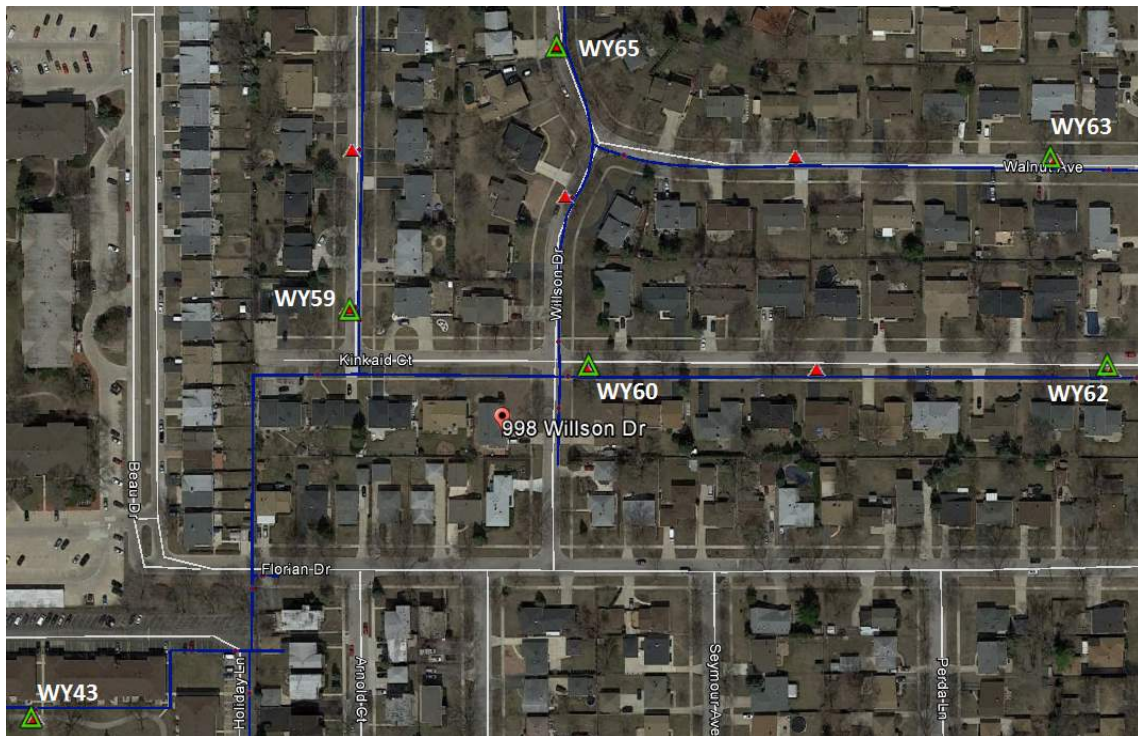
Figure 3.18 Acoustic monitors near 998 Wilson Drive leak.

A leak of less than 5 gpm surfaced on Willson Drive near Kinkaid Court on May 4, 2015, close to the site of leak 1 (see section 3.2.1). The main break at the service connection for 998 Willson Drive was fixed that same day as it surfaced. It is estimated the leak ran for 10 hours, losing about 3,000 gallons.

The Echologics acoustic monitoring system did not detect the leak prior to the leak surfacing and being found. Echologics staff downloaded recordings from the surrounding nodes prior to the break to decipher whether the nodes heard the leak noise. There was no evidence of leak noise and the nodes were operating satisfactorily. Files from nodes WY00043, WY00059, WY00060, WY00062, WY00065, and WY00121 were downloaded and analyzed from May 1-5, 2015. None of the files showed any evidence of leaks, even a small one. Because a prior burst in the same area was detected earlier, most issues with possible equipment failure were ruled out. In this case, it is likely this leak surfaced rapidly.

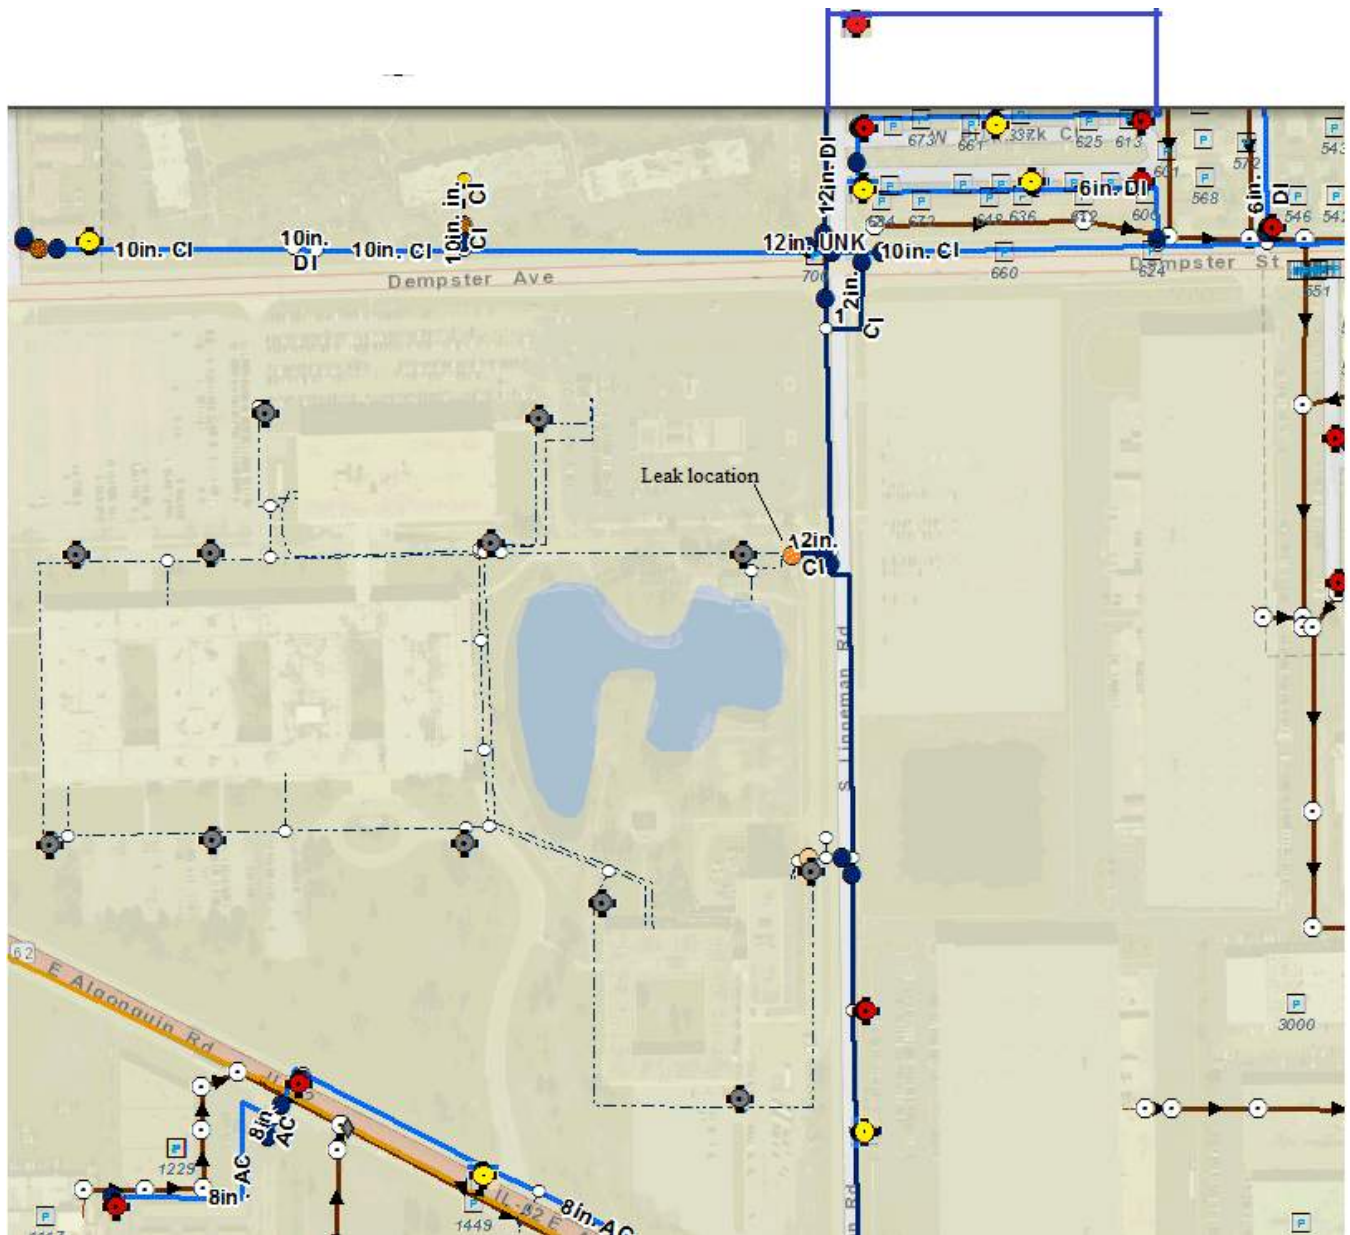
Figure 3.20 Acoustic monitors near 1650 South Linneman leak.

A sudden increase in water demand was noted in the Waycinden system beginning at approximately 11 PM on June 25, 2015. The issue continued through the early morning hours, until Illinois American Water staff asked Echologics to help find a suspected hidden leak. Before 5:00 AM and before Echologics could respond, the surfacing leak was found. The source was a broken pipeline on the internal metered piping serving the United Airlines computer building. The leak wasted 700,000 gallons of water.

Because the leak ran during the night, the Echologics system had opportunity to provide data about the acoustics of the leak, even though it was at some distance from the utility pipe network. Figure 3.20 shows the monitoring hydrants circled in orange. The hydrant near Linneman Road at the top of the map is the closest hydrant to the north (about 550 feet from the leak); the other acoustically-monitored hydrants in red at the upper right are in an apartment complex. Note the units in the apartment complex are actually farther from the leak because of the system layout. The closest hydrant to the south is on Linneman Road, 800 feet south of Dempster Avenue. Note also that there is no monitor on the western dead end of Dempster Avenue, 800 feet west of Linneman Road. This means the closest monitors on either side of the connection to the break were 1,350 feet apart, in addition to the distance along the service line of 250 feet. The pipe in this area is also asbestos cement, which does not carry sound nearly as well as cast iron. It has been suggested for critical water users who rely heavily on water supply for operation and fire protection that permission be secured to add monitors on their private hydrants (in green). After this event, it is likely at least this one customer will be willing to participate in leakage control in the future.

In Figure 3.20, the hydrant near Linneman Road at the top of the map is the closest hydrant to the north; the other acoustically-monitored hydrants in red at the upper right are in an apartment complex.

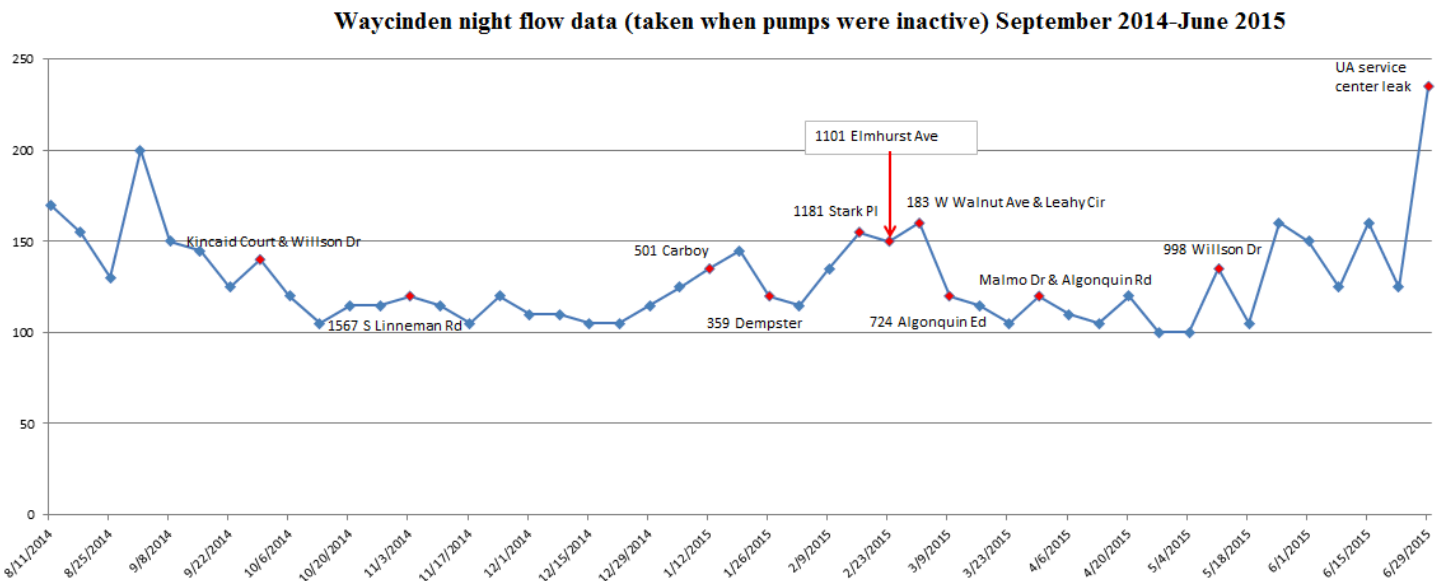
Figure 3.21 Night flow for project period.

The SCADA link was successful in providing pertinent information about flow within the Waycinden system on most nights (between 3 and 4 AM). Data collection started in August and was stabilized in September, but the 12-day leak in September prevented examination of minimum night flow until October because it was adding to the night flow. For most days, the only source of supply between 3 and 4 AM was the Waycinden tank (Figure 3.21). The typical night flow was about 115 gpm (6,900 gph). It is noted that the granularity of the tank level is 0.1 feet, translating to 1,500 gallons. The margin of error (1,500 gallons per hour or 25 gpm) can be a significant portion of the hourly flow. The research team considered a more accurate reading approach using a more sensitive pressure data logger, but the use of night flow appeared sufficient with the use of existing equipment. There appeared to be a matchup with three leaks that ran overnight with the three highest peaks of night flow.

delivery into the system, an underestimation of other forms of non-revenue water and continuous leaks that have not been detected from the start of the project through to the end. Further work will be necessary to determine where the differences lie. There is some suspicion with the corrosive soils that the contribution from small (inaudible) leaks is underestimated. The unaccounted water flow if it ran during the entire ten month period would approximate 65 gallons per minute – well below the minimum night flow, per Figure 3.21.

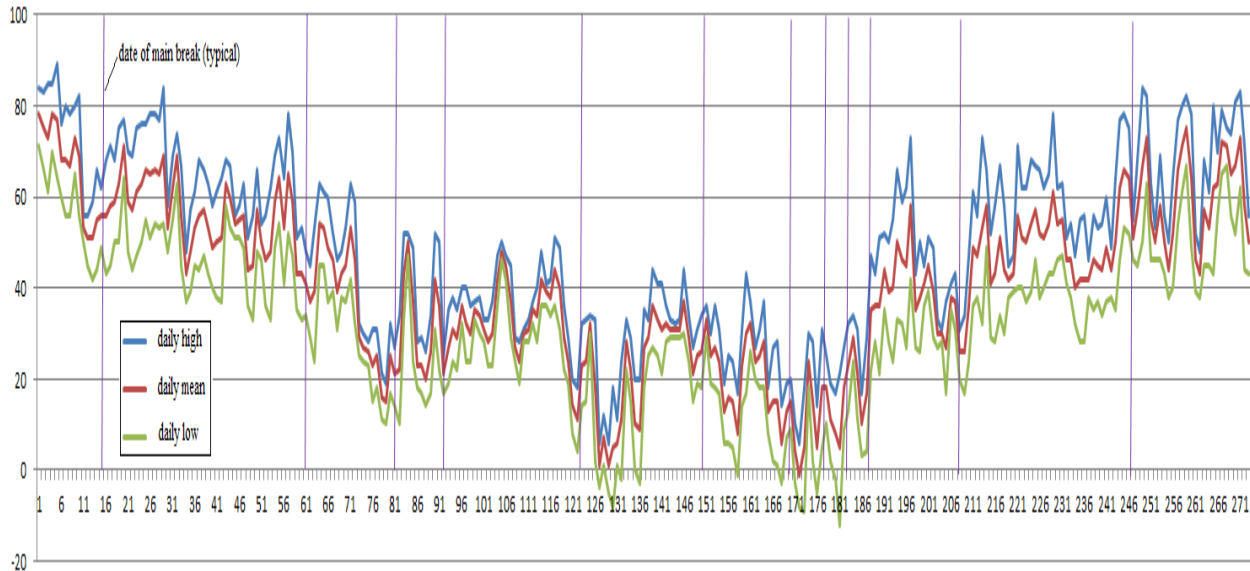
Figure 3.22 Area air temperatures and breaks through the project period.

The most significant environmental factors were air and water temperatures. Water temperature is speculated to be a contributing cause to circumferential breaks as the cold water would put thermal forces of contraction on the pipe in contrast to the weight of the cover and the joints holding the pipe in place. The source of water is the Chicago water supply from Lake Michigan. It is difficult to project the magnitude of temperature changes into the Waycinden system from Lake Michigan owing to the cribs that Chicago uses to extract water at depth from Lake Michigan. Moreover, the water must travel an estimated 25 miles underground where water can be warmed and then exposed to the cold at elevated water tanks in systems along the way. There were an insufficient number of breaks to justify a study with water temperature for this project, so the focus was placed on air temperature.

An examination was made of air temperatures from Mount Prospect. Figure 3.22 shows a plot of high, low, and median temperatures along with the time of breaks (vertical lines). As has been found in prior studies, leaks tend to occur at low and dropping temperatures. This phenomenon is not unknown to distribution operators. What is significant about data involving acoustic monitors is that the start of the leak (or at least when it becomes acoustically significant) is better known than in studies relating temperature to the surfacing leak.

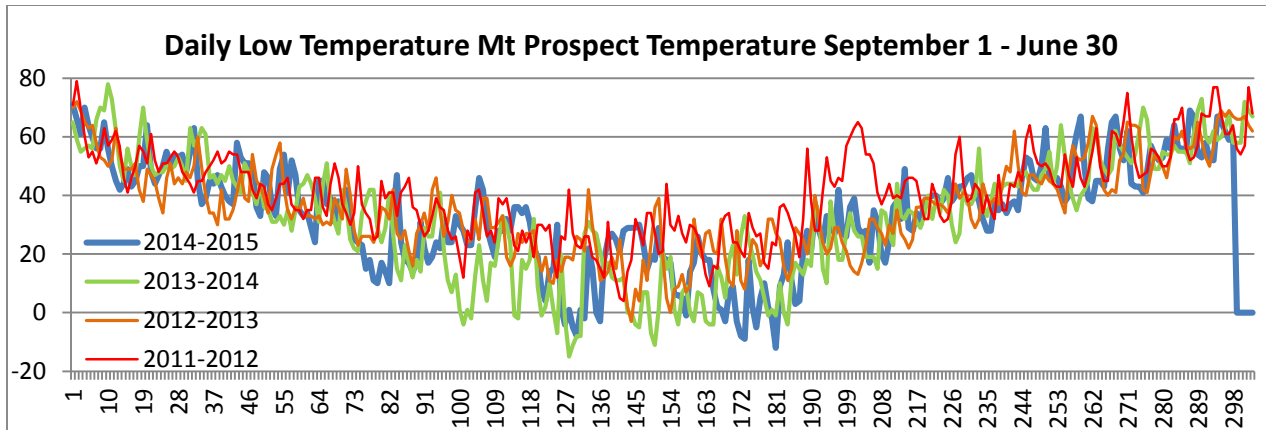
Figure 4.2 Daily temperatures over four years.

The number of leaks in Waycinden (13) in ten months was above the yearly average for the prior three years. Temperature was a thought to be a reason for more failures than previous periods. Figure 4.2 shows a comparison of daily low temperatures through the September to June 2015 window for 2011 - 2015. It seems that 2013-2014 appears to have been colder than the study period in 2014-2015, but both periods were decidedly cooler than 2011-2013. The cold extended into February and March, when leaks continued to occur. As a consequence, the additional breaks tended to be circumferential breaks, the leak type associated with cold weather stresses.
