INVENTORY OF PHYSICAL CHARACTERISTICS
OF THE
ILLINOIS SHORE NORTH OF CHICAGO

Charles Collinson
Patricia L. Drake
Charlene K. Anchor

Prepared by the
ILLINOIS STATE GEOLOGICAL SURVEY
for
THE ILLINOIS COASTAL ZONE
MANAGEMENT PROGRAM

October 1975

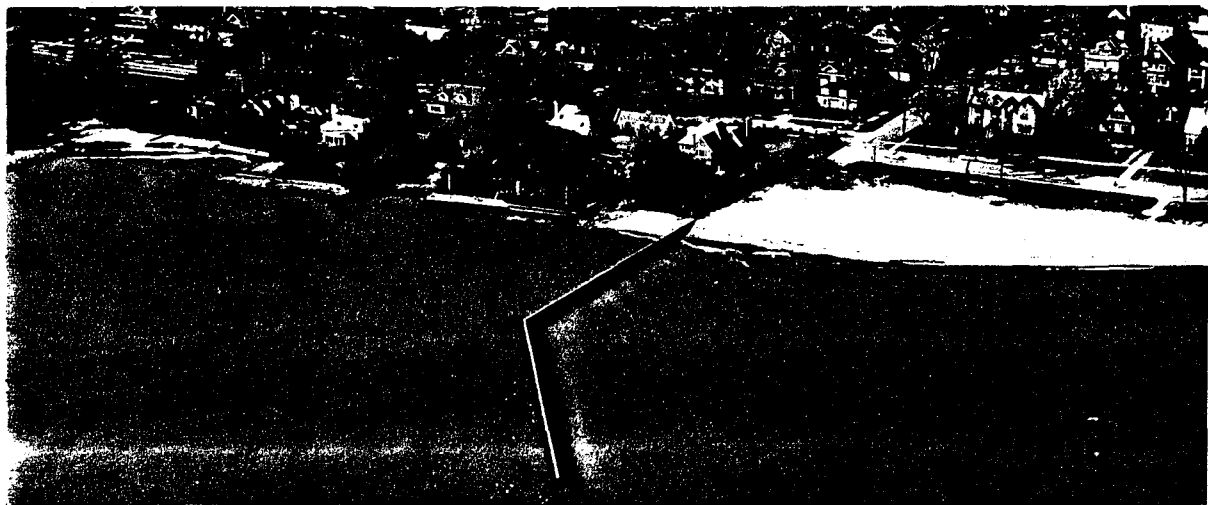
Fig. 2 - (middle) View, looking southwest, at the Northwestern University landfill and lagoon area (E14). The fill is well protected by organized rubble mound seawalls. The area projects more than a 1000 feet into the lake and is one of the major promontories on the shore. Some littoral sediment is impounded on its north side, whereas other sediment is deflected into deeper water. Current and sediment distribution studies may lead to discovery of usable sediment resources associated with the structure.

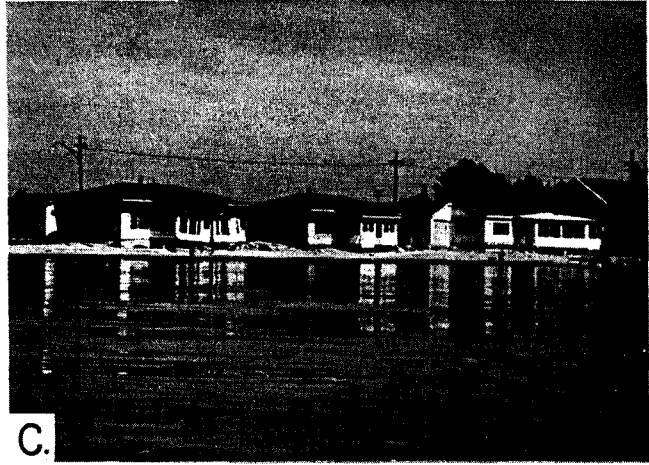
C.

North of the Zion Generation Station as far as the Wisconsin line, shore property has been acquired by the State of Illinois and is being included in Illinois Beach State Park. Severe and rapid shore recession, resulting from present high lake levels, has undermined houses and roads (Figs. 10C,10D) along the entire reach so that most of the houses shown along the shore on inventory Map 1 have been demolished or moved. Hard points and rubble remain where owners attempted to protect their property, but the shore is being returned to a natural configuration by the Illinois Department of Conservation and by the action of the lake. Camp Logan, which is protected by groins and a bulkhead, also has been acquired by the Department of Conservation. The protective structures there apparently will not be demolished.

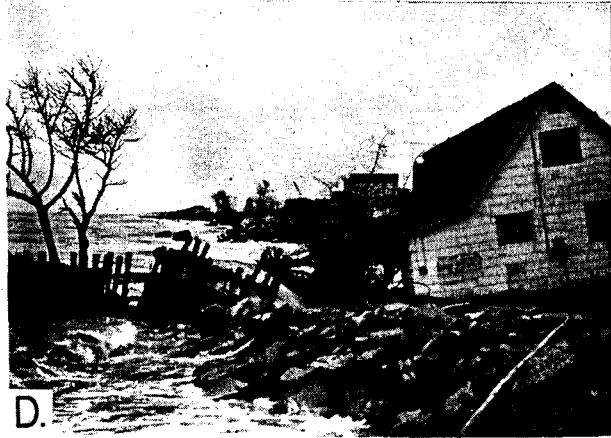
D.

Shore recession rates between the Lodge (IBSP4) and the Zion Nuclear Generation Station (Z4) 1 1/2 miles to the north, range between 2 and 6 feet per year. During the present high-water cycle the main beach at the north end of IBSP3 (Figs. 10D,10E) has receded more than 250 feet. The reach of shore in front of the park bathhouses (IBSP2) has been temporarily protected by riprap and rubble (Figs. 10A,10B) while the reach between the northernmost bathhouse and the reactor (IBSP1) has been protected by sheet piling that is largely buried by recently deposited sand. The reactor (Z4) is shielded by a bulkhead that permits littoral sand to bypass freely.

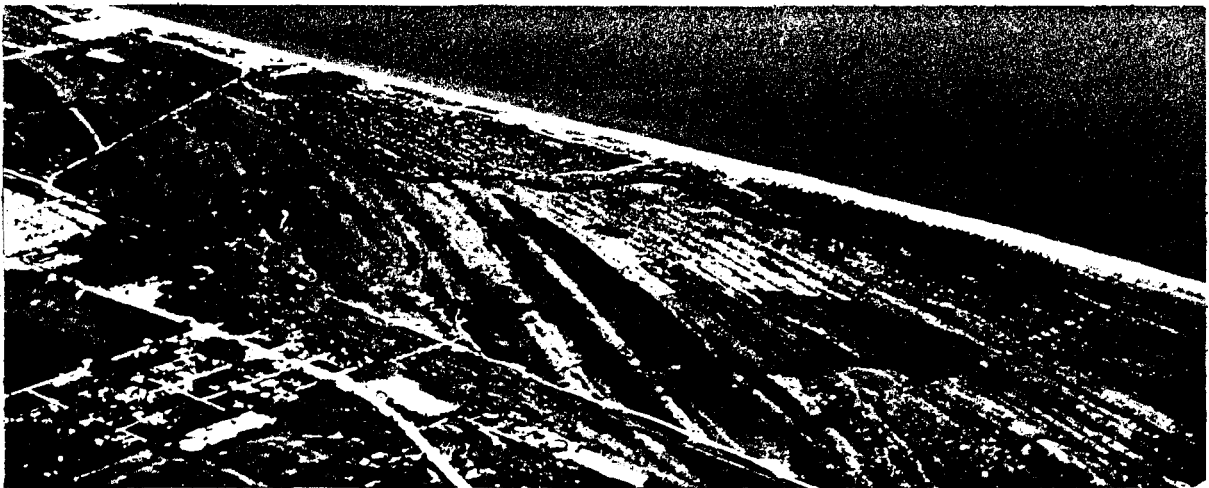
Fig. 12 - (middle) View of the low floodable shore at Winthrop Harbor (WH2). The shore consists of medium to fine sand that is easily eroded by wave impact. Stabilization of the shore is highly dependent on longshore littoral drift to replenish sand as it is removed.
