NSEL Report Series
Report No. NSEL-046
December 2016

Structural and Geotechnical Observations after the April 25, 2015 M7.8 Gorkha, Nepal Earthquake and its Aftershocks

**Larry A. Fahnestock
and
Youssef M. A. Hashash**

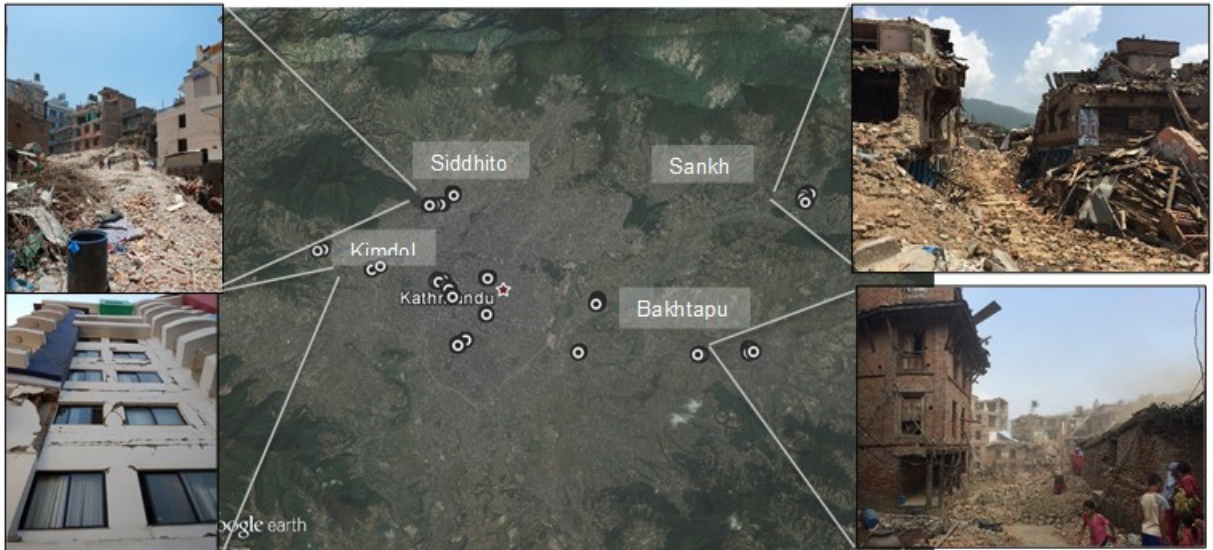
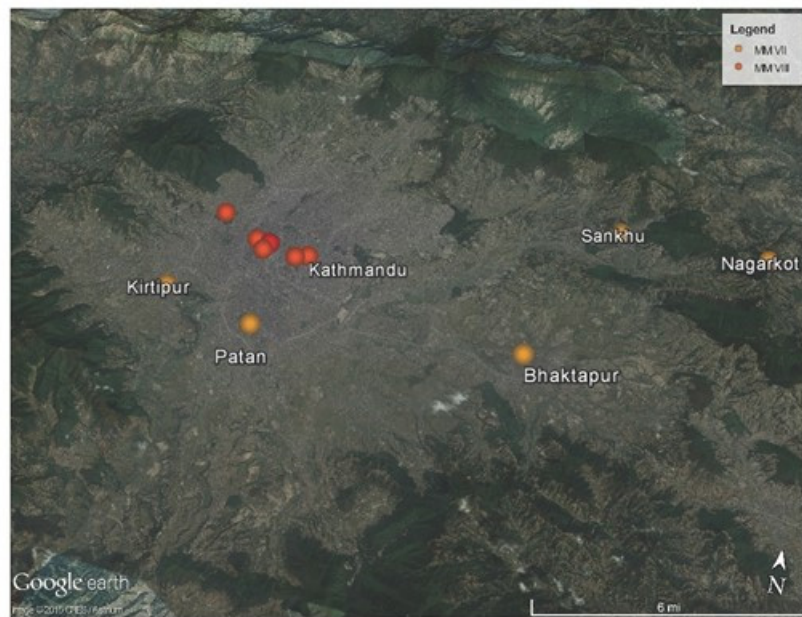
Severe damage has been observed adjacent to basin edges around the Kathmandu Valley after the April 25 M7.8 earthquake and subsequent aftershocks. The two main locations where the damage due to ground shaking is concentrated is in the center of the Kathmandu Valley, and the damage in the center of the valley is most likely due to site amplification caused by the sedimentary basin. Significant damage has also been observed along the basin edges, especially around Bhaktapur and Sakhu where most of the old structures were collapsed. At these locations the observed damage and higher intensity of the ground shaking (Figure 2.3b) is most probably an indicator of the influence of the basin edge effects.

Figure 2.3 Damage distribution in the Kathmandu Valley: (a) primary locations of observed building damage (after Hashash et al. 2015); (b) Modified Mercalli Intensities assigned to main cities in the Kathmandu Valley (GeoNames.org).

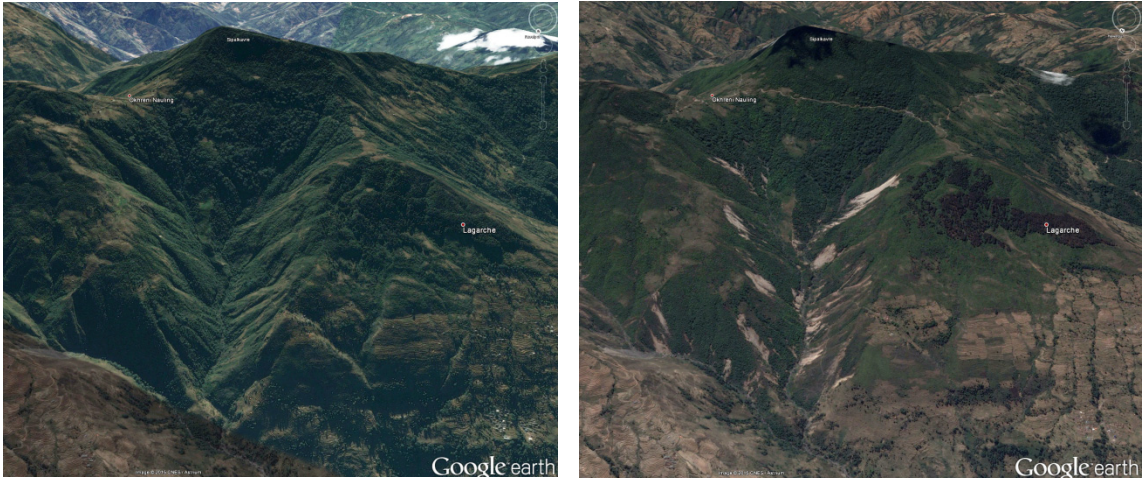
(a) (b)
Figure 2.5 Satellite imagery from: (a) December 2014; (b) May 2015 ($27^{\circ}52'3.57''\text{N}$, $85^{\circ}39'5.41''\text{E}$). Light scars in right image indicate areas of earthquake-induced landsliding (after Hashash et al. 2015).

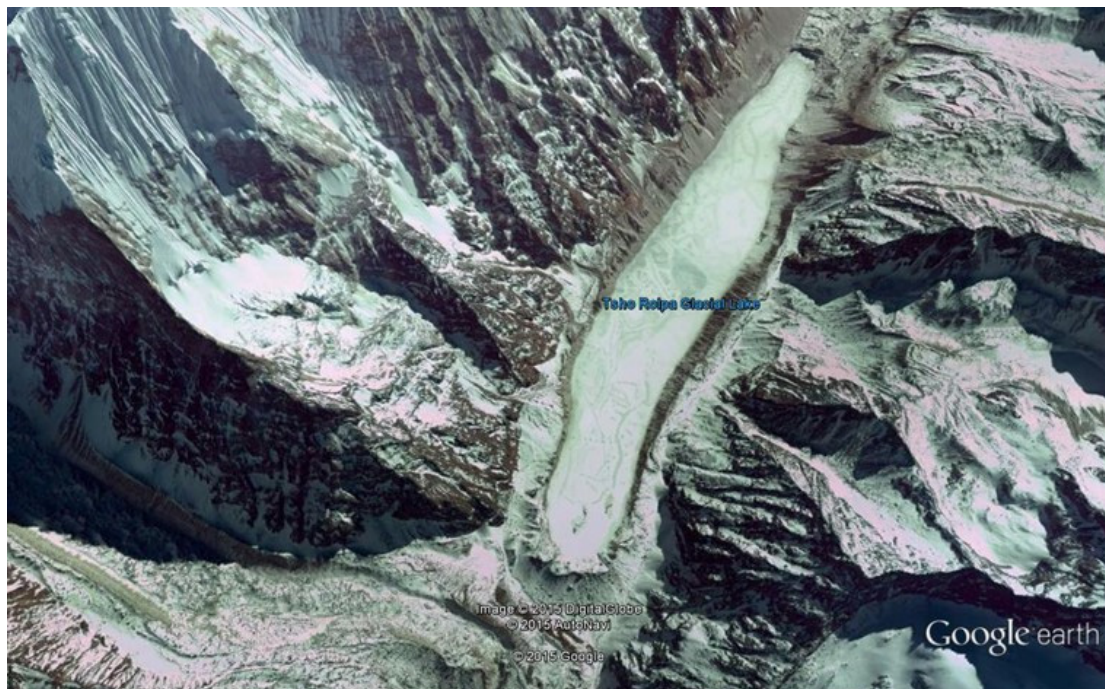
The Tsho Lorpa glacial lake dam is a natural lake located at an elevation of 4,535m (Figure 2.18). A spillway was built to control the water level in the lake and prevent overtopping and possible breaching of the natural dam. The site was visited by helicopter to examine the integrity of the natural dam material around the lake (Figure 2.19) as well as the spillway (Figure 2.20). The natural dam material showed no cracking or slumping. At the spillway, lateral spreading was observed on the lake side. Significant lateral and vertical displacement (Figure 2.21) are observed in excess of a total of approximately 1.5m laterally and 0.5 m vertically.

Figure 2.18 Plan view of Tsho Lorpa Glacial Lake Dam ($27^{\circ}52'9.57''\text{N}$, $86^{\circ}27'44''\text{E}$) (after Hashash et al. 2015).

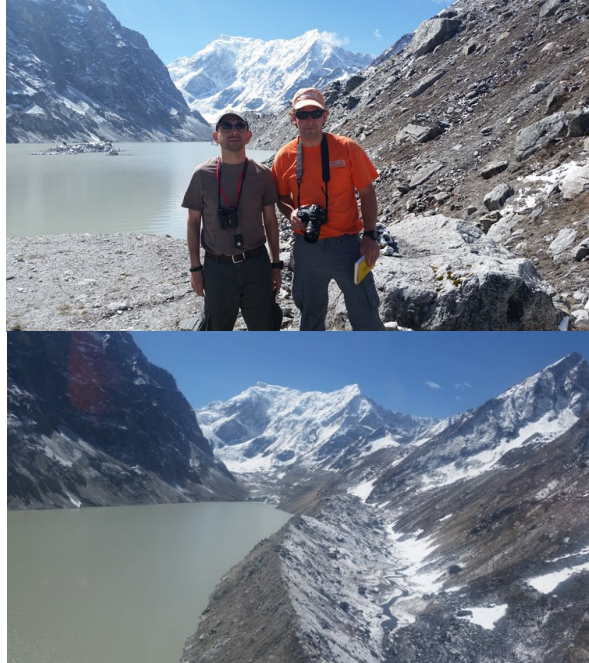
Figure 2.19 Glacial Lake ($27^{\circ}52'9.57''\text{N}$, $86^{\circ}27'44''\text{E}$) (after Hashash et al. 2015).

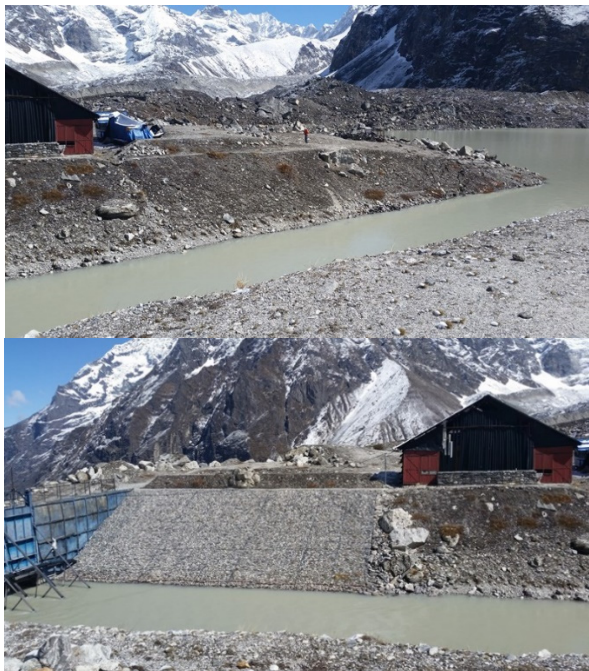
Figure 2.20 Spillway of Glacial Lake ($27^{\circ}52'9.57''\text{N}$, $86^{\circ}27'44''\text{E}$) (after Hashash et al. 2015).

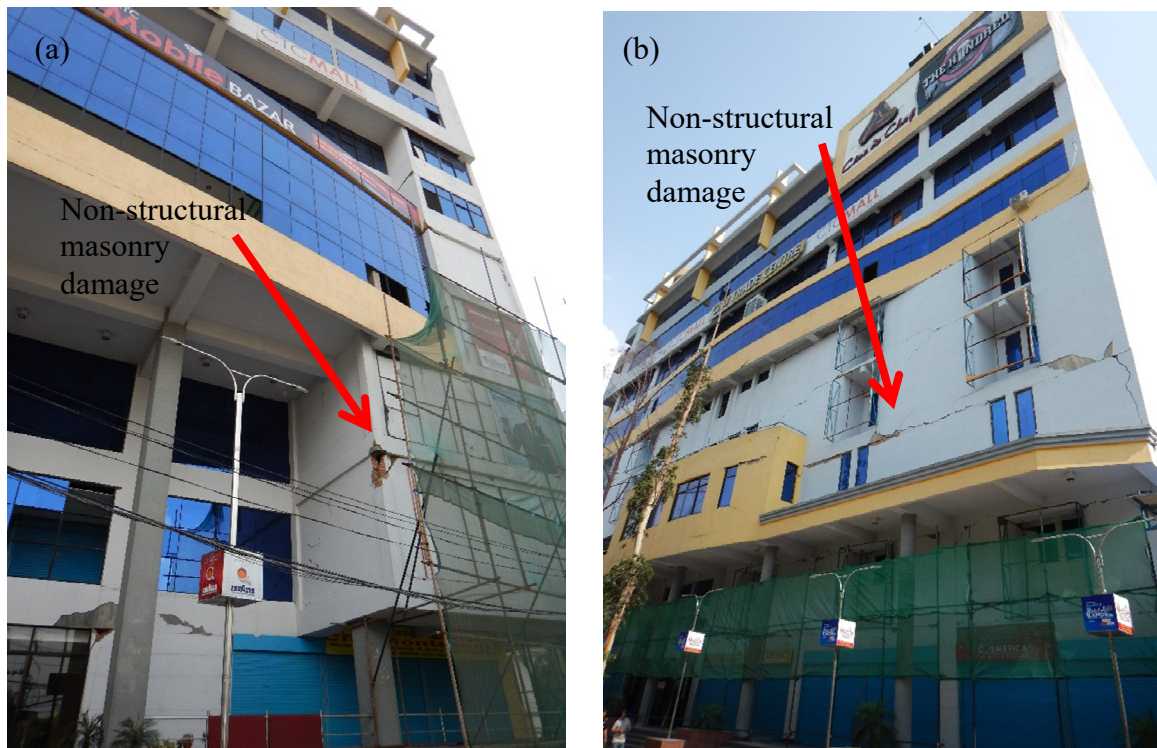
Constructed at roughly the same time as the Valachhen Building (2013), the Civil Trade Centre (CTC) Mall is a large shopping and entertainment complex in the Sundhara region of Kathmandu. The CTC Mall has two subgrade parking levels, nine primary stories and a rooftop penthouse level. As shown in the exterior views in Figure 3.8, it sustained damage to non-structural masonry, and localized structural damage was also observed.

Figure 3.8 CTC Mall – exterior views: (a) view from east side (Kanti Path); (b) view from north side (China Town Road).

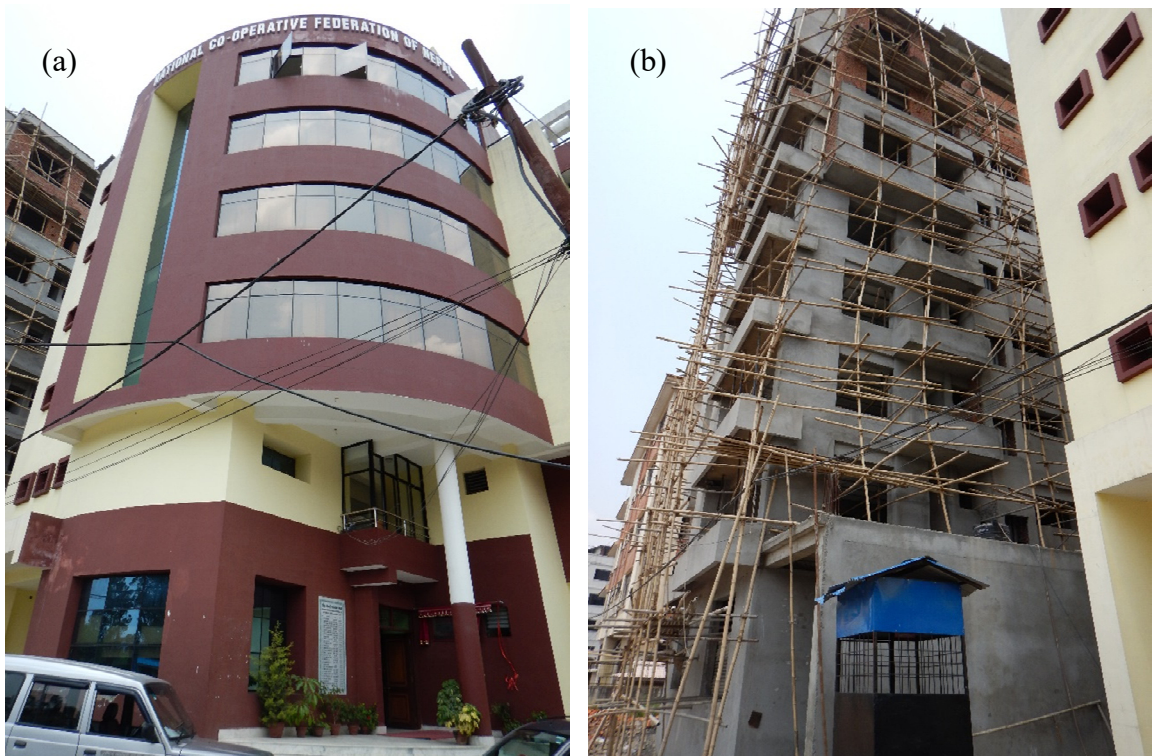
In contrast to the significant damage observed in the Valachhen Building and the CTC Mall, two new buildings, which were designed by Pumori Engineers, were observed to have only very minor non-structural damage. The buildings are directly adjacent to each other, and one (6-story) was finished and occupied at the time of the earthquake (Figure 3.12a), whereas the other (8-story) was under construction (Figure 3.12b).

Figure 3.12 New buildings designed by Pumori Engineers: (a) occupied 6-story building; (b) 8-story building under construction.

Slight cracking occurred on a very limited basis in non-structural masonry walls. No structural damage was observed, and the well-conceived structural design was illustrated by a particular detail in the basement of the buildings. As shown in Figure 3.13,

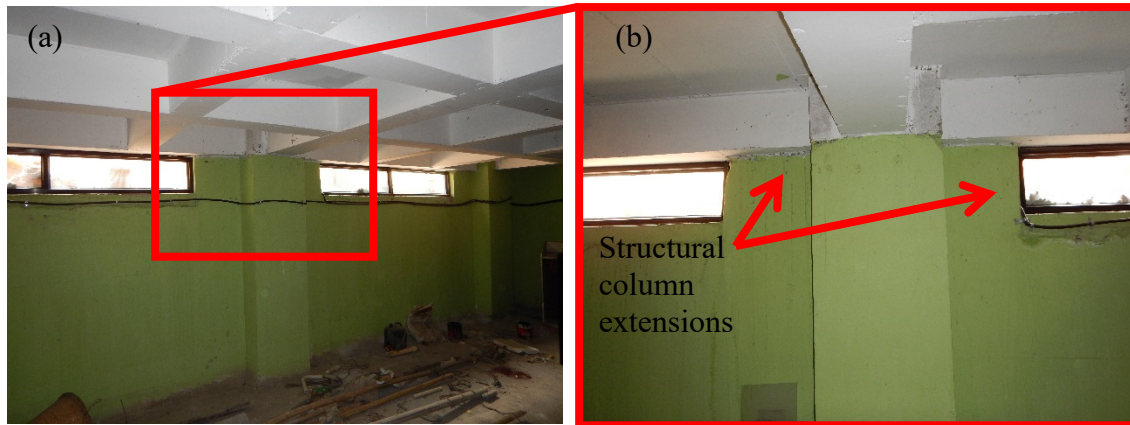
for the finished 6-story building, clerestory windows at the top of the basement level allow light into the basement. This is a common scenario, and as will be shown below for a different building, it can lead to “short column” shear failure at the clerestory windows. In these buildings, the structural engineer intentionally did not allow the windows to extend to the column edges, but instead designed column extensions adjacent to the windows to provide additional shear resistance and prevent column shear failure (Figure 3.13).

Figure 3.13 Column extensions at basement clerestory windows to prevent column shear failure in short column region: (a) overall view; (b) close-up view.

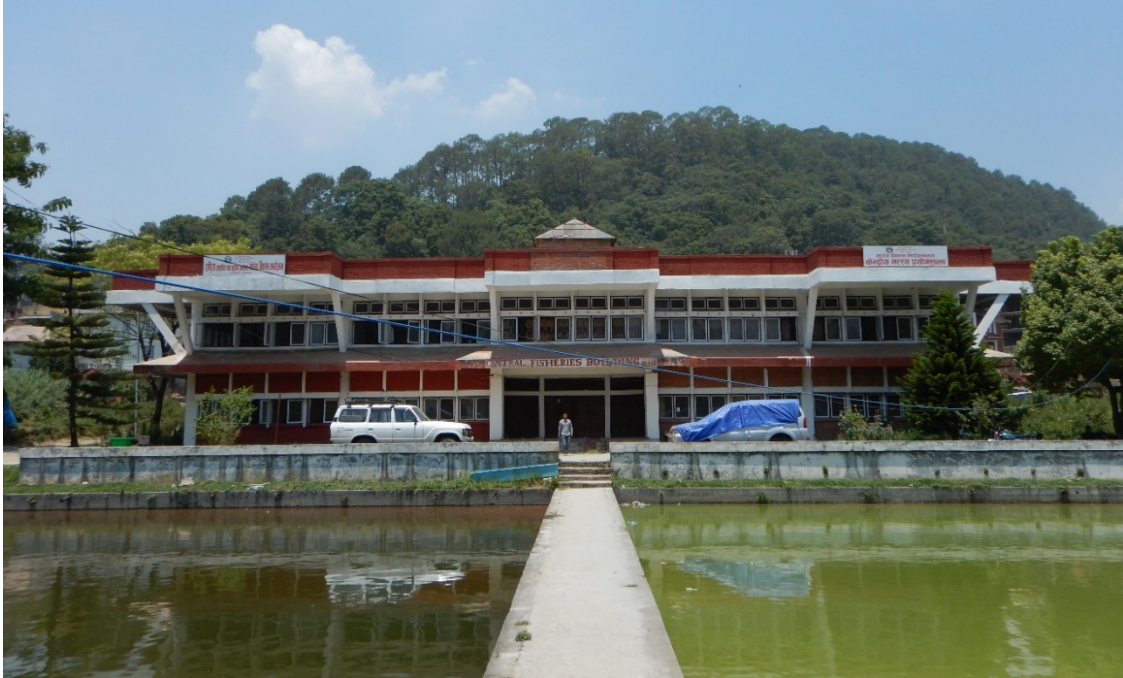
The Government of Nepal Central Fisheries Building, which houses the Directorate of Fisheries Development under the Ministry of Agricultural Development, is located in the Balaju region of Kathmandu, in close proximity to the heavily damaged and collapsed common residential / commercial buildings described above. As shown in Figure 3.14, this two-story building has a RC frame structure that is visually much stouter than the common residential / commercial buildings discussed above. Although the building survived the earthquake sequence, it did still sustain significant structural damage, which was concentrated in the first story. The second story had minimal structural damage. As shown in Figure 3.15, major damage was observed at the base of one corner column, and less visible shear cracking was observed at other column base locations. Figure 3.16 shows close-up views of representative shear failures that were observed at the tops of the first story columns in multiple locations throughout the building. Non-structural infill framing may have influenced the column response and reduced the effective height of the columns and contributed to the shear failures (Figure 3.16c).

Figure 3.14 Central Fisheries Building – exterior view.

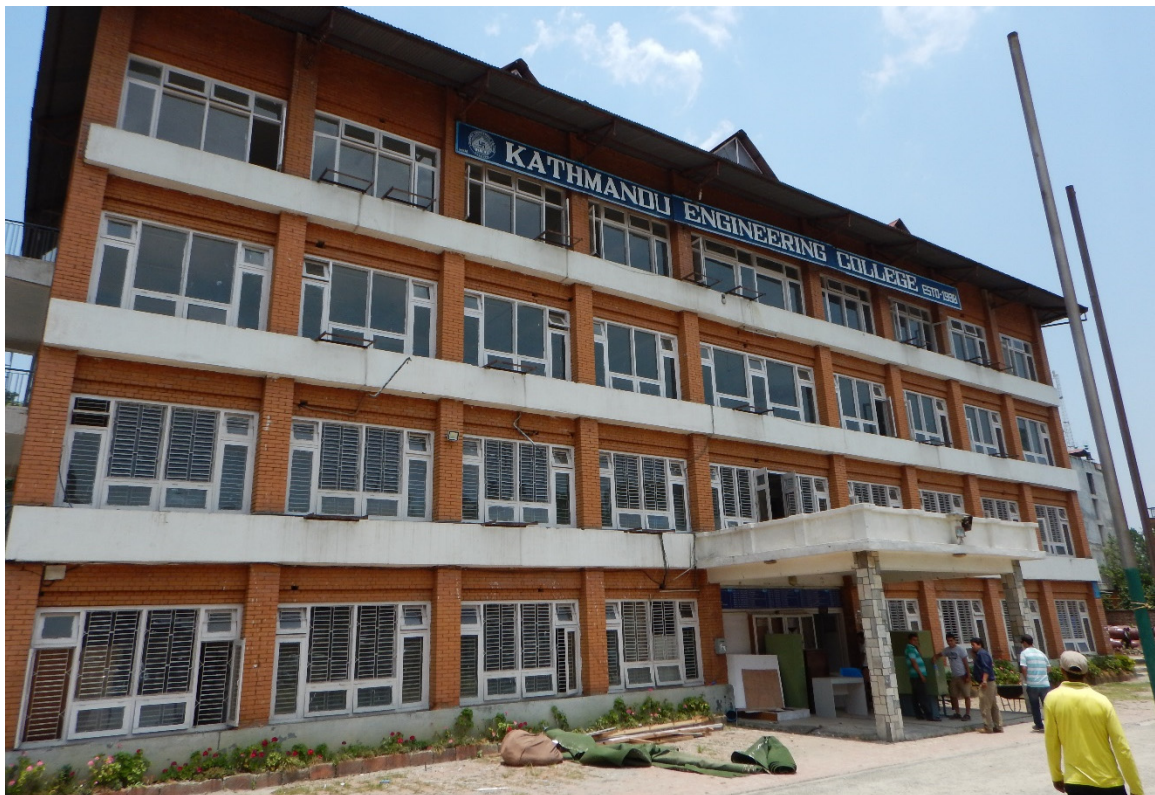
Figure 3.18 Kathmandu Engineering College Block C Building – exterior view.

On the campus of Kathmandu Engineering College (KEC), short column effects were responsible for column shear failure in the 4-story Block C Building, which was constructed in 1983. As shown in the exterior view in Figure 3.18, windows extended over the majority of the stories at the building perimeter, and the exterior columns were not damaged. However, on the interior, partial-height non-structural masonry walls were below windows that allowed natural light to penetrate into interior spaces, and column shear failure occurred in the short span within the window region (Figures 3.19 and 3.20). Almost no transverse reinforcement was evident and longitudinal bar buckling occurred. The interior walls were predominantly placed in the east-west direction (long direction of the building), so column response in the north-south direction primarily occurred over the full clear story height without constraint from the interior walls. The KEC Block C Building formed a first-story mechanism, with the remaining stories exhibiting no observable structural damage. The shoring seen in these photos was placed after the earthquake.

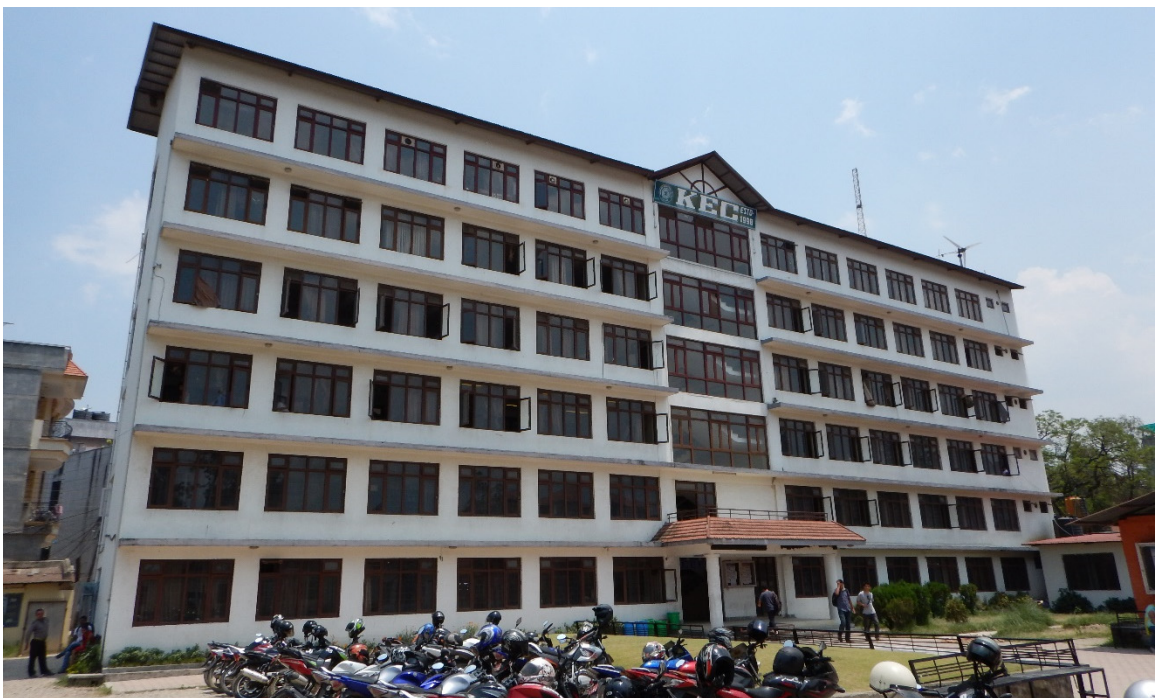
In contrast to the KEC Block C Building, the KEC Block E Building (Figure 3.21), which is a six-story structure constructed in 2003, sustained only very light non-structural damage to infill masonry. The Block E Building had a very similar configuration as the Block C Building, with full-height exterior windows and partial height non-structural interior masonry walls topped with windows to allow light penetration (Figure 3.22). In this case, the interior walls were predominantly placed in the north-south direction, which is the long direction of the building. Thus, the interior columns had significantly shortened spans in the north-south direction, but they suffered no ill effects.

Figure 3.21 Kathmandu Engineering College Block E Building – exterior view.

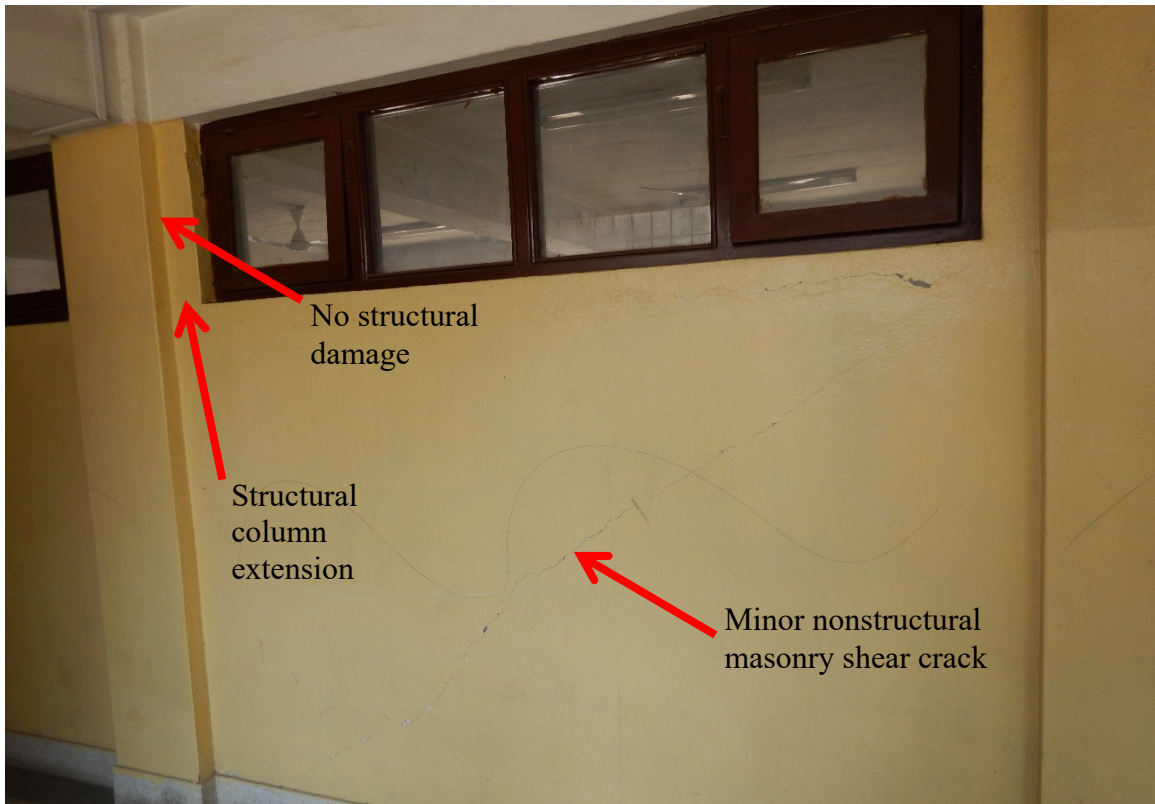
Figure 3.22 Kathmandu Engineering College Block E Building – interior view.

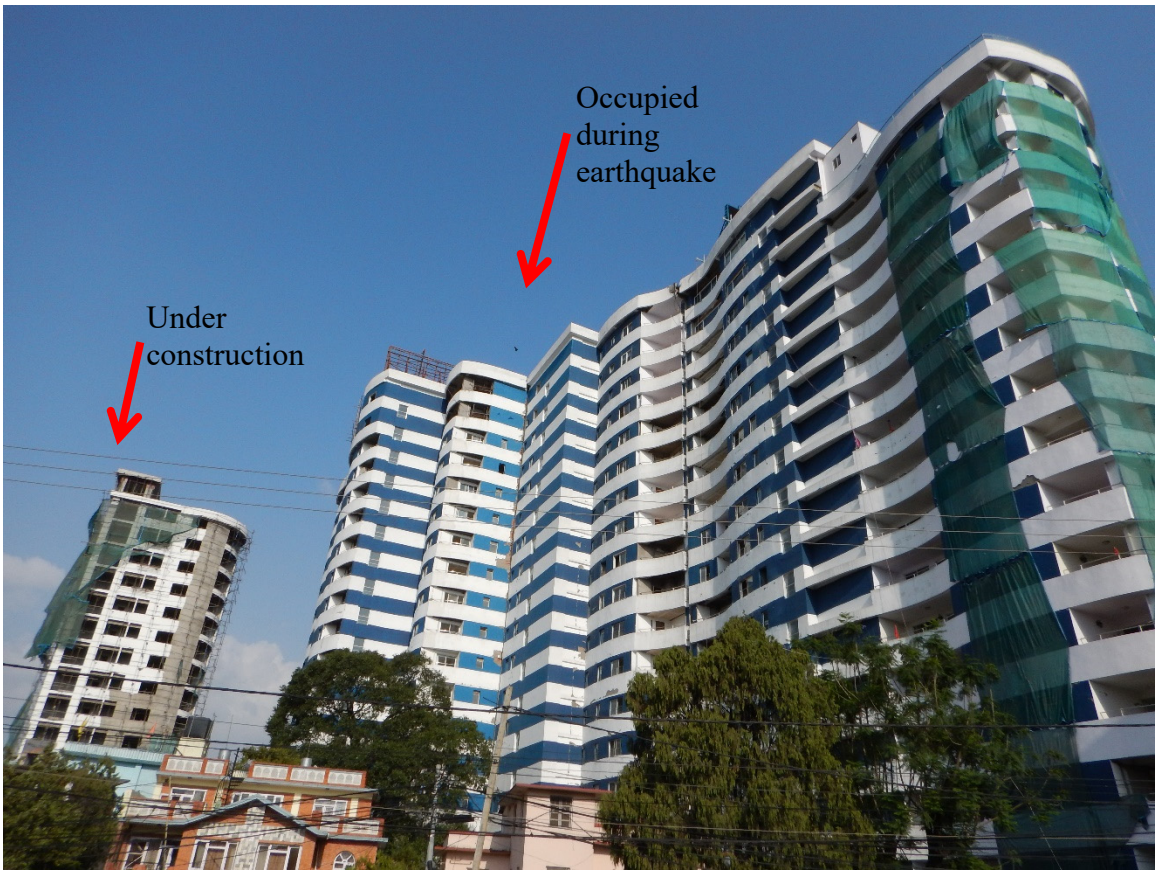
Figure 3.27 Silver City Apartment Complex.

In the Kalikasthan region of Kathmandu, the Silver City Apartment complex is one of the tallest in the city and it sits at one of the highest points of the city. The complex comprises two buildings, one of which was still under construction at the time of the earthquake (Figure 3.27). The portion of the complex under construction is shown at the left of Figure 3.27 and was not inspected. The occupied building is actually composed of

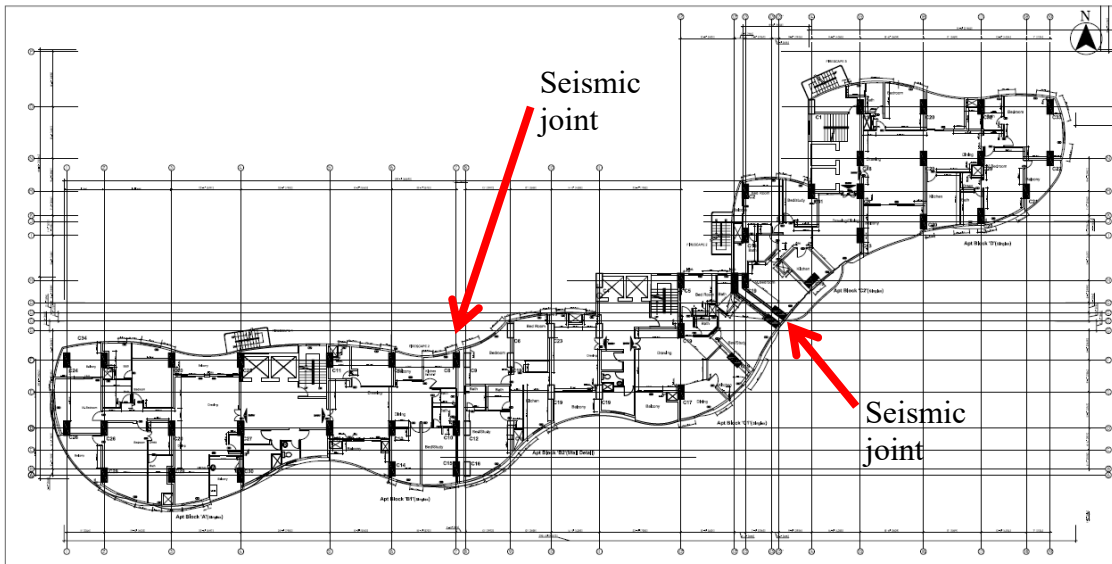
Figure 3.28 Silver City Apartment Complex – occupied building (drawing courtesy of Bimal Poddar).

three structurally independent units separated by seismic joints (Figure 3.28). As shown in figure 3.28, one of these joints is straight (north-south) and the other is irregular, with the primary portion of the joint oriented northwest-southeast and a short segment at the northwest end turning north-south. Photographs of the two joints are also shown in Figure 3.29.

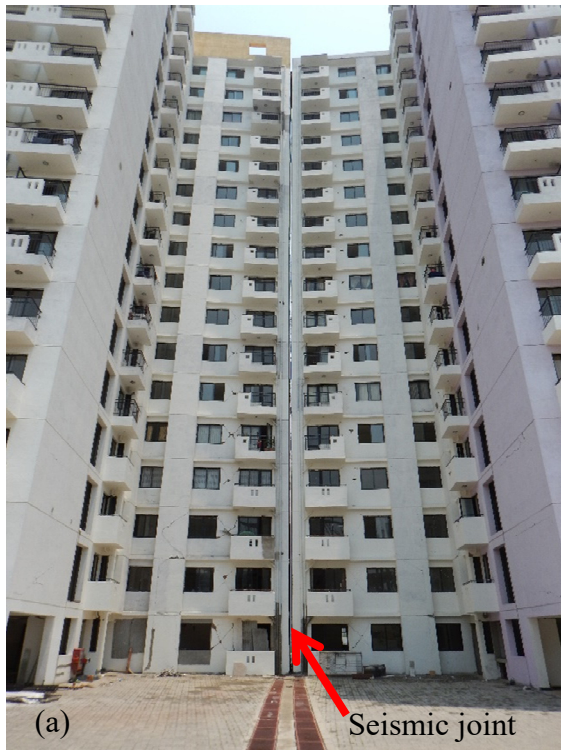
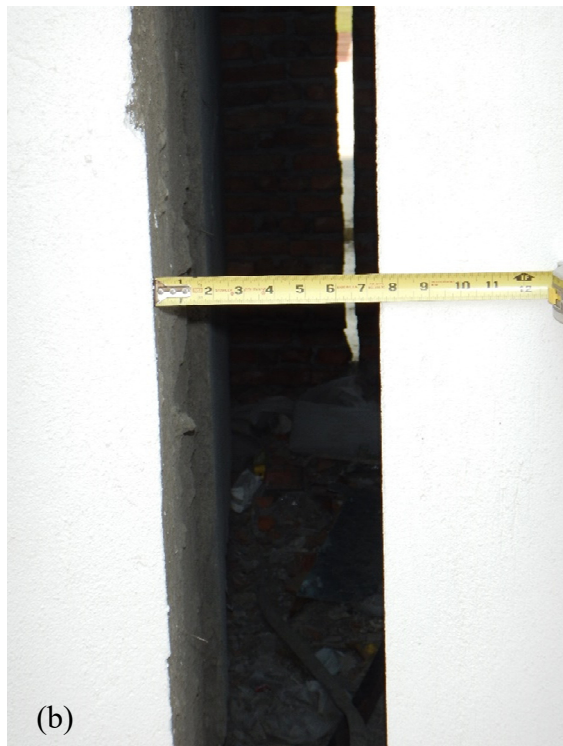
Figure 3.36 Sun City Apartment Complex – representative seismic joint: (a) overall view; (b) detail.

Also notable, particularly compared to Silver City, is the complete lack of pounding between adjacent towers. As shown in Figure 3.36, the seismic joint was roughly 8 inches at the narrowest, although it did widen towards the interior of the building. This joint is roughly half that provided at Silver City, where significant pounding was observed. This observation points to significantly different excitation at the Silver City and Sun City sites. Silver City may have been affected by local site effects or ridge amplification effects. In addition, the wide variation in response between the two groups of buildings in the Sun City complex indicates that the primary direction of shaking at the site was northeast-southwest, which is roughly one of the primary axes of the building triple set, but skewed roughly 45 degrees to the primary axes of the double set.

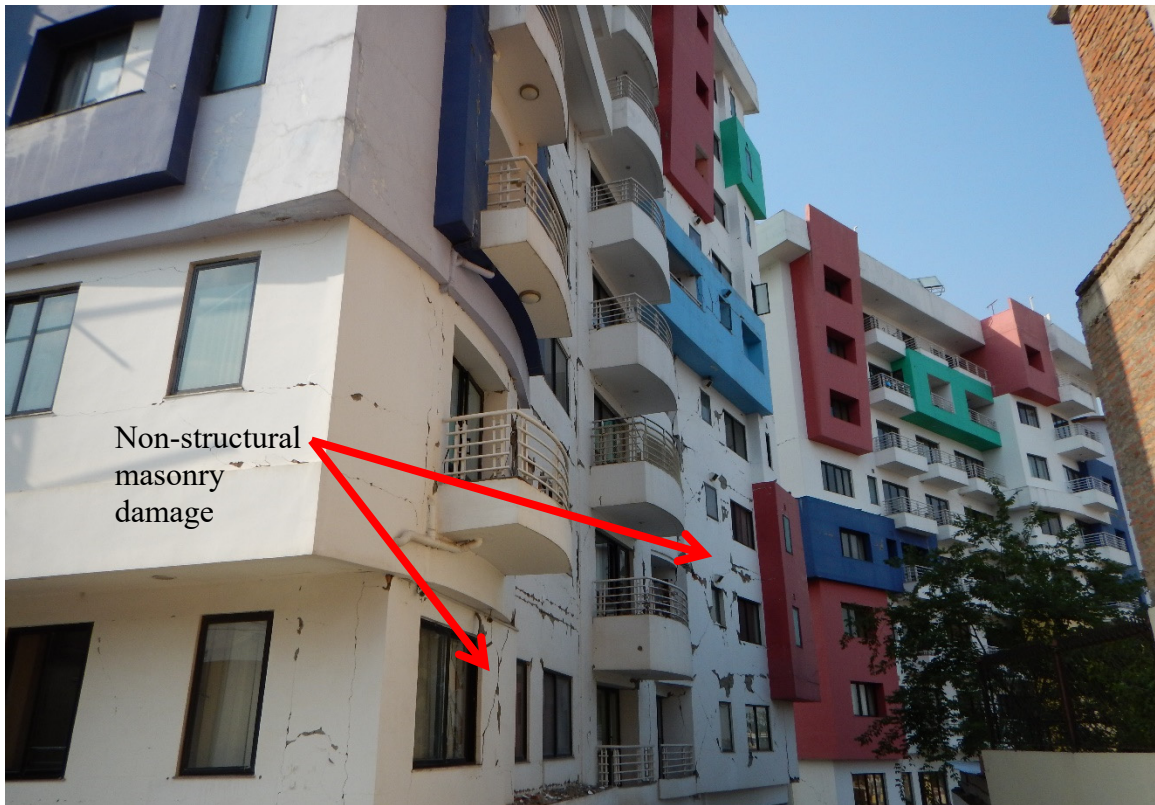
Figure 3.37 Swayambhu Apartment Complex.

The Swayambhu Apartment complex is a pair of towers located on a ridge, and locally built on a steep slope (Figure 3.37). The towers experienced moderate to heavy non-structural damage (Figure 3.38), which included extensive diagonal shear cracking and in some locations masonry walls became unstable and dislodged from the building. On the steep slope, settlement of backfill adjacent to the towers was also observed (Figure 3.39). Despite these indications of significant excitation at the site, no structural damage was observed in these buildings.
