Taylor Wimpey – Thermal Imaging Project

Site: Hele Park
 Newton Abbot
 TQ12 6JN

Visit Date: 18th December 2017

Plot(s): 294 & 297

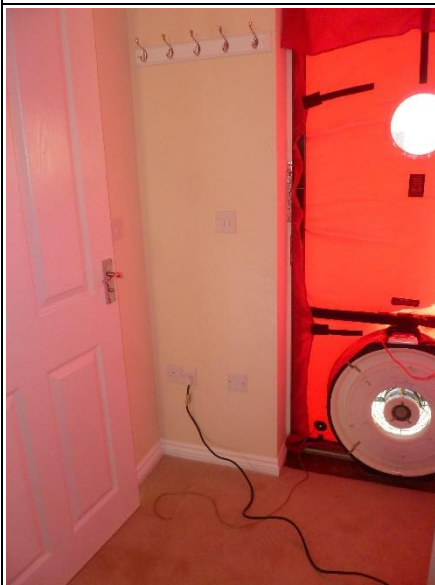
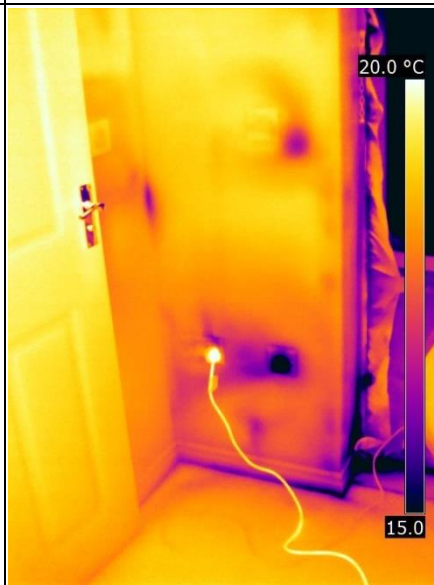
Under depressurisation air was also getting beneath the hall carpet and lifting it slightly, although it was not clear where this air was entering it seemed to be from around the door jamb junctions with the threshold.

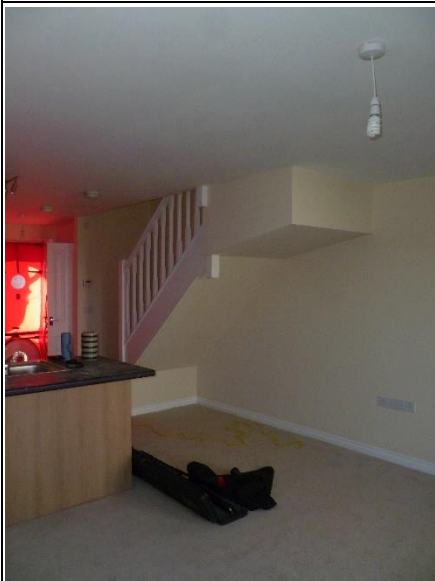
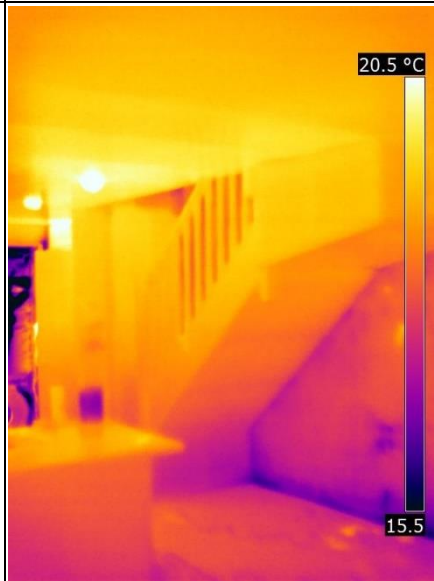
The service riser at the edge of the kitchen units appeared cooler under depressurisation, the direction of airflow through it was not obvious.

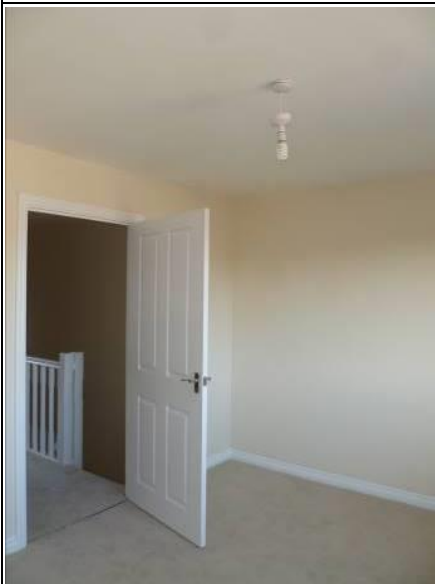
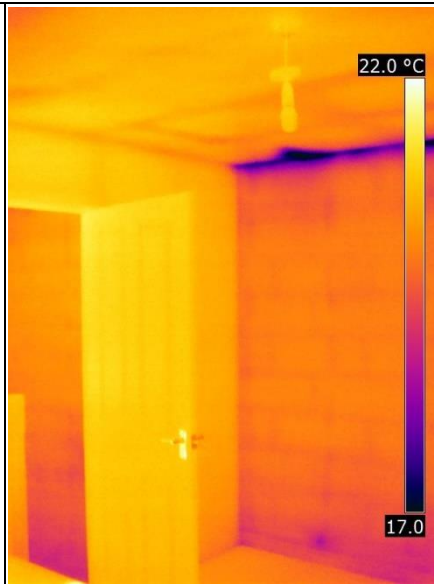
Bedroom 1 – Under natural conditions

As observed in bedroom 2.

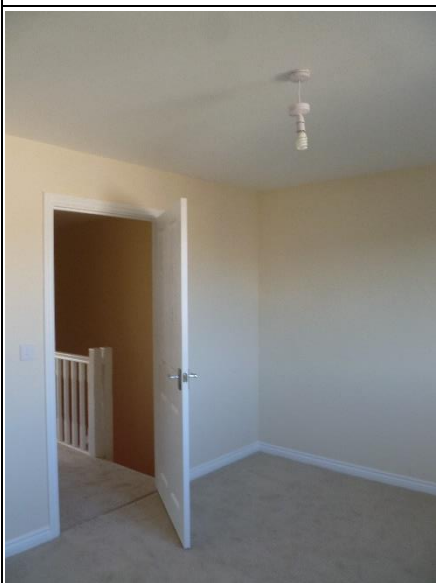
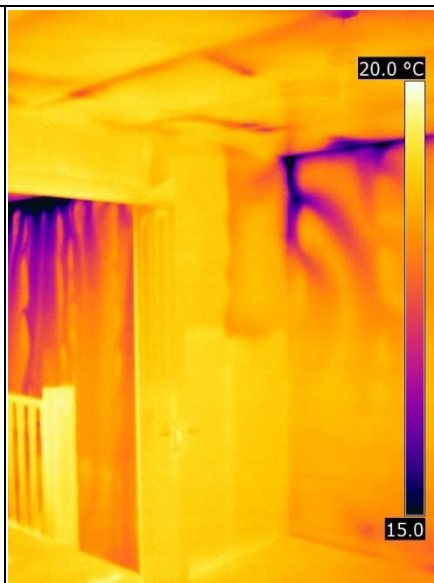
Bedroom 1 – Under depressurisation

Under depressurisation air could be seen being drawn in from the loft space on both external walls and on the party wall.

On the gable wall, cooler air could also be seen entering the internal partition wall adjacent to the stairs/landing.

On the party wall, cooler air could also be seen entering the internal partition wall adjacent to the bathroom there the soil stack was positioned.

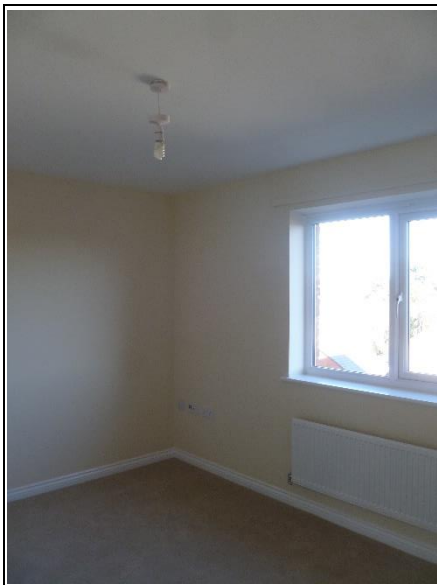
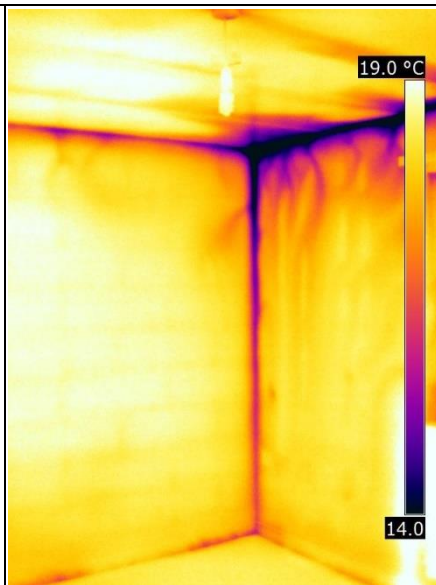
The external corner junction with the ceiling was again very cold, as seen in the airing cupboard in bedroom 2.

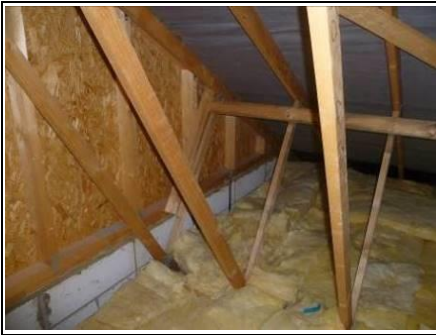
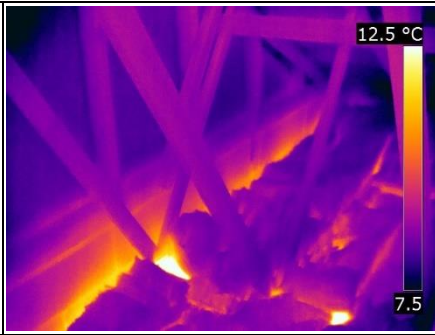
The North West facing gable wall showed a similar pattern of heat loss to the party wall. Here it was possible to see that there was no insulation between the end trussed rafter and the wall, with the non-continuous ribbon of plasterboard adhesive dabs clearly visible from above.

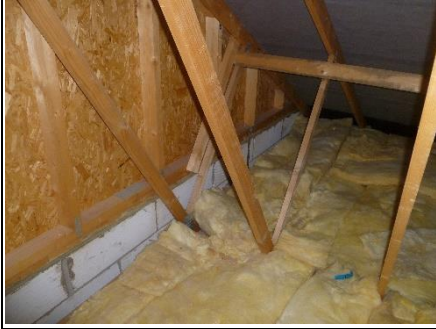
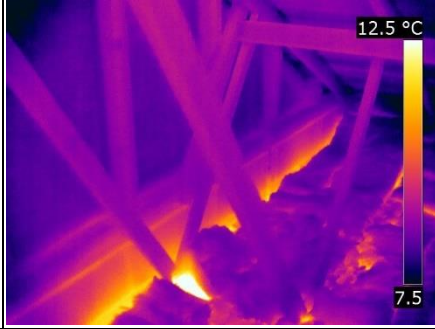
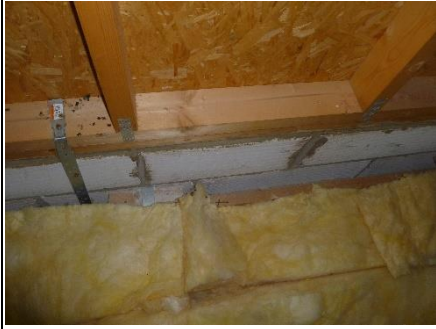
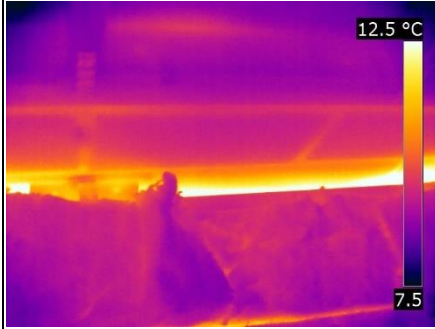
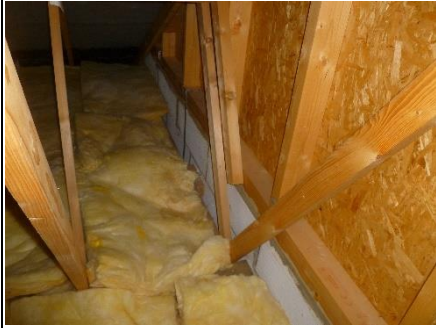
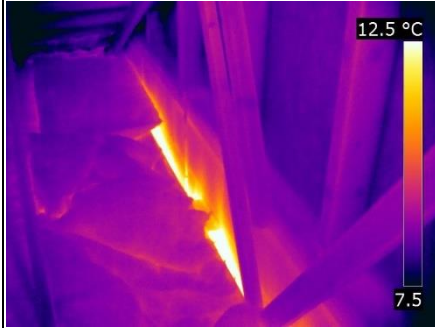
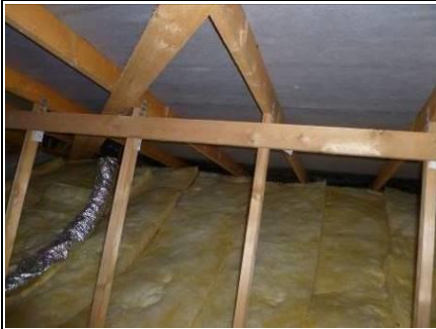
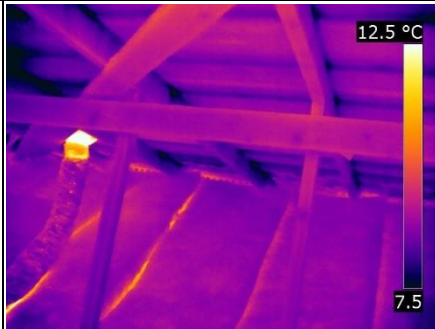
The South West facing front eaves, above bedroom 2, looks similar to the other eaves junction.

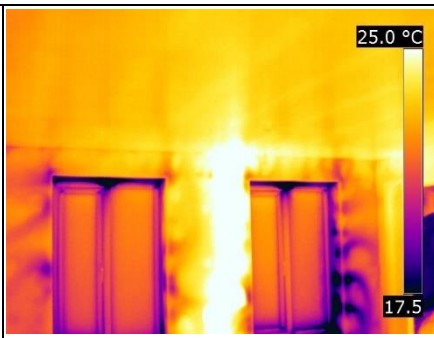
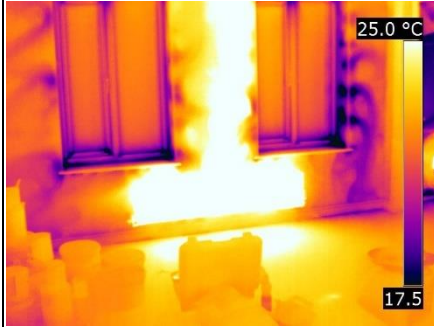
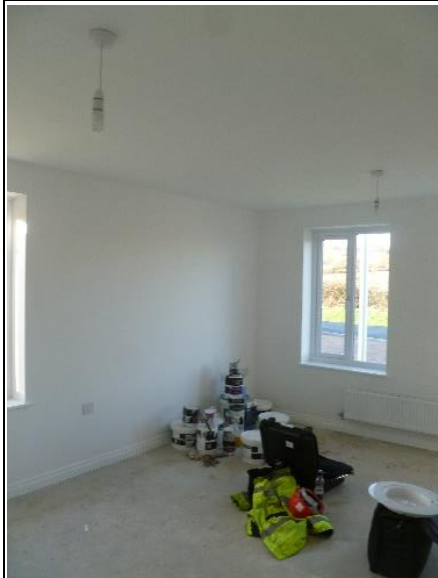
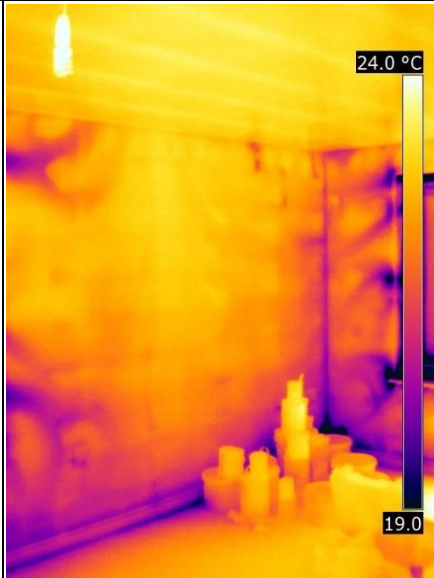
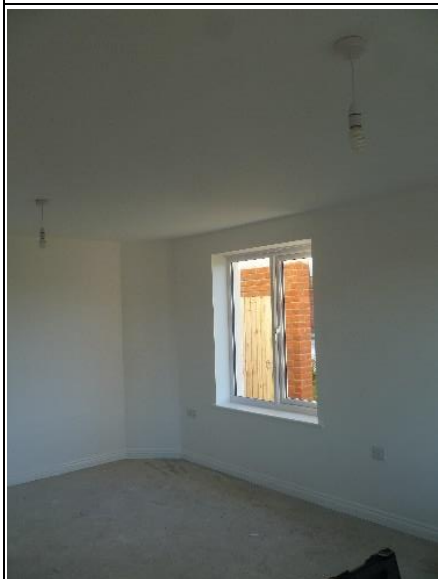
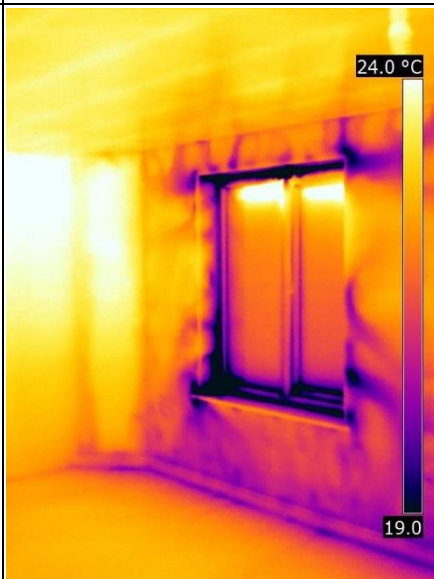
Lounge – Under depressurisation

The infiltration observed under natural conditions was exacerbated under depressurisation on both the front elevation and on the South West facing gable wall.

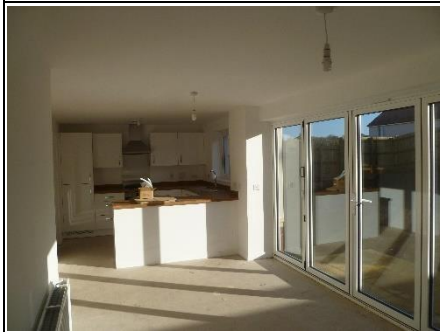
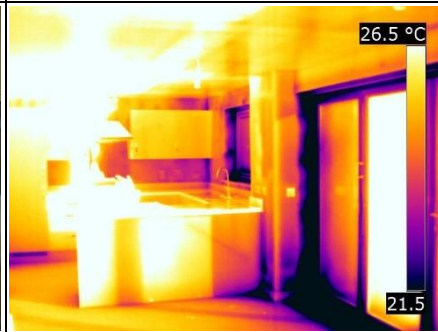
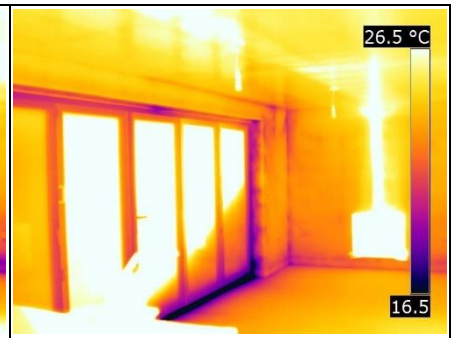
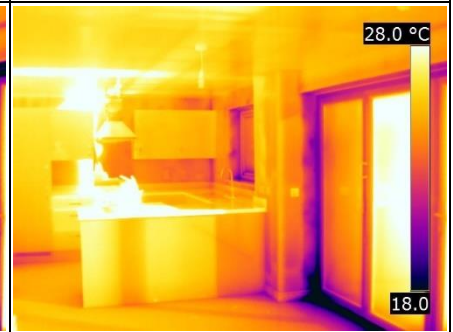
Dining/Kitchen – Under natural conditions

The Dining/Kitchen extended across the entire rear elevation at the ground floor; unlike the Lounge and Study this was on the leeward side of the dwelling and infiltration around the windows under natural conditions was much reduced. However the patio door jambs and threshold appeared particularly cool. The jamb adjacent to the kitchen was even colder than the window head, but this was partially due to shading by the frame. The threshold also appeared very cool.

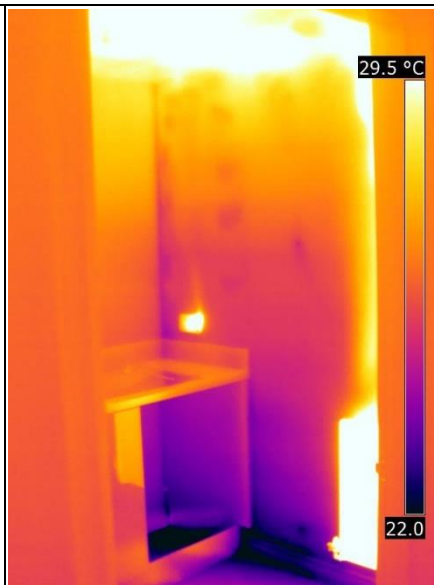
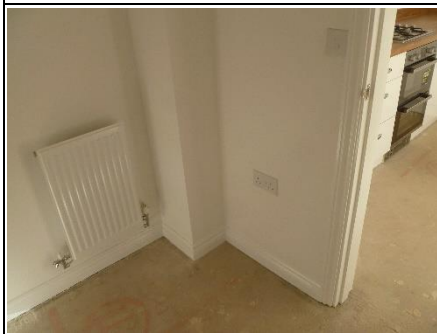
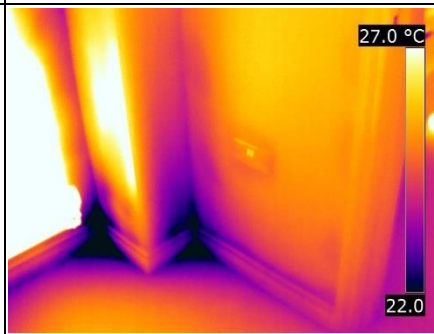
Utility – Under natural conditions

The floor wall junction backing on to the garage looked cooler, but as this room was warmer than the rest of the house it was hard to tell if this was significant.

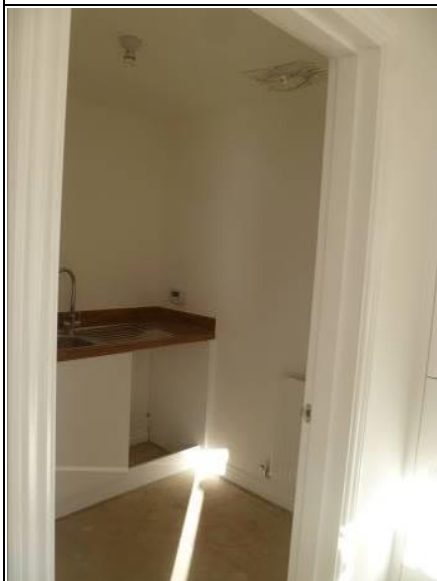
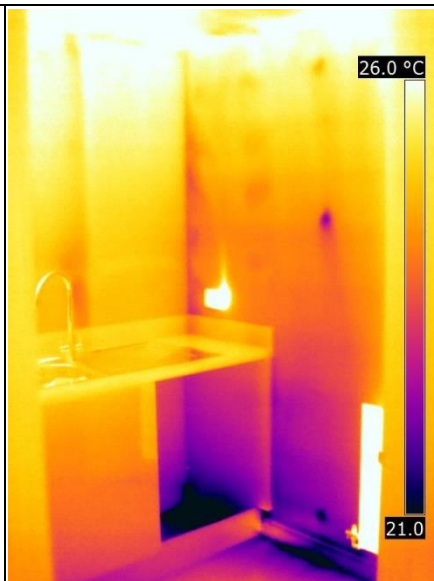
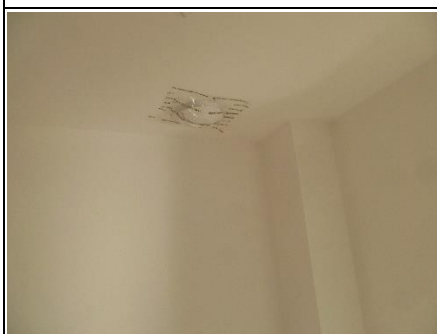
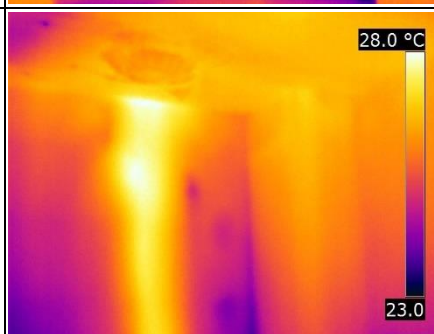
Utility – Under depressurisation

Cold spots on the external wall again suggest (as in the previous plot) that there may be gaps in the inner leaf blockwork that allow air to infiltrated directly from the external wall cavity into the void behind the dry lining.

The service riser looks a little cooler nearer the base, but it is still fairly warm.

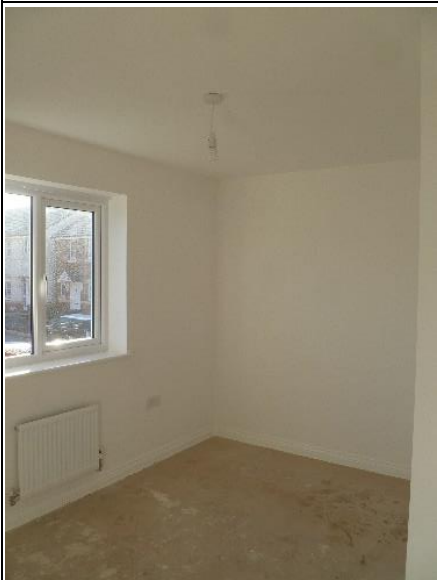
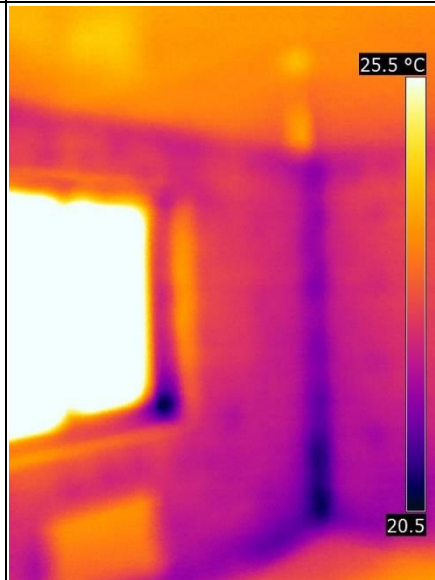
Bedroom 4 – Under natural conditions

The internal partition walls backing onto the en-suite shower and service void in the bathroom look slightly cooler than the rest of the partition walls, but otherwise the room appears very similar to the observations made for bedroom 1.

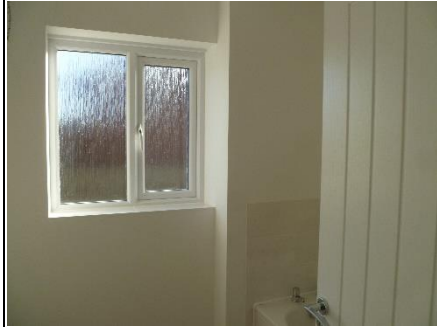
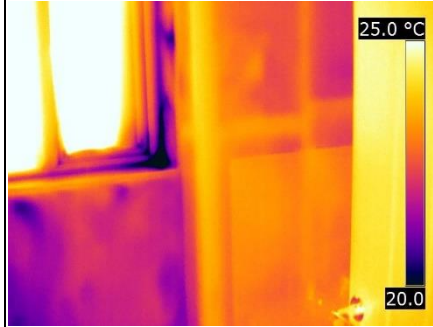
There is a great deal of air movement in the void behind the plasterboard, particularly around the extract grille. It would appear that the grille is sealed nicely to the plasterboard where it is visible, but not sealed behind the plasterboard where it penetrated the blockwork.

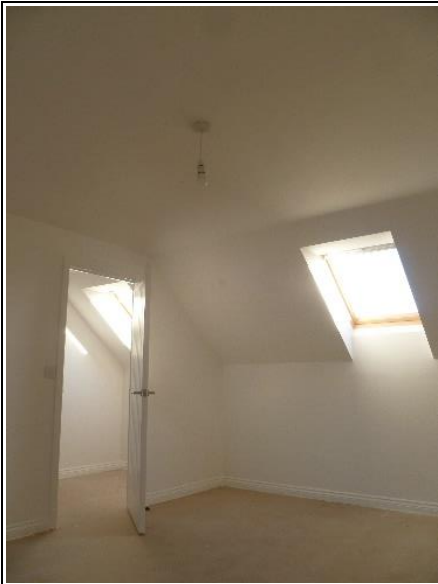
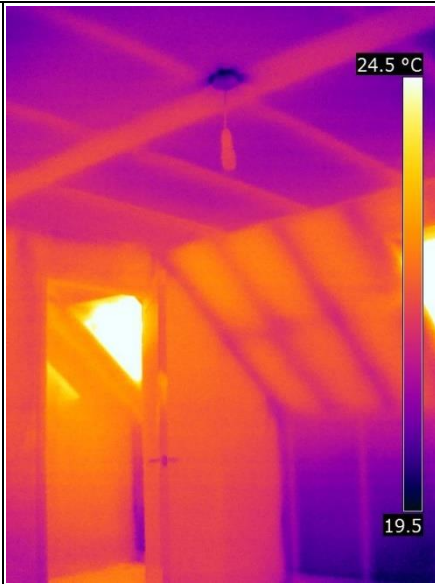
Bedroom 6 – Under depressurisation

The areas with voids behind have become much cooler as cold air is drawn into those voids under depressurisation. This cooler air can be seen being drawn down the gable wall and emerging at the floor/wall junction.

The dormer cheeks appear to be an issue when the direction of air movement is reversed. Cold air appears to be bypassing any insulation in the cheeks.

Air infiltrations around the dormer window appears to still be of

concern; the roof-light however appeared to perform very well.

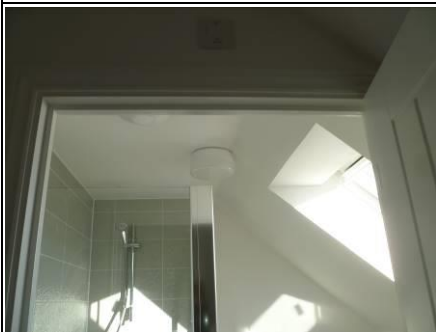
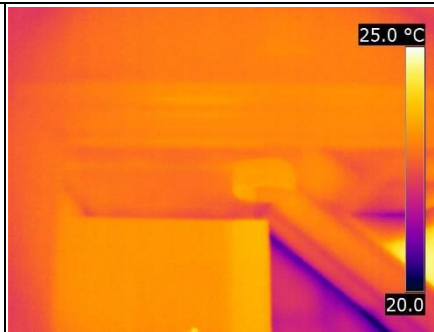
2nd Floor En-Suite – Under natural conditions

The gable wall looks slightly cooler, but with all the direct sunlight and reflection it's difficult to assess.

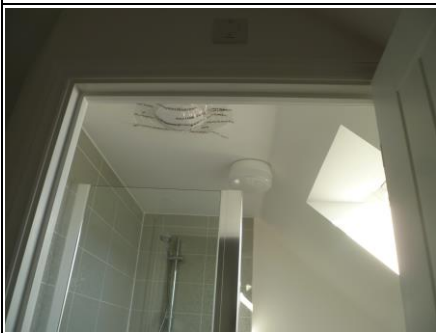
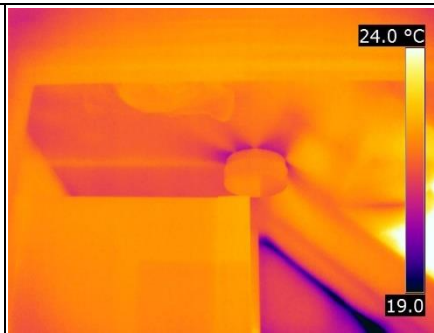
2nd Floor En-Suite – Under depressurisation

Under depressurisation air can be seen drawn in from above around the central light, and at the floor/wall junctions on both external facades. Again, there was too much direct solar to view most of the room.

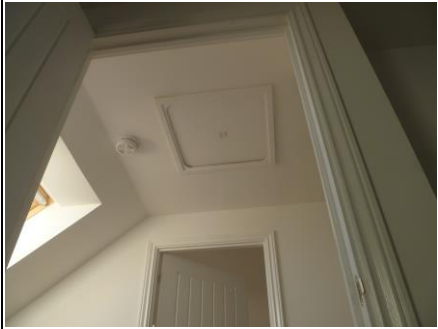
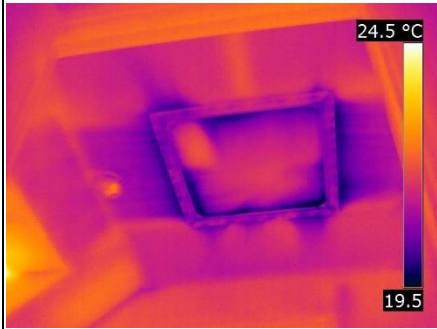
2nd Floor Landing – Under depressurisation

Under depressurisation air leakage was detected around the loft hatch.

Again the areas backing onto voids appeared to cool more under depressurisation than those backing directly onto panels.
