XIV International Conference on Building Pathology and Constructions Repair – CINPAR 2018

Rehabilitation and seismic upgrading of the masonry arch bridge over the Magra river in Villafranca

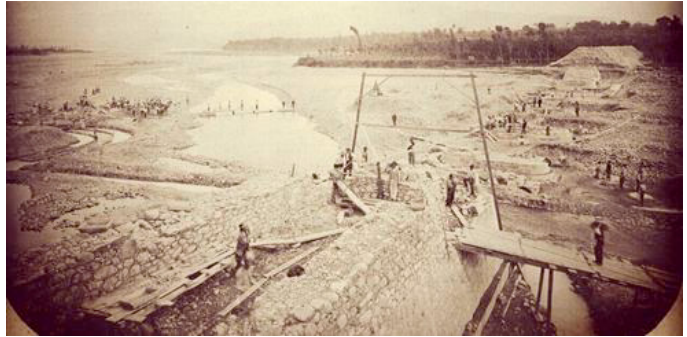
Fig. 2. The Villafranca bridge during the erection phase (1874)

The single lane carriageway masonry arch bridge, characterized by eight arches spanning 19 m around each and by around 12 m height intermediate masonry piers on shallow foundations, was built in 1874. In Fig. 2 it is shown the bridge during the erection phase of the piers. It must be stressed, that at that time the course of the river was slightly different; the bridge was on a right bend, so that the velocity of the current was usually higher on the left bank, Villafranca side, than on the right bank, the Mulazzo, as it is evident looking at the river bed in fig. 2. This is presumably the reason why the dept of the original pier foundations diminished from Villafranca toward Mulazzo.

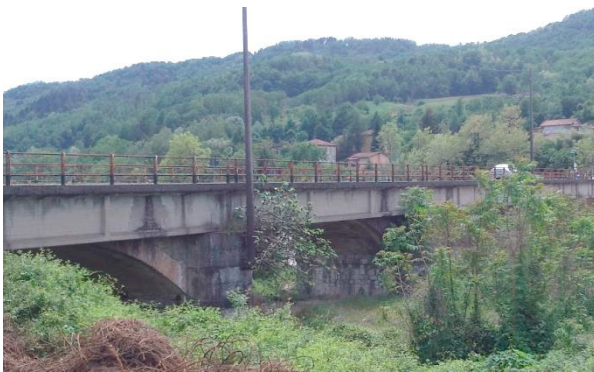
Fig. 3. Elevation of the bridge after the carriageway widening (1961)

Since the original carriageway width was not sufficient to allow two lanes, in 1961 it was widened by means of two lateral prestressed concrete beams, supported by the piers, so hiding the arches and modifying severely the original aspect of the bridge itself, as shown in Fig. 3.

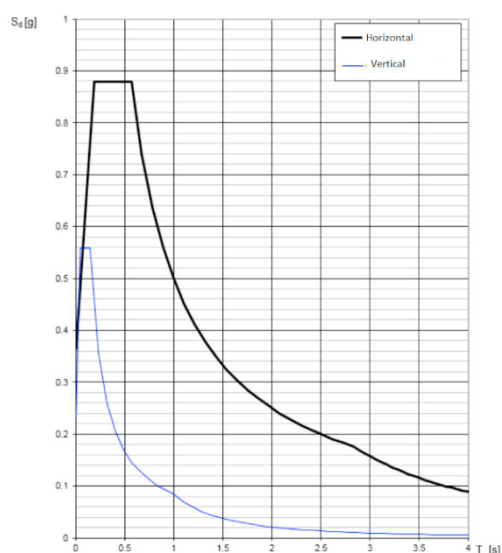
Fig. 13. Design (elastic) response spectra for bridge

Considering that the reference PGA on soil Category A for the considered site is 0.309 g and taking into account the presence of masonry arches, the behavior factors has been set to 1.0 both for vertical and horizontal component

of the response spectra. Therefore, the dynamic linear seismic analysis has been carried out considering the horizontal and vertical elastic response spectra represented in Fig. 13.
