*Analysis of urban plot of Lorca after the earthquake (2011): the effects
of damages and urbanistic and geotechnical adjustment of the city.*

FINAL BACHELOR DEGREE PROJECT

Alexey Pudovkin Lazchenko

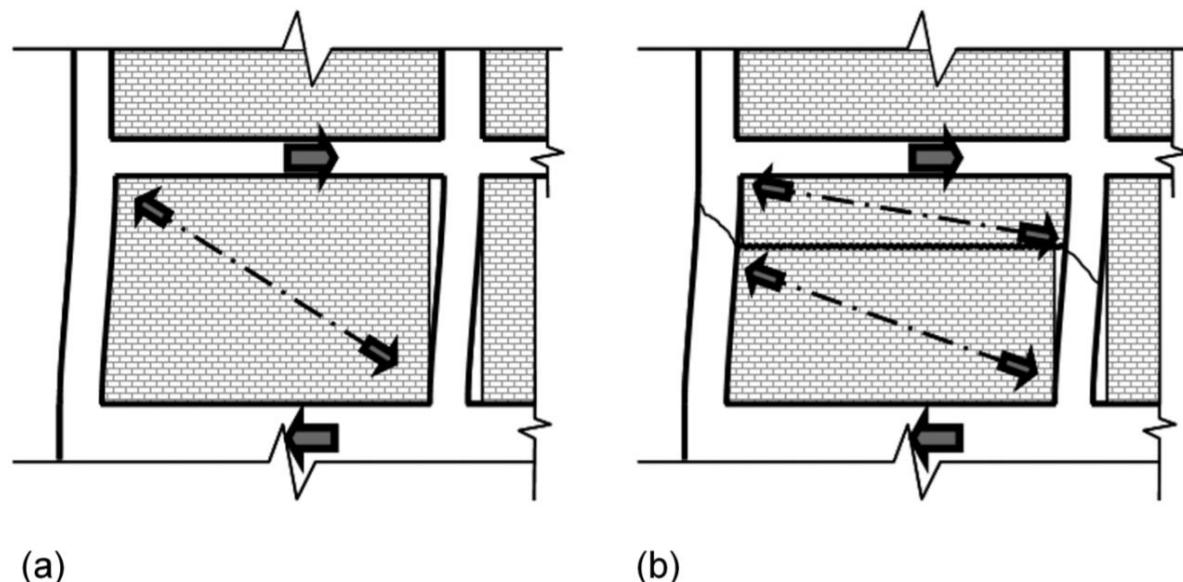
Figure 15. Force transmission before (Fig. 15 a) and after (Fig. 15 b) shear failure of the infill panel.

This type of failure is particularly dangerous because of the damage that is caused to the compression zone of the infill panel i.e. the load carrying strut in an equivalent strut model. If the failure results in the formation of two struts like indicated in Figure 15 b important forces act on the column sections almost at mid-floor height. The formation of two struts may be favoured by the existence of conduits, openings or other discontinuities in the infill panel.

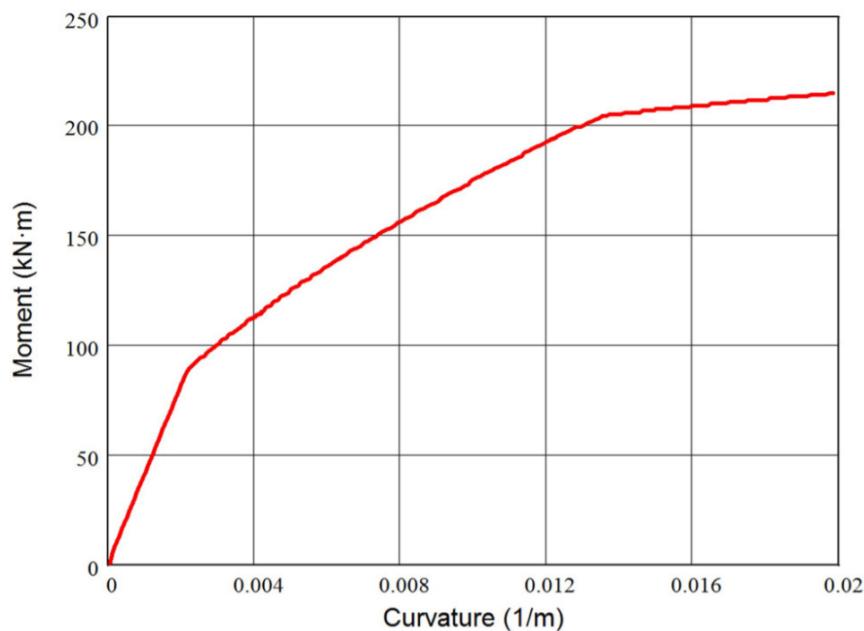
As an example, suppose a concrete column with square cross section of 40 x 40 cm and a compressive strength of 25 MPa (5% cylinder strength f_{ck}) that is reinforced with 3 bars of diameter 16 mm on each face subjected to an axial load that results in an average compressive stress of 5 MPa. In Figure 11 the corresponding moment-curvature diagram is displayed.

Figure 11: Moment-curvature diagram of the compressed column.

The maximum value reaches 215 kNm. Based on equilibrium considerations of the capacity design method, see Figure 8, and considering a floor height h of 4 m, the corresponding maximum shear force is 107.5 kN.

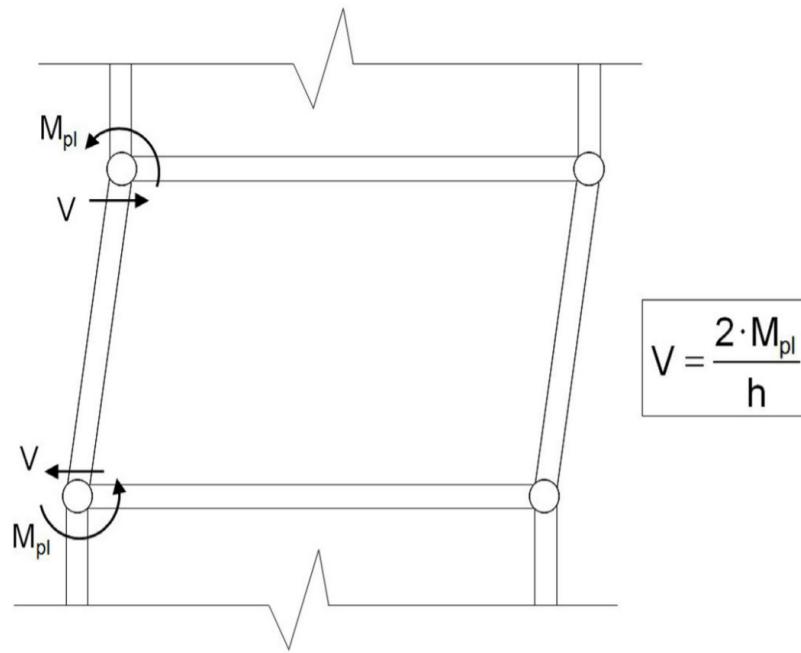
Figure 12. Estimation of the shear demand in a column.

The shear capacity of this column without shear reinforcement is according to the Spanish Seismic Design Code (NCSE 2002) 182.5 kN. Considering the same limit values for the maximum moment and the shear capacity of the column a floor height of 2.36 m would be necessary to increase the shear demand to an extent that the shear capacity is exceeded when reaching the maximum moment. However, this floor height is much lower than the limit value established by the urban building standards. This means that, in general, a column shear failure may be avoided if the capacity design approach is followed and properly detailed shear reinforcement is designed and provided. In the following section the interaction between frame structure and infill panels will be further discussed.

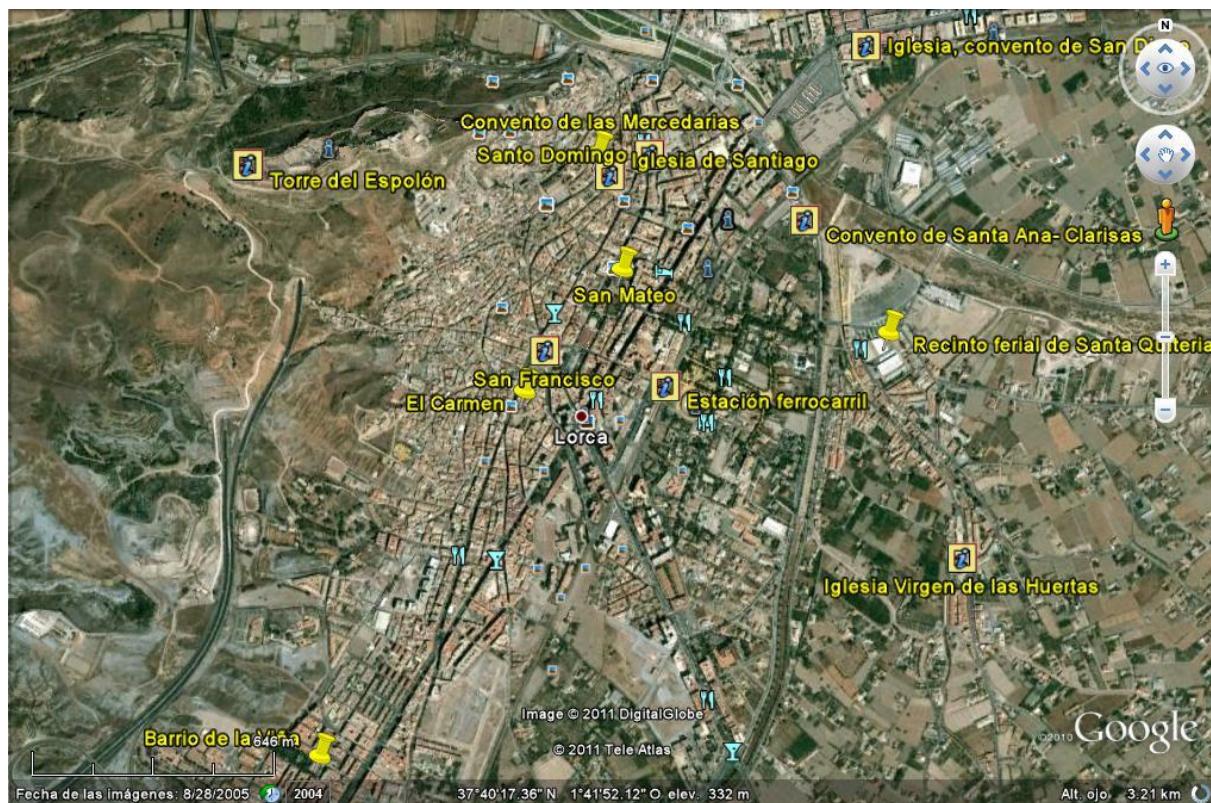
Public and historical buildings affected by the earthquake.

The damage caused by the seismic series of 2011 (and by the one of 1674) show the historical building vulnerability against seismic actions. The historical buildings damages are directly related to the different typologies, the structural complexity, and the conservation and maintenance state, finding cases of a very different nature. This has conditioned different responses to the earthquake, for instance, the response of the big walls built with different materials and heterogeneous constructive systems.

The historical civil buildings having a structural organization with walls in the two directions or a dense compartmentation with structural and non-structural elements have been less vulnerable than the religious buildings. The damages show the heterogeneity of their stones. Many damages to the joints were caused by a lack of connection or by a discontinuity of the constructive elements. In many cases, the damages were due to inadequate alterations that have unbalanced the structure of the constructions. The stair cores have been particularly affected, since they are points of structural discontinuity. (PDRPCL, 2011).

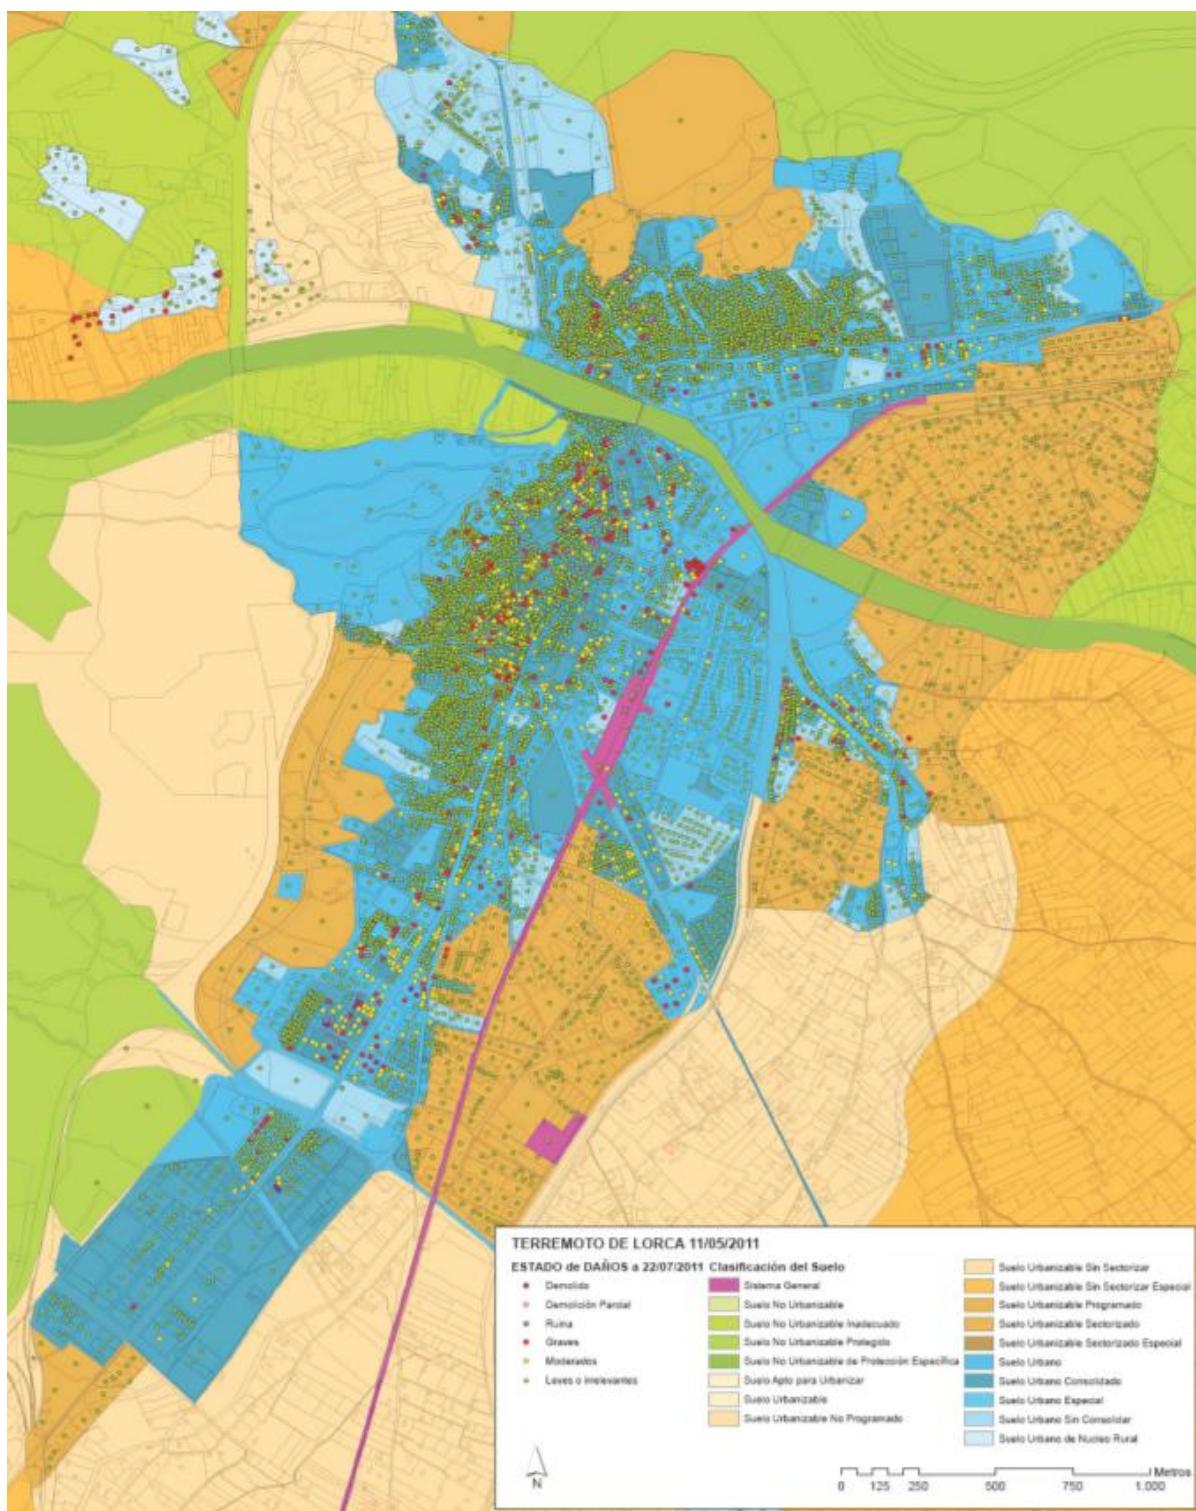
At a local level, a strategic action to prepare the city of Lorca for a possible new earthquake lies in adequate planning. Lorca is a city under reconstruction and in continuous urban growth (Fig. 19).

Figure 19: Distribution of damage in urban planning schedule.

In this field, it is important to consider the necessary adaptation of many buildings now to be rebuilt with CTE legislation approved in 2007. This will alter the original configuration of almost all these buildings. That presents a unique opportunity to review the entire General Plan, the principal technical tool in the Spanish legal system at municipal level.
