LONG-TERM PERFORMANCE OF WICKING FABRIC TO REDUCE DAMAGE IN
ALASKAN PAVEMENTS

APPLICATION OF WICKING FABRIC TO REDUCE DAMAGE IN ALASKAN
PAVEMENTS

A
THESIS

Presented to the Faculty
of the University of Alaska Fairbanks

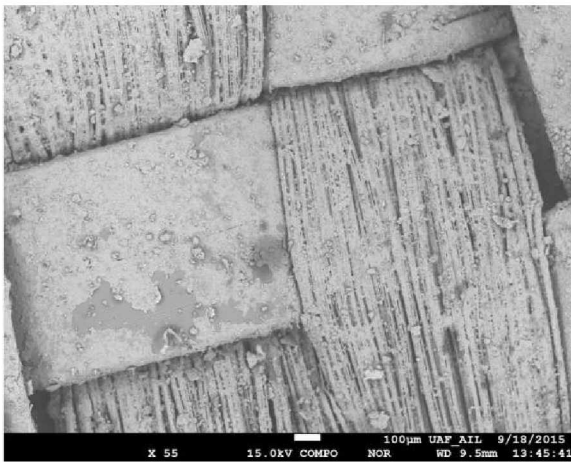
Figures 5.22 through 5.25 show some of the SEM images of samples collected from the Beaver Slide site. Figure 5.22 presents the woven structure of an intact sample with $\times 55$ magnification. It appears that large amounts of soil particles were detained on the surface of the wicking fabric. Figure 5.23 shows a closer view of the wicking fabric at the surface with $\times 350$ magnification. It further illustrates that the deep grooved drainage paths in the surface fibers were completely filled with fine soil particles. In comparison, Figure 5.24 shows the wicking fabric fibers just beneath the surface layer. The deep grooves beneath the surface were much cleaner than those above, and there were very few particles that had been detained in the drainage paths. In other words, the fibers of the wicking fabric at the surface served as a protective layer, preventing the fine soil particles from penetrating deeper into the fabric structure. Figure 5.25 shows the comparison of the wicking fibers on the surface and the fibers just beneath the surface. It can be visualized

Figure 5.22 Intact Sample (Sample 4)

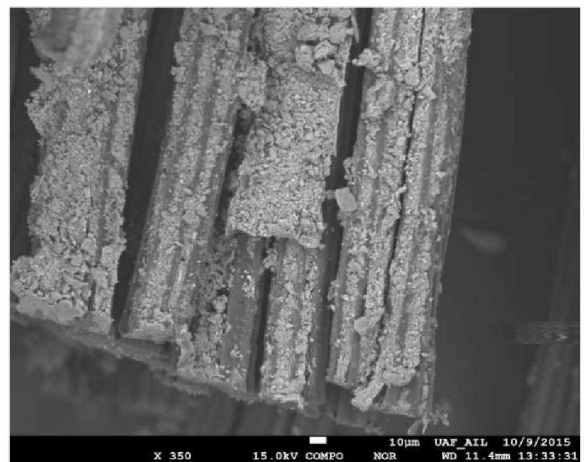
Figure 5.23 Surface Clogging (Sample 20)

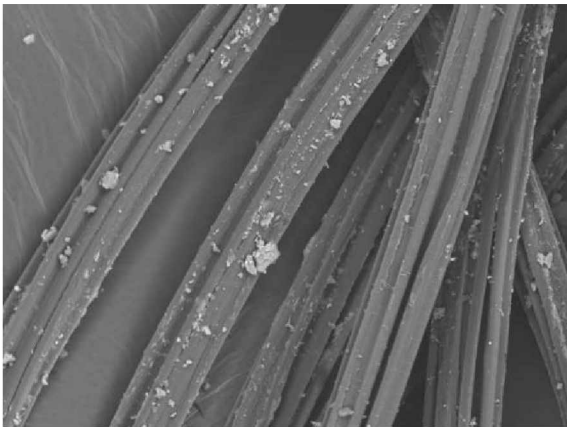
from the figures that even though the wicking fabric fibers on the surface appeared to suffer from the clogging effect, the wicking fibers beneath the surface were relatively clean and still worked effectively to laterally drain water out of the pavement structure. Therefore, it is worth considering installing a layer of clean sand on top of the wicking fabric during the construction process in order to reduce the clogging effect, and improve the long-term performance of the fabric.

Figure 5.24 Beneath Sample (Sample 25)

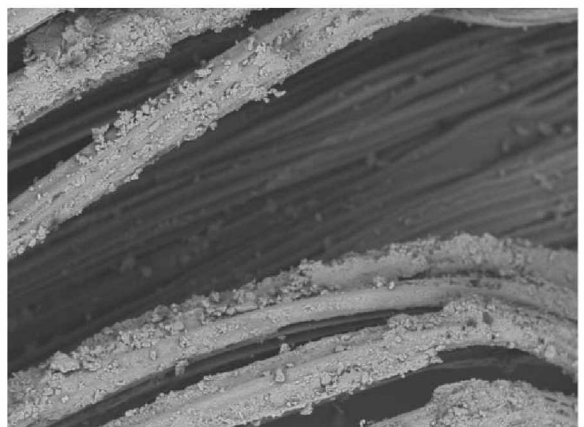
Figure 5.25 Wicking Fiber Comparison

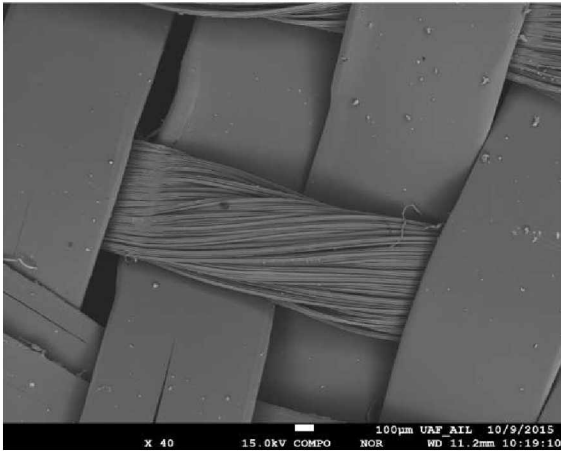
Figures 5.26 through 5.29 present the SEM images of samples that suffered permanent deformation. Figures 5.26 and 5.27 present images of new wicking fabric, which were never used before. It was apparent that the wicking fabric fibers under the woven polypropylene yarns had already experienced some permanent deformation, and that the deformation was in the vertical direction. This deformation may have been caused by the pressure applied in the manufacturing process, or it may have occurred during the transportation process. Figures 5.28 and 5.29 show SEM images of the wicking fabric that was collected from the field. The permanent deformation observed in the new materials had further increased, as shown in these figures. Due to additional vertical pressure, the wicking fibers were nearly flattened, and the deep grooves were not able to hold water under unsaturated conditions. Furthermore, Figure 5.29 presents the front view of the wicking fabric; deep grooves are seen not only in the vertical direction, but deep grooves also tended to close in the horizontal direction.

Figure 5.26 New Wicking Fabric

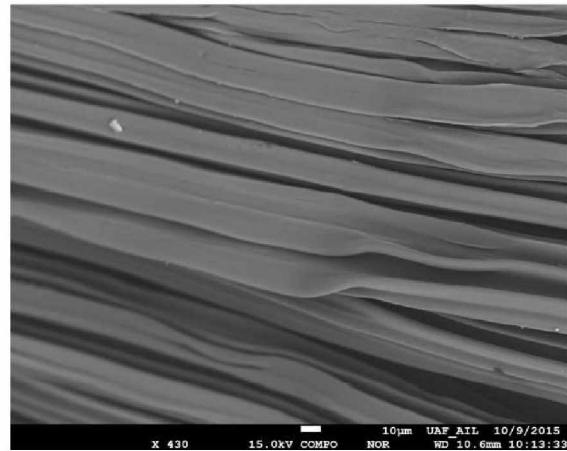
Figure 5.27 Permanent Deformation

4. The permanent deformation might be an issue that will affect the long-term performance of the wicking fabric. The deformed, deep grooves or drainage paths will reduce the amount of water that the wicking fabric can laterally transport. The permanent deformation may develop further over time due to high vertical pressure induced by the dynamic traffic loads and the overburden soils. The wicking fabric implementation depth and its influence on long-term performance should be studied further.
5. Mechanical failure and aging of surface fibers were observed in a limited number of samples. Mechanical failure may be caused by compaction during the construction process and high vertical pressure during its service life. Aging was observed in the surface fibers of the wicking fabric, where fibers were directly in contact with the surrounding soils.

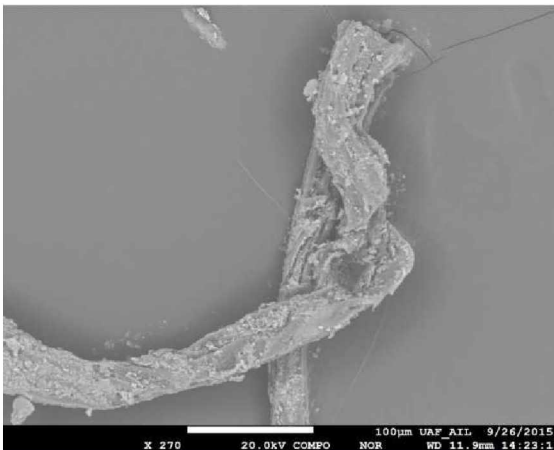
Figure 5.30 Sample 17

Another mechanical failure known as “puncturation” is illustrated in Figures 5.30 and 5.31. “Puncturation” refers to the puncturing of the soil fibers by the large soil particles that were detained on the wicking fabric surface. The large soil particles, especially those with sharp edges, acted as a cutting edge that severed the deep grooves of the wicking fabric. This likely occurred due to the high overburden soil pressures and the dynamic traffic loads applied to the road surface. The drainage paths were broken and became unable to continue to laterally transport water; however, this phenomenon was only observed in 5 of the 30 samples collected from the field.

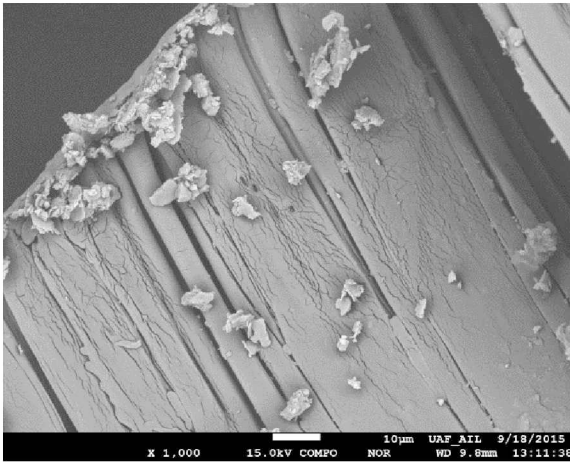
Figure 5.32 Sample 3

Because the wicking fabric is buried under the soil, another concern involves the wicking fabric's physical and mechanical aging issue, as shown in Figures 5.32 through 5.35. Figure 5.32 shows the aging severity of the wicking fabric fibers under the woven polypropylene yarns. Because the wicking fibers on the surface were directly in contact with the soil particles, the aging phenomena were usually observed in the fibers located at the surface of the fabric. Figure 5.33 shows the wicking fabric fibers at the surface without the woven polypropylene yarns. As believed, the aging phenomenon was likely due to direct contact with the soil particles. The aging effect at the bottom of the deep grooves was more severe than in the other areas of the wicking fabric. In comparison, Figures 5.34 and 5.35 show the wicking fabric fibers beneath the surface fibers. No obvious aging effect was observed below the surface layer of fibers, and the deep grooves were much cleaner than those of the fibers on surface of the fiber bundle.
