## Building Performance Evaluation – A design approach for refurbishment of a small traditional building in Scotland

J. A. Foster<sup>1</sup>, A. Poston<sup>1</sup> and S. A. Foster<sup>2</sup>.

This paper introduces a case study building, the Land Sea and Islands Centre (LSIC) located in Arisaig, Highland Scotland, where BPE was undertaken to provide information on the current building condition. This information allowed the architect to develop an evidence based refurbishment design approach for this building. A second BPE process post refurbishment evaluated the building performance and provided verification of the design process.

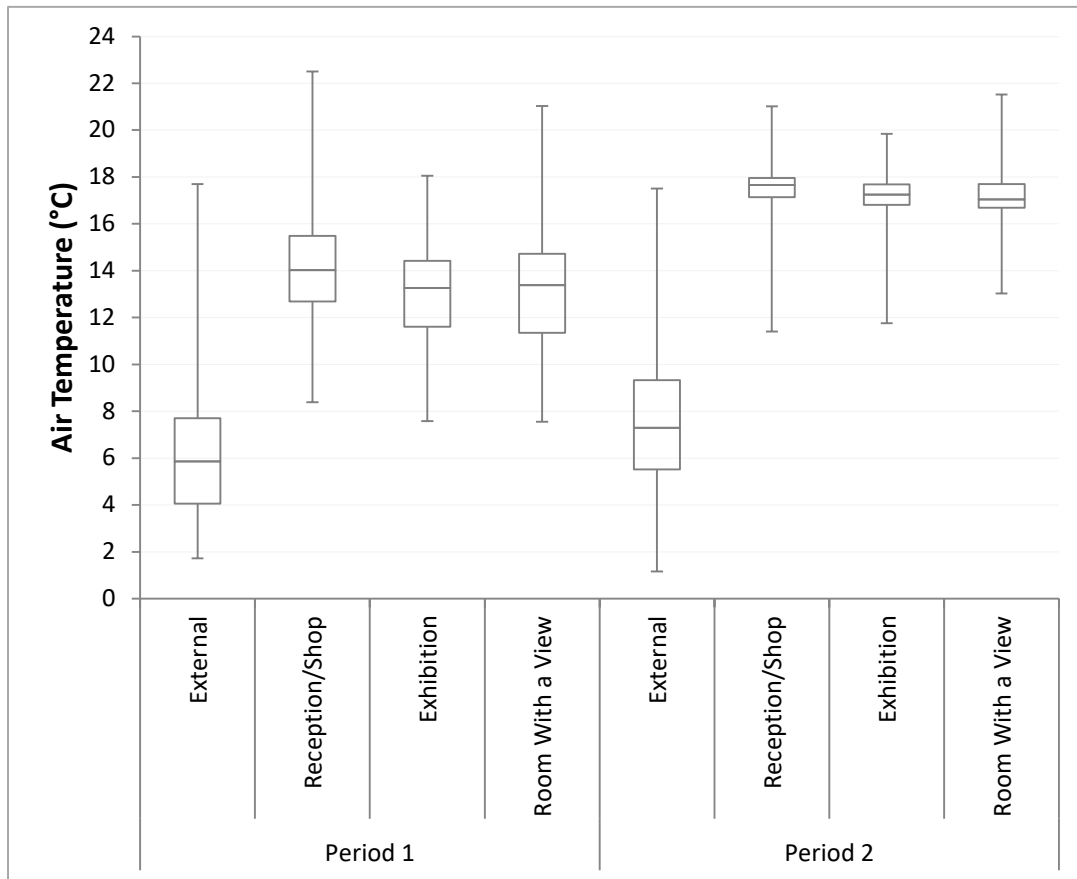
The external temperature throughout both monitoring periods was unseasonably warm for the time of year. Figure 6 presents an overview of the temperature ranges through two monitoring periods where median external air temperature was around 6°C and 7°C for PERIOD 1 and PERIOD 2 respectively. There were similar weather patterns during both of the monitoring periods with unexpected warm days, during which the external temperature rarely fell below 0°C. However, when comparing internal air temperature data for both PERIOD 1 and PERIOD 2 significant differences were observed. In PERIOD 1 the internal temperature distribution is relatively wide with the majority of internal temperatures remaining between 11-15°C. Conversely, the comparison of data between PERIOD 1 and

PERIOD 2 indicates higher internal air temperatures for PERIOD 2 that are relatively stable between 16-18°C in each of the three monitored rooms.

Figure 6. Overview of PERIOD 1 and PERIOD 2 temperature (°C) ranges.

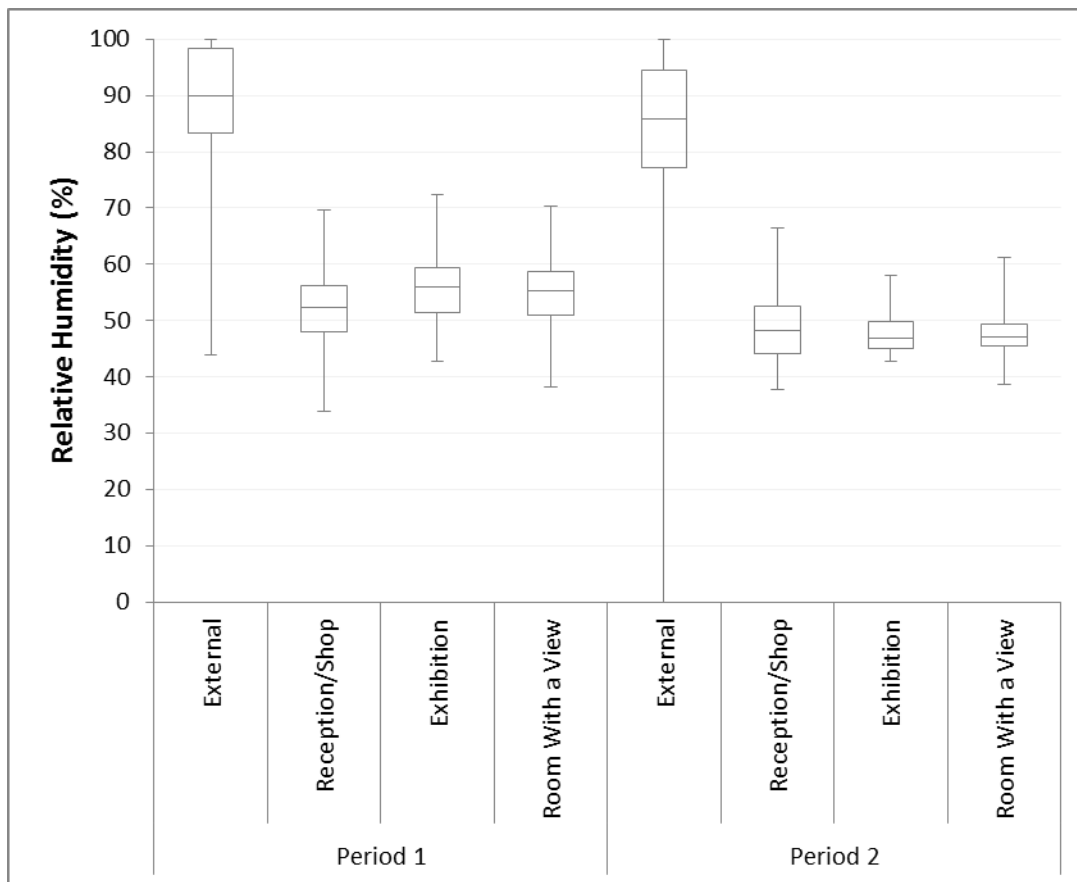
External relative humidity (RH) readings were wide ranging, with the bulk of external data between 75 and 98%. While the RH data in Figure 7 indicates that PERIOD 2 was slightly less humid than PERIOD 1, when correlating between external temperature and RH on a psychrometric chart the external moisture content for both monitoring periods are similar. The indoor monitoring indicated the RH remained between 30-70% with the median

at around 50-55% RH for PERIOD 1. Comparing this data with PERIOD 2 there is a distinct difference where lower RH was recorded and RH conditions were more stable.

*Figure 7. Overview of PERIOD 1 and PERIOD 2 relative humidity (%) ranges*

The reception has the largest fluctuations; however, this was an expected outcome due to the cosmetic upgrade designed for this area. The exhibition room indicated a narrow RH band showing less of a RH swing. This type of behaviour is favourable for the exhibits on display and aligns well with the recognised RH band for health of buildings and occupants. Furthermore, there were no significant differences in overall internal moisture content, and therefore the more stable conditions could be a result of the quantity of vapour open building materials used in this room.

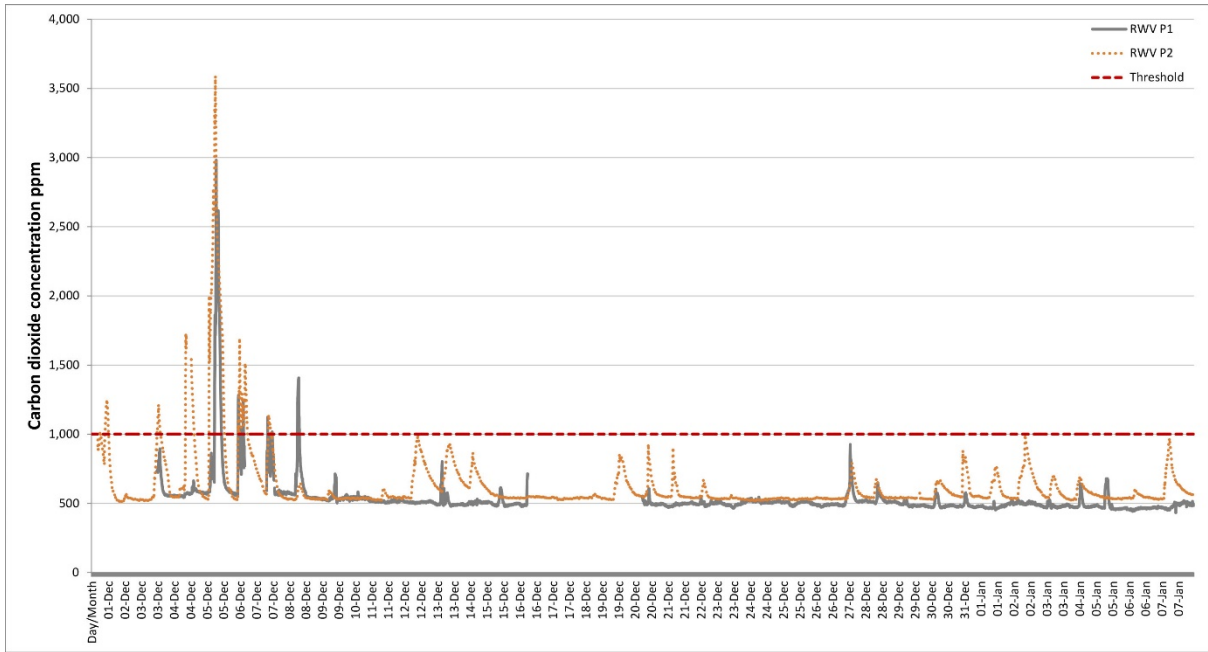
Carbon dioxide concentrations were measured to allow evaluation of the ventilation rates within the building. A comparison of PERIOD 1 and PERIOD 2 concentration rates were made for all three monitored rooms and were additionally compared against established benchmarks. There were unexpected differences in concentration rates where PERIOD 2 had higher peaks than PERIOD 1 in concentrations during the two monitoring periods. The data plotted for the room with a view (RWV) in Figure 8 indicates that there were large peaks and troughs in carbon dioxide concentrations over three consecutive days during both monitoring periods and similarly with the reception/shop area results in Figure 9. These peaks were later associated with Christmas fair events that were well attended by the local community. Aside from this annual event, what is interesting about the data is that there were frequent carbon dioxide concentration increases, most notable during PERIOD 2 monitoring. While these peaks have been taken to be within acceptable carbon dioxide concentration limits, of less than 1,000ppm, for acceptable indoor air quality, a theme is emerging where the building may not be being adequately ventilated when occupied.

**Figure 8. Room with a view (RWV) Carbon Dioxide (CO<sub>2</sub>) concentrations throughout PERIOD 1 and PERIOD 2.**

Contrary to expectations the PERIOD 2 monitoring indicated that there was the lack of engagement with the ventilation strategy, where the staff and volunteers continue to keep windows closed during periods of cold weather. A consequence of this is periods of poor indoor air quality at times of high occupancy. The former window opening habits from the previous building condition have continued in the refurbished building. This had been

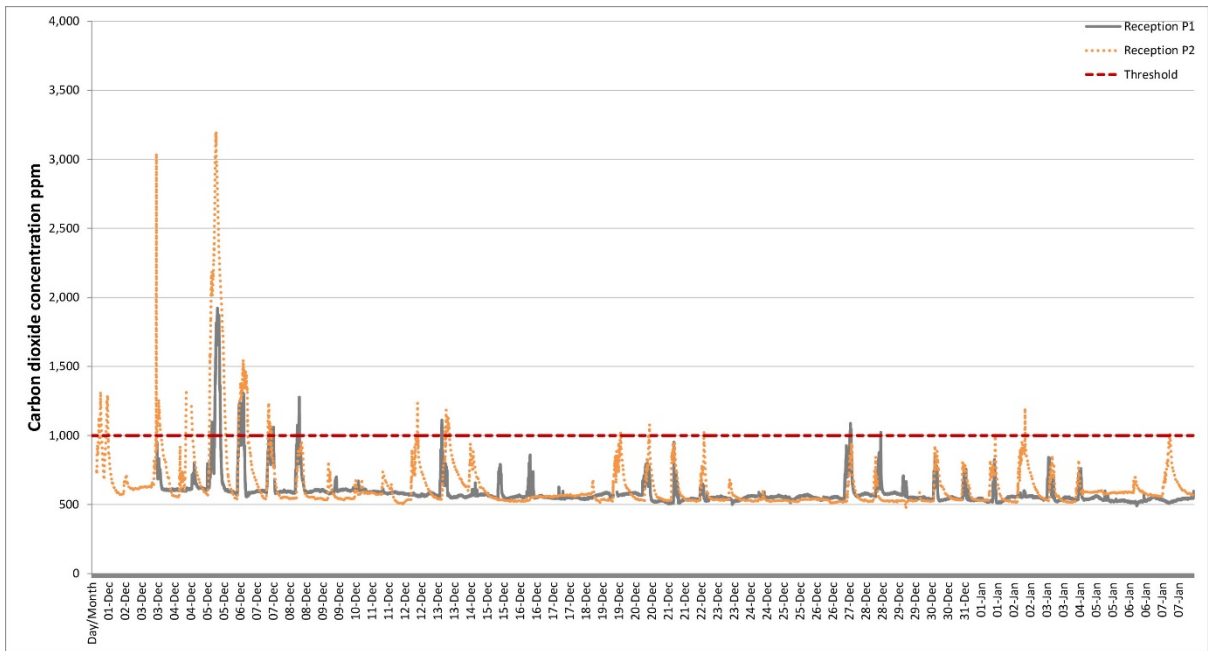
**Figure 9. Reception/shop area Carbon Dioxide (CO<sub>2</sub>) concentrations throughout PERIOD 1 and PERIOD 2.**

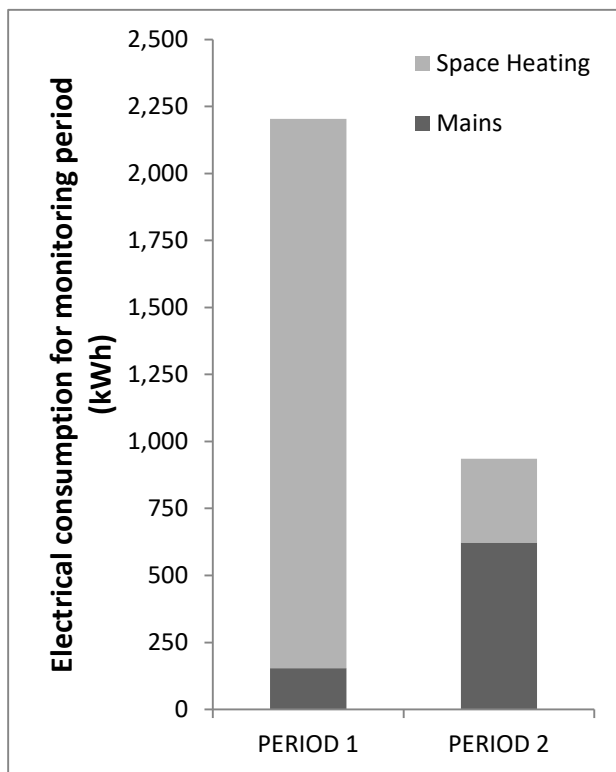
Electrical meter readings were recorded twice each day and this information was used to assess the overall energy reductions in the building. Figure 10 indicates a significant overall energy consumption reduction of 57% between the two monitoring periods. This is 18% less than the 75% prediction. However, the building occupation increased from around six months opening per year before the refurbishment to twelve months opening per year after the refurbishment (PERIOD 2) which affects the overall energy reduction.

*Figure 10. Overall energy consumption, space heating and mains, in PERIOD 1 and PERIOD 2.*

The most surprising aspect of this data was the unexplained dramatic increase in mains electrical energy consumption between the two monitoring periods. Post PERIOD 2 BPE the LSIC employed the services of an electrician to determine the cause of the unexpected increase in mains power consumption. It was found that two of the electric storage heaters
