**Materiales de construcción incompatibles dentro de las esculturas
estereotómicas de Avalos en el Valle de Caídos (Madrid, España)**

**Incompatible building materials within the stereotomic
Avalos sculptures of the Valley of Fallen (Madrid, Spain)**

J. García-Guinea^{a,*}; G. Almendros^a; D. Benavente^b; V. Correcher^c; A. Pérez-García^d;
L. Recio-Vázquez^a and S. Sánchez-Moral^a

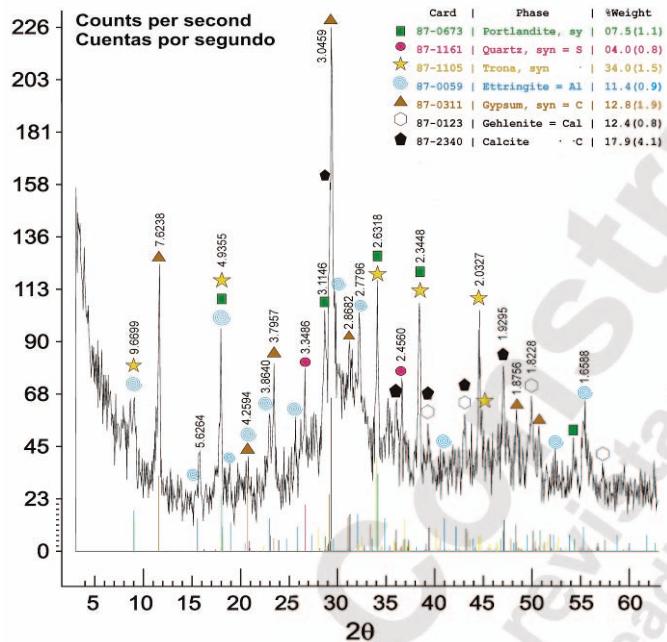
Figura 3b/**Figure 3b**

Figura 3/**Figure 3.** (a) Nueve muestras recogidas en el interior de la escultura de La Piedad analizadas por difracción de rayos X. Se trata de calizas de Calatorao, hormigón meteorizado, sulfatos y carbonatos hidratados y fragmentos de mezclas de unión epoxy-cuarzo. La tabla 1 muestra los respectivos porcentajes de minerales de cada muestra. (b) Difractograma de la muestra de mortero-b con asignaciones y porcentajes de fases determinadas mediante software español Xpowder.// (a) Nine stones collected in the La Piety inside analyzed by semi-quantitative X-ray diffraction. They are Calatorao limestone, weathered concrete, hydrous sulphates and carbonates of the sulfate join blend and epoxy-quartz fragments. Table 1 displays mineral percentages by each sample. (b) XRD pattern of a mortar-b sample including the phase assignations and percentages determined using the Spanish software Xpowder.
