# Attoyac Bayou Recreational Use Attainability Analysis

**Attoyac Bayou  
Recreational Use Attainability Analysis**

**Texas State Soil and Water Conservation Board  
Project # 09-10**

**October 2012**

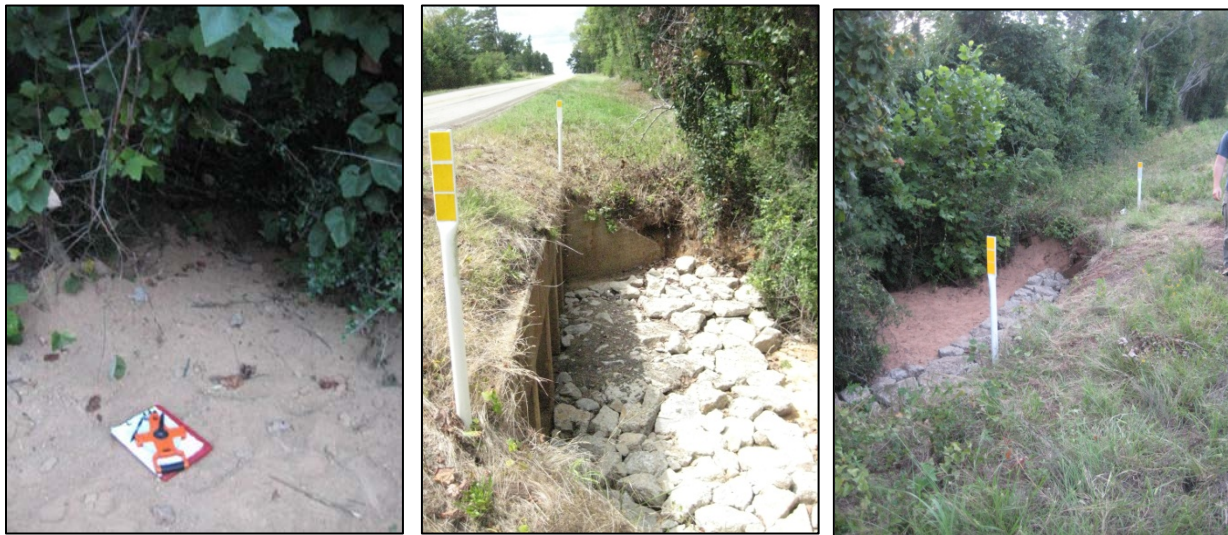
**Photogroup 4-1** Attoyac 1 depicting general appearance of the site from public access point, FM 95. Top left: 0-m transect, downstream view, stream channel with dense vegetation, July 2012; Top center: 0-m transect, downstream view, August 2012; Top right: 0-m transect, downstream view July 2012.

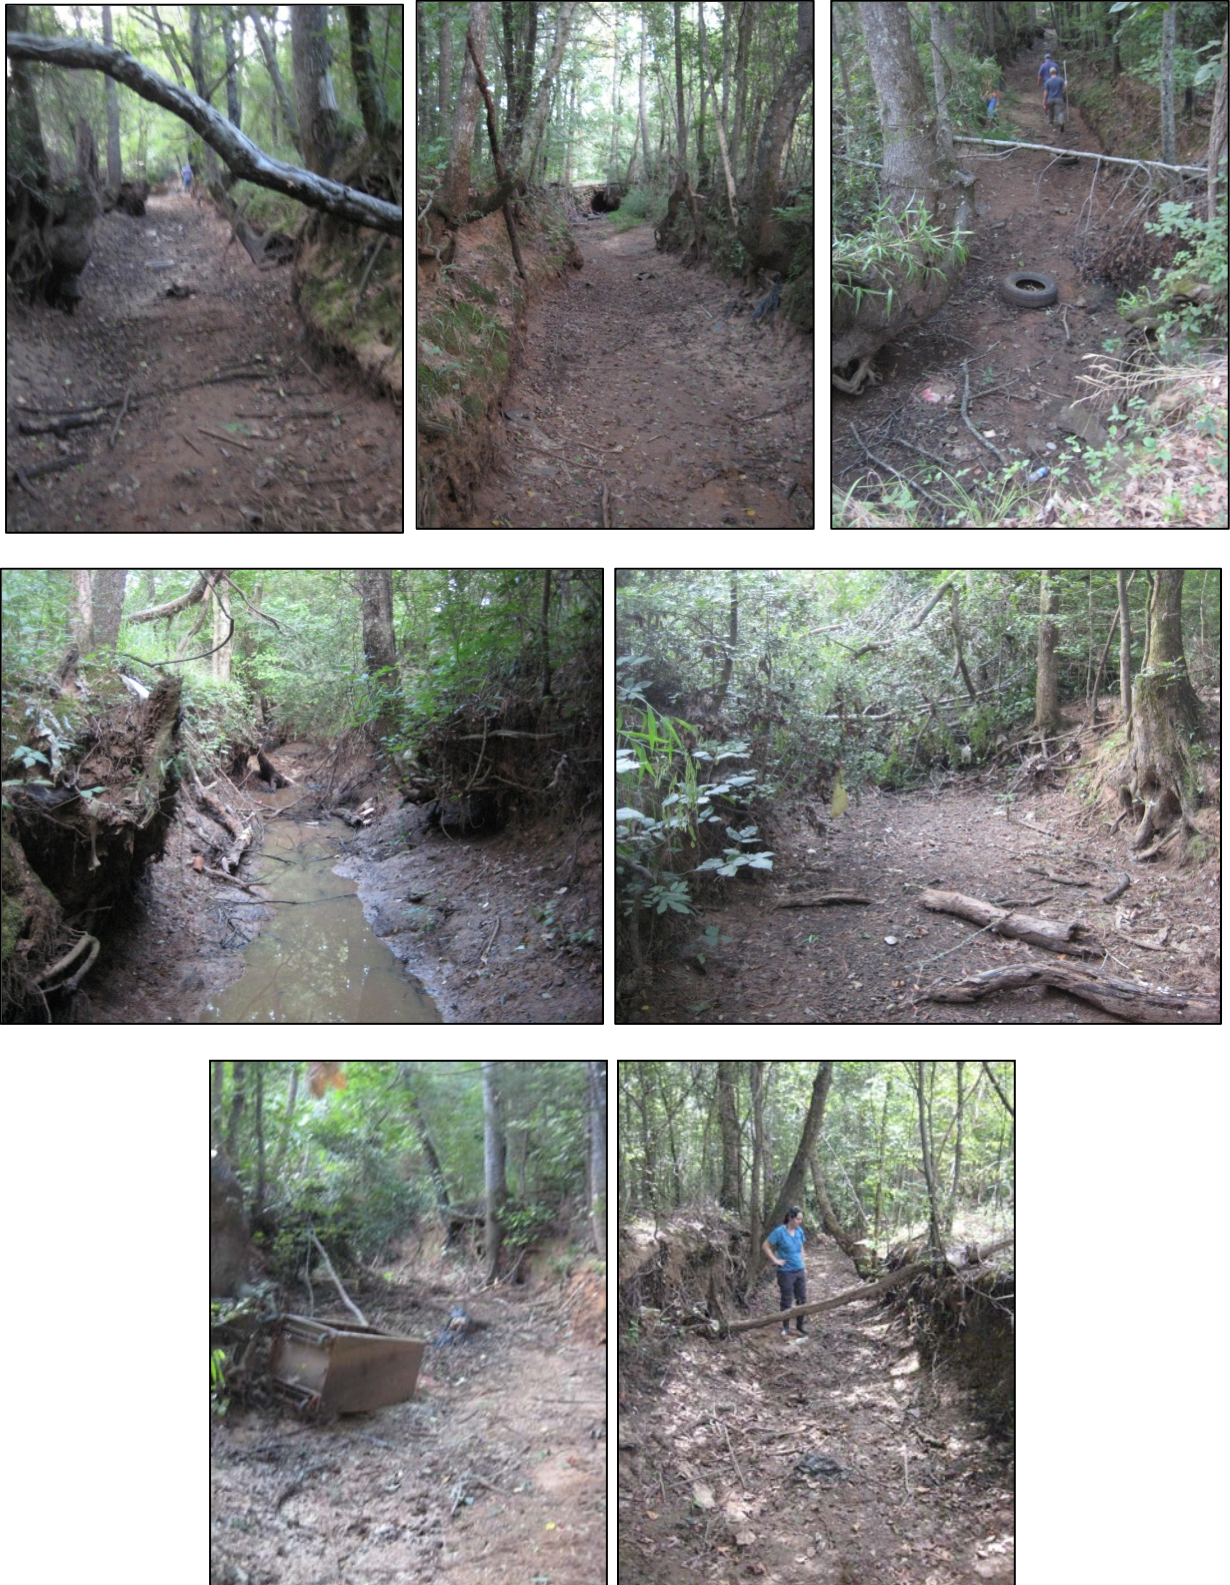
**Photogroup 4-2** Attoyac 2 depicting general appearance of the site. All individuals featured are SFASU and CES staff. Top left: 30-m transect, upstream, July 2012; Top center: 30-m downstream, July 2012; Top right: 90-m transect, downstream, July 2012; Middle left: 300-m transect, upstream, July 2012; Middle right: large woody debris, July 2012; Bottom left: large channel litter, July 2012; Bottom right: 300-m transect, upstream, August 2012.

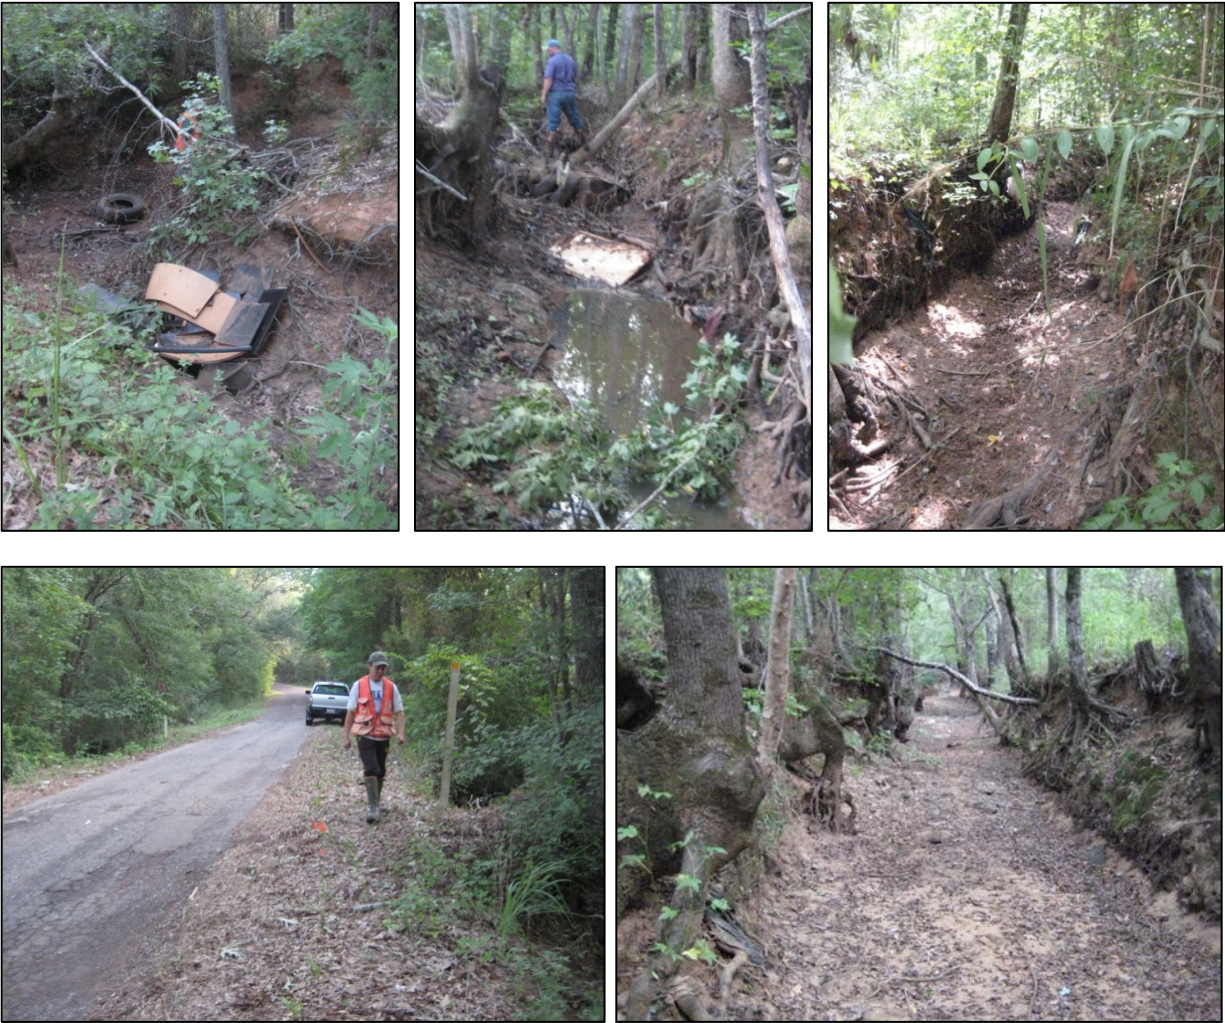
**Photogroup 4-2** Attoyac 2 depicting general bank appearance and stream access point. All individuals featured are SFASU and CES staff. Top left: 0-m transect, downstream bank, July 2012; Top center: 150-m transect, downstream, July 2012; Top right: 150-m transect, upstream, August 2012. Bottom left: Stream access point from CR 3122, July 2012; Bottom right: 30-m transect, downstream, August 2012.

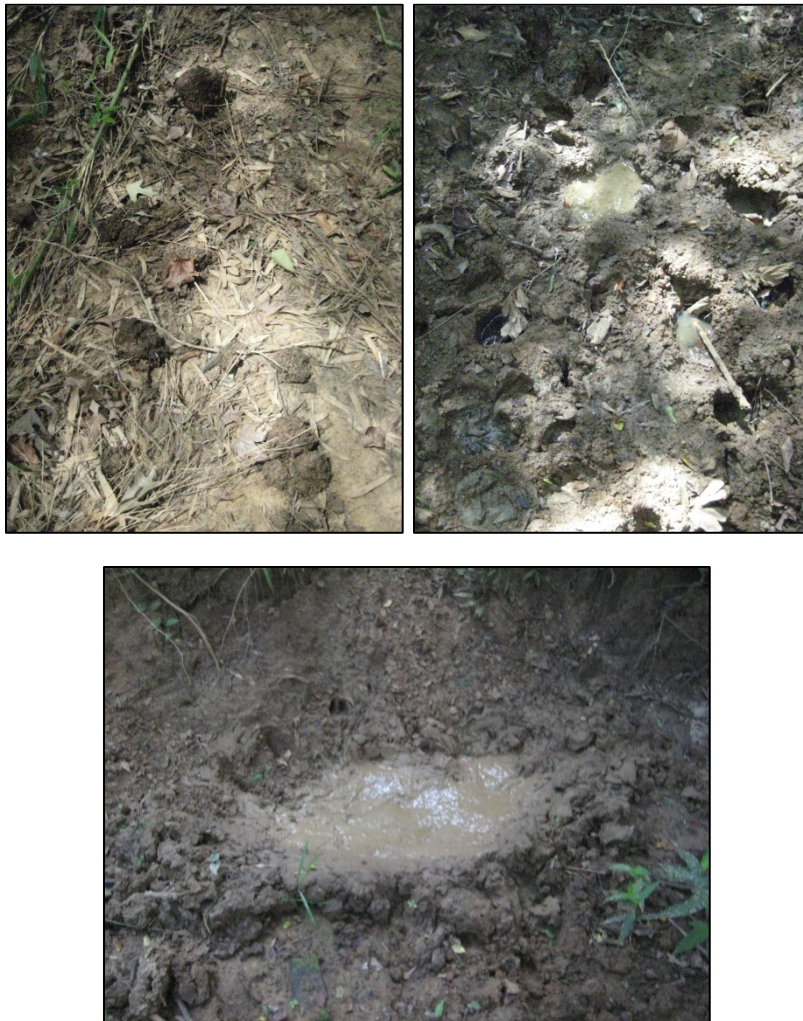
**Photogroup 4-2** Attoyac 2 depicting potential sources of contamination. Top left: Livestock fecal, August 2012. Top right: Livestock tracks in channel, August 2012; Bottom: Feral hog wallow, July 2012.

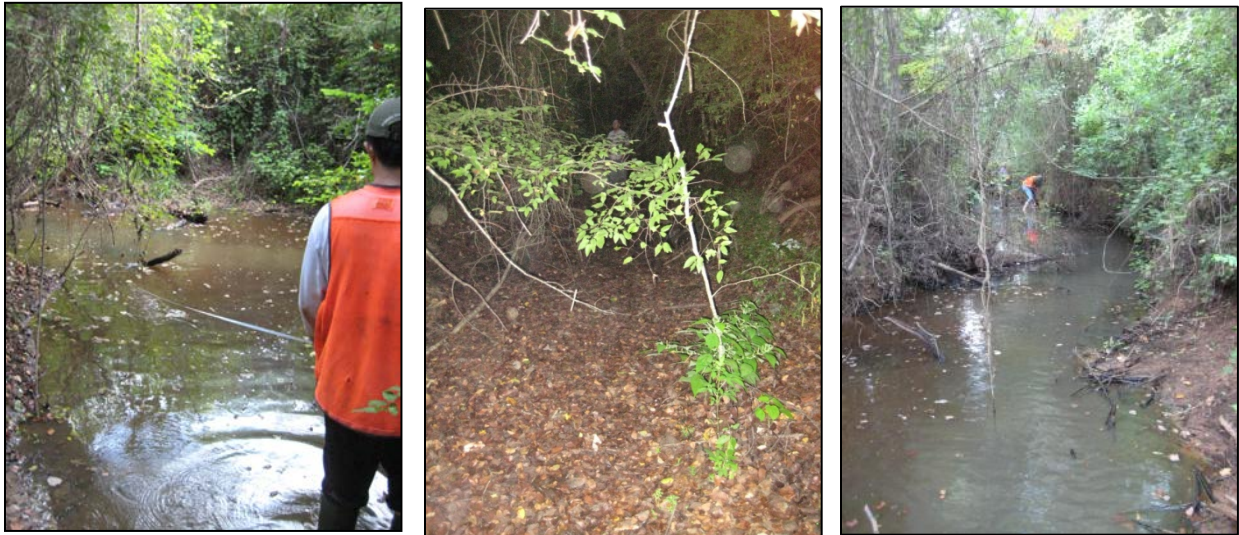
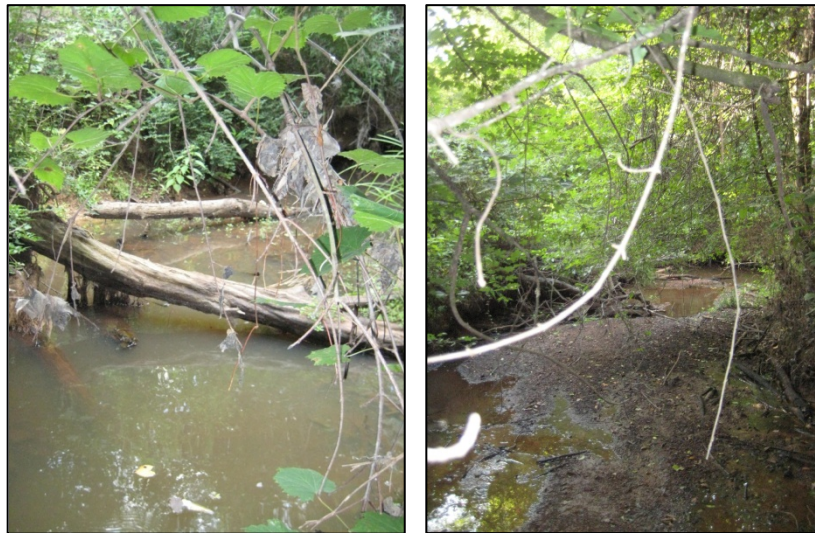
**Photogroup 4-3** Attoyac 3 depicting general stream appearance. All individuals featured are SFASU and CES staff. Top left: 30-m transect, downstream, July 2012; Top center: 150-m transect, upstream, August 2012; Top right: 30-m transect, July 2012; Bottom Left: 150-m transect, downstream, July 2012. Bottom right: 300-m transect, upstream, July 2012.

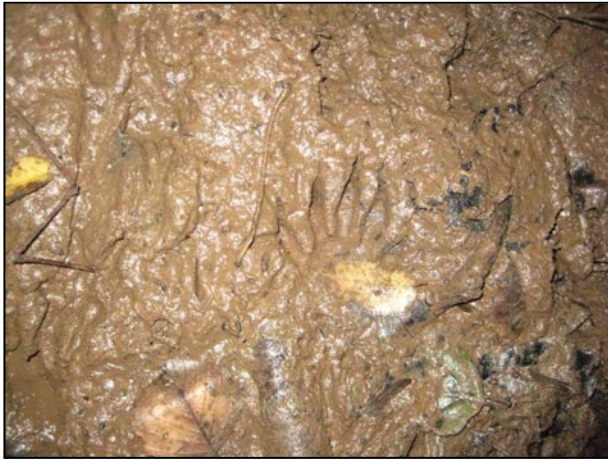
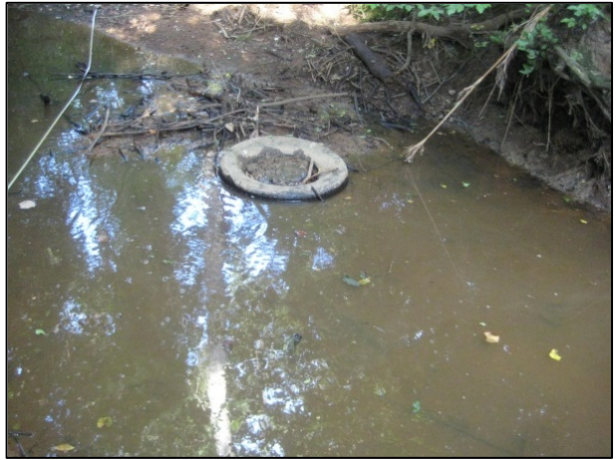
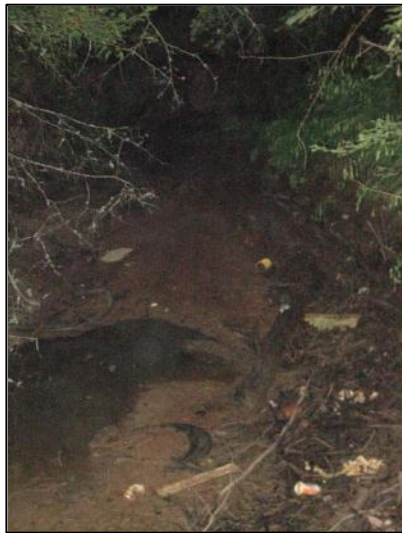
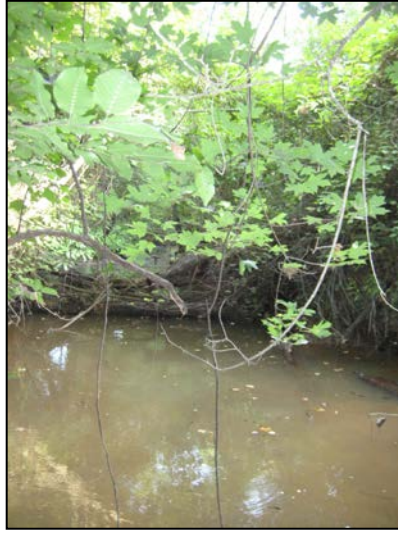
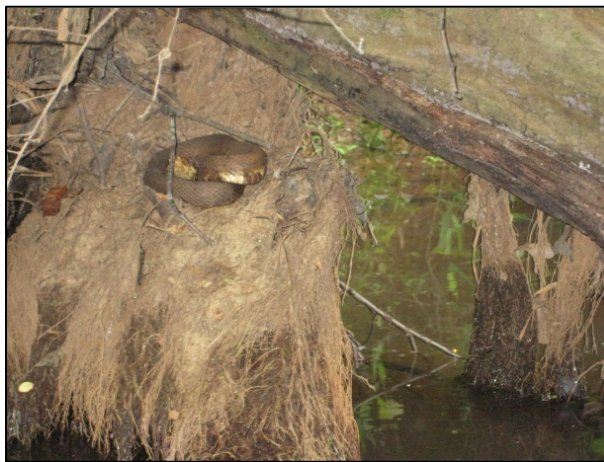
**Photogroup 4-3** Attoyac 3 Depicting water surface characteristics further stream features. Top left Raccoon tracks, August 2012; Top right: Large litter in channel (tire), July 2012; Middle left: 300-m transect, upstream, August 2012; Middle right: 300-m transect, downstream, July 2012; Bottom: Water Moccasin in channel, July 2012.

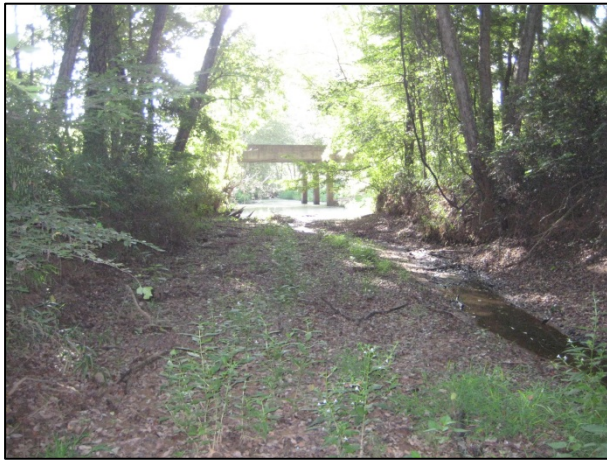
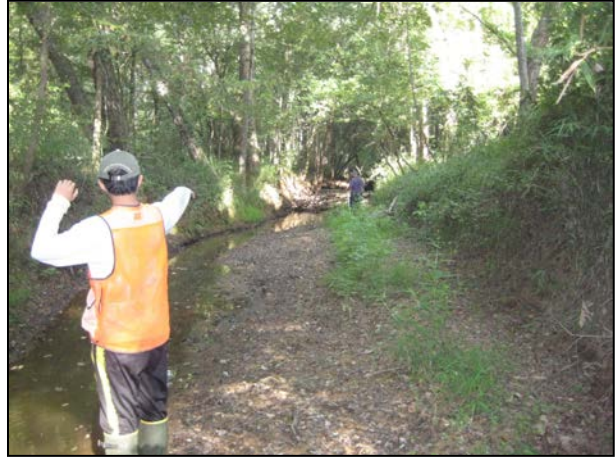
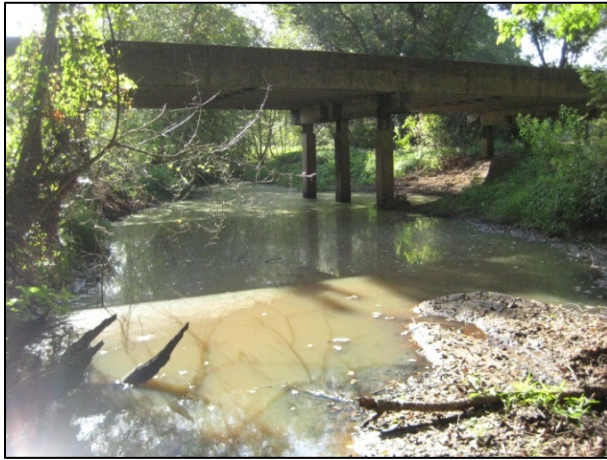
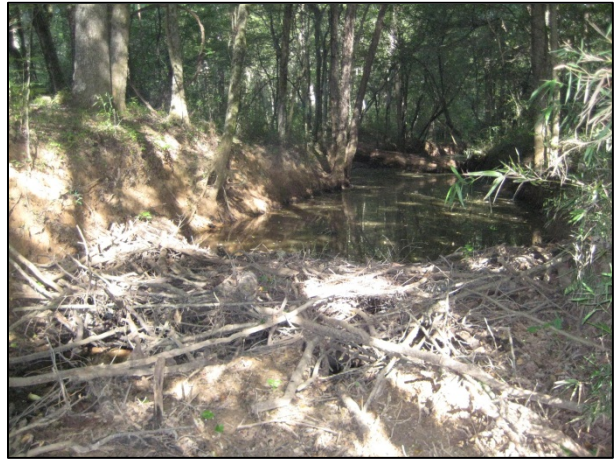
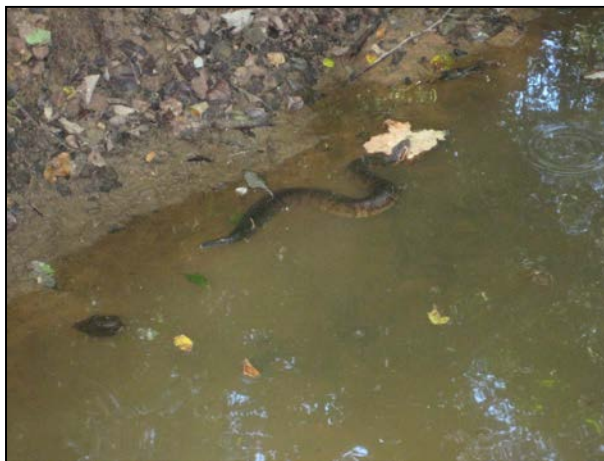
**Photogroup 4-4** Attoyac 4 depicting general stream characteristics. All individuals featured are SFASU and CES staff. Top left: 30-m transect, downstream, July 2012; Top right: 30-m transect, upstream, July 2012; Middle left: Pool at access point, July 2012; Middle right: Beaver dam, upstream, July 2012. Bottom: Water Moccasin in pool, July 2012.

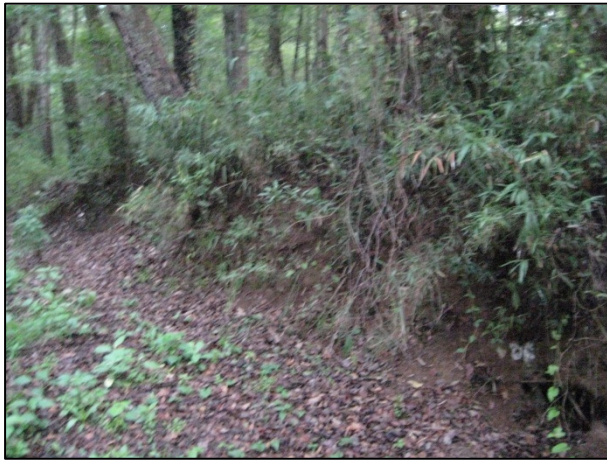
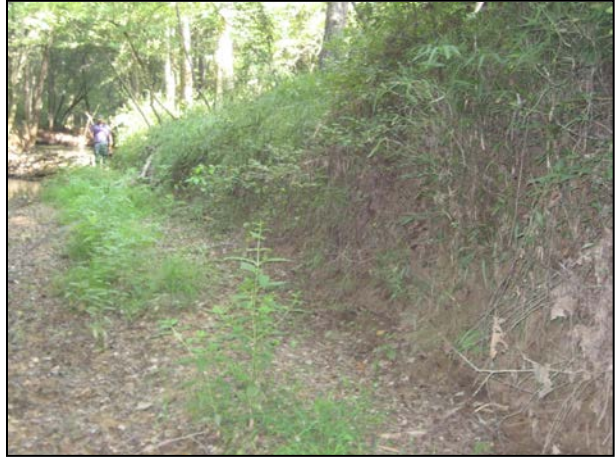
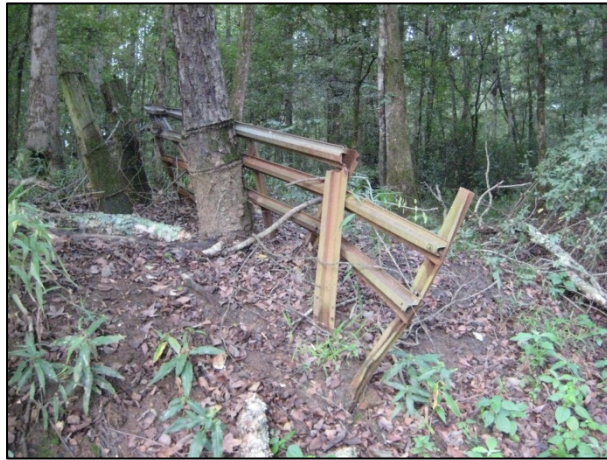
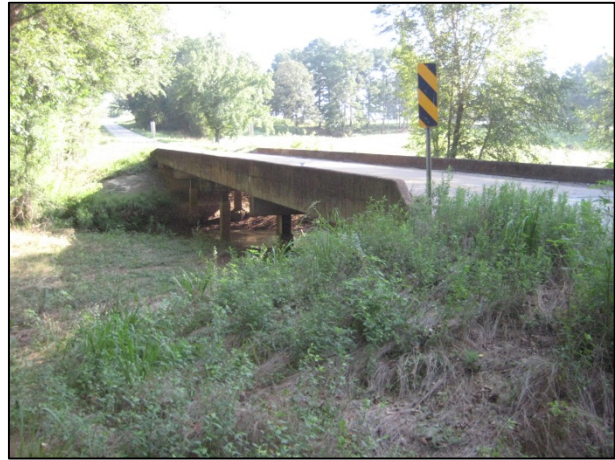
**Photogroup 4-4** Attoyac 4 depicting access point and general bank appearance. Top left: 0-m transect, left bank, July 2012; Top right: 30-m transect, right bank, August 2012; Bottom left: Fence on Right bank, August 2012; Bottom Right: Stream access point from FM 1971, July 2012.

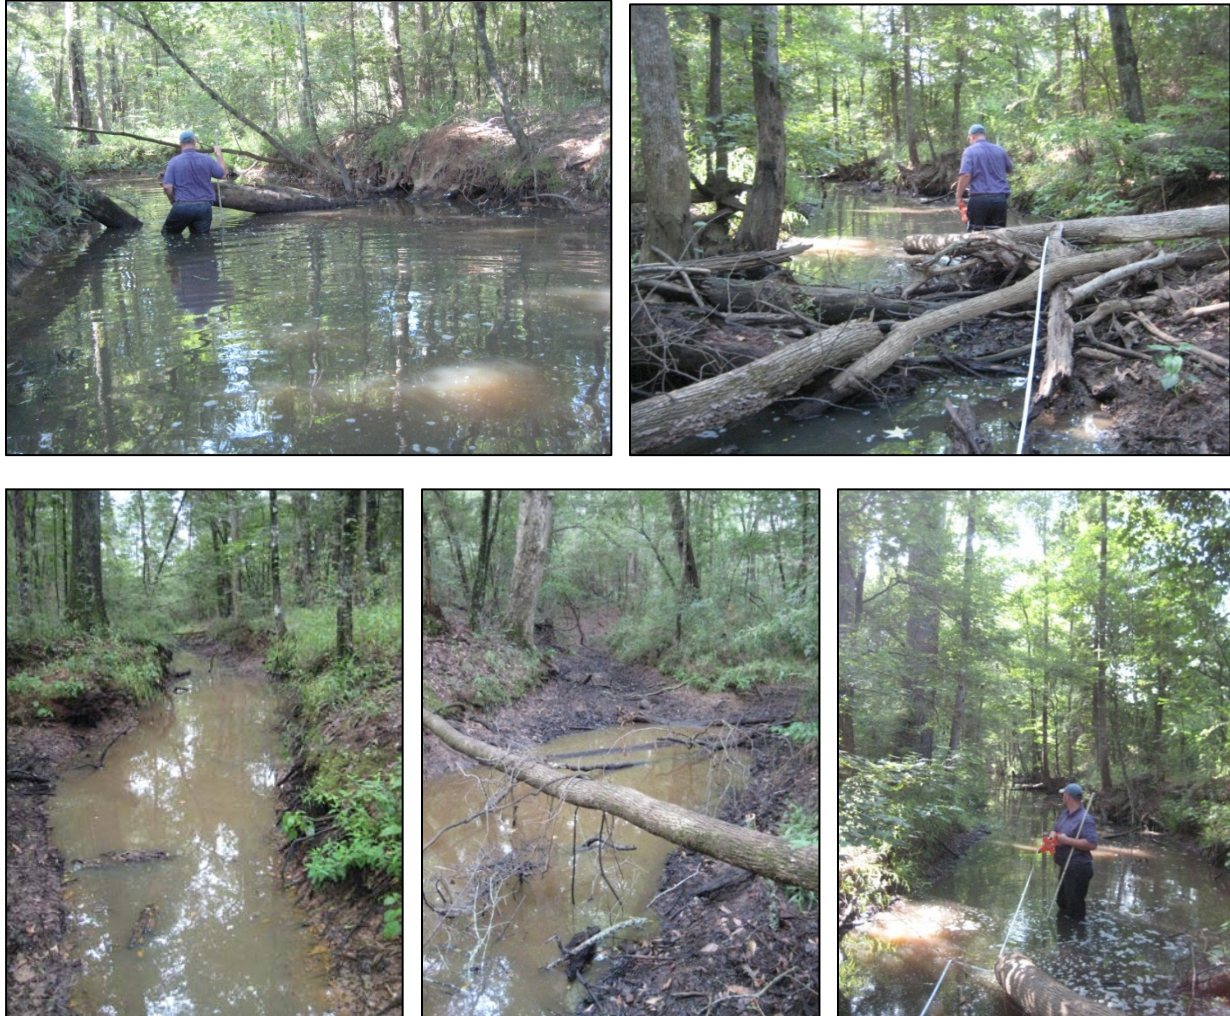
**Photogroup 4-5** Attoyac 5 (20842) depicting general stream characteristics. All individuals featured are SFASU and CES staff. Top left: 30-m transect, downstream, July 2012; Top right, Large woody debris, July 2012; Bottom left: 30-m transect, downstream, August 2012; Bottom center: 150-m transect, upstream, August 2012; Bottom right: 150-m transect, downstream, July 2012.

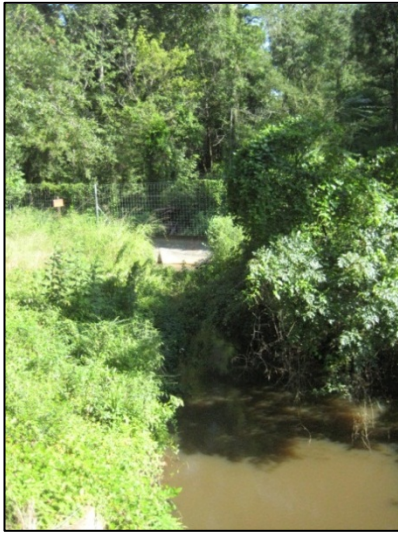
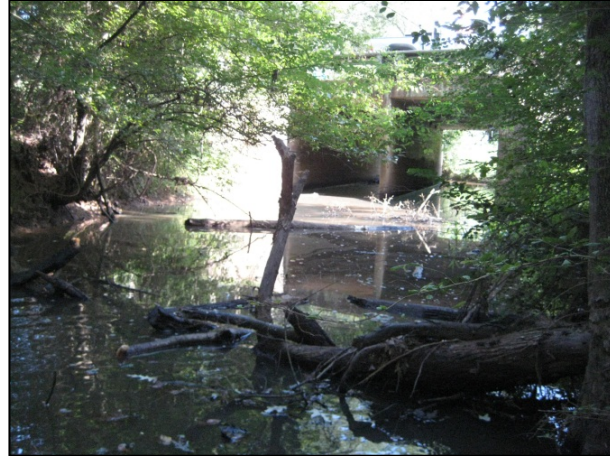
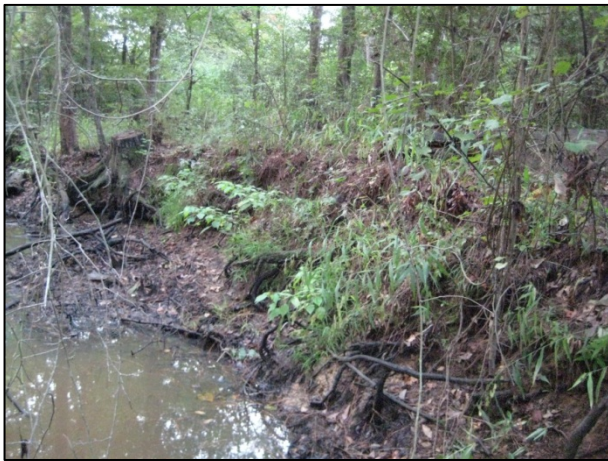
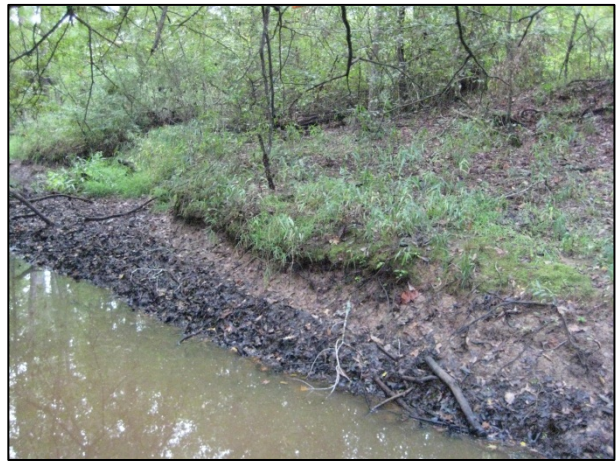
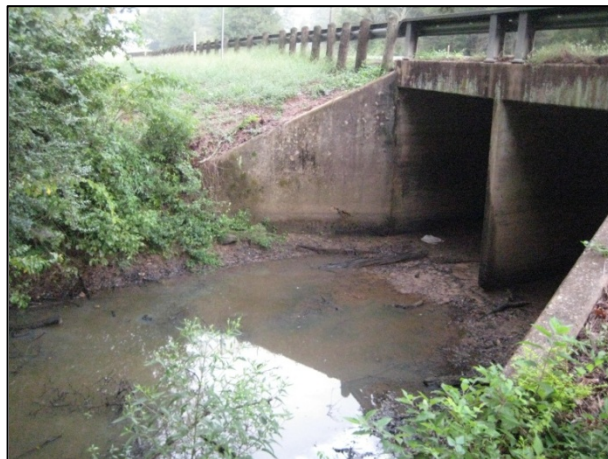
**Photogroup 4-5** Attoyac 5 (20842) depicting stream banka access and general bank appearance. Top left: Upstream channel fenced, July 2012; Top right: 30-m transect, upstream, July 2012; Middle left: 300-m transect, rightbank, August 2012; Middle right: 30-m transect, rightbank; Bottom: 0-m transect, stream access from Hwy 84; August 2012.

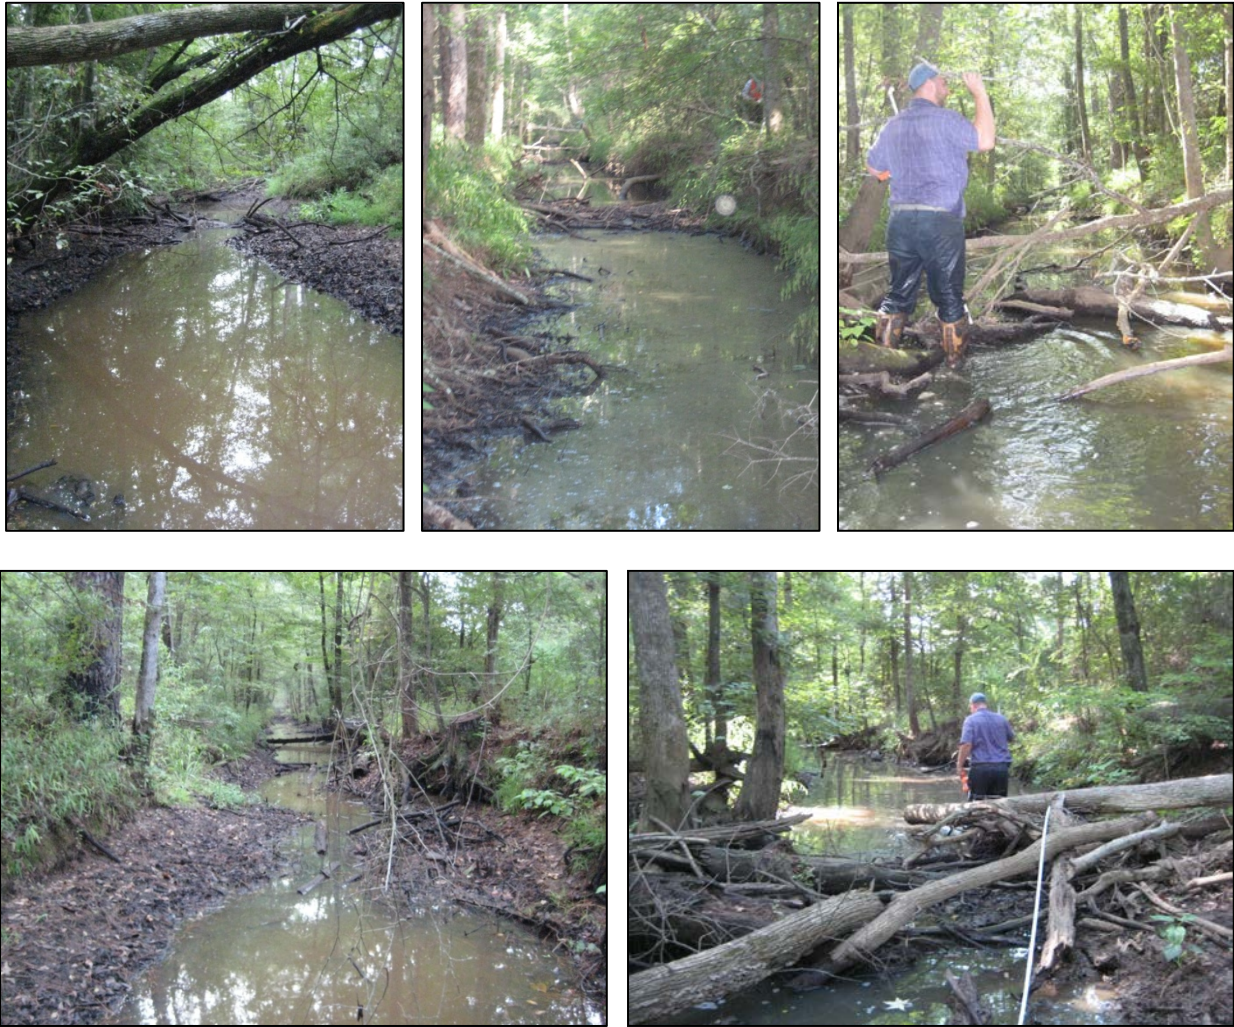
**Photogroup 4-5** Attoyac 5 (20842) depicting stream surface characteristics. All individuals featured are SFASU and CES staff. Top left: 150-m, downstream, August 2012; Top center: 300-m, upstream, July 2012; Top right: Large woody debris, July 2012; Bottom left: 300-m, downstream, August 2012; Bottom right: Large woody debris, July 2012.

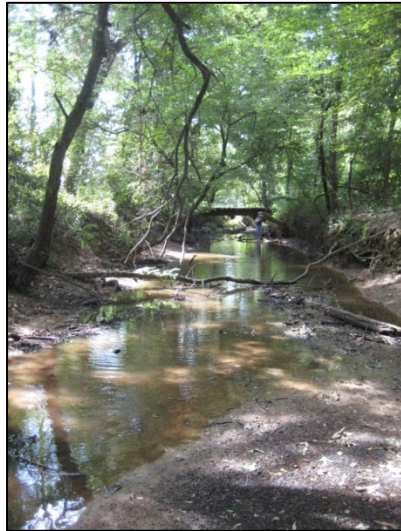
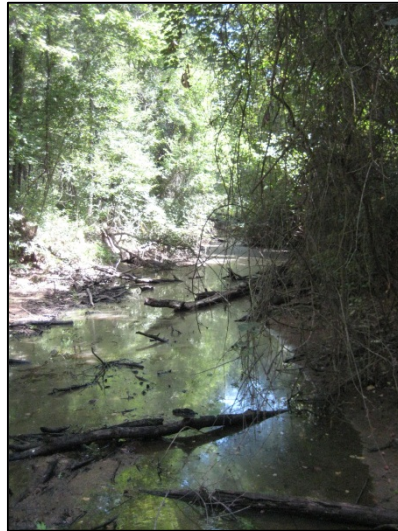
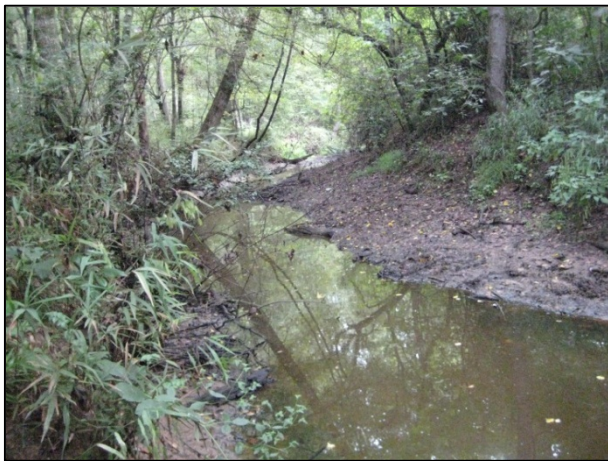
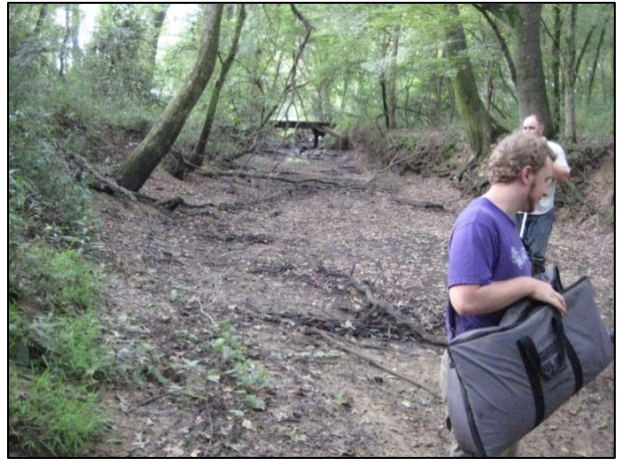
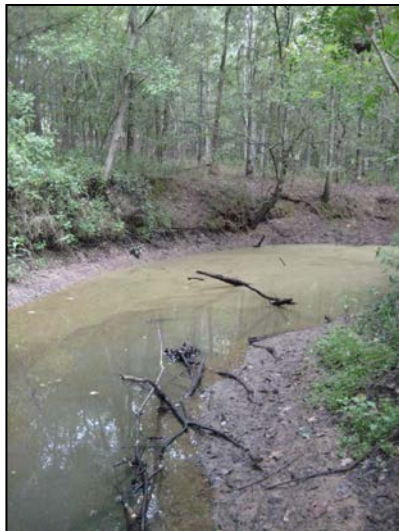
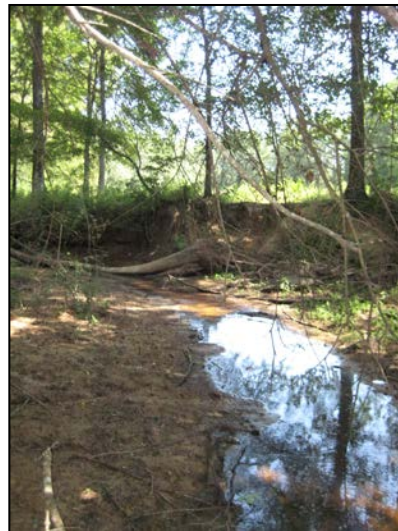
**Photogroup 4-6** Attoyac 6 depicting general stream characteristics. Top left: 30-m, downstream, July 2012; Top right: 150-m, upstream, July 2012; Middle left: 300-m, upstream, August 2012; Middle right: 30-m, downstream, August 2012; Bottom left: 30-m, upstream, August 2012; Bottom right: 300-m downstream, August 2012.

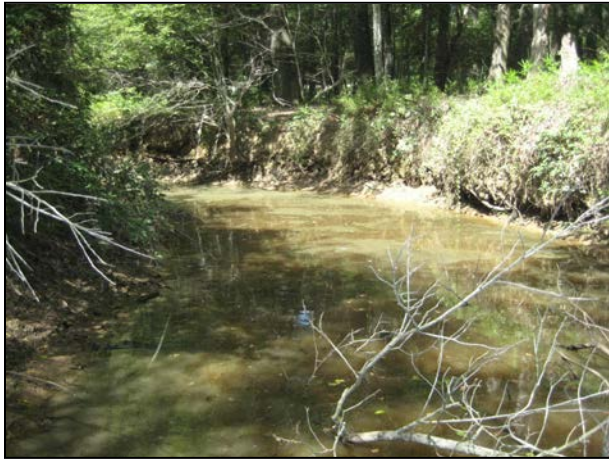
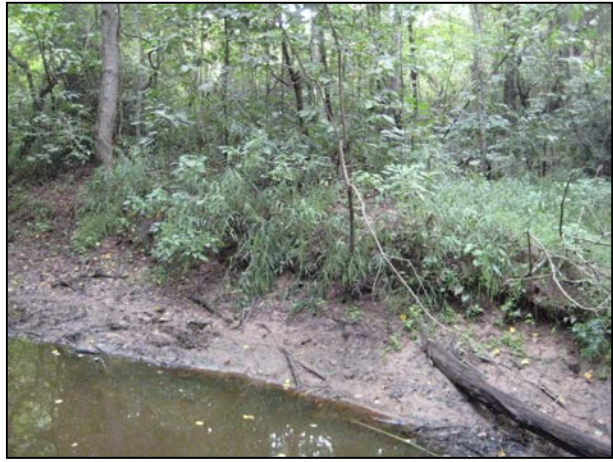
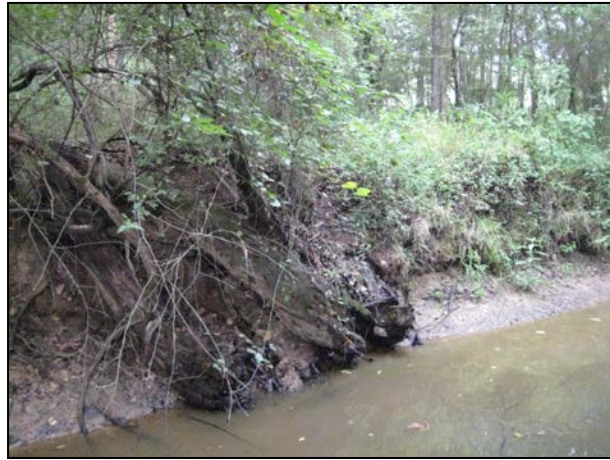
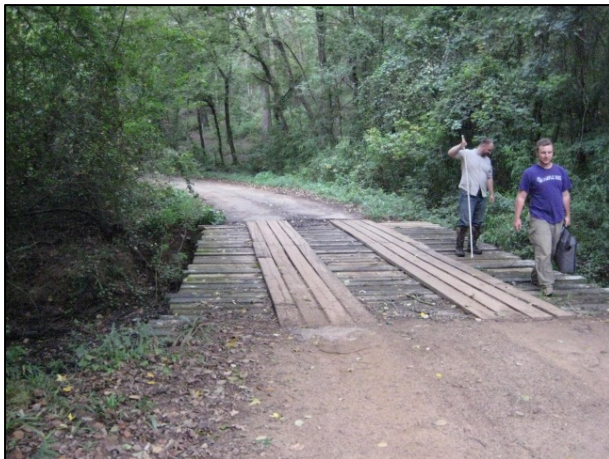
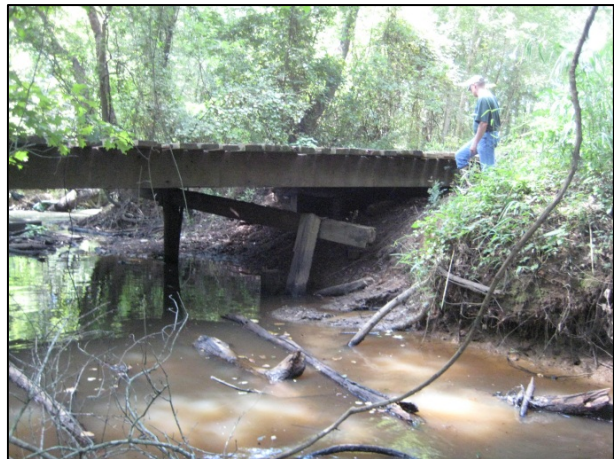
**Photogroup 4-6** Attoyac 6 depicting bank access and general bank appearance. All individuals featured are SFASU and CES staff. Top left: 150-m, downstream, July 2012; Top right: 300-m, right bank, August 2012; Middle: 30-m, left bank, August 2012; Bottom left: CR 4760 crossing, August 2012; Bottom right: 0-m, Bank access from CR 4760 crossing, July 2012.

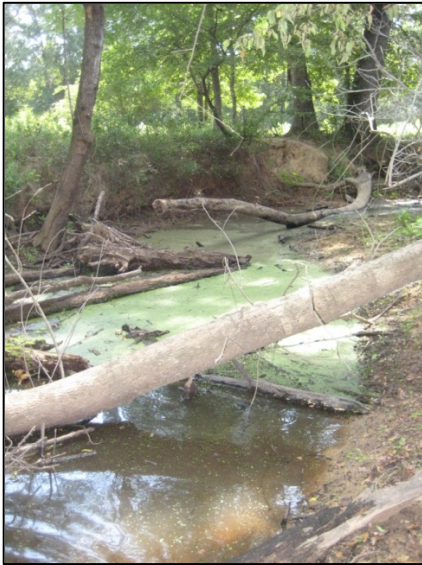
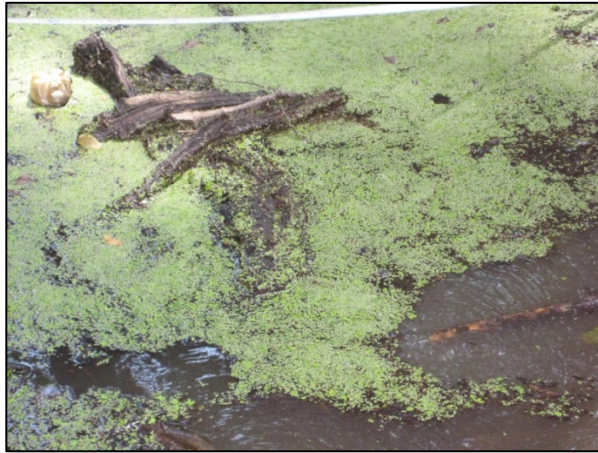
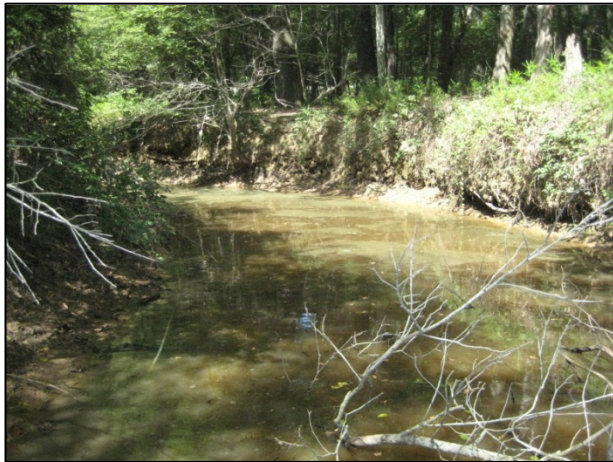
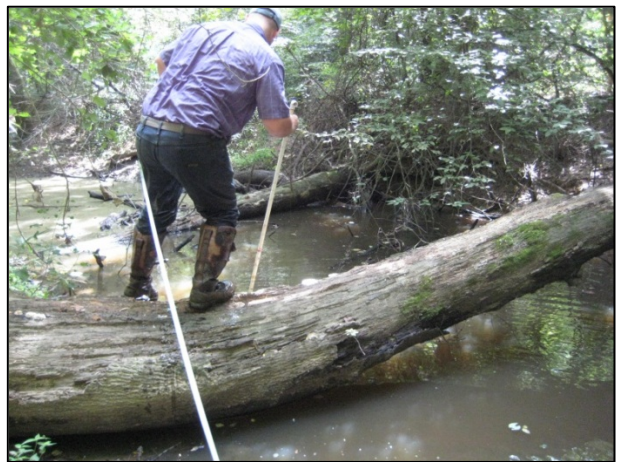
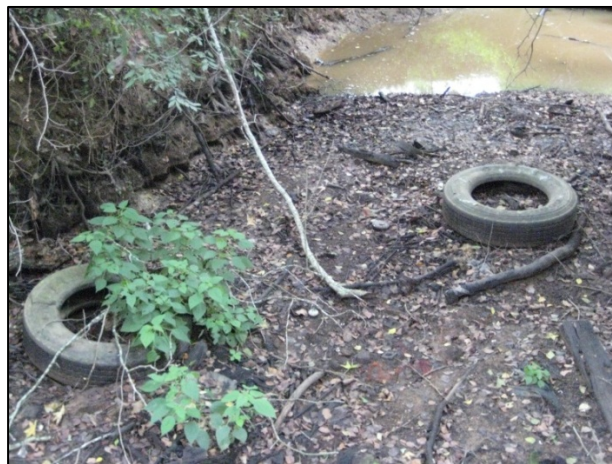
**Photogroup 4-6** Attoyac 6 depicting water surface characteristics. All individuals featured are SFASU and CES staff. Top left: Large woody debris in channel, July 2012; Top right: Woody debris and aquatic vegetation, July 2012; Middle left: 150-m transect, downstream, July 2012; Middle right: Large woody debris, July 2012; Bottom: Large channel litter (tires), July 2012.

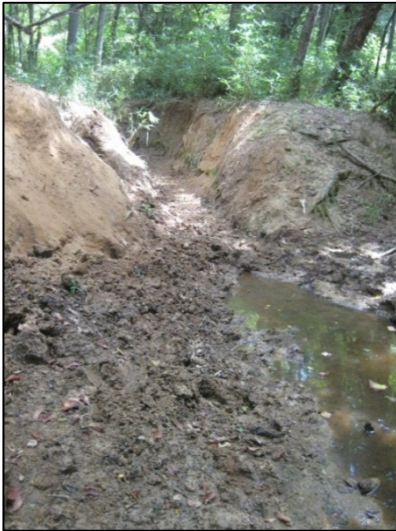
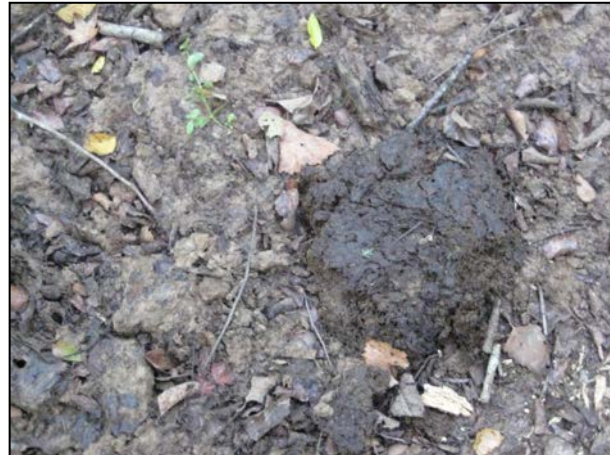
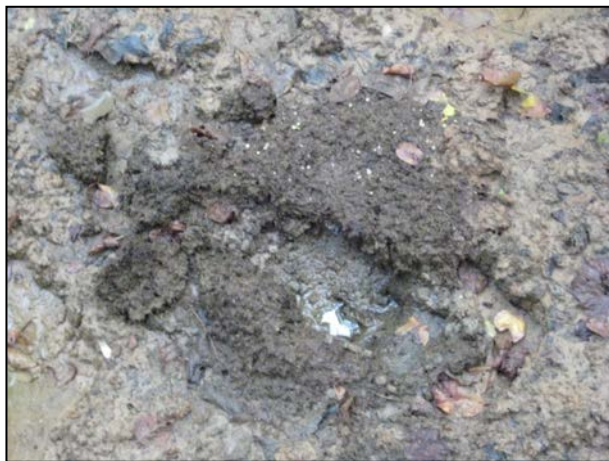
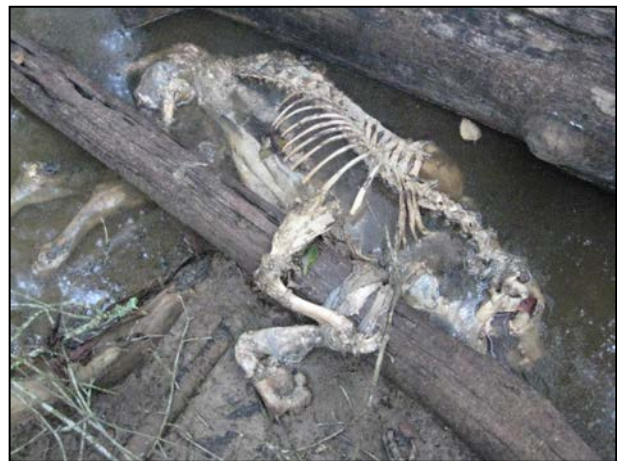
**Photogroup 4-6** Attoyac 6 depicting potential contamination sources. Top left: Livestock access bank access, July 2012; Top right: Livestock fecal, August 2012; Bottom left: Livestock fecal, August 2012; Bottom right: 0-m transect, animal carcass, August 2012.

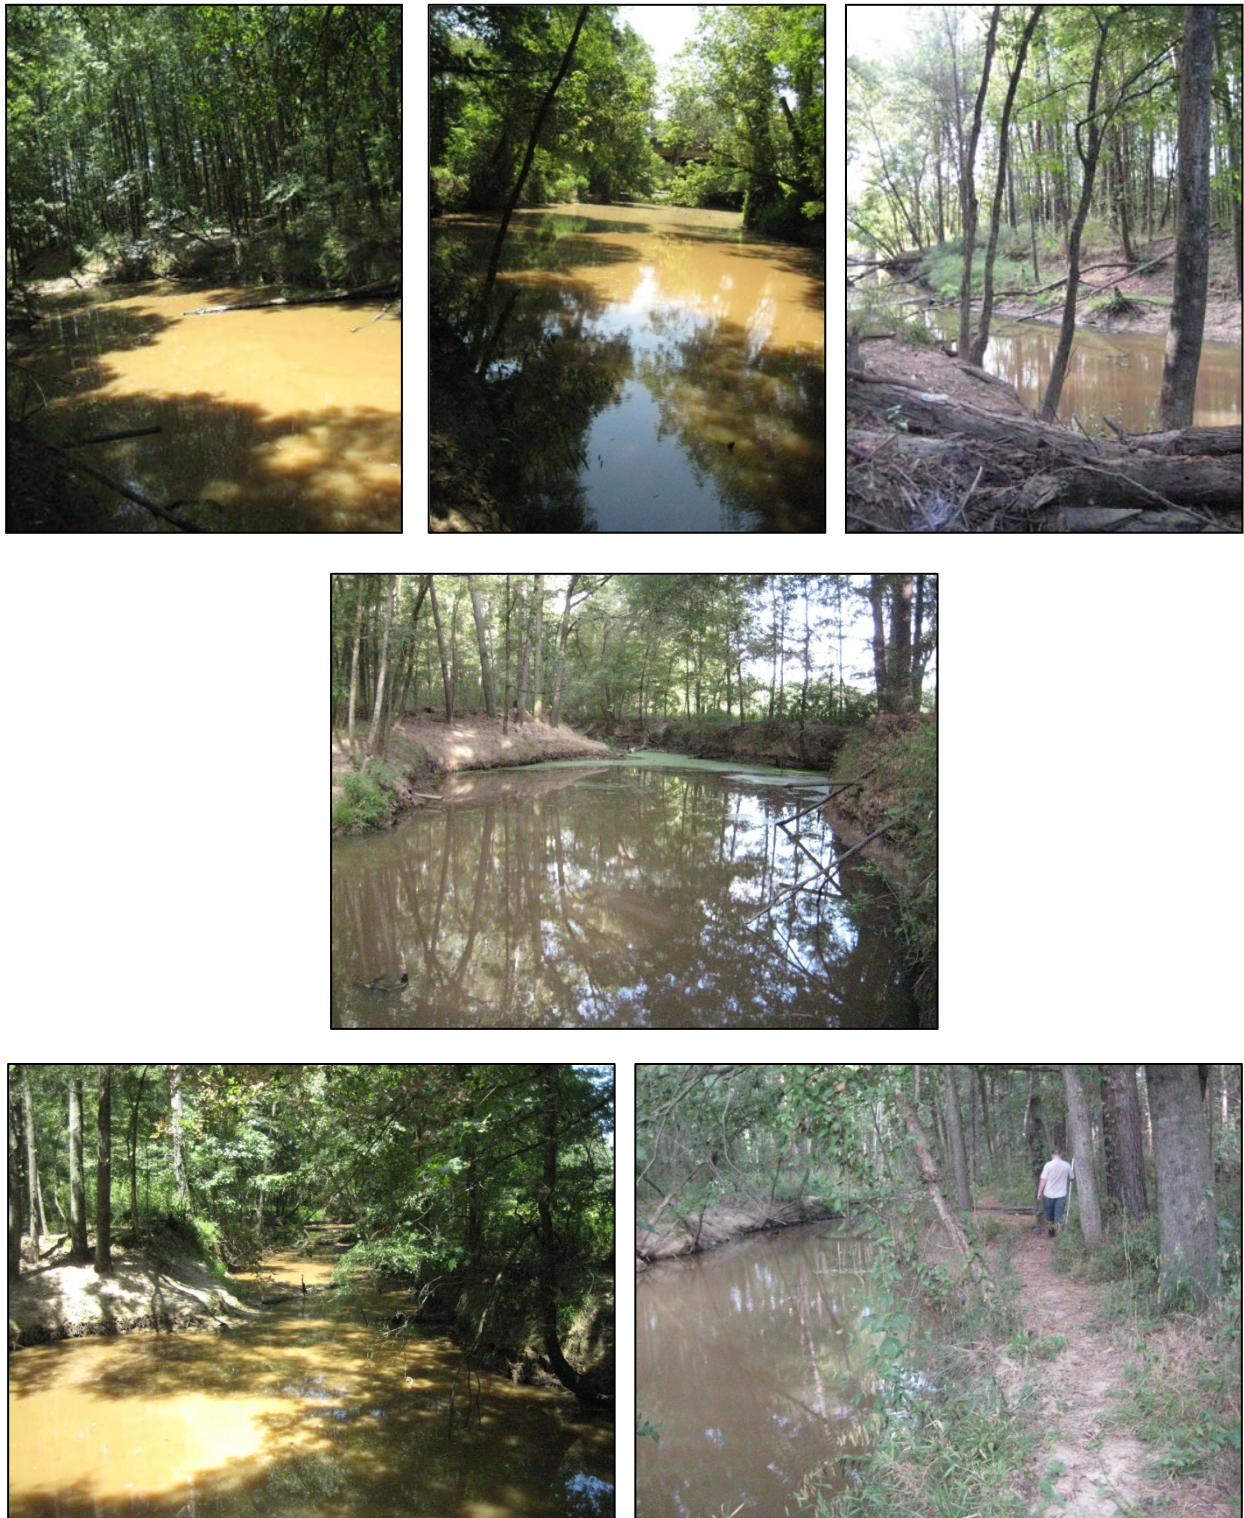
**Photogroup 4-7** Attoyac 7 depicting general stream characteristics. All individuals featured are SFASU and CES staff. Top left: 150-m, downstream, July 2012; Top center: 30-m downstream, July 2012; Top right: 150-m, downstream, August 2012; Middle: 150-m, upstream, August 2012; Bottom left: 150-m, upstream, July 2012; Bottom right: Establish trail along left bank, August 2012.
