# Attoyac Bayou Recreational Use Attainability Analysis

**Attoyac Bayou  
Recreational Use Attainability Analysis**

**Texas State Soil and Water Conservation Board  
Project # 09-10**

**October 2012**

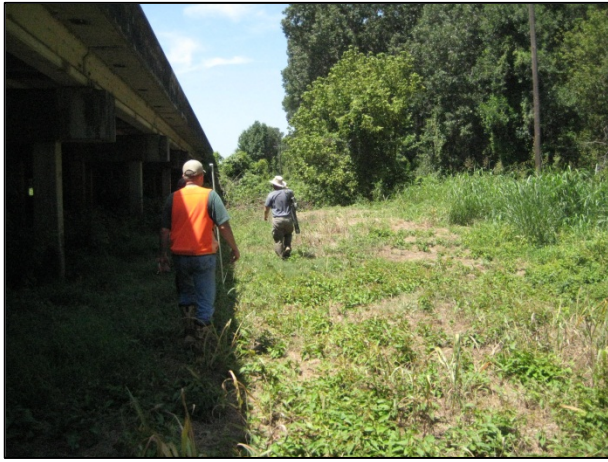
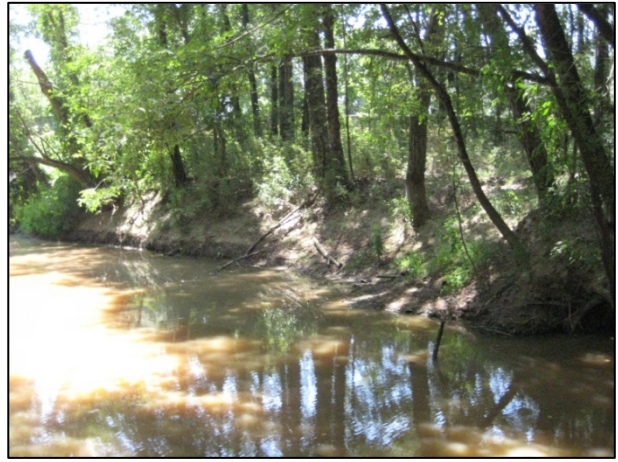
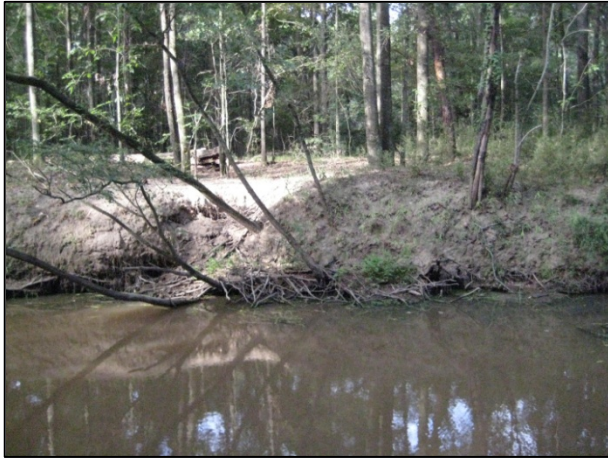
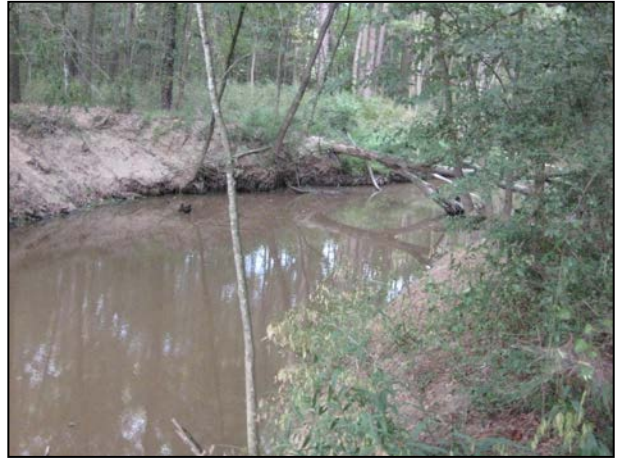
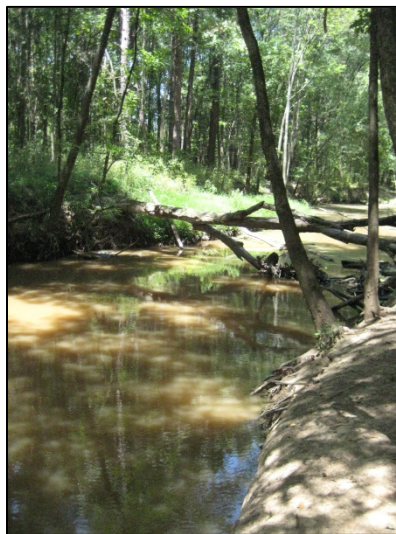
**Photogroup 4-7** Attoyac 7 depicting bank access and general bank appearance. All individuals featured are SFASU and CES staff. Top left: Stream access point from Hwy 59, July 2012; Top right: 30-m, right bank, July 2012; Middle left: 150-m, right bank, August 2012; Middle right: 30-m, upstream, August 2012; Bottom: 30-m, upstream, July 2012.

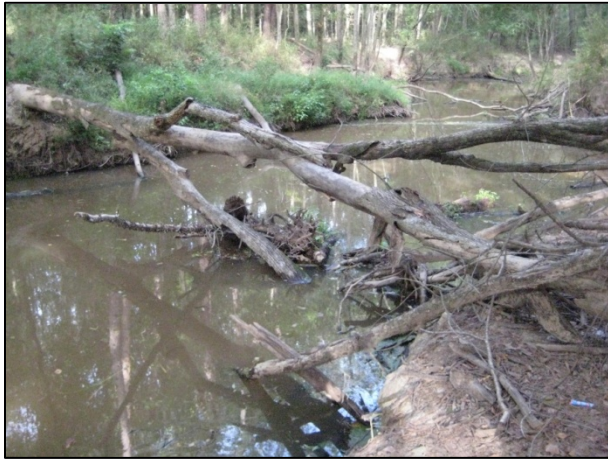
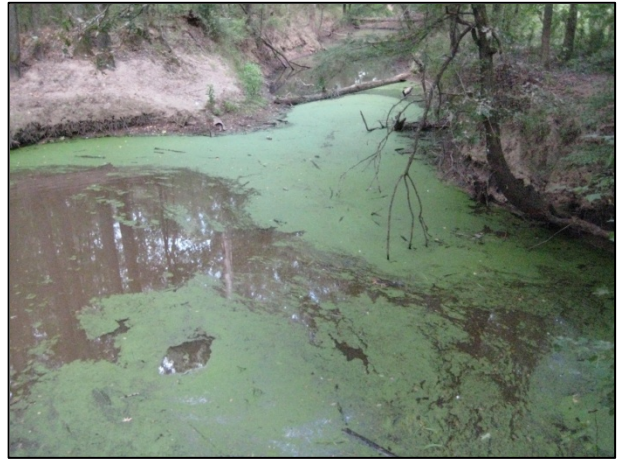
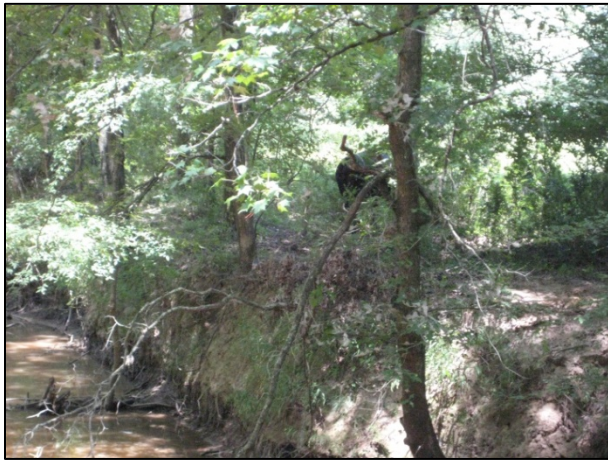
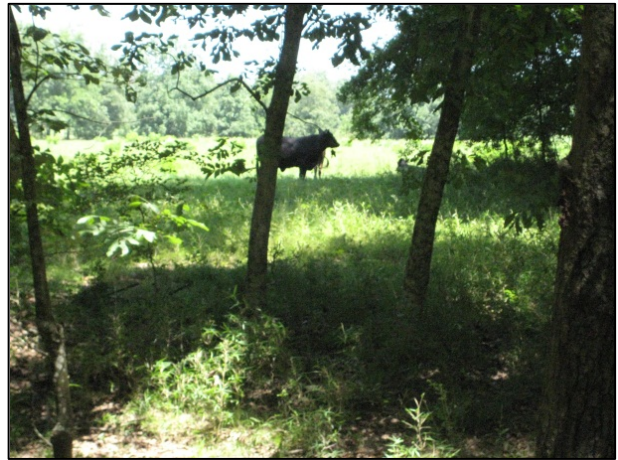
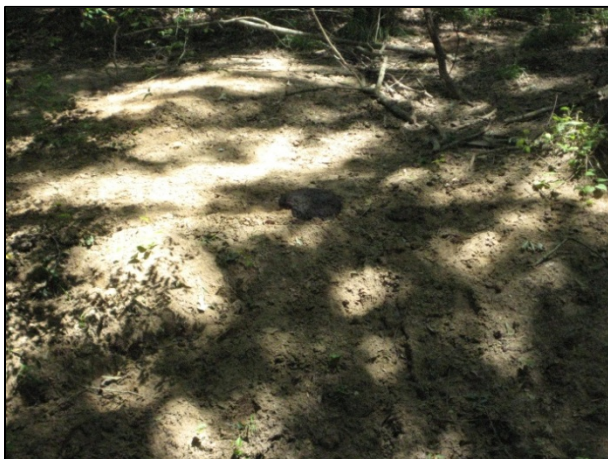
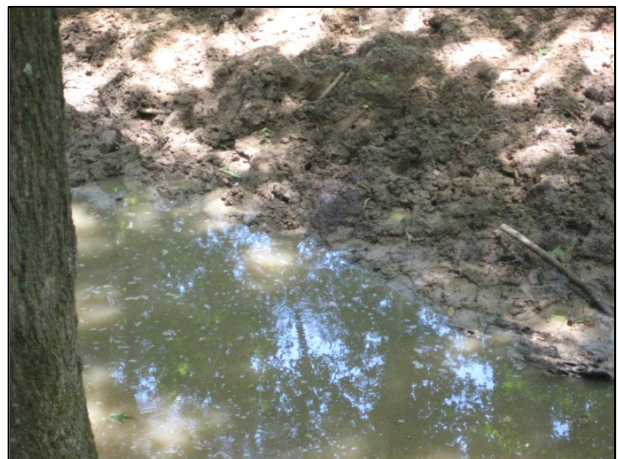
**Photogroup 4-7** Attoyac 4-7 depicting water surface characteristics and potential sources of contamination. Top left: Large woody debris, August 2012; Top right: Aquatic vegetation, August 2012; Middle left: Livestock use, left bank, July 2012; Middle right: Livestock use, left bank, July 2012; Bottom left: Livestock fecal, July 2012; Bottom right: Livestock fecal and tracks, July 2012.

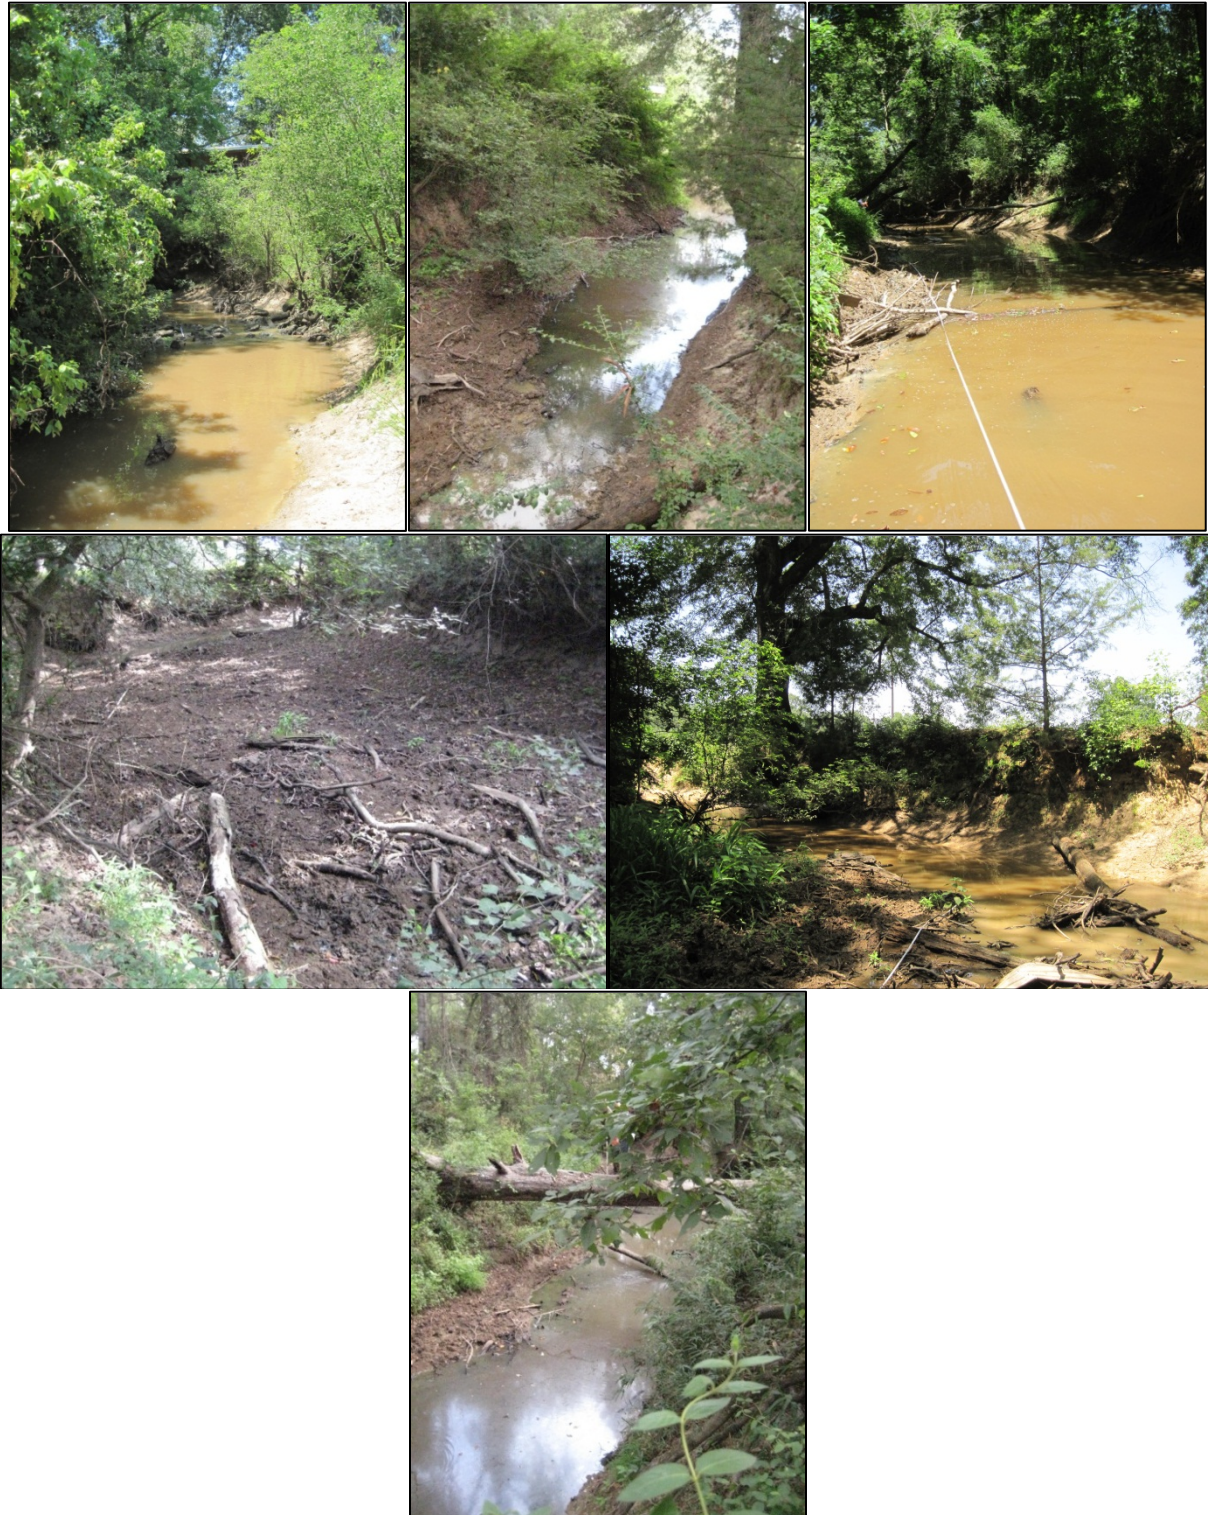
**Photogroup 4-8** Attoyac 8 depicting general stream characteristics. Top left: 150-m, upstream, July 2012; Top center: 300-m, downstream, August 2012; Top right: 30-m, downstream, July 2012; Middle left: Dry stream channel, August 2012; Middle right: Upstream from major logjam; July 2012; Bottom: 30-m, upstream, August 2012.

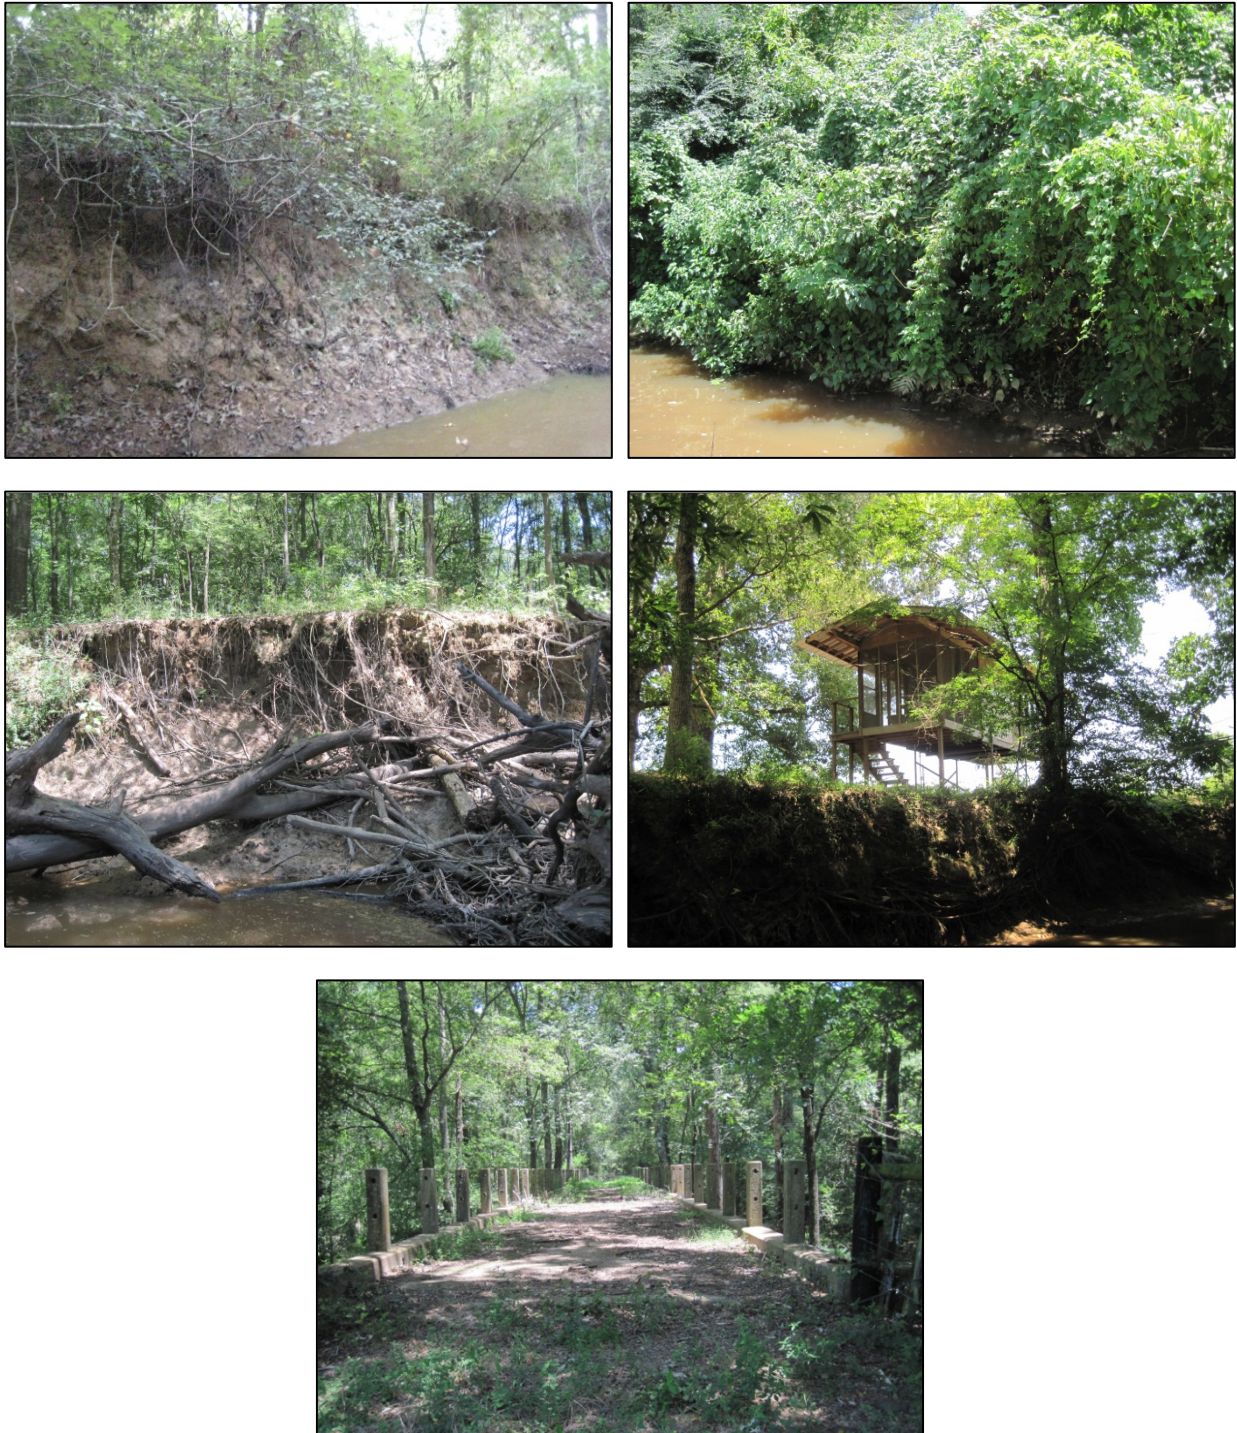
**Photogroup 4-8** Attoyac 8 depicting bank access and general bank appearance. Top left: 150-m, leftbank, August 2012; Top right: 150-m; right bank, July 2012; Middle left: Large woody debris, July 2012; Middle right: Camp house on left bank, July 2012; Bottom: Defunct CR 294.

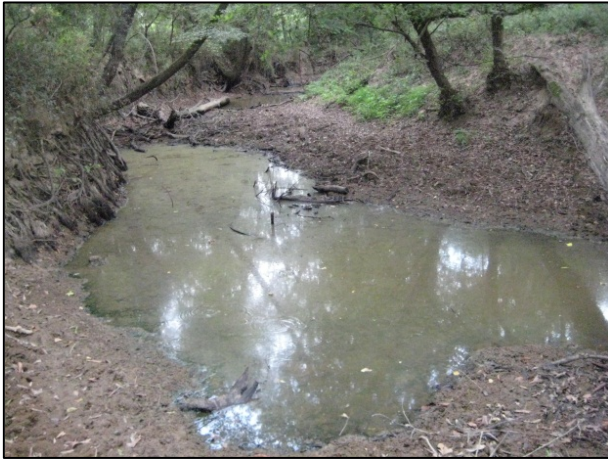
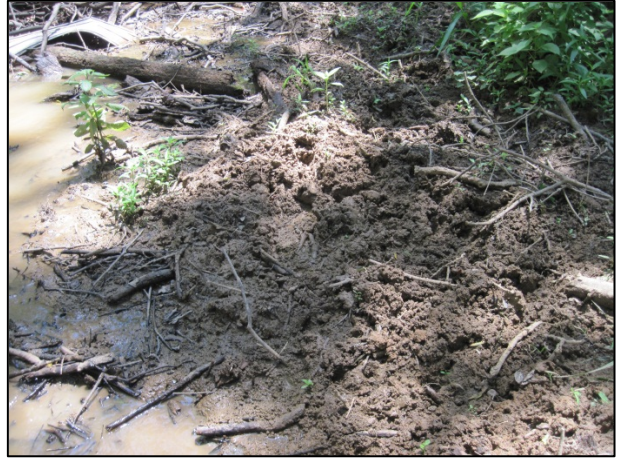
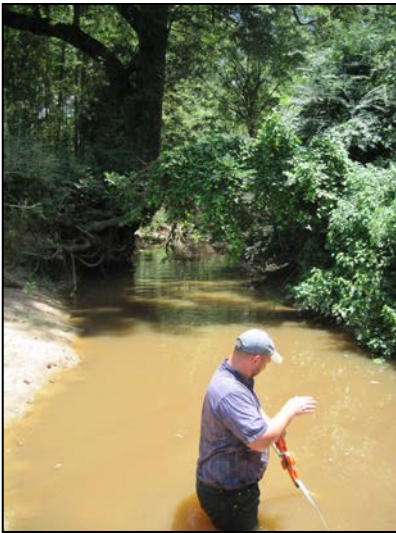
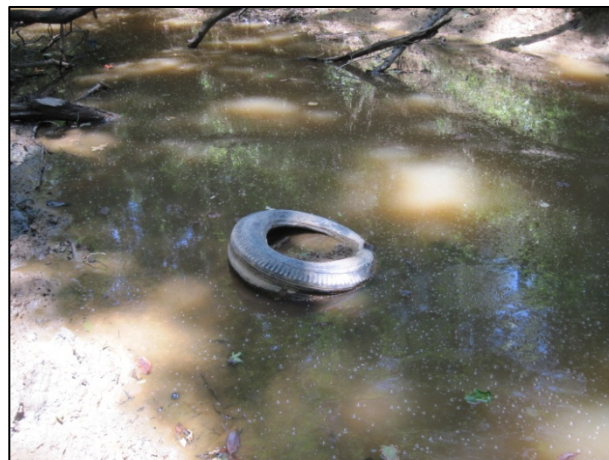
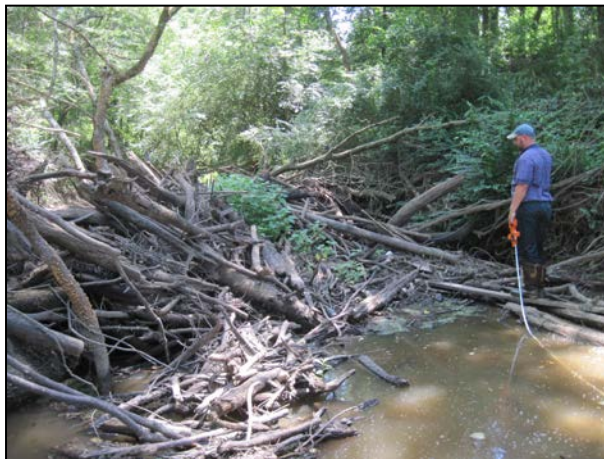
**Photogroup 4-8** Attoyac 8 depicting stream surface characteristics and potential sources of contamination. Top left: Pool with scum, August 2012; Top right: Feral hog use, August 2012; Middle left: 150-m, downstream, July 2012; Middle right: Channel litter, July 2012; Bottom: Downstream logjam, July 2012.

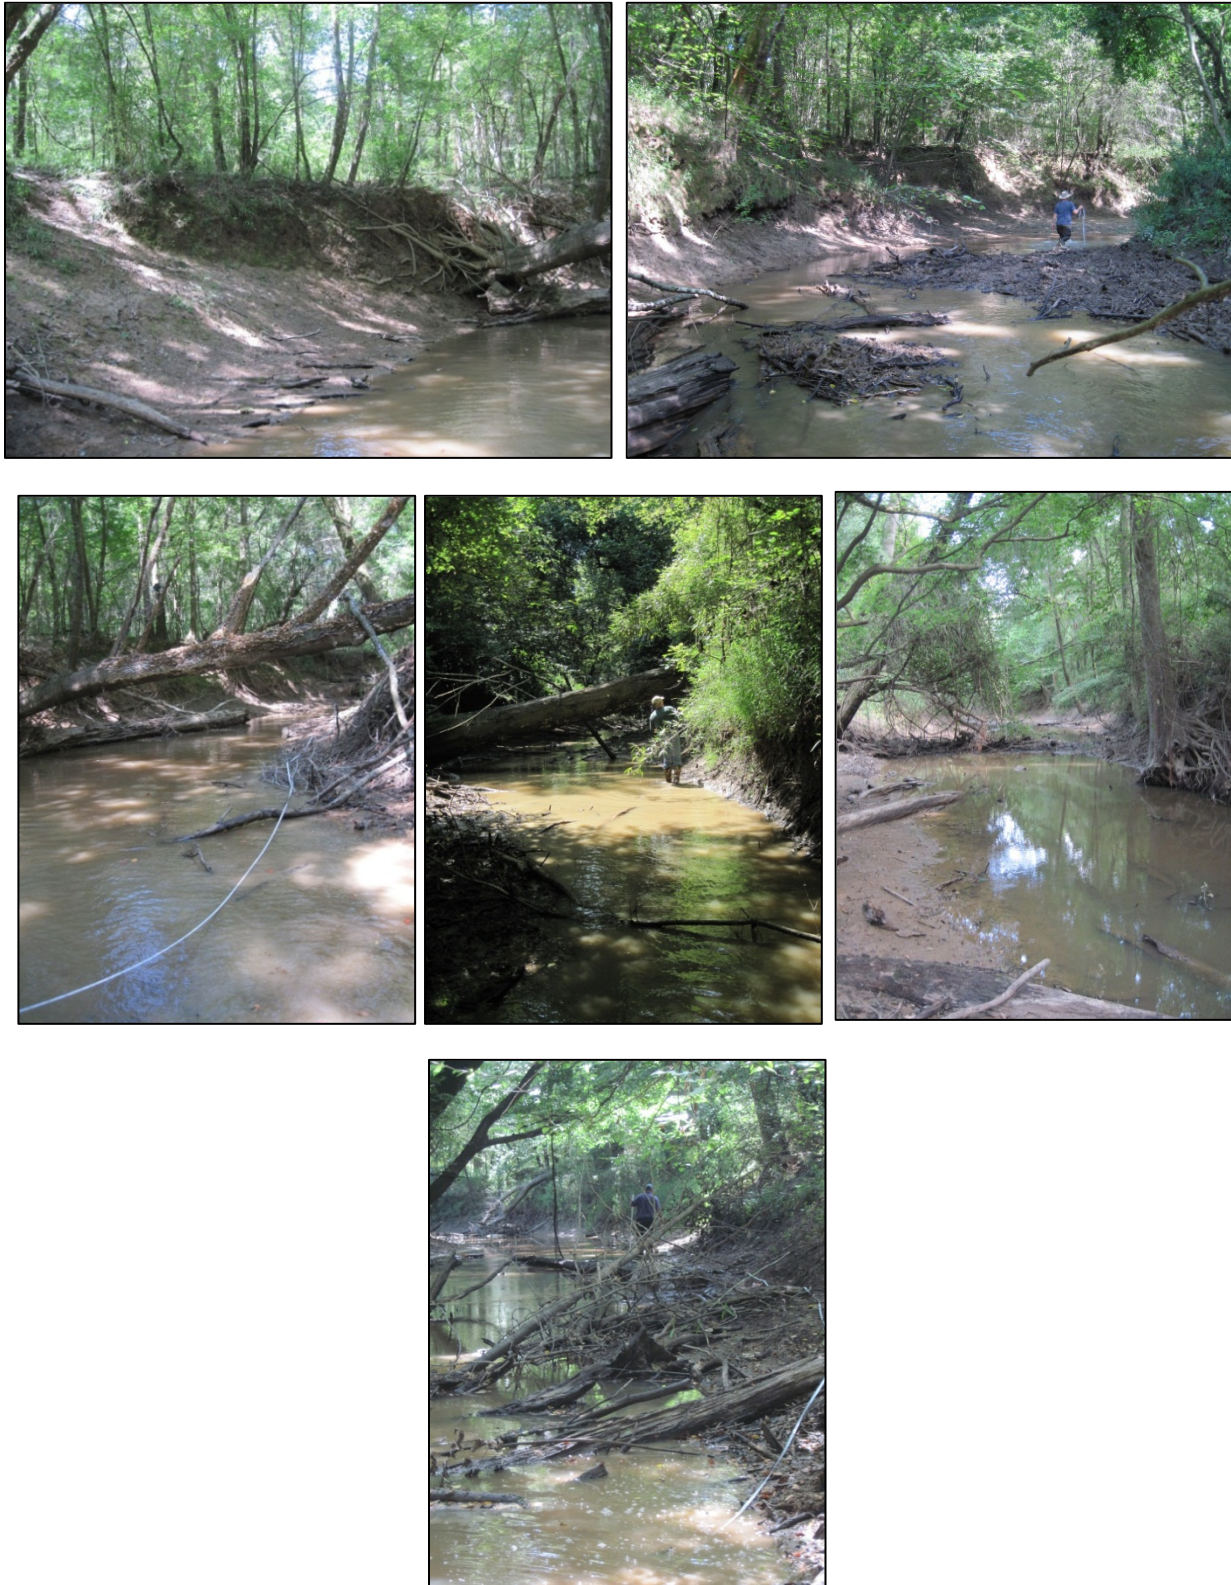
**Photogroup 4-9** Attoyac 9 depicting general stream characteristics. All individuals featured are SFASU and CES staff. Top left: 30-m, left bank, July 2012; Top right: 150-m, downstream, July 2012; Middle left: 30-m, downstream, July 2012; Middle center: 150-m, upstream, July 2012; Middle right: 300-m, downstream, July 2012; Bottom: Large woody debris, July 2012.

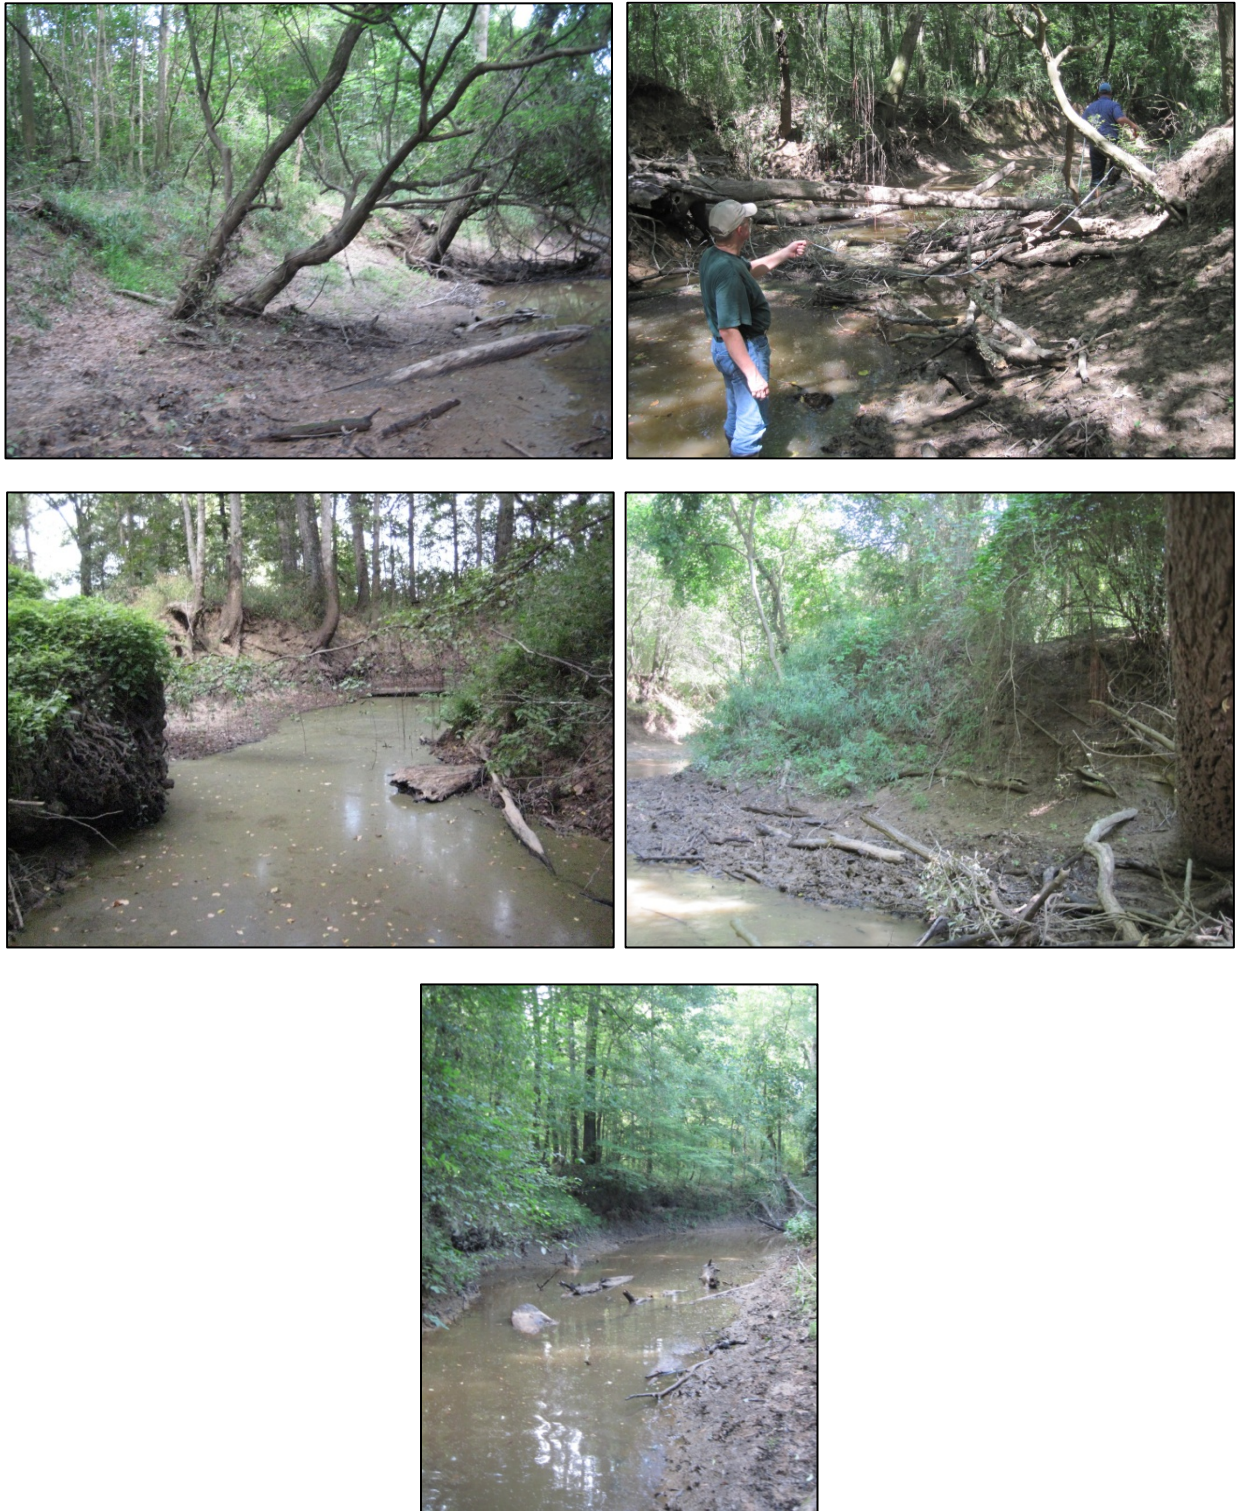
**Photogroup 4-9** Attoyac 9 depicting general bank appearance. All individuals featured are SFASU and CES staff. Top left: 300-m, left bank, July 2012; Top right: Large woody debris, July 2012; Middle left: 30-m, upstream, August 2012; Middle right: 150-m, right bank, July 2012; Bottom: 300-m, upstream, July 2012.

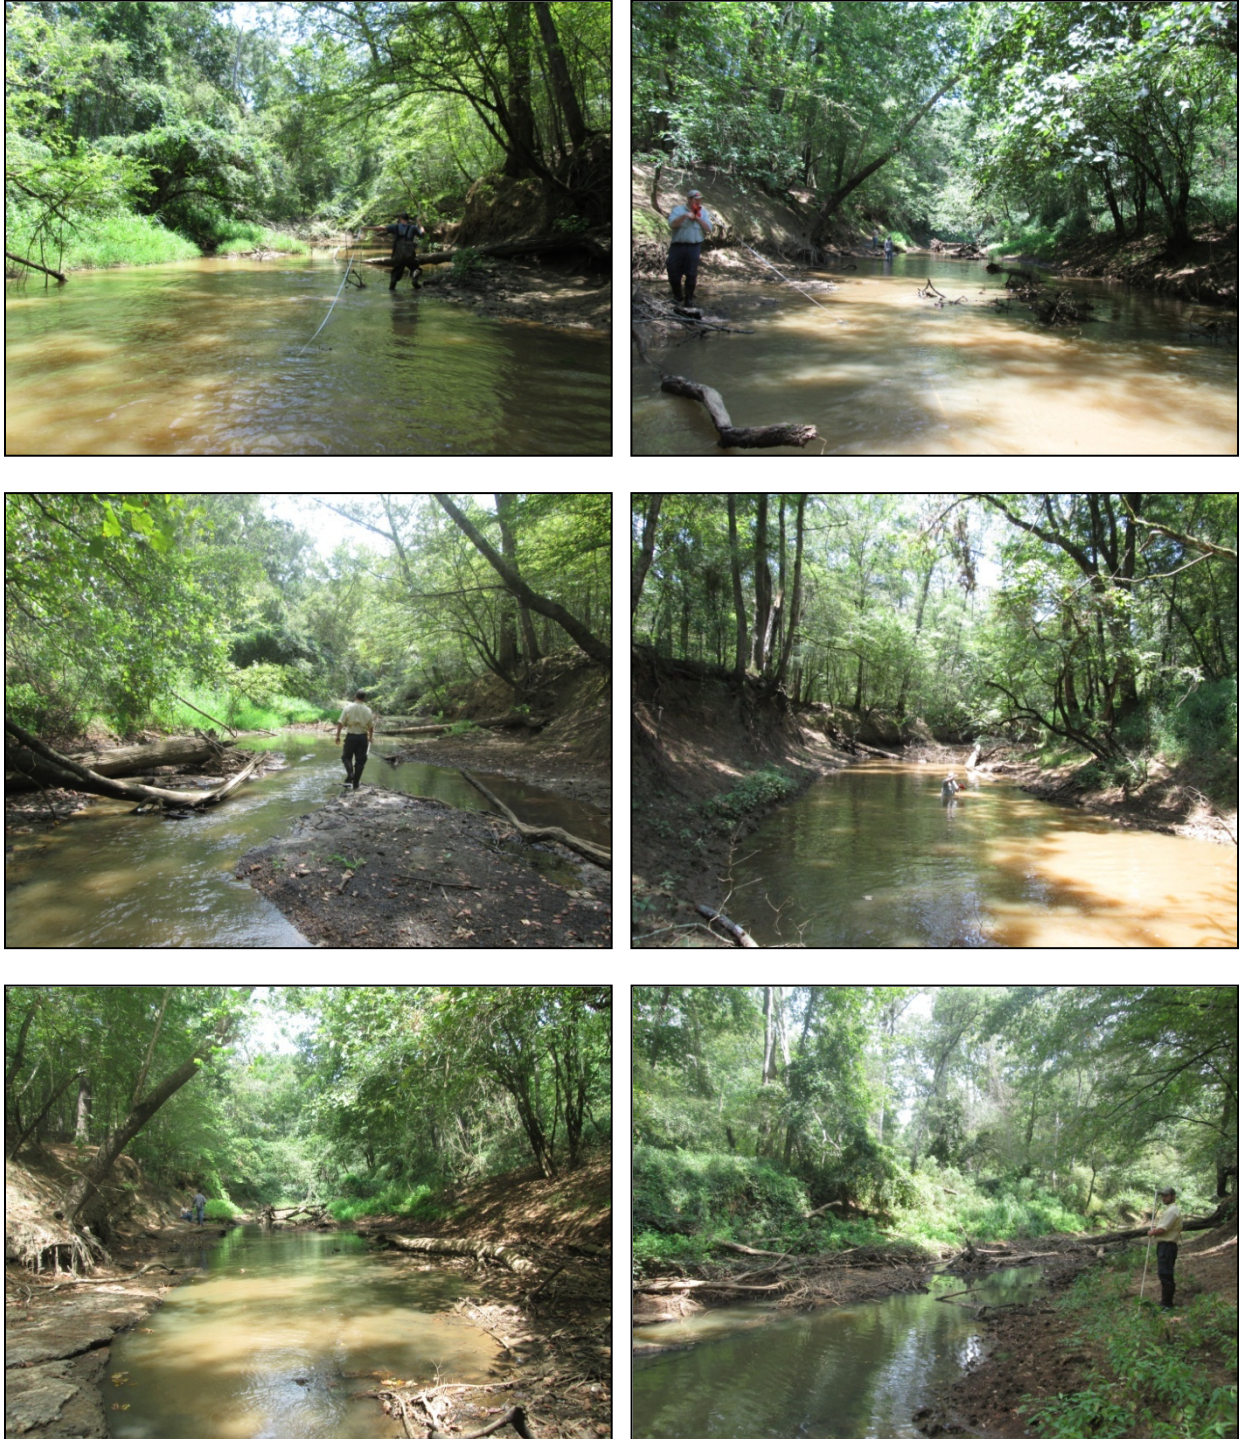
**Photogroup 4-14** Attoyac 15 depicting water surface characteristics. All individuals featured are SFASU and CES staff. Top left: 300-m transect, upstream, August 2012; Top right: 300-m, downstream, July 2012; Middle left: Stream width measurement, July 2012; Middle right: 150-m transect, upstream, July 2012; Bottom: Channel litter (tire), August 2012.

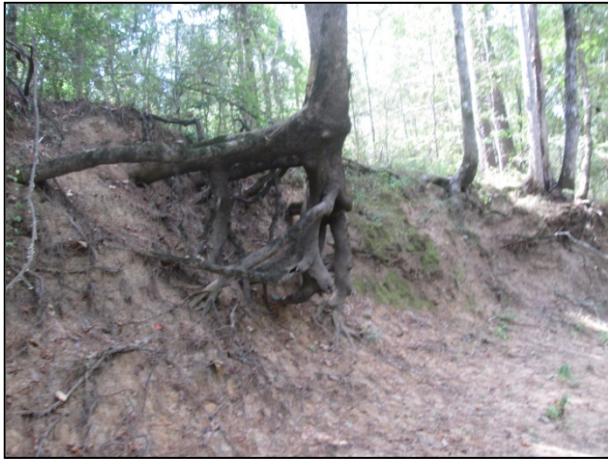
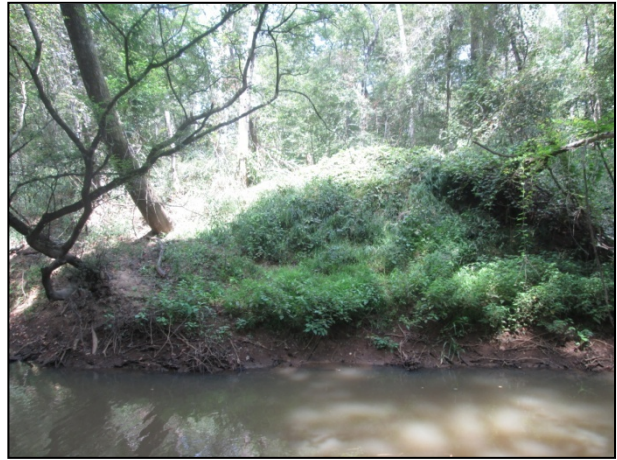
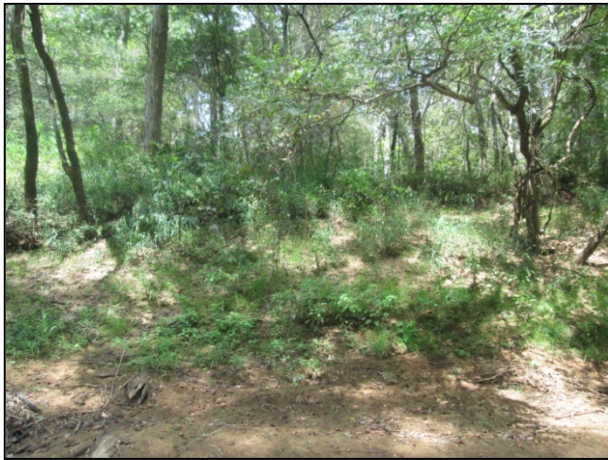
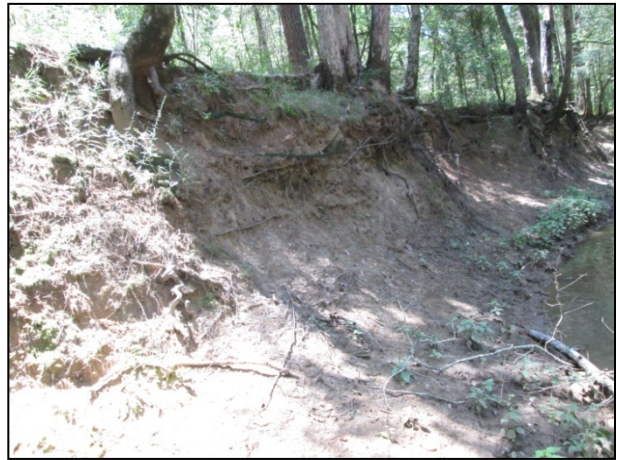
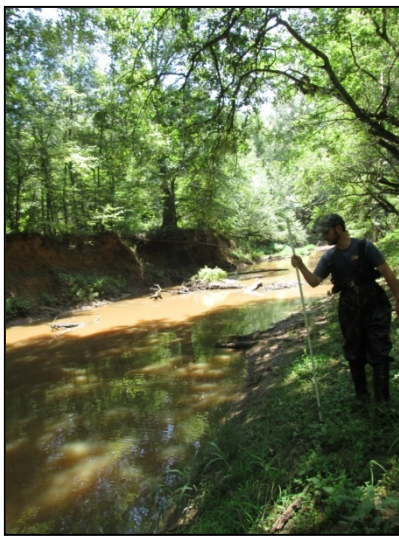
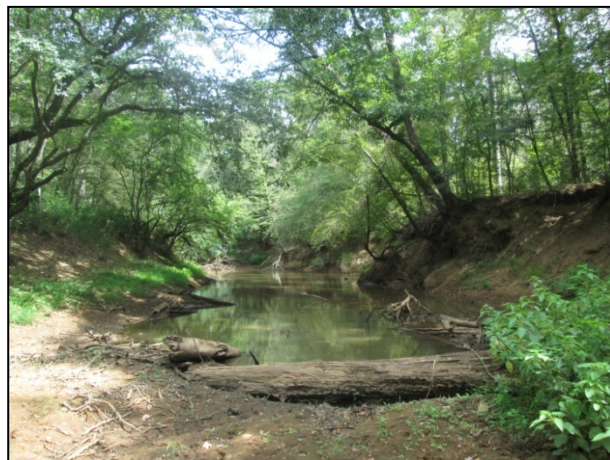
**Photogroup 4-15** Attoyac 16 depicting general stream characteristics. All individuals featured are SFASU and CES staff. Top left: 30-m transect, downstream, July 2012; Top right: 30-m transect, upstream, July 2012; Middle left: 30-m transect, downstream, August 2012; Middle right: 150-m transect, upstream, July 2012; Bottom left: 30-m transect, upstream, August 2012; Bottom right: 150-m transect, downstream, August 2012.

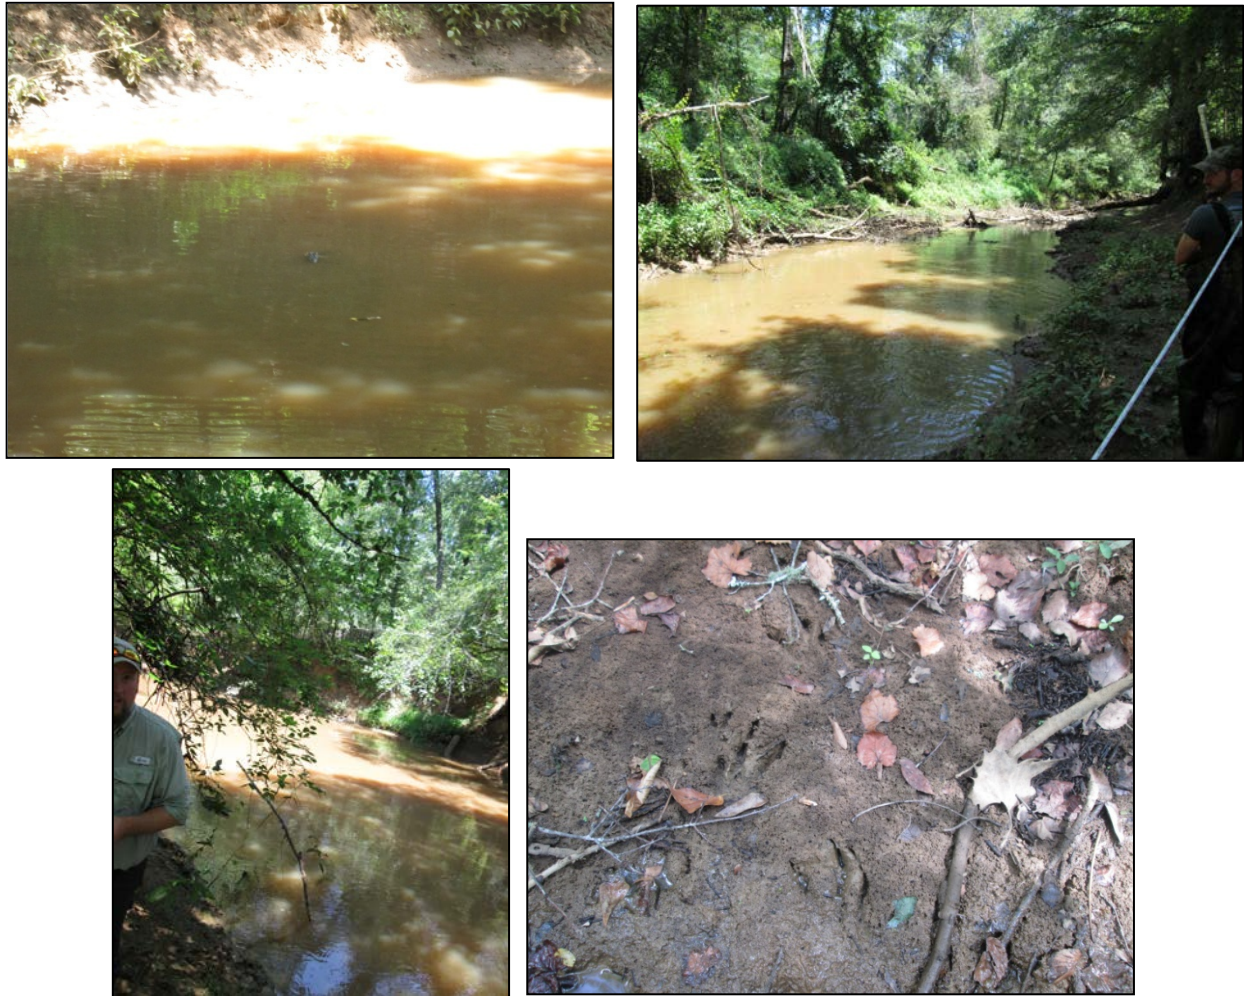
**Photogroup 4-15** Attoyac 16 depicting general bank appearance. All individuals featured are SFASU and CES staff. Top left: 150-m transect, left bank, August 2012; Top right: 150-m transect, right bank, August 2012; Middle left: 300-m transect, left bank, August 2012; Middle right: 150-m transect, left bank, July 2012; Bottom left: 300-m transect, downstream, July 2012; Bottom right: 300-m transect, upstream, August 2012.

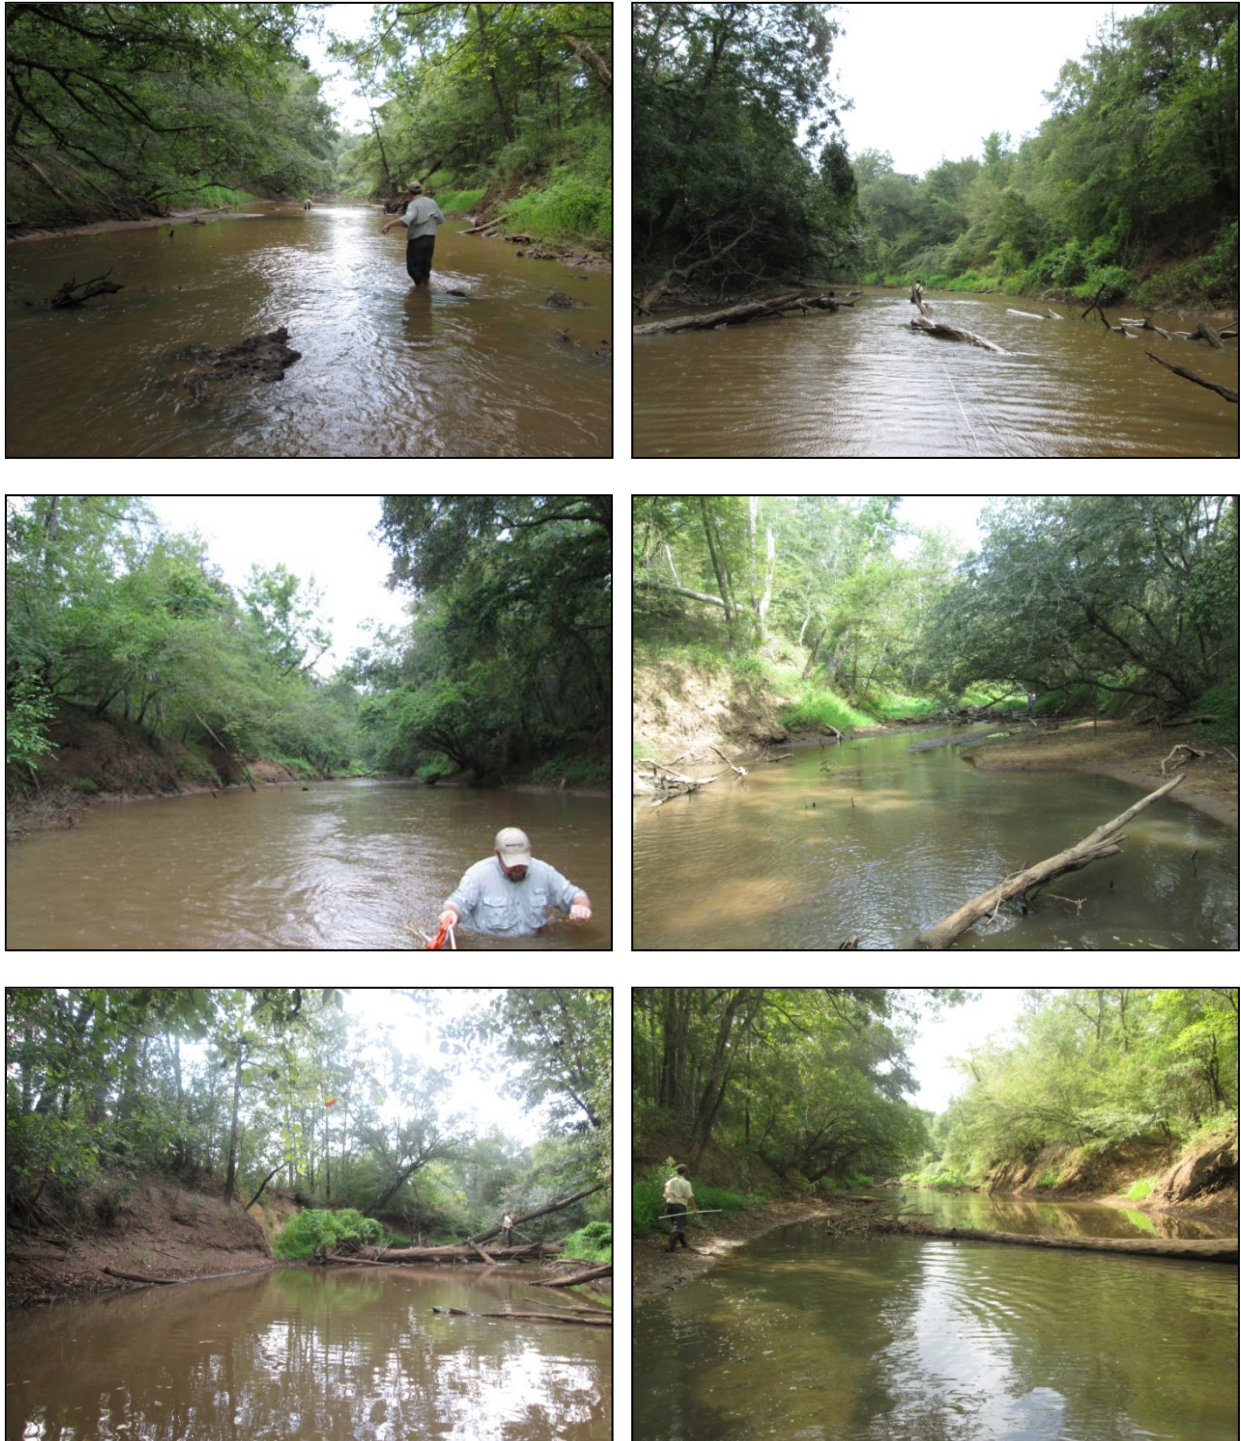
**Photogroup 4-15** Attoyac 16 depicting water surface characteristics. All individuals featured are SFASU and CES staff. Top left: Adolescent Alligator, July 2012; Top right: 150-m transect, downstream, July 2012; Bottom left: 300-m transect, upstream, July 2012; Bottom right: Raccoon prints, August 2012.

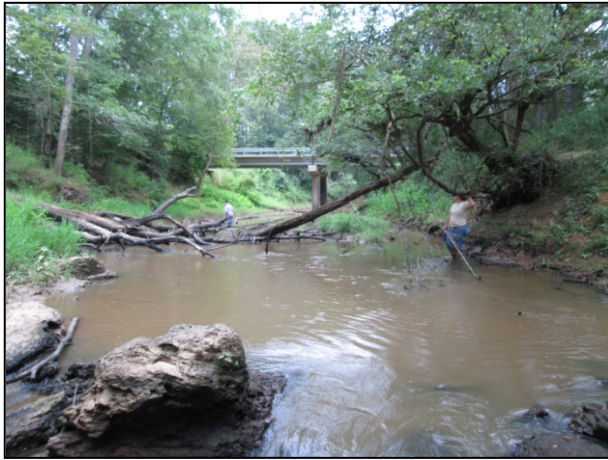
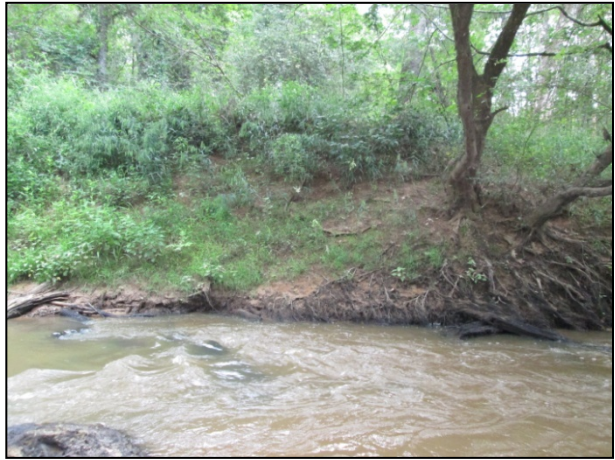
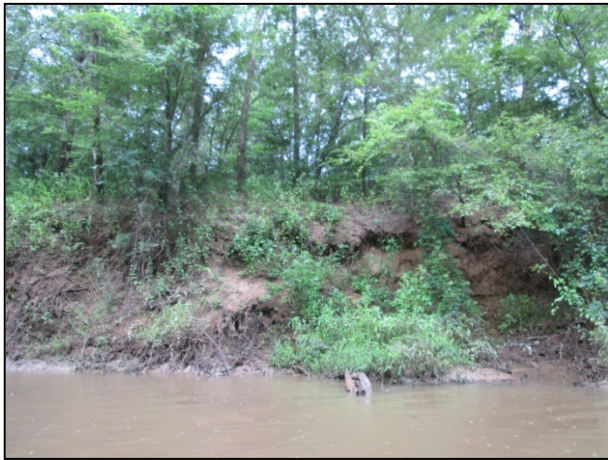
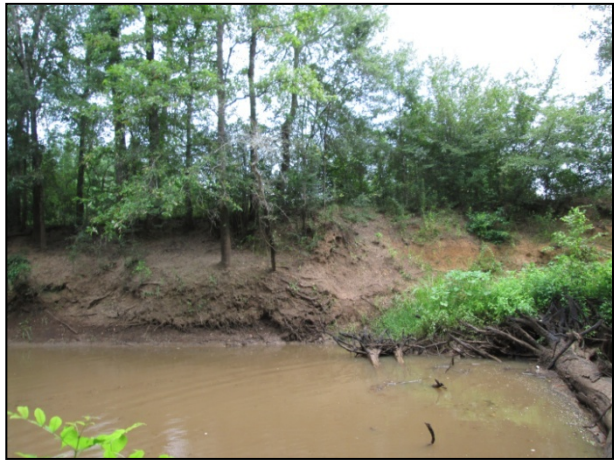
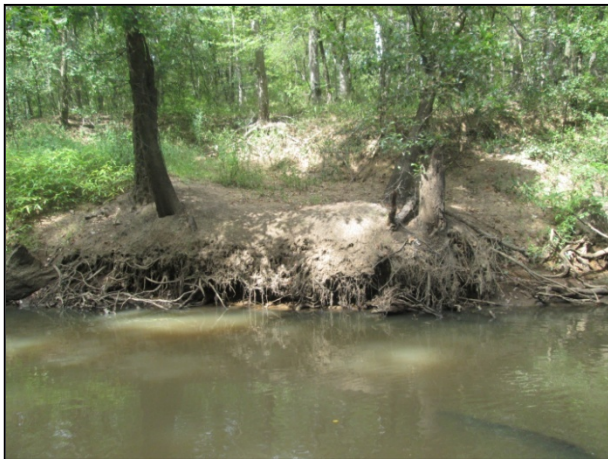
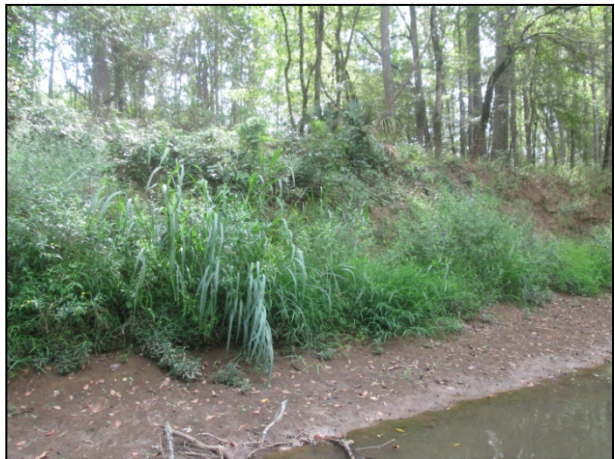
**Photogroup 4-16** Attoyac 17 depicting general stream characteristics. All individuals featured are SFASU and CES staff. Top left: 30-m transect, downstream, July 2012; Top right: 150-m transect, downstream, July 2012; Middle left: 150-m transect, upstream, July 2012; Middle right: 30-m transect, downstream, August 2012; Bottom left: 300-m transect, upstream, August 2012; Bottom right: 30-m transect, upstream, August 2012.

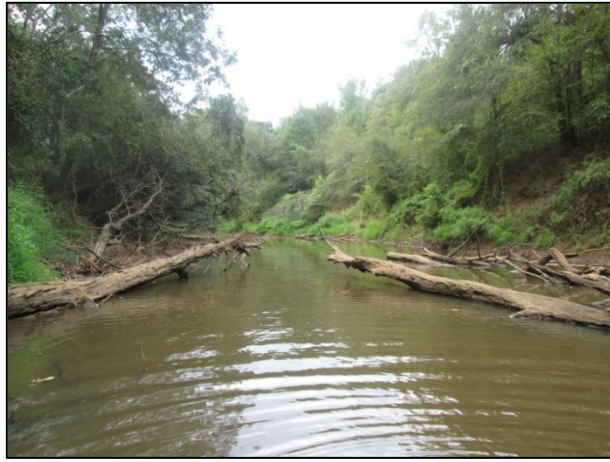
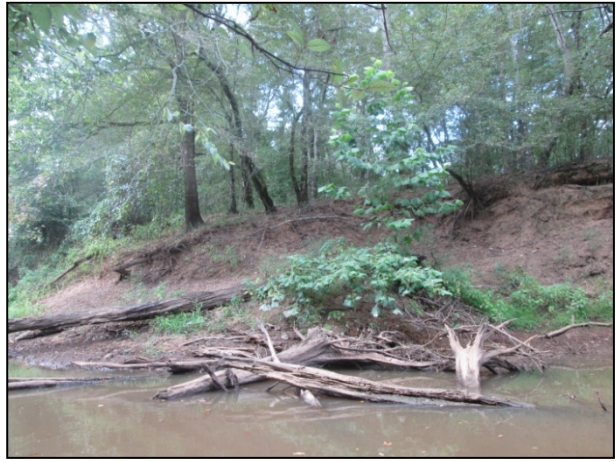
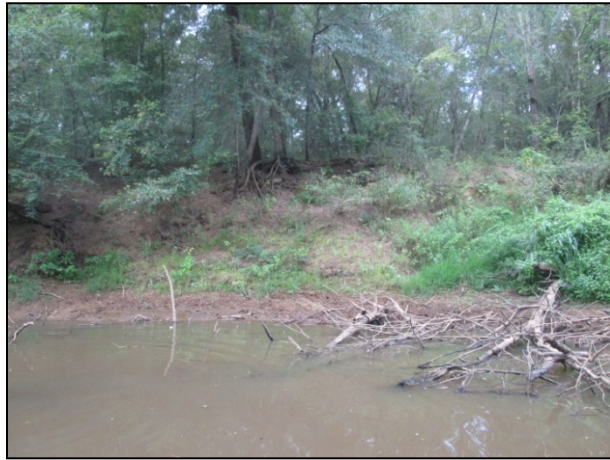
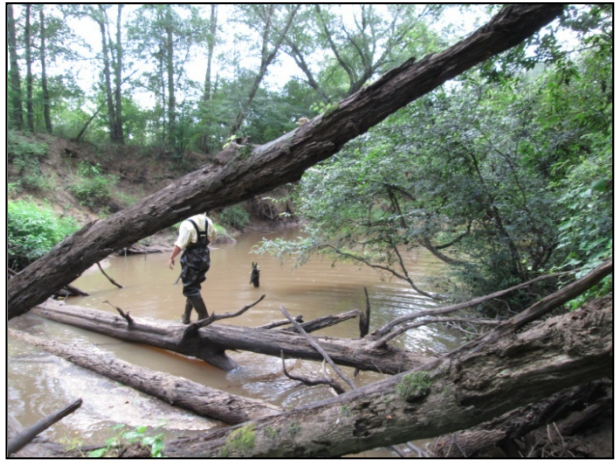
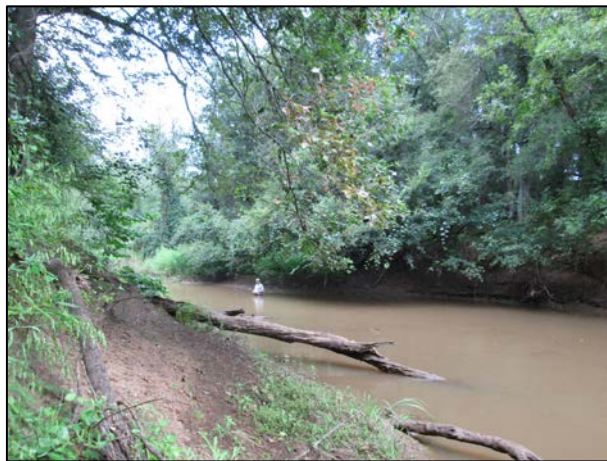
**Photogroup 4-16** Attoyac 17 depicting general bank appearance. All individuals featured are SFASU and CES staff. Top left: 30-m transect, upstream, July 2012; Top right: 30-m transect, left bank, July 2012; Middle left: 150-m transect, right bank, July 2012; Middle right: 300-m transect, left bank, July 2012; Bottom left: 30-m transect, right bank, August 2012; Bottom right: 30-m transect, left bank, August 2012.
