# Attoyac Bayou Recreational Use Attainability Analysis

**Attoyac Bayou  
Recreational Use Attainability Analysis**

**Texas State Soil and Water Conservation Board  
Project # 09-10**

**October 2012**

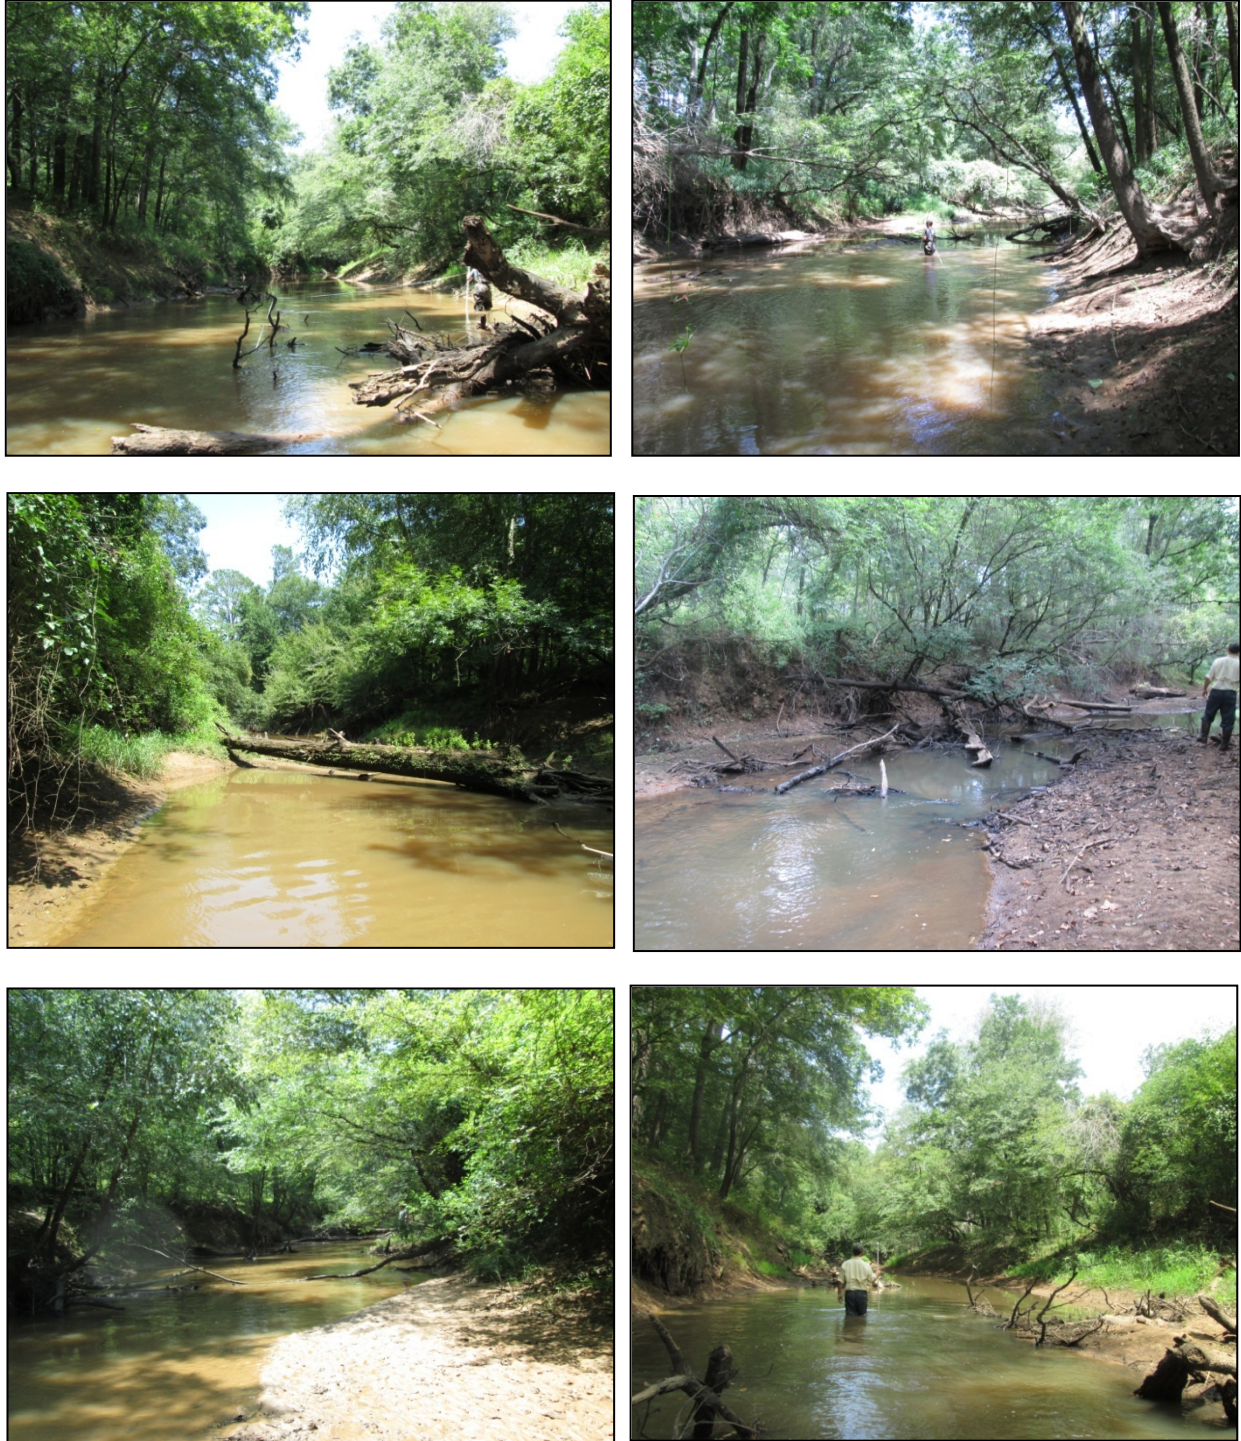
**Photogroup 4-16** Attoyac 17 depicting water surface characteristics. All individuals featured are SFASU and CES staff. Top left: Large woody debris, August 2012; Top right: 300-m transect, left bank, August 2012; Middle left: 150-m transect, right bank, August 2012; Middle right: 300-m transect, downstream, July 2012; Bottom: 300-m transect, upstream, July 2012.

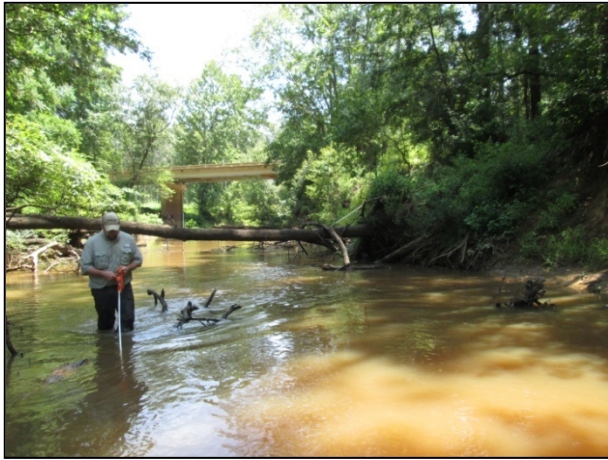
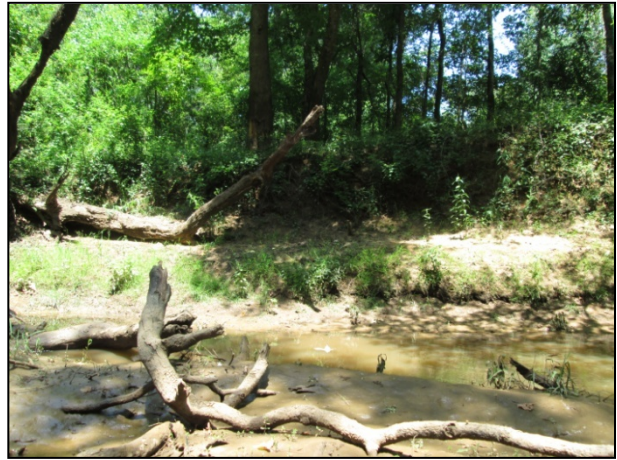
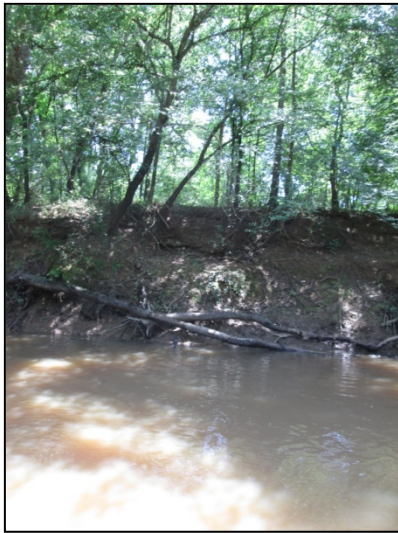
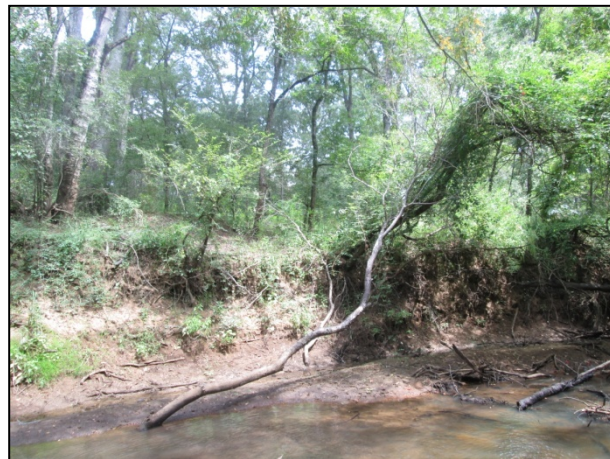
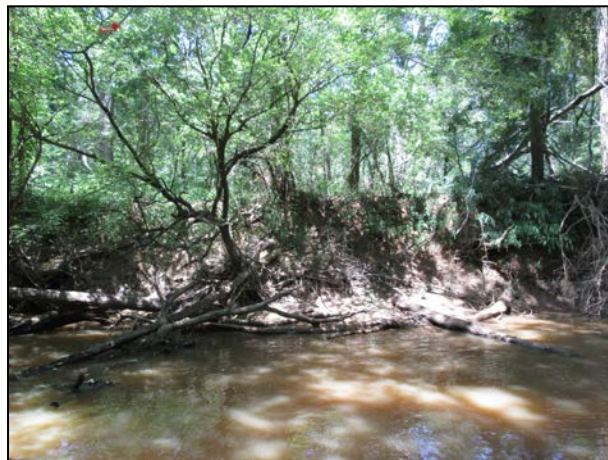
**Photogroup 4-17** Attoyac 18 depicting general stream appearance. All individuals featured are SFASU and CES staff. Top Left: 30-m transect, upstream, July 2012; Top right: 150-m transect, upstream, July 2012; Middle left: 300-m transect, upstream, July 2012; Middle right: 150-m transect, upstream, August 2012; Bottom left: 300-m transect, downstream, July 2012; Bottom right: 30-m transect, upstream, August 2012.

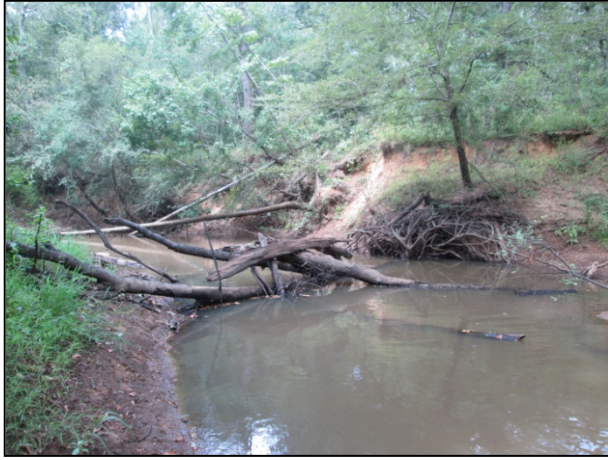
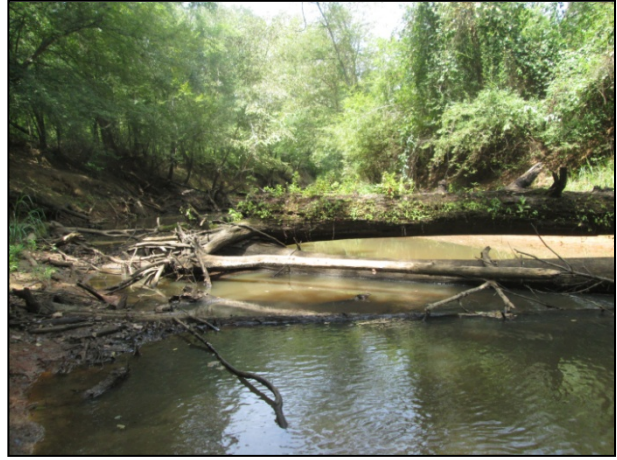
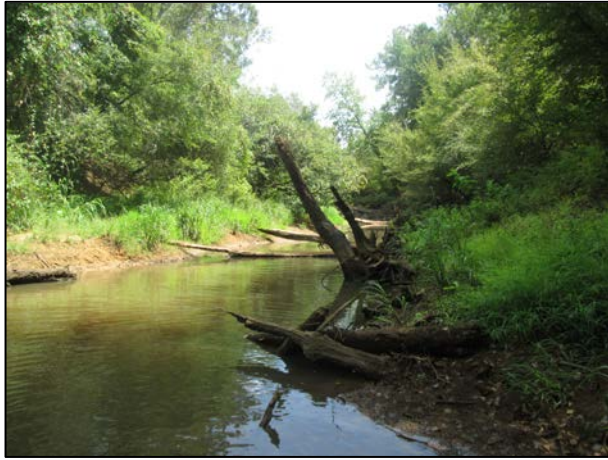
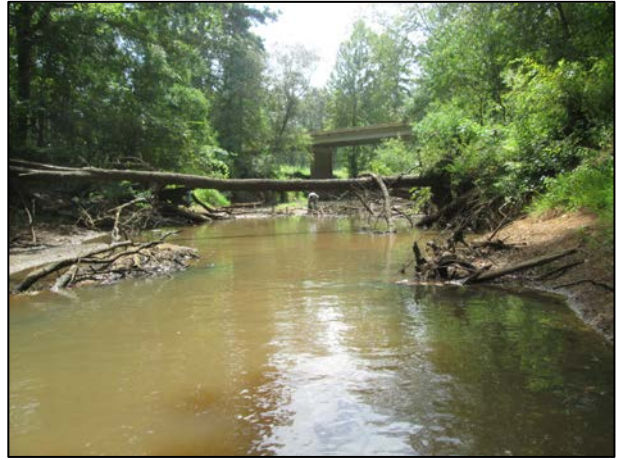
**Photogroup 4-17** Attoyac 18 depicting general bank appearance. All individuals featured are SFASU and CES staff. Top left: 30-m transect, downstream, July 2012; Top right: 30-m transect, left bank, July 2012; Middle left: 300-m transect, right bank, August 2012; Middle right: 150-m transect, left bank, August 2012; Bottom: 150-m transect, left bank, July 2012.

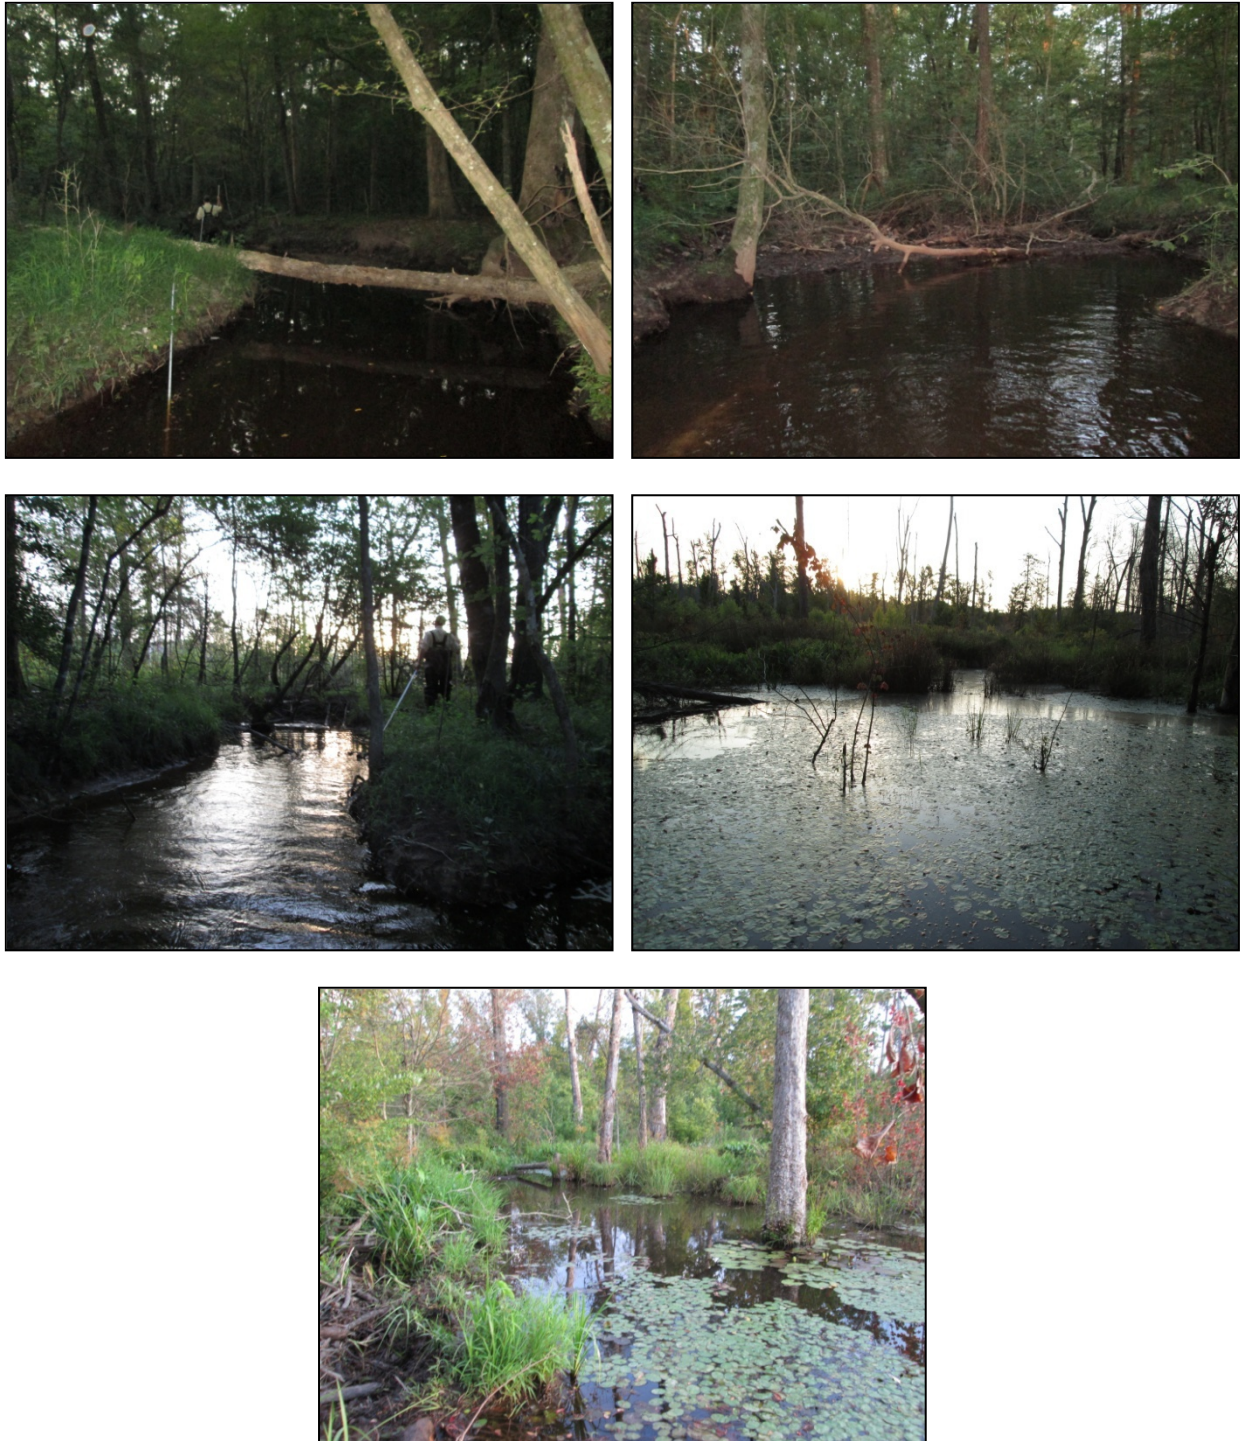
**Photogroup 4-18** Big Iron Ore 1 depicting general stream characteristics. All individuals featured are SFASU and CES staff. Top left: 30-m transect, upstream, July 2012; Top right: 150-m transect, downstream, July 2012; Middle left: 150-m transect, upstream, July 2012; Middle right: 300-m transect, upstream, July 2012; Bottom: 300-m transect, left bank, July 2012.

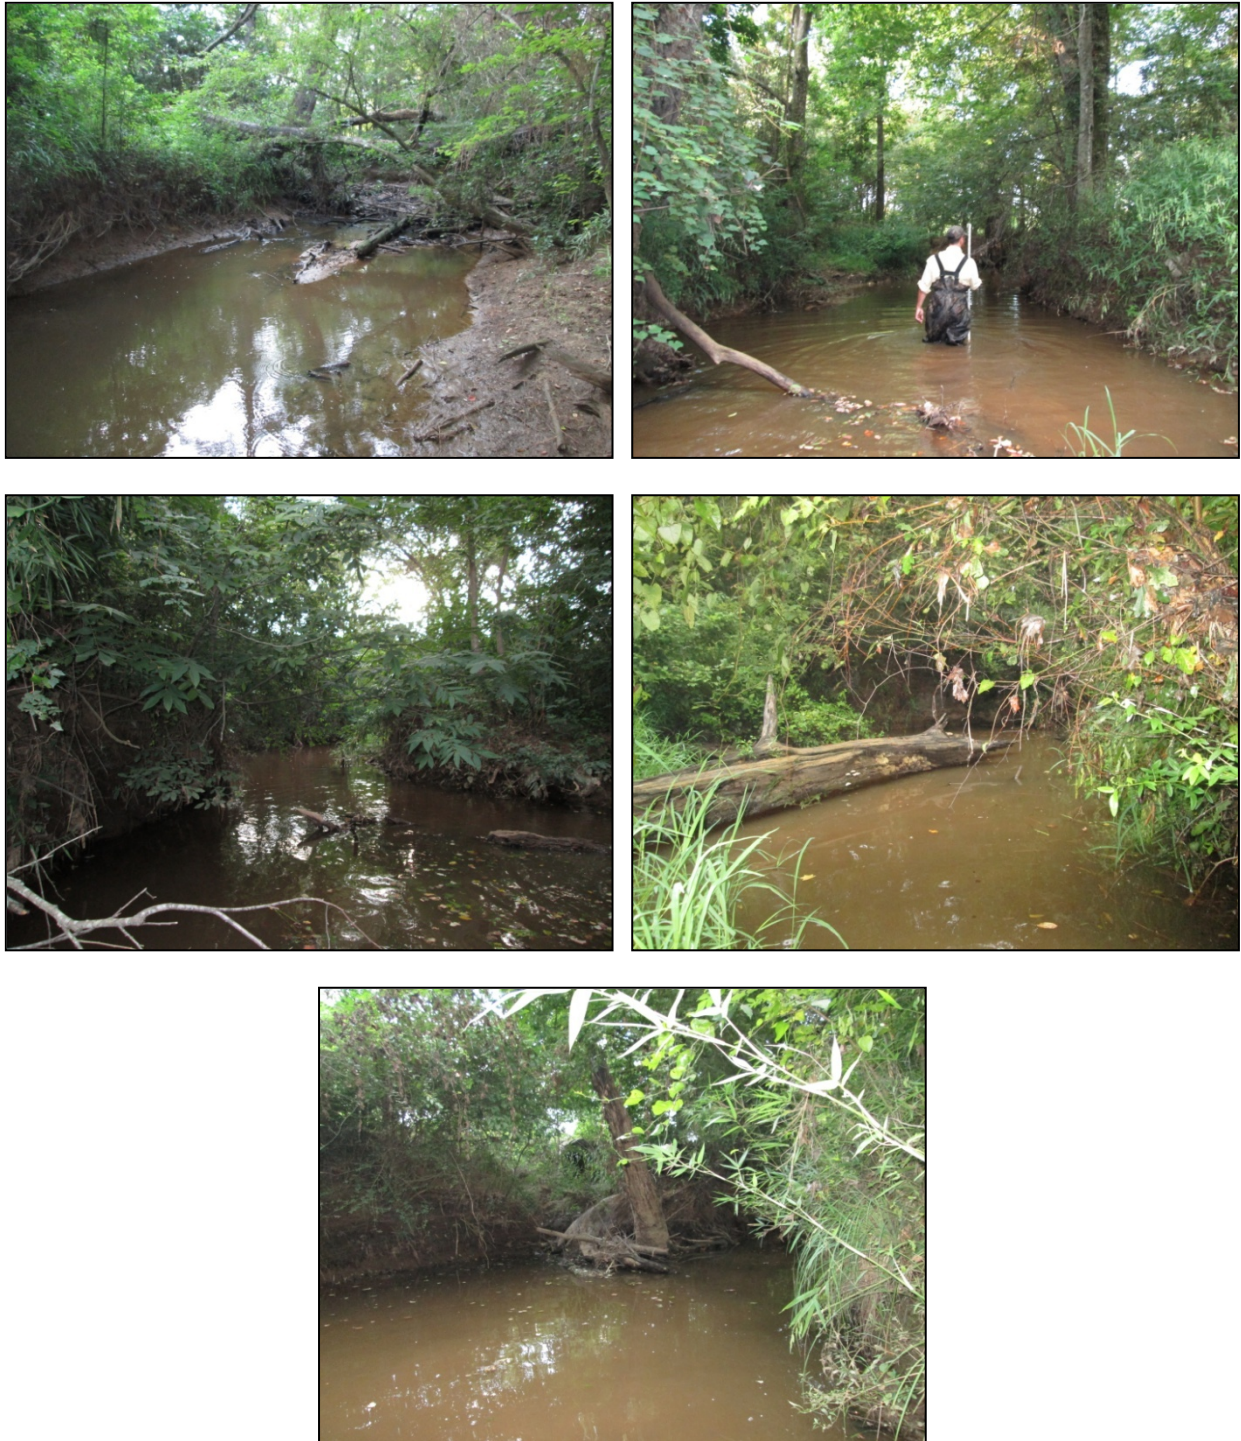
**Photogroup 4-19** Big Iron Ore 2 depicting general stream characteristics. All individuals featured are SFASU and CES staff. Top left: 30-m transect, upstream, July 2012; Top right: 150-m transect, upstream, July 2012; Middle left: 300-m, upstream, July 2012; Middle right: 150-m transect, downstream, August 2012; Bottom: 300-m transect, downstream, August 2012.

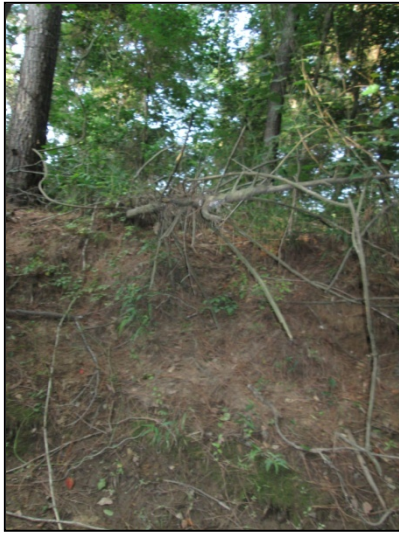
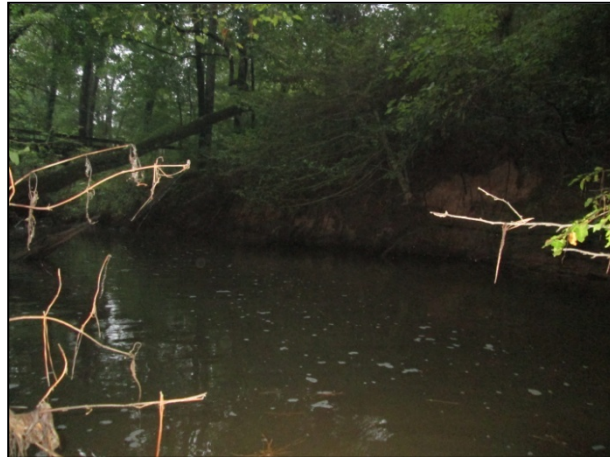
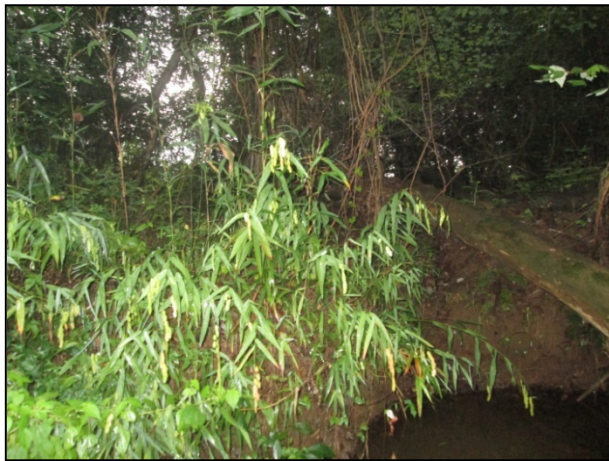
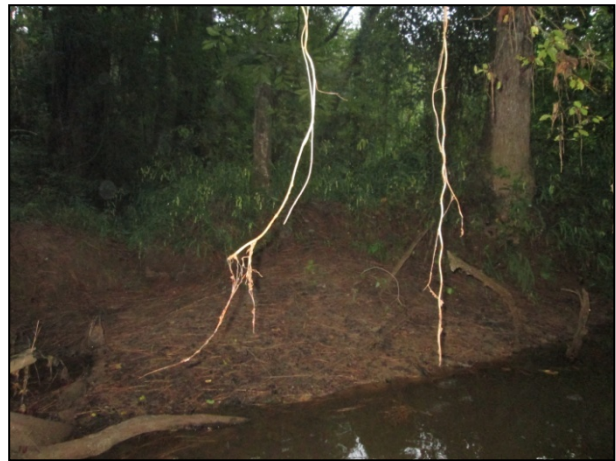
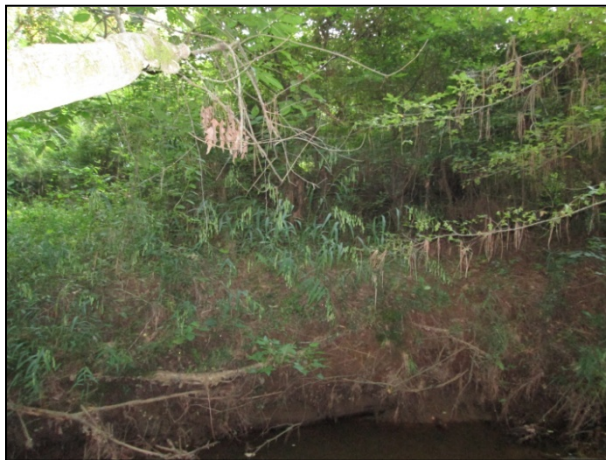
**Photogroup 4-19** Big Iron Ore 2 depicting general bank appearance. Top left: 30-m transect, right bank, July 2012; Top right: 30-m transect, downstream, August 2012; Middle left: 150-m transect, left bank, August 2012; Middle right: 30-m transect, left bank, August 2012; Bottom: 30-m transect, left bank, July 2012.

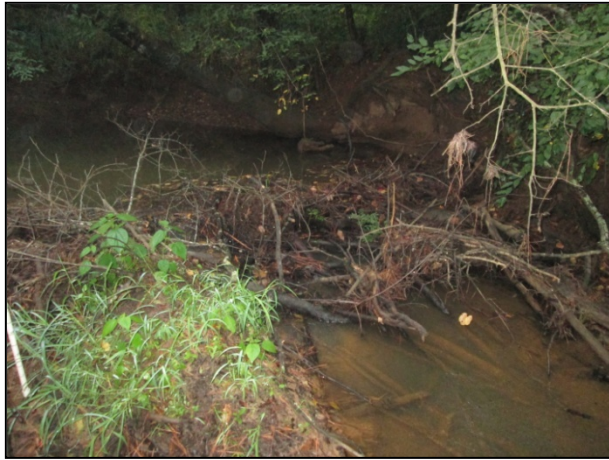
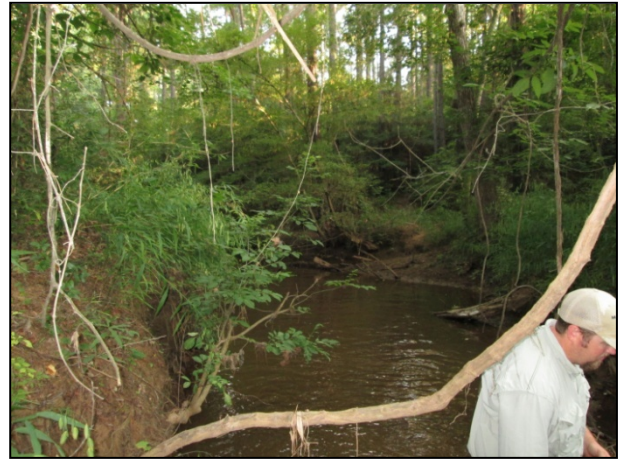
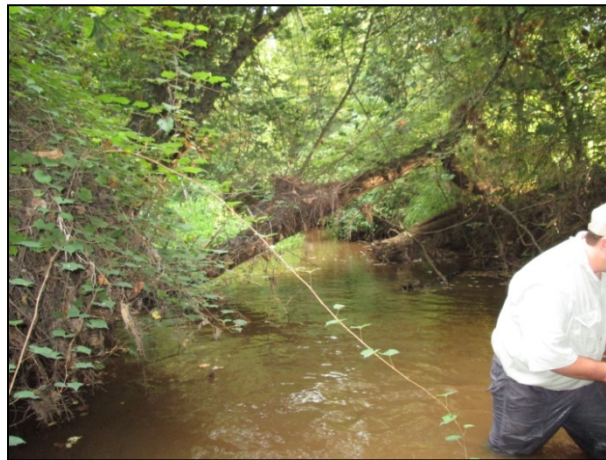
**Photogroup 4-19** Big Iron Ore 2 depicting water surface characteristics. Top left: Beaver dam; Top right: 30-m transect, downstream, July 2012; Bottom: 150-m transect, downstream, July 2012.

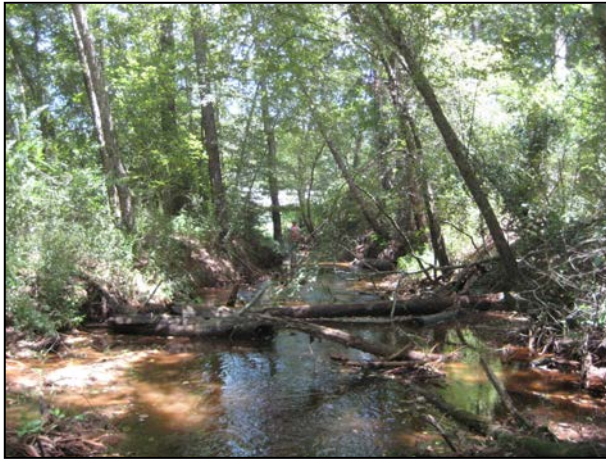
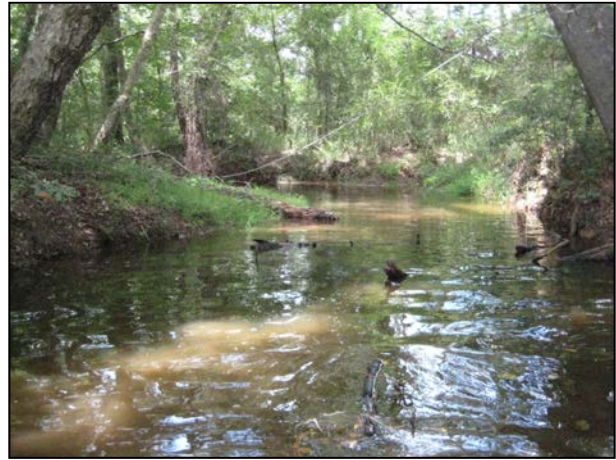
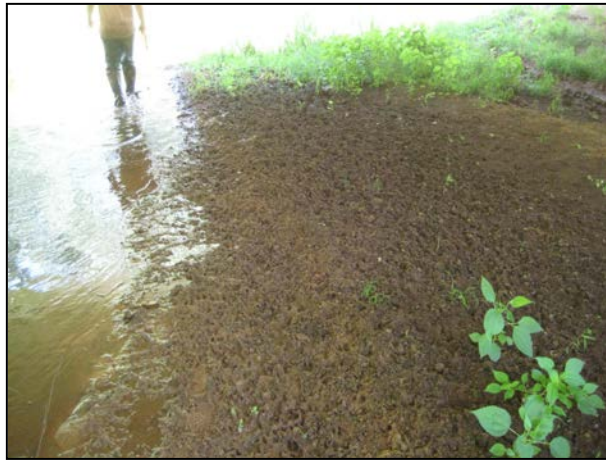
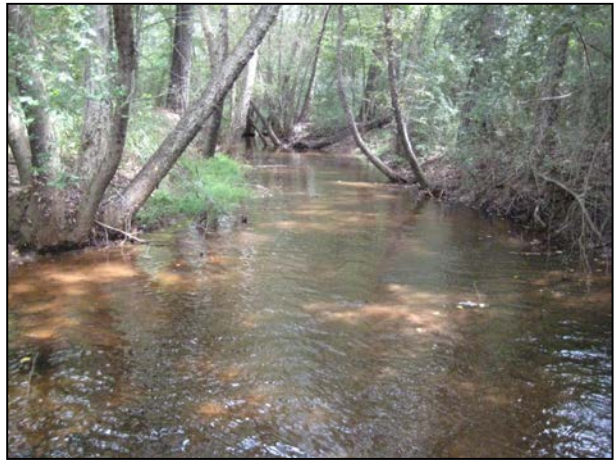
**Photogroup 4-25** Naconiche 6 depicting water surface characteristics and possible source of contamination. All individuals featured are SFASU and CES staff. Top left: 300-m transect, downstream, July 2012; Top right: 30-m transect, upstream, August 2012; Bottom left: Feral hog tracks/heavy use under CR 2435 crossing, July 2012; Bottom right: 150-m transect, downstream, August 2012.

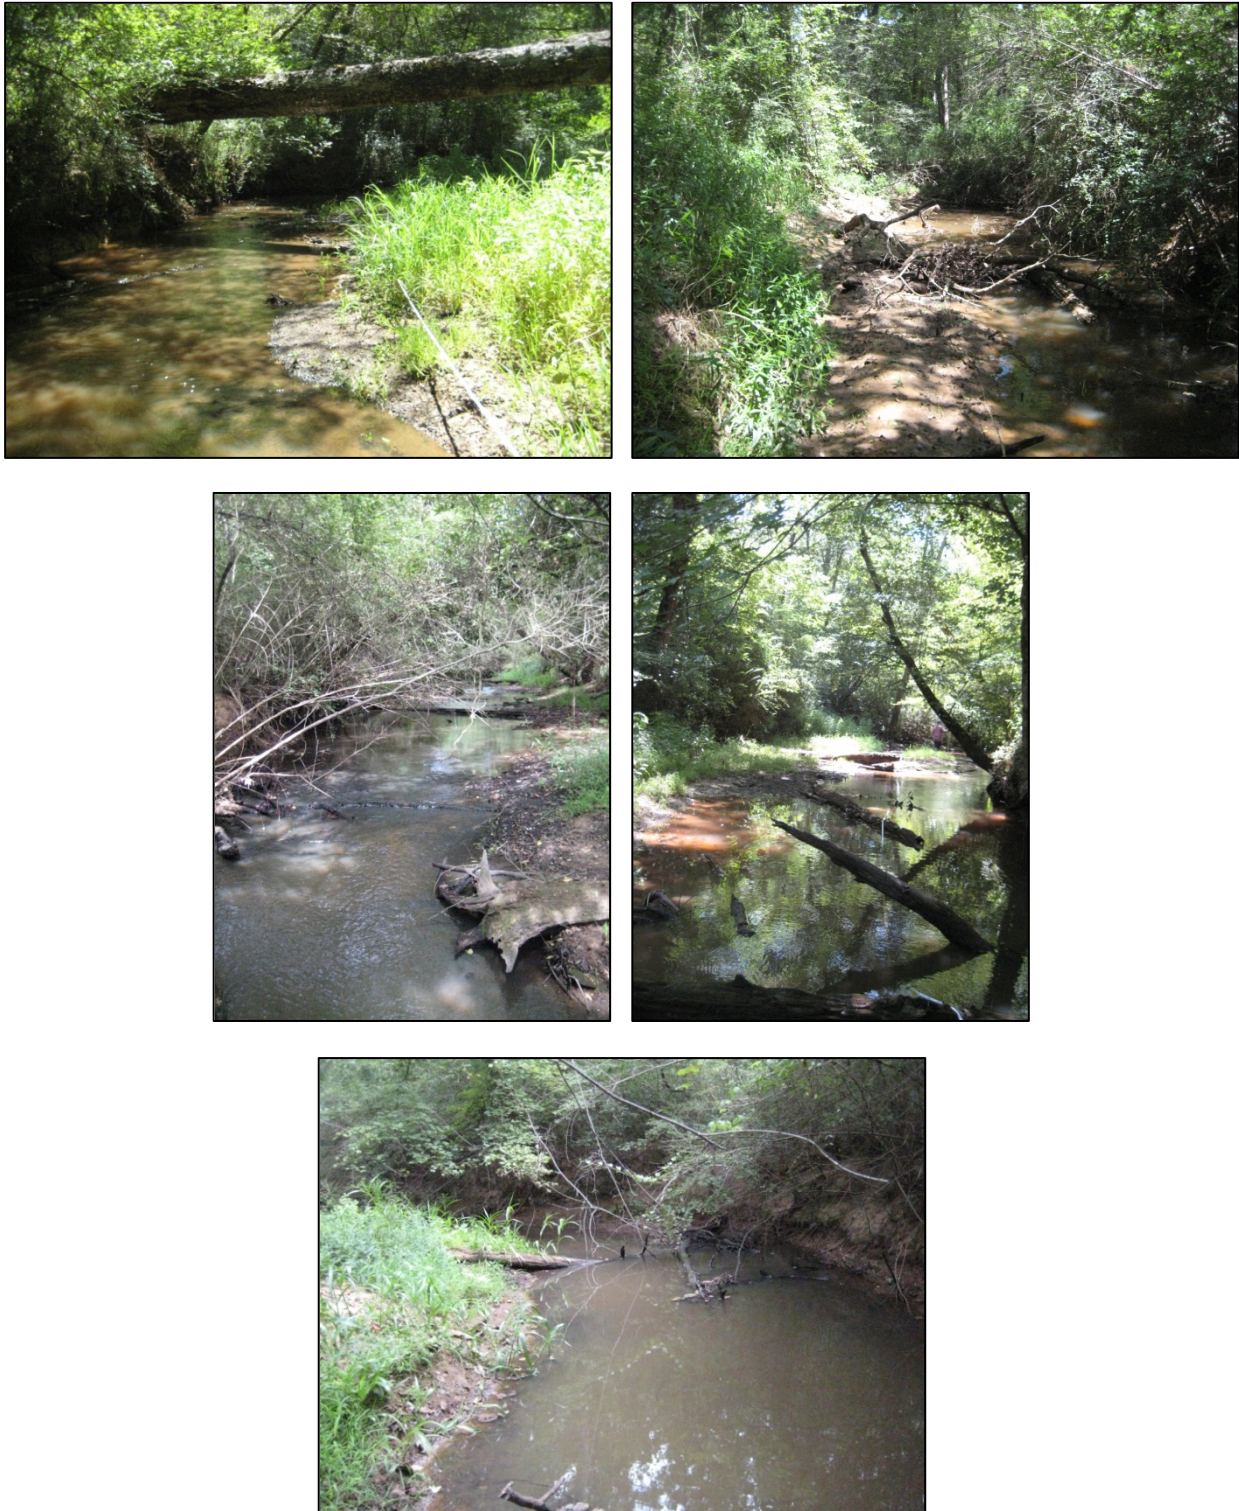
**Photogroup 4-26** Naconiche 7 depicting general stream characteristics. Top left: 150-m transect, downstream, July 2012; Top right: 300-m transect, upstream, July 2012; Middle left: 150-m transect, upstream, August 2012; Middle right: 30-m transect, downstream, July 2012; Bottom: 300-m transect, upstream, August 2012.

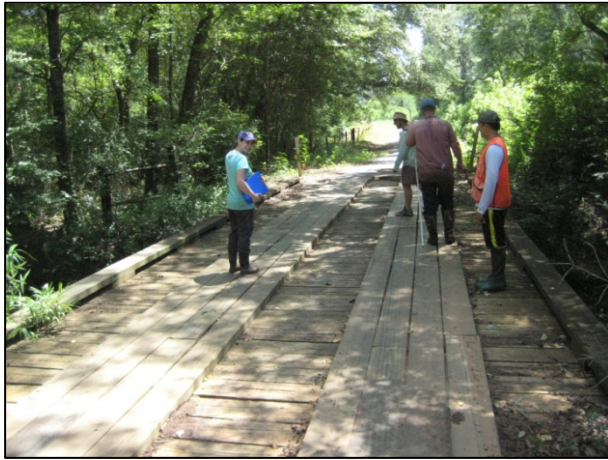
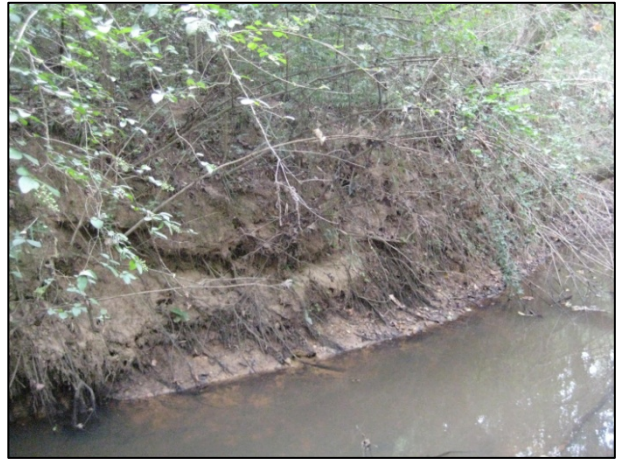
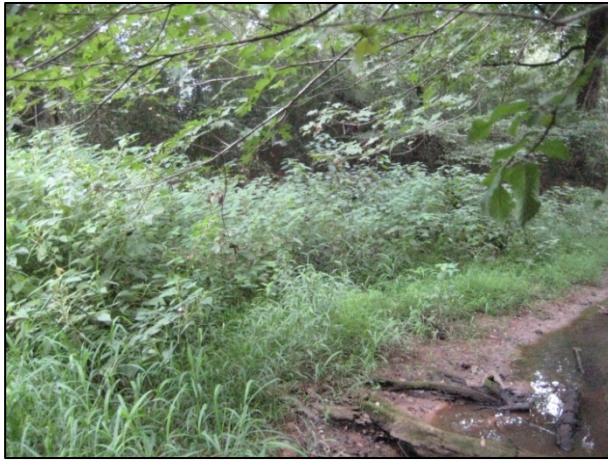
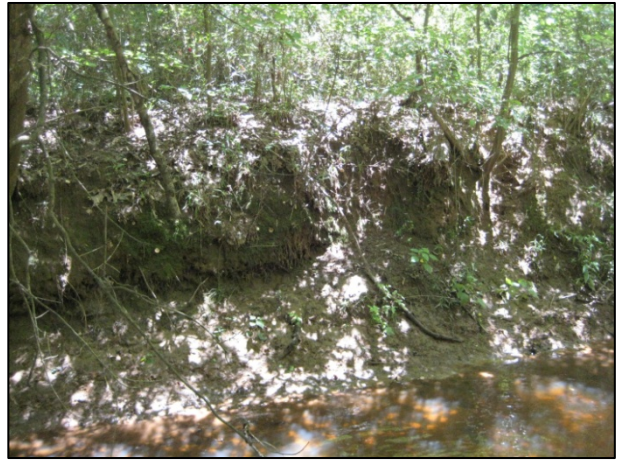
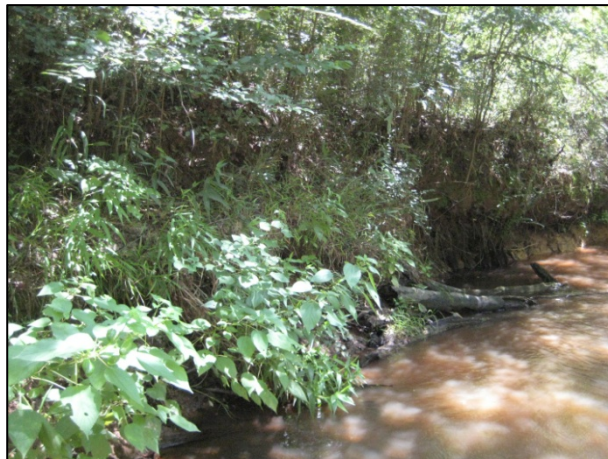
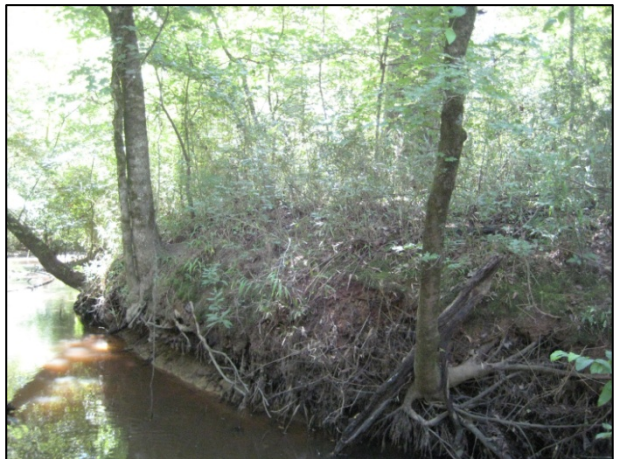
**Photogroup 4-26** Naconiche 7 depicting bank access and general bank appearance. All individuals featured SFASU and CES staff. Top left: CR 271 crossing/access point, July 2012; Top right: 300-m transect, left bank, August 2012; Middle left: 30-m transect, left bank, August 2012; Middle right: 300-m transect, right bank, July 2012; Bottom left: 150-m transect, right bank, July 2012; Bottom right: 30-m transect, right bank, July 2012.

The owner of a tract adjacent to Naconiche 7 states that he swam in the Naconiche frequently as a child, and also heard community members speaking in generalities about fishing in the stream. However, both instances of recreation he mentioned pre-date the 1975 established RUAA standard of relevance. He noted specifically the Naconiche flows significantly less now than it did when he was growing up.

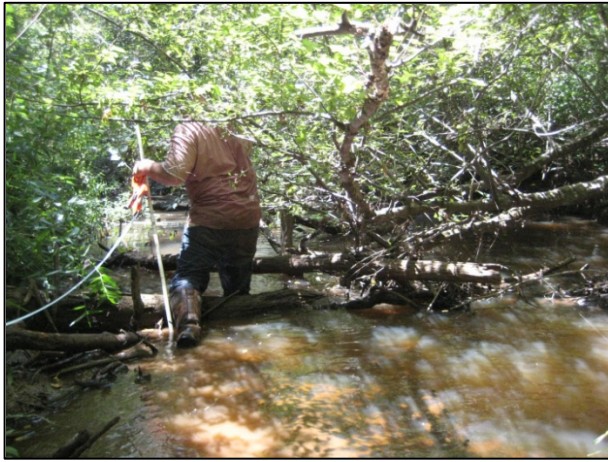
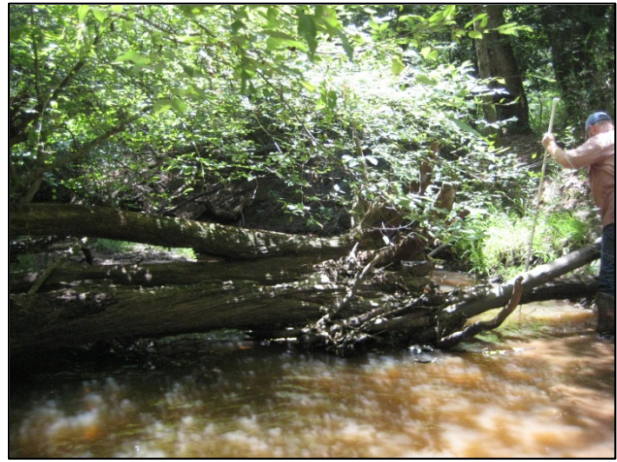
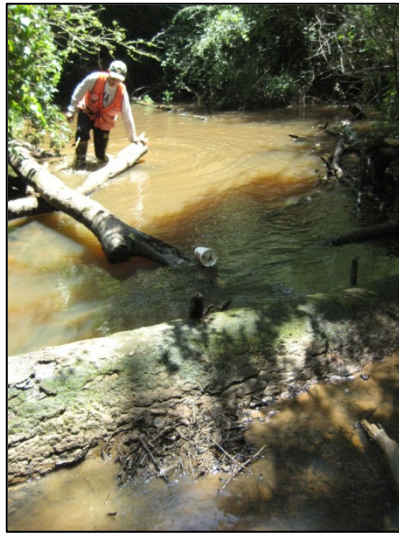
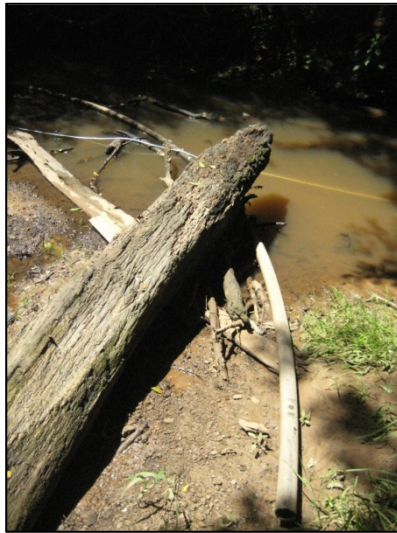
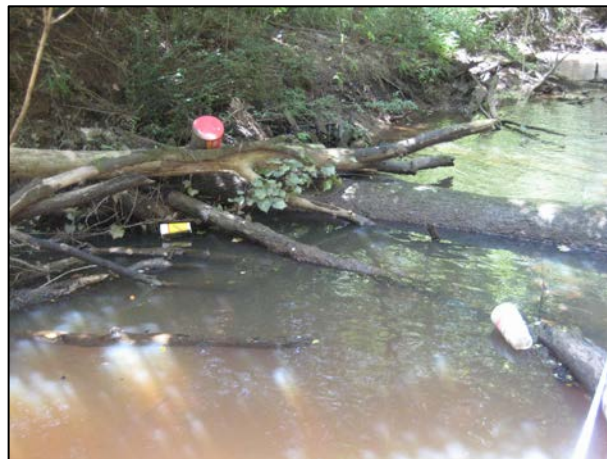
**Photogroup 4-26** Naconiche 7 depicting water surface characteristics. All individuals featured SFASU and CES staff. Top left: Large woody debris across/within channel, July 2012; Top right: Large woody debris across/within channel, July 2012; Middle left: Large woody debris in channel, July 2012; Middle right: Large woody debris and littler within channel, July 2012; Bottom: Large woody debris and small litter within channel, July 2012.

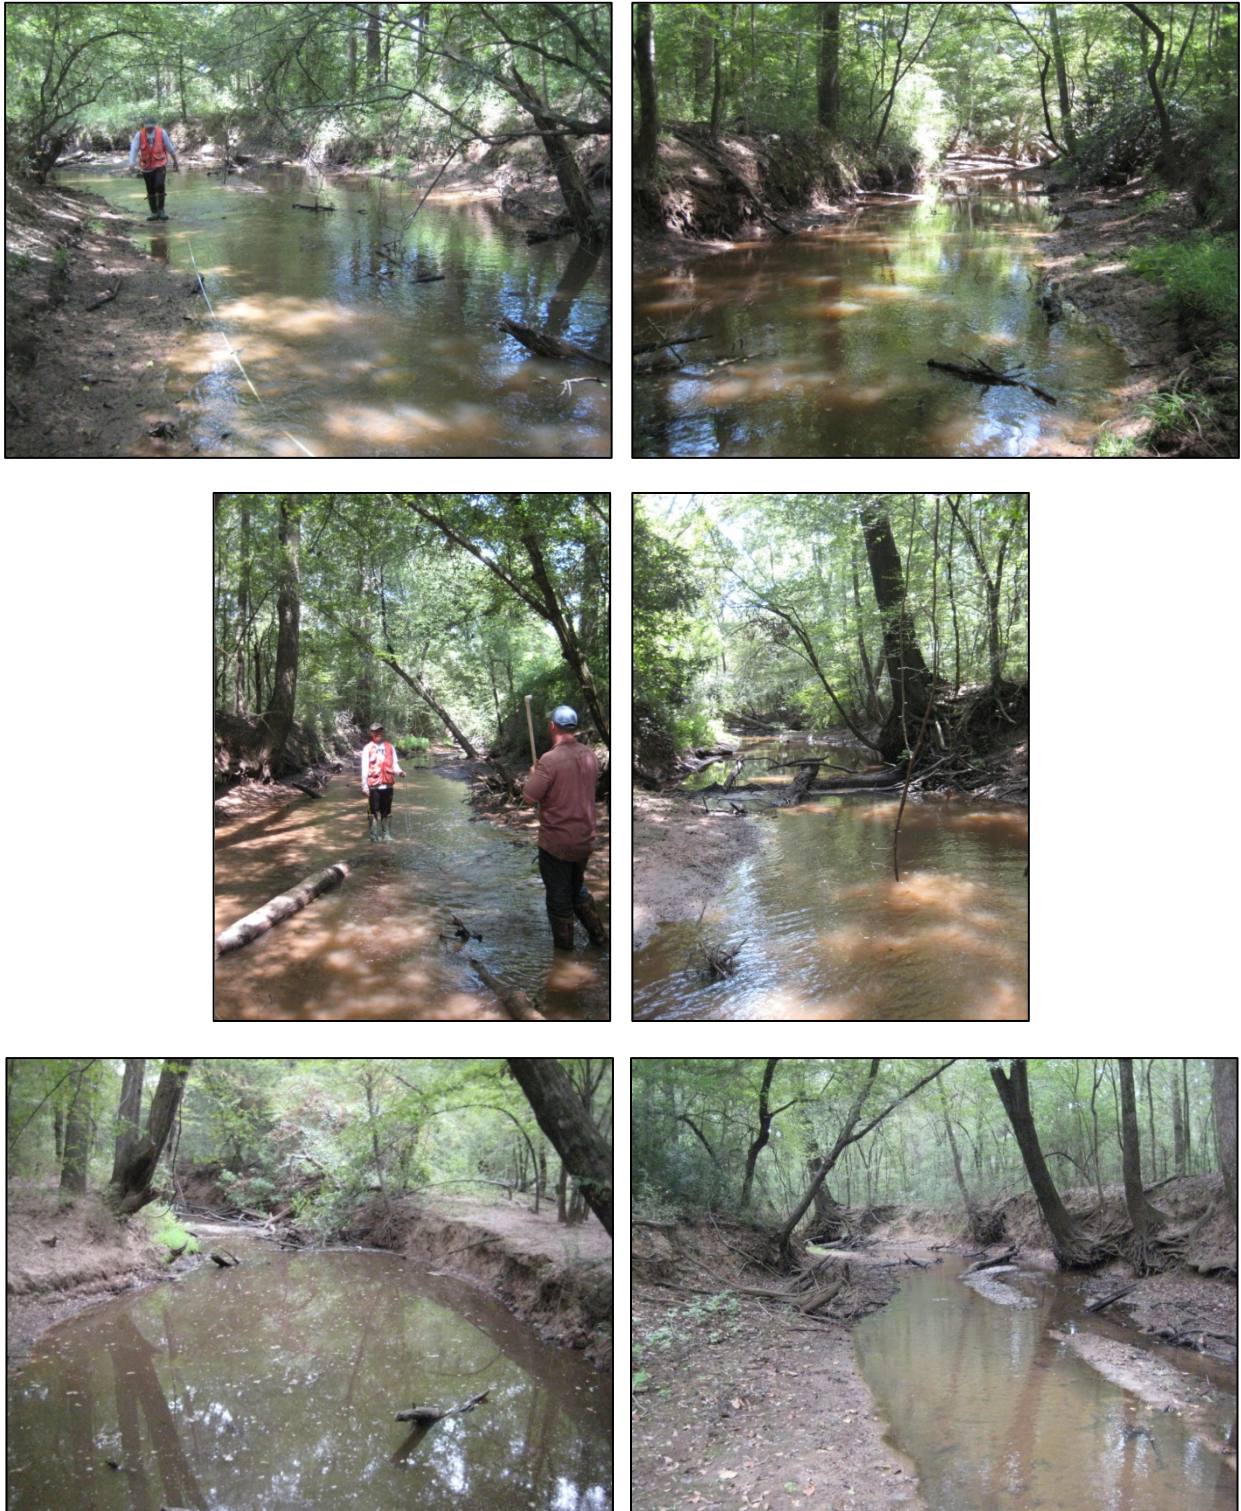
**Photogroup 4-27** Naconiche 8 depicting general stream characteristics. All individuals featured are SFASU and CES staff. Top left: 150-m transect, upstream, July 2012; Top right: 150-m transect, downstream, July 2012; Middle left: 300-m transect, upstream, July 2012; Middle right: 300-m transect, downstream, July 2012; Bottom left: 30-m transect, downstream, August 2012; Bottom right: 300-m transect, downstream, August 2012.

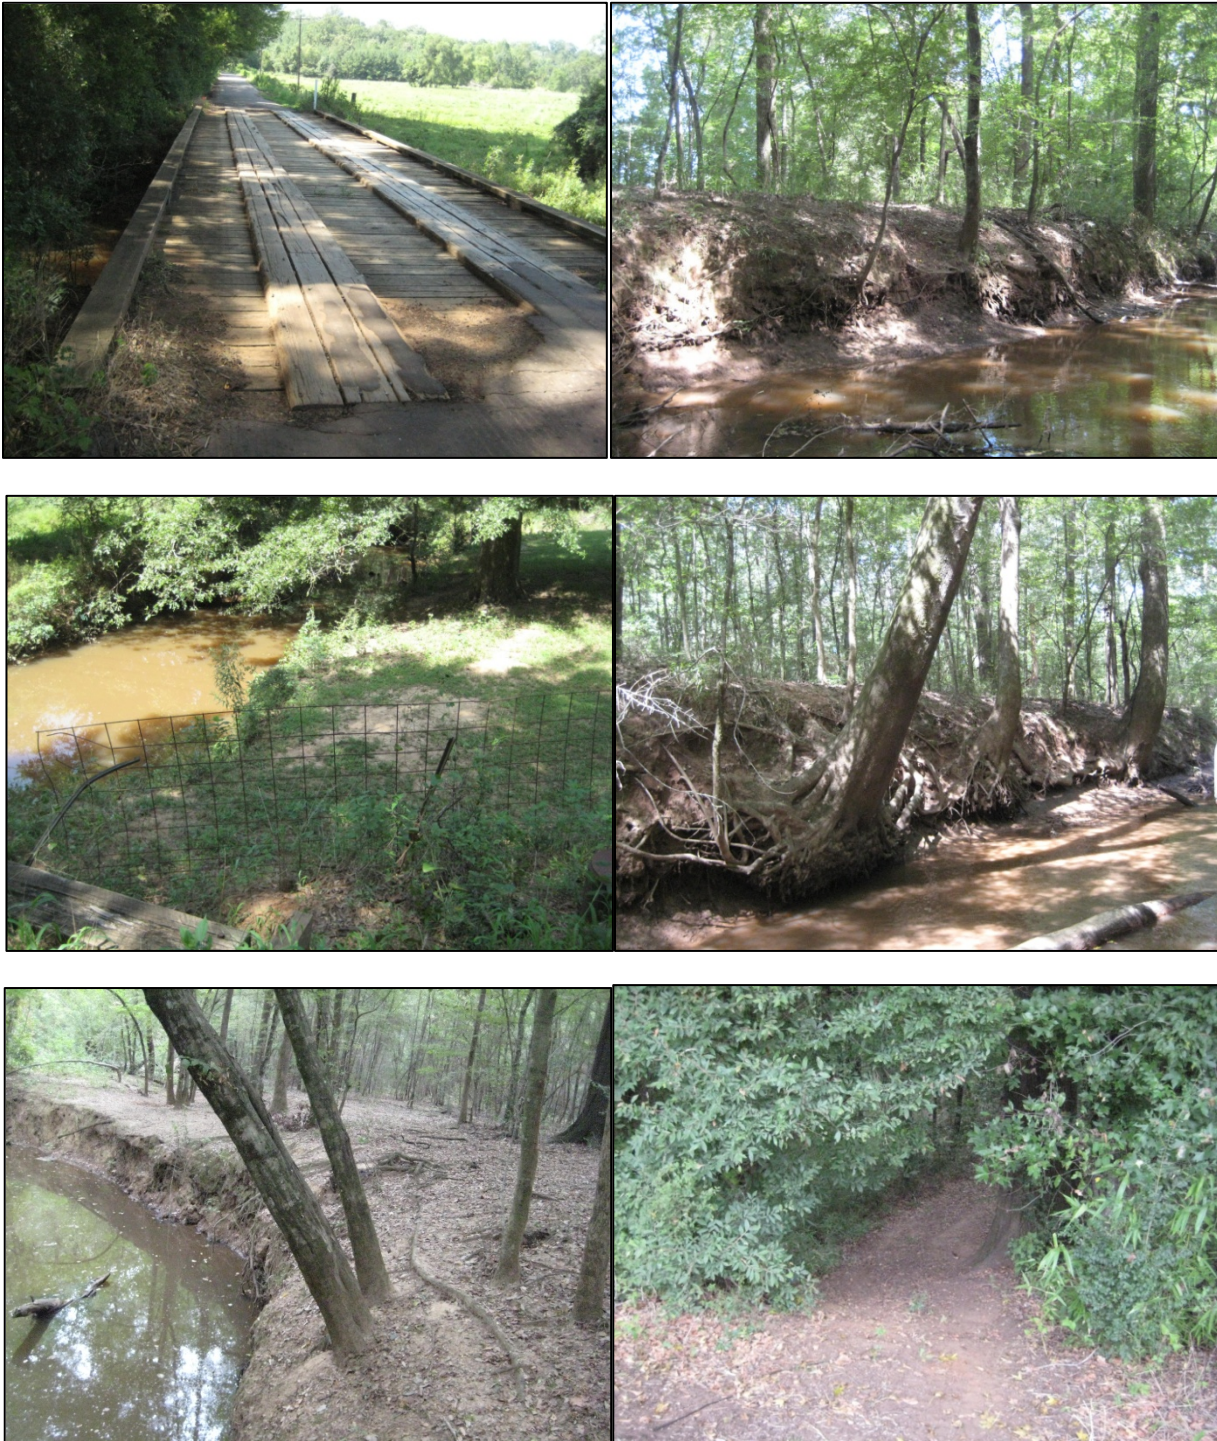
An ATV trail/access point was present on the right bank adjacent to the Cedar Bluff Road. No further signs of human access points were evident within the 300 meter reach of the survey. A portion of the upstream, left bank is fenced at the road crossing to prevent public access. Signs of recreation were also present in the form of a fish bait container. A portion of the container was found on the bank next to the road crossing while the bottom of the container was found in the stream channel. A tire, bucket, and old drink can were also present in the stream channel. Photogroup 5-14 documents these indications of recreational activity.

**Photogroup 4-27** Naconiche 8 depicting general bank appearance. All individuals featured are SFASU and CES staff. Top left: Cedar Bluff Road (CR 273) crossing, July 2012; Top right: 150-m transect, left bank, July 2012; Middle left: Fenced bank upstream adjacent to road crossing, July 2012; Middle right: 300-m transect, right bank, July 2012; Bottom left: 30-m transect, right bank, August 2012; Bottom right: Possible ATV trail entrance adjacent to stream crossing, August 2012.

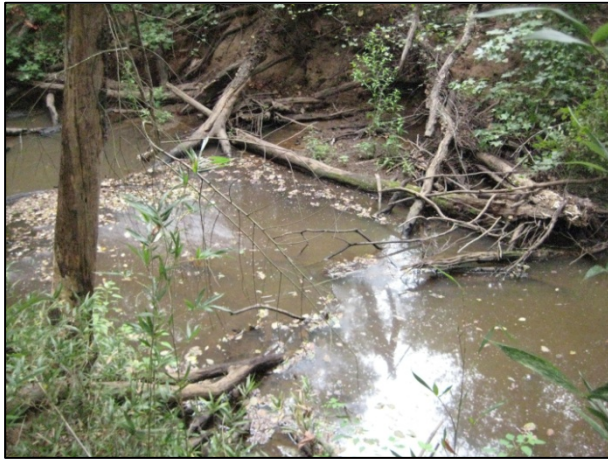
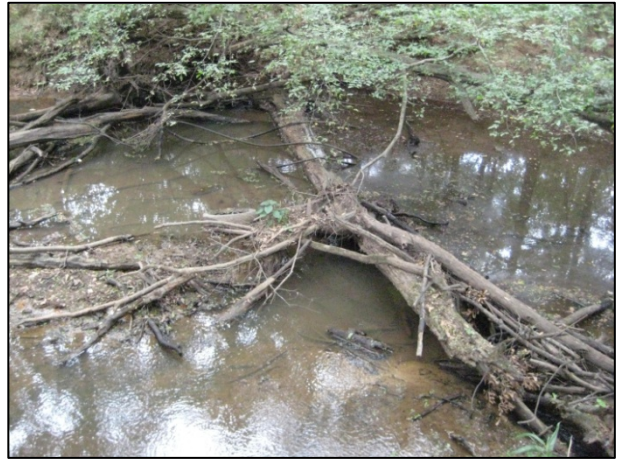
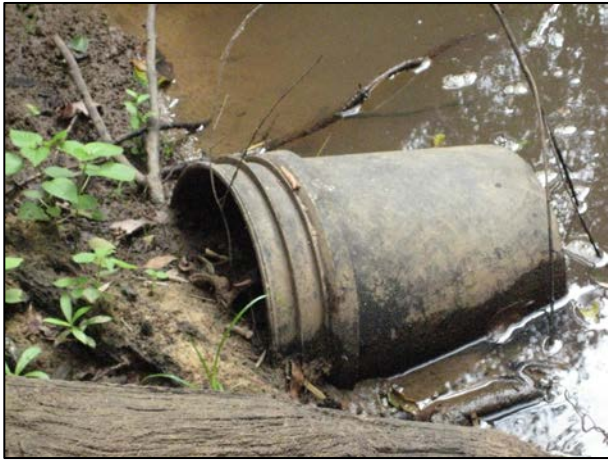
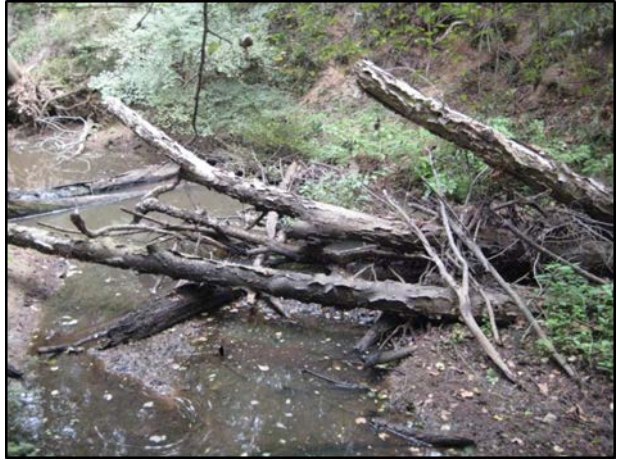
**Photogroup 4-27** Naconiche 8 depicting stream surface characteristics. Top left: Large woody debris within channel, August 2012; Top right: Large woody debris across/within channel, August 2012; Bottom left: Large channel litter (bucket), August 2012; Bottom right: Large woody debris across channel, August 2012.
