# Attoyac Bayou Recreational Use Attainability Analysis

**Attoyac Bayou  
Recreational Use Attainability Analysis**

**Texas State Soil and Water Conservation Board  
Project # 09-10**

**October 2012**

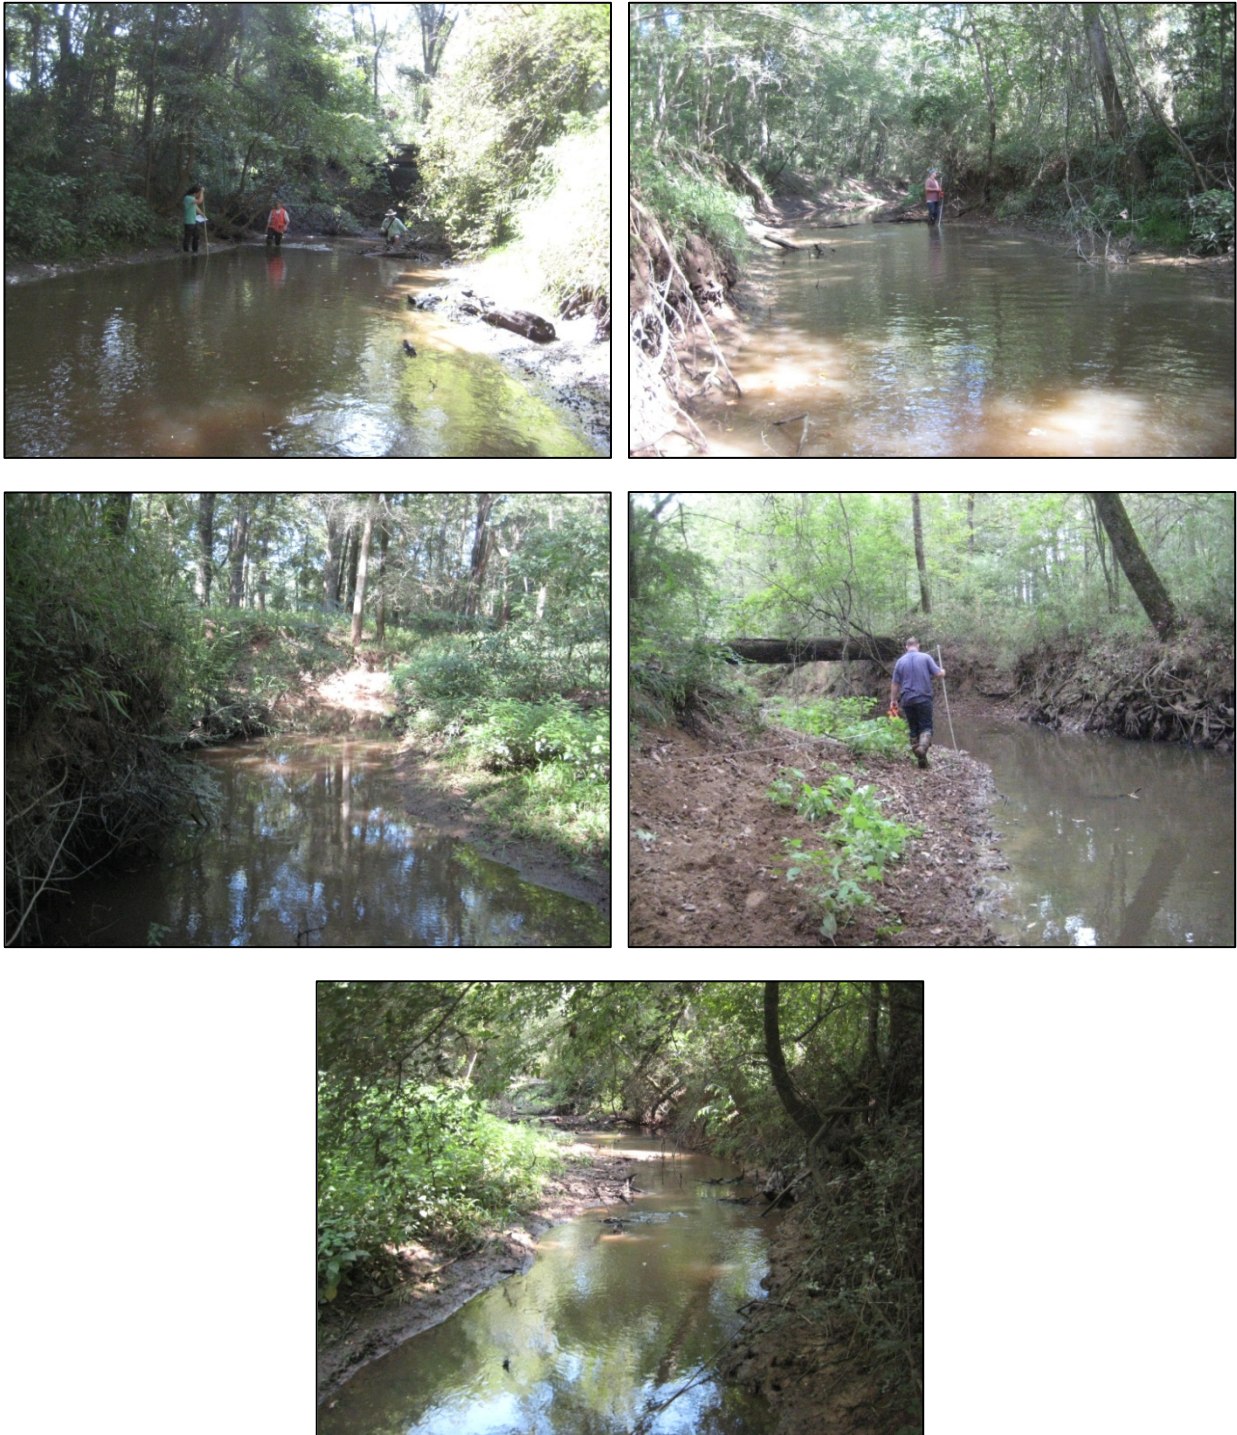
**Photogroup 4-28** Naconiche 9 depicting general stream characteristics. All individuals featured are SFASU and CES staff. Top left: 30-m transect, downstream, July 2012; Top right: 30-m transect, upstream, July 2012; Middle left: 300-m transect, downstream, July 2012; Middle right: 150-m transect, upstream, August 2012; Bottom: 300-m transect, upstream, August 2012.

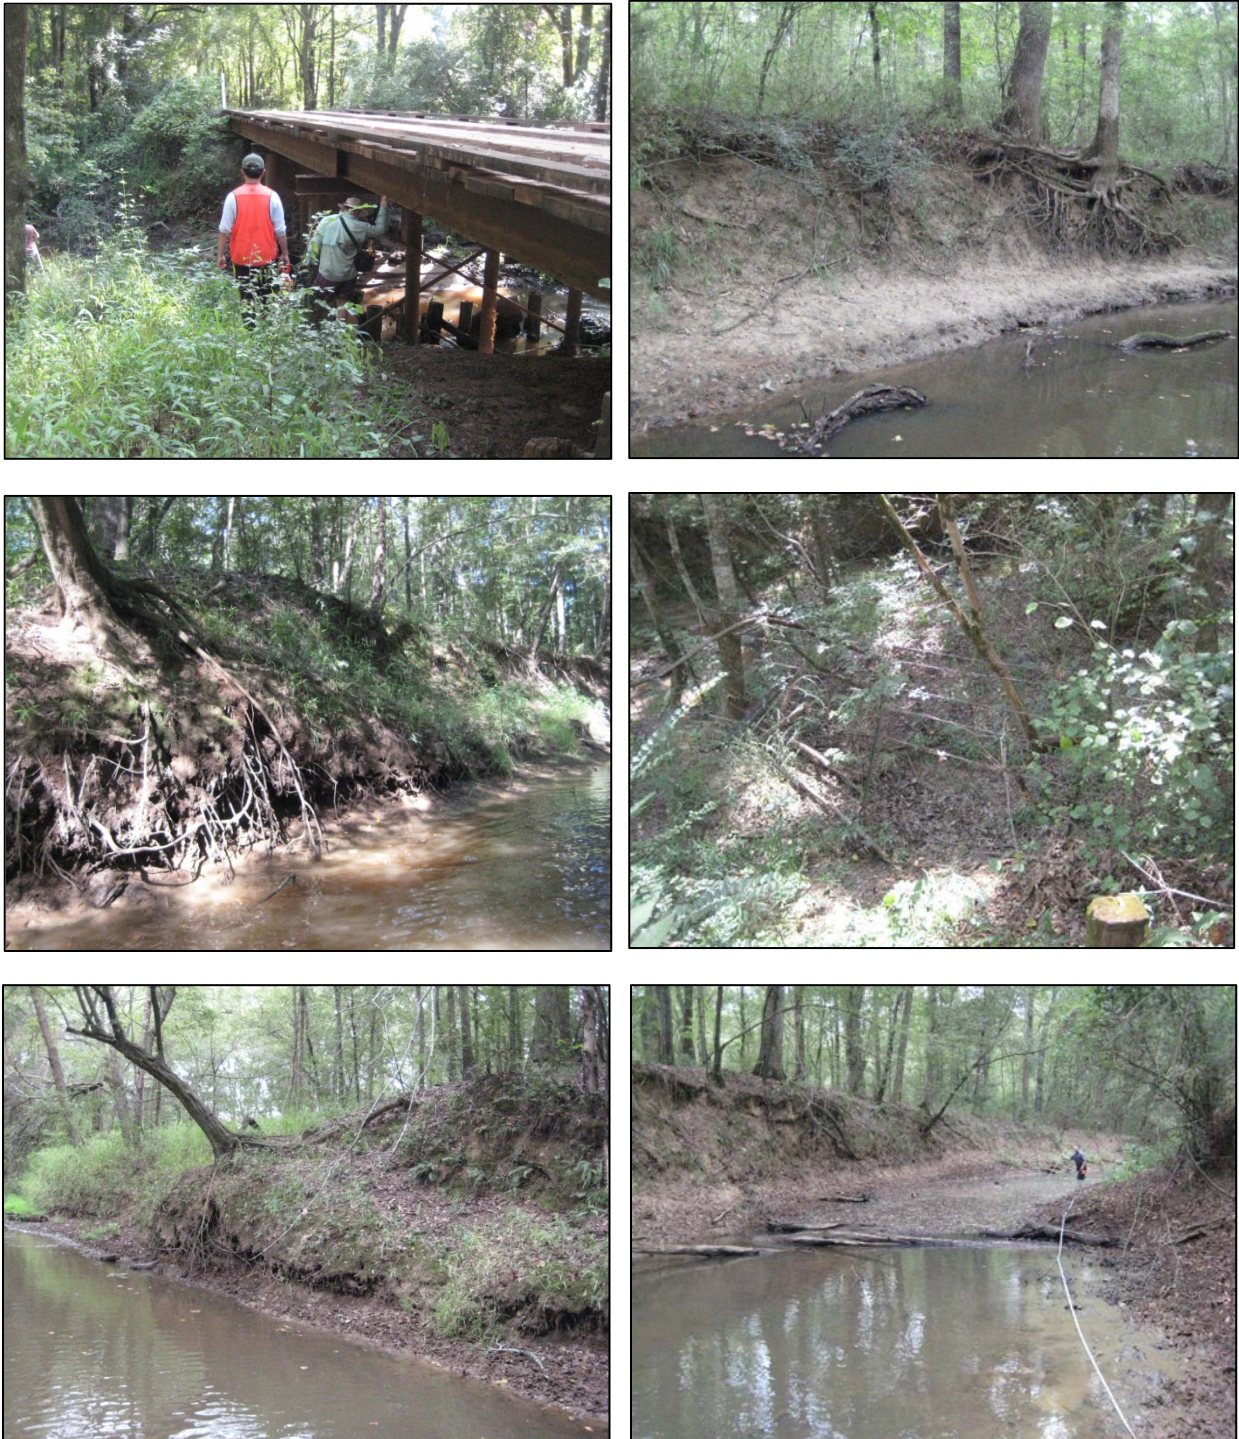
**Photogroup 4-28** Naconiche 9 depicting bank access and general bank appearance. All individuals featured are SFASU and CES staff. Top left: CR 280 crossing/channel access point, July 2012; Top right: 150-m transect, downstream, August 2012; Middle left: 30-m transect, right bank, July 2012; Middle right: Fenced downstream bank, July 2012; Bottom left: 30-m transect, right bank, August 2012; Bottom right: 30-m transect, upstream, August 2012.

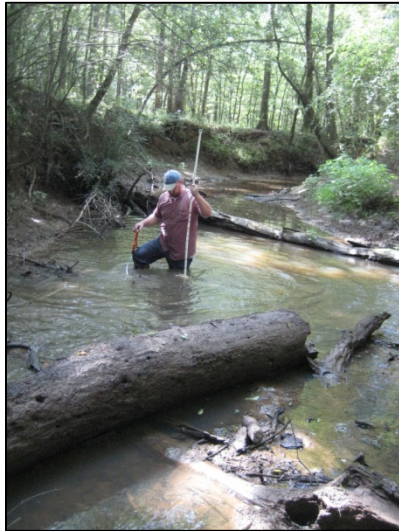
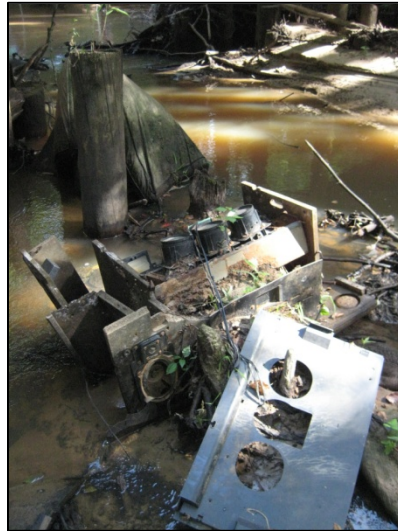
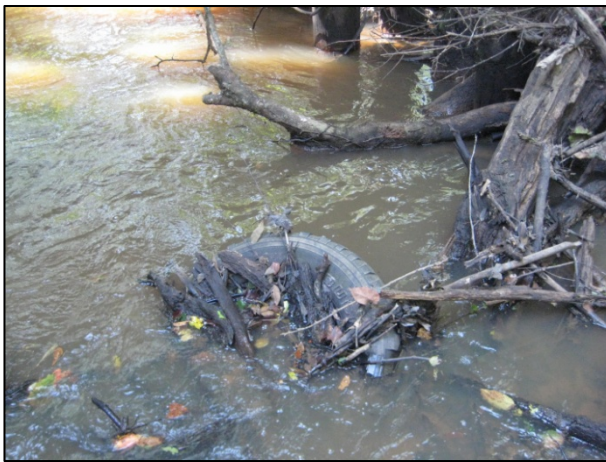
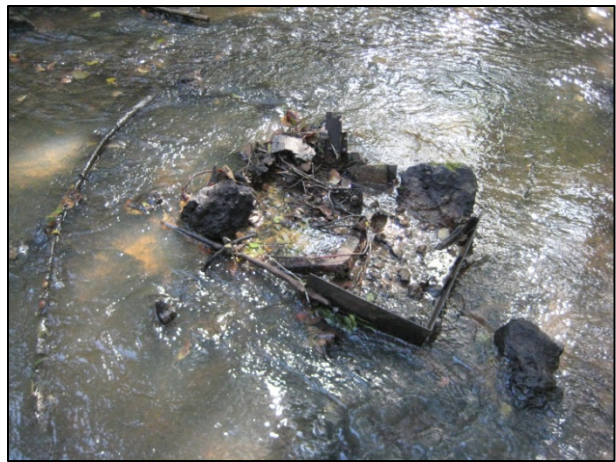
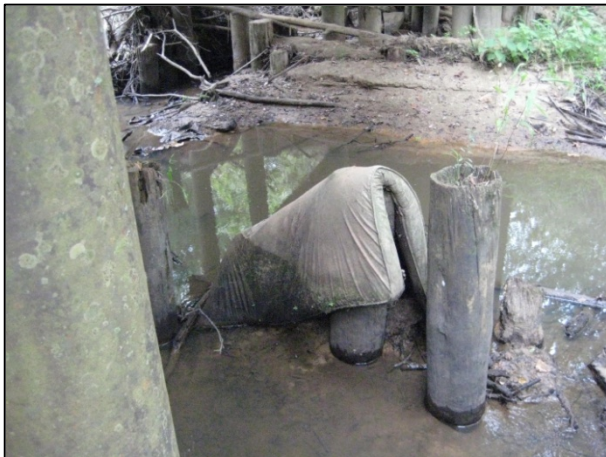
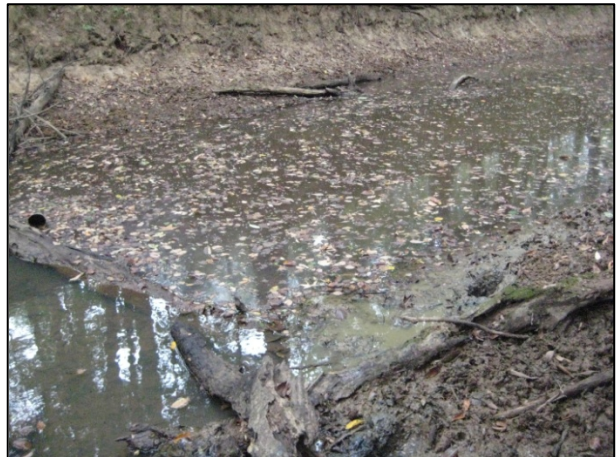
**Photogroup 4-28** Naconiche 9 depicting water surface characteristics. All individuals featured are SFASU and CES staff. Top left: Large woody debris, July 2012; Top right: Large channel litter (electronic metal object) under CR 280 crossing July 2012; Middle left: Large channel litter (tire) adjacent to CR 280 crossing, July 2012; Middle right: Large channel litter (metal object) adjacent to CR 280 crossing; Bottom left: Large channel litter (mattress) under CR 280 crossing, July 2012; Bottom right: Organic debris on water surface, August 2012.

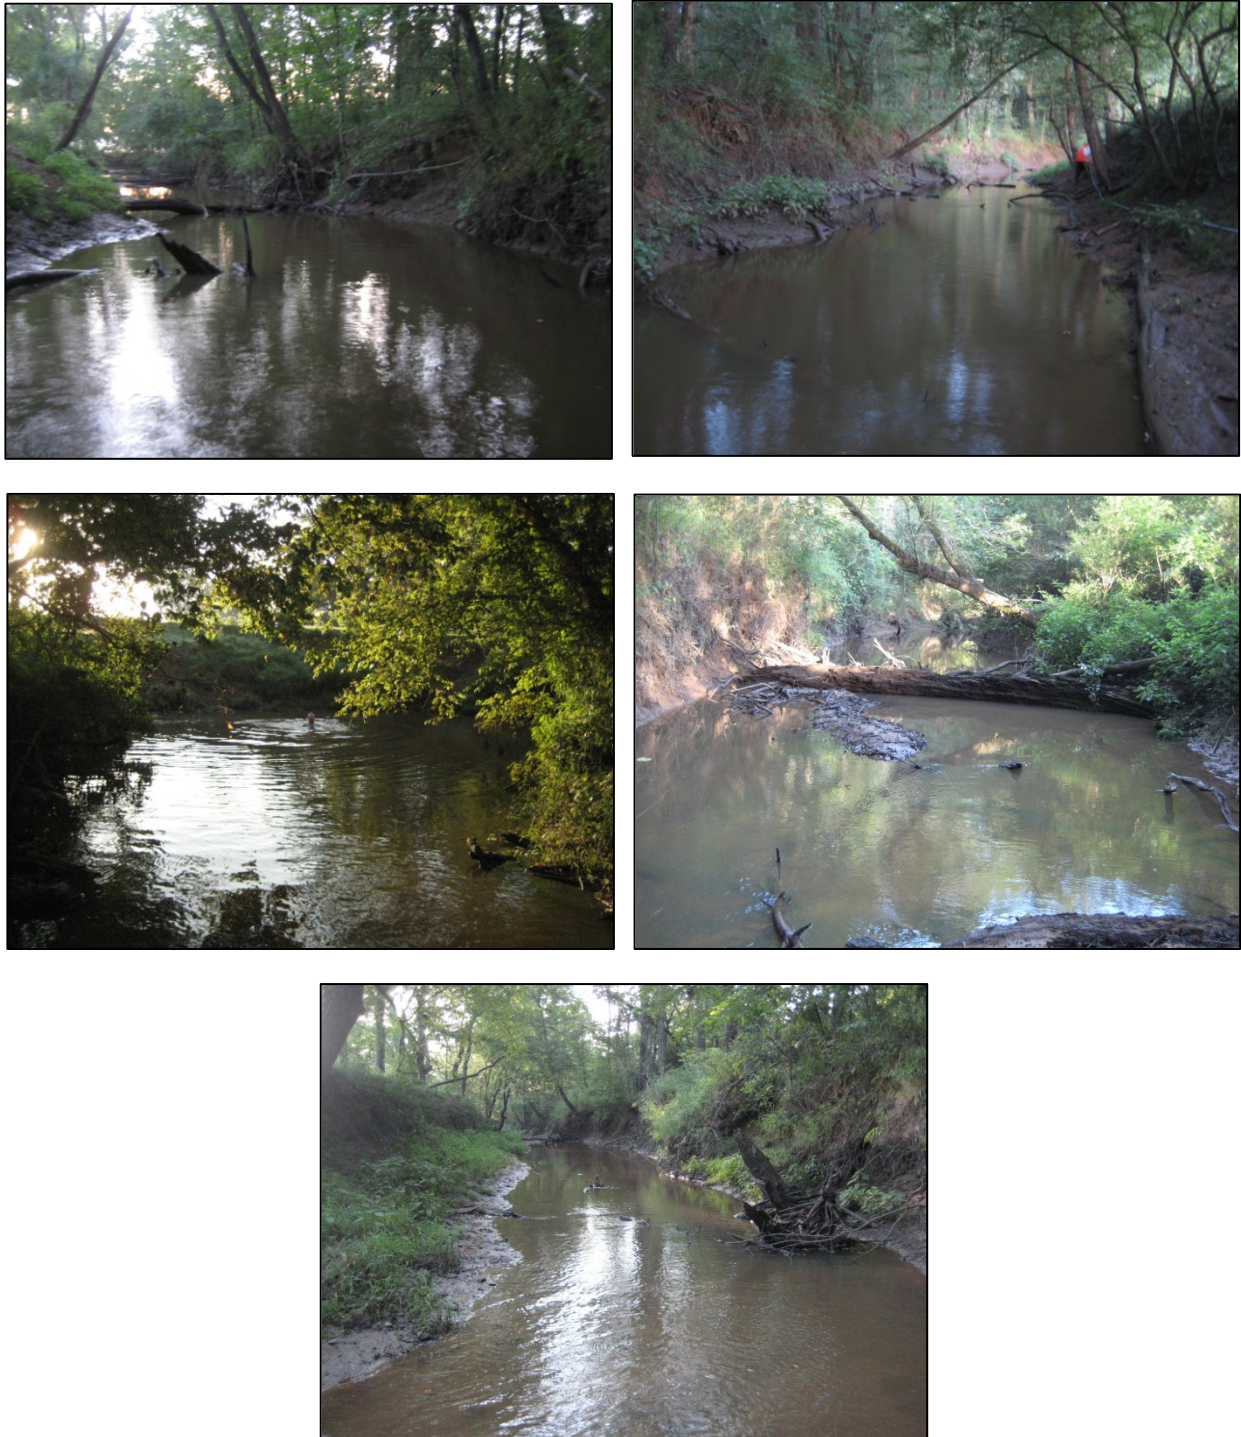
**Photogroup 4-29** Naconiche 10 depicting general stream characteristics. All individuals featured are SFASU and CES staff. Top left: 30-m transect, downstream, July 2012; Top right: 30-m transect, upstream, July 2012; Middle left: Deep pool in channel (>2m deep), July 2012; Middle right: 300-m transect, upstream, July 2012; Bottom : 300-m transect, downstream, July 2012.

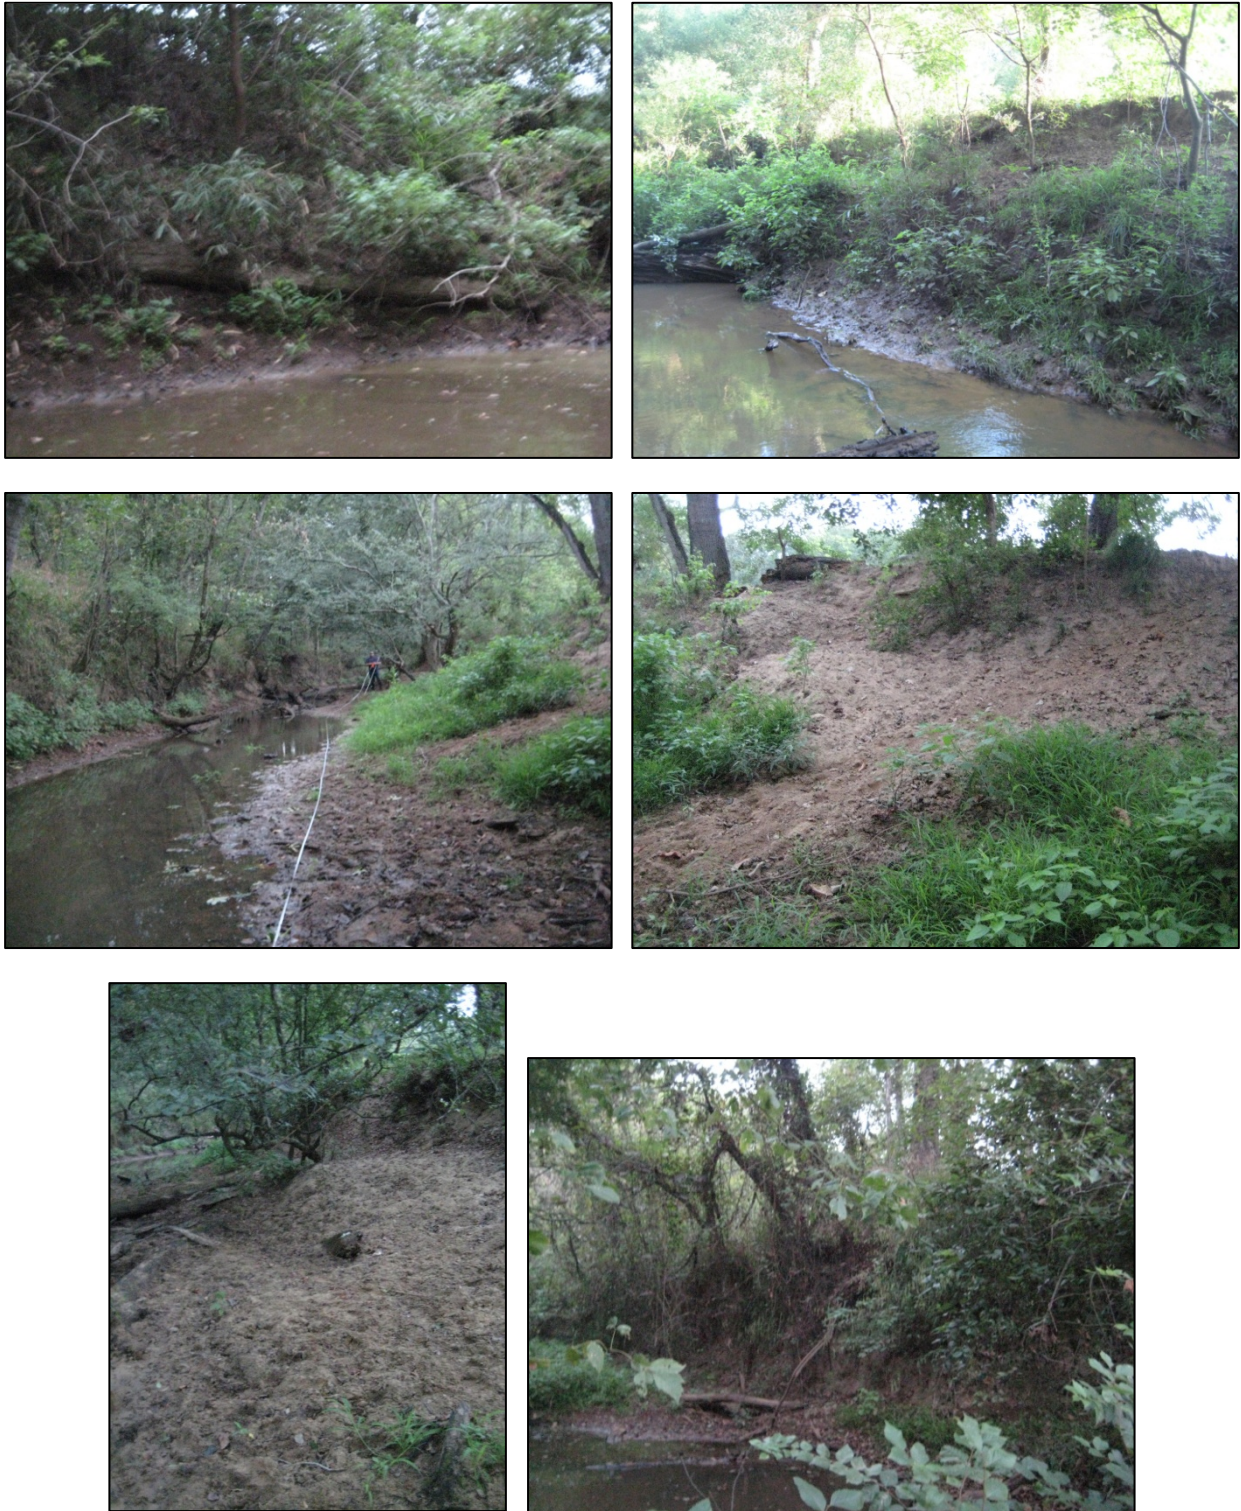
**Photogroup 4-29** Naconiche 10 depicting general bank appearance. Top left: 300-m transect, left bank, August 2012; Top right: 300-m transect, left bank, July 2012; Middle left: Downstream view with cattle access along bank, August 2012; Middle right: Livestock access along bank, August 2012; Bottom left: Heavy cattle use along right bank; August 2012; Bottom right: 150-m transect, right bank, August 2012.

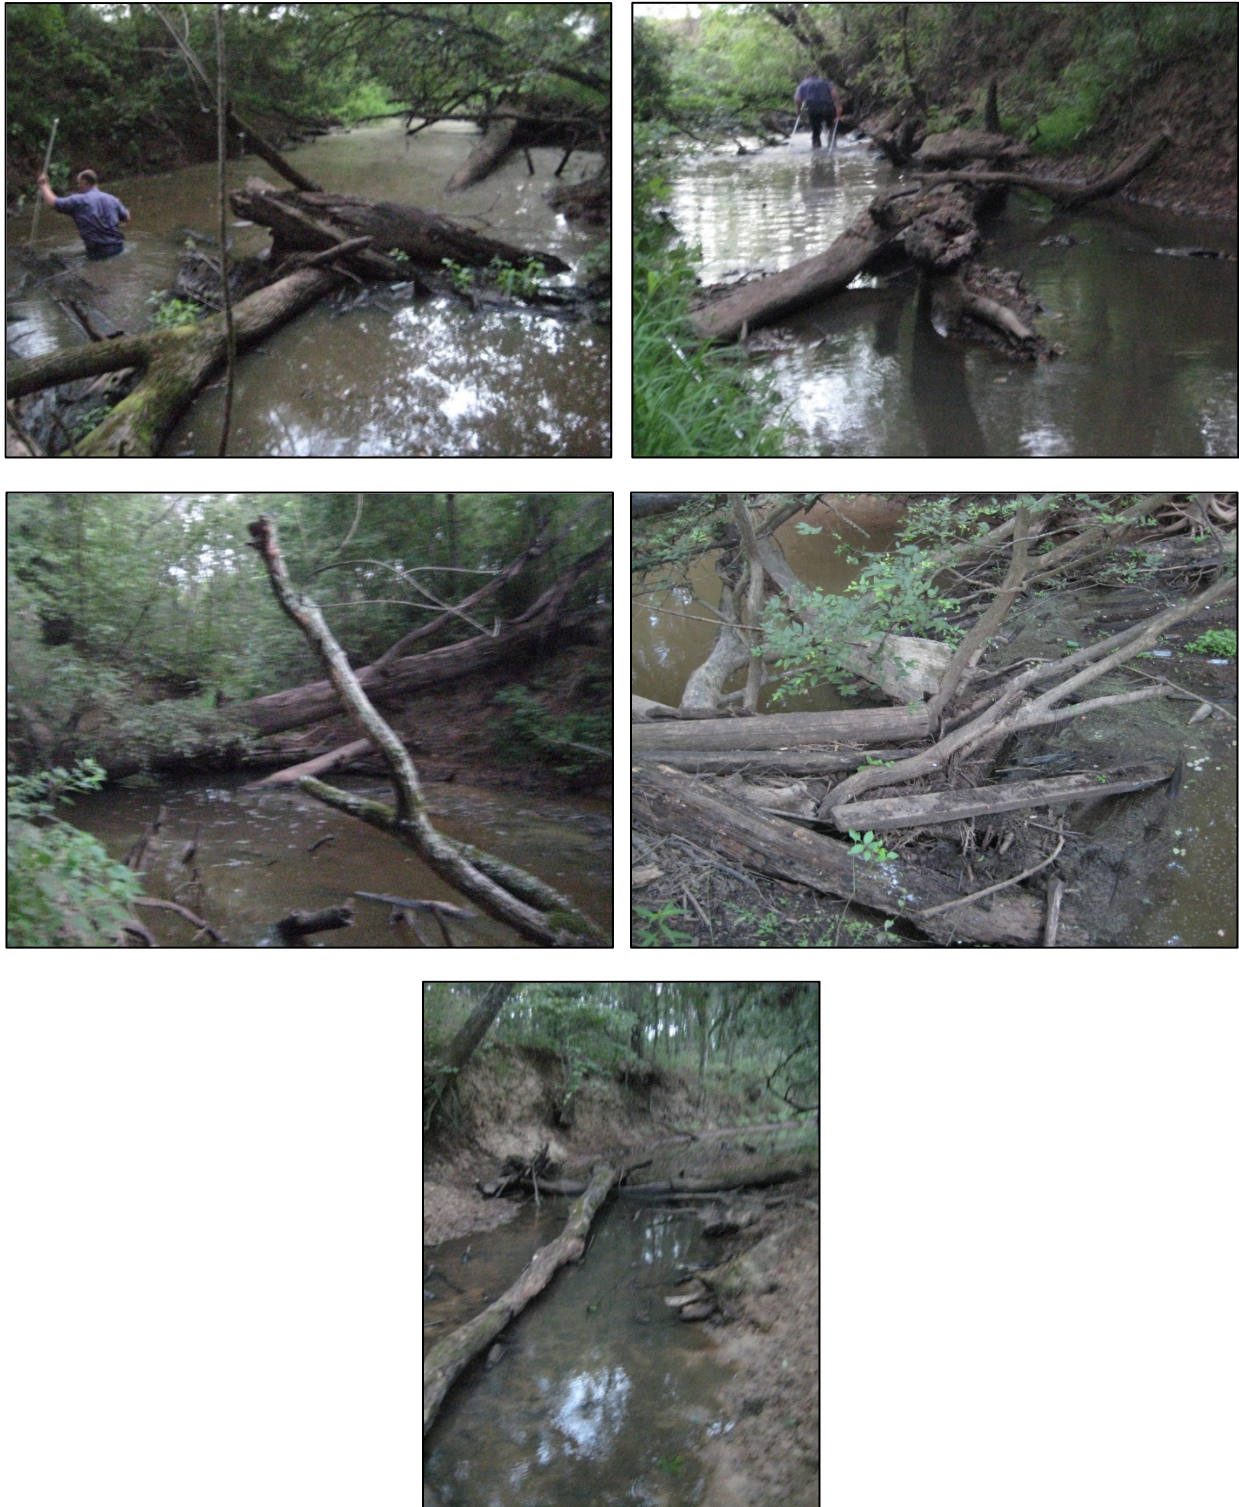
**Photogroup 4-29** Naconiche 10 depicting water surface characteristics. All individuals featured are SFASU and CES staff. Top left: Large woody debris, August 2012, Top right: Large woody debris in channel, August 2012; Middle left: Large woody debris across/within channel, August 2012; Middle right: Large woody debris in channel with slight foam, July 2012; Bottom: Large woody debris in channel, August 2012.

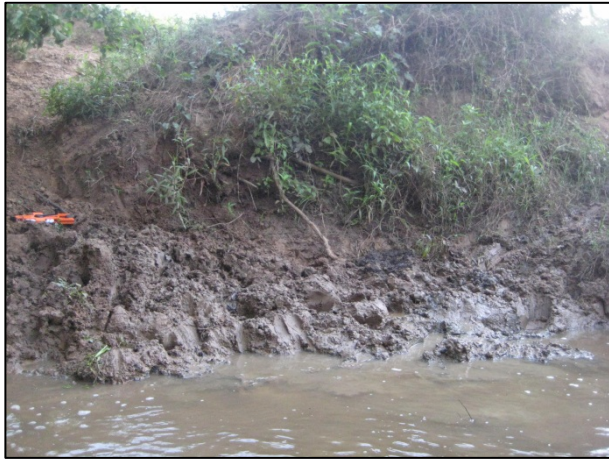
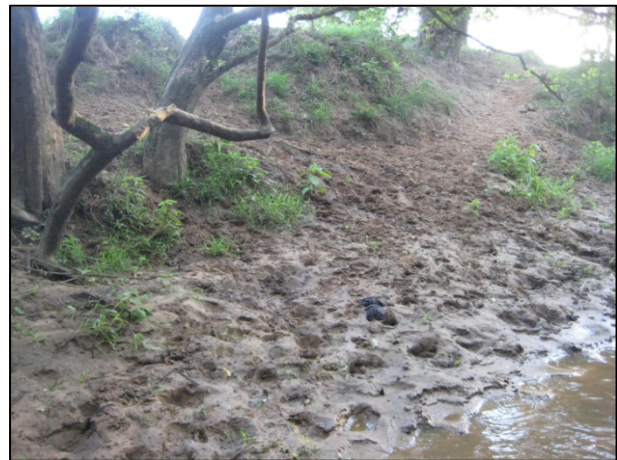
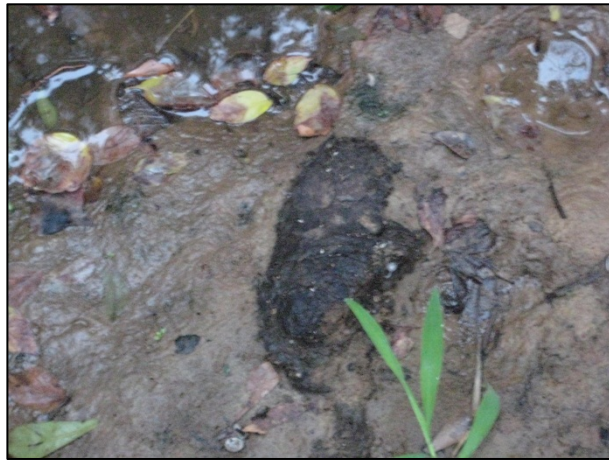
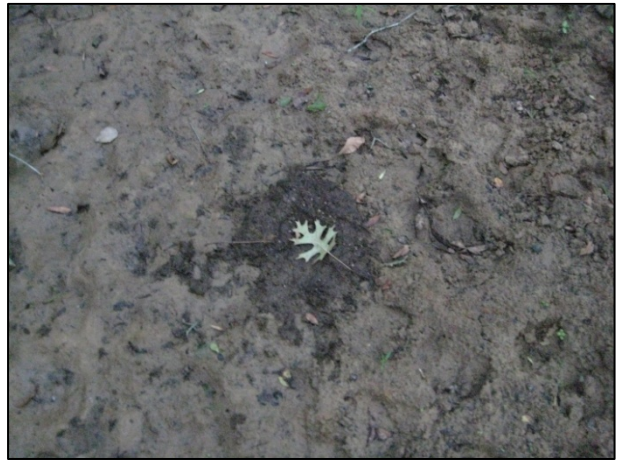
**Photogroup 4-29** Naconiche 10 depicting livestock access and potential sources of contamination. Top left: Heavy livestock use along stream bank, July 2012; Top right: Heavy livestock use with fecal matter along stream bank, July 2012; Bottom left: Livestock fecal, August 2012; Bottom right: Livestock fecal, August 2012.

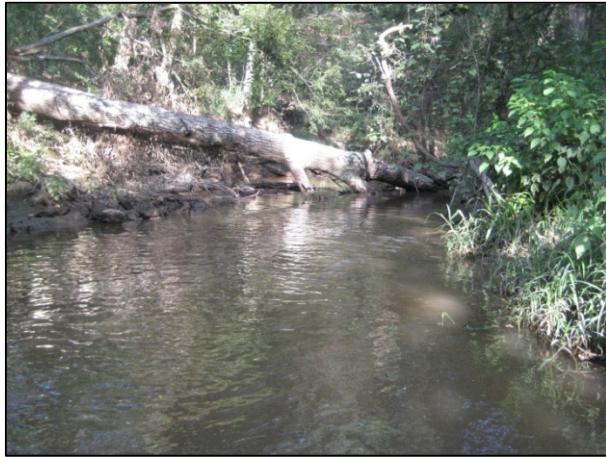
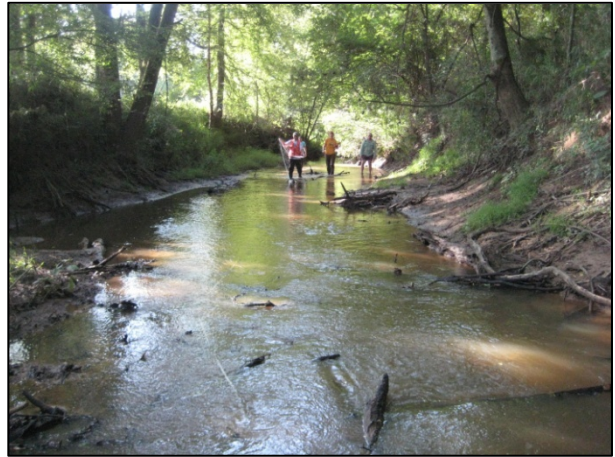
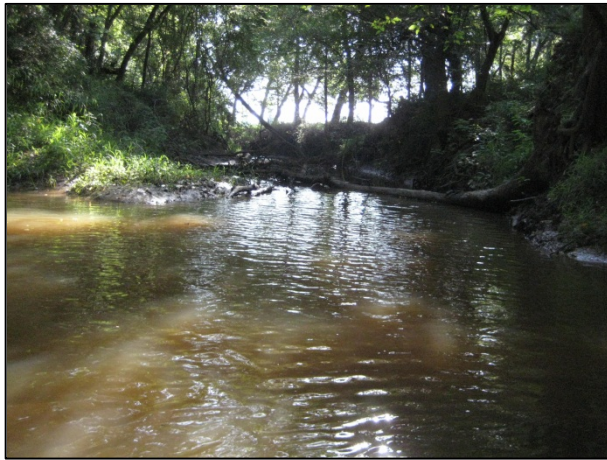
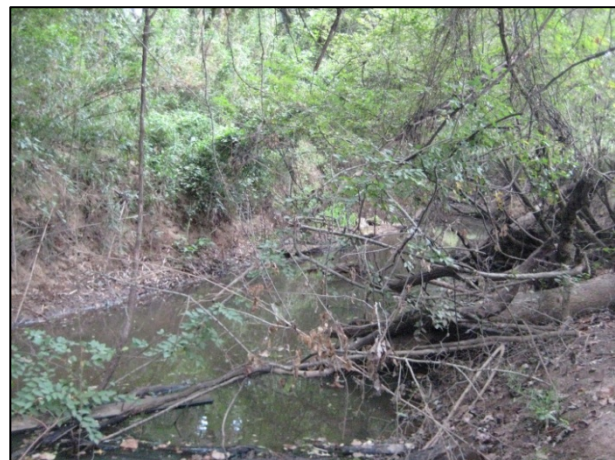
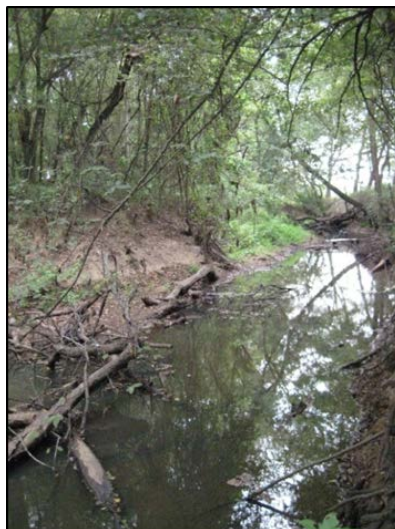
**Photogroup 4-30** Naconiche 11 depicting general stream characteristics. All individuals featured are SFASU and CES staff. Top left: 30-m transect, upstream, July 2012; Top right: 30-m transect, downstream, July 2012; Middle left: 300-m transect, upstream, July 2012; Middle right: 150-m transect, upstream, August 2012; Bottom: 300-m transect, upstream, August 2012.

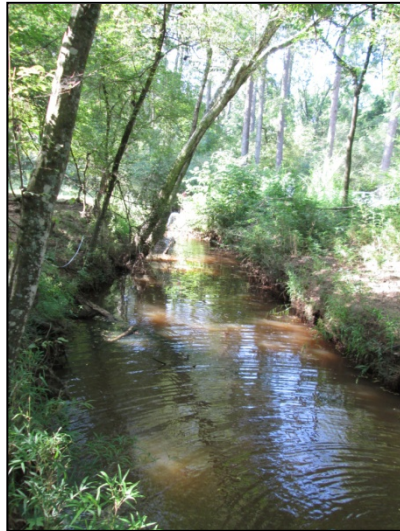
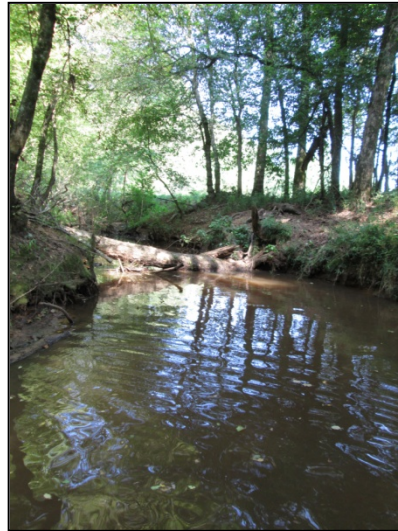
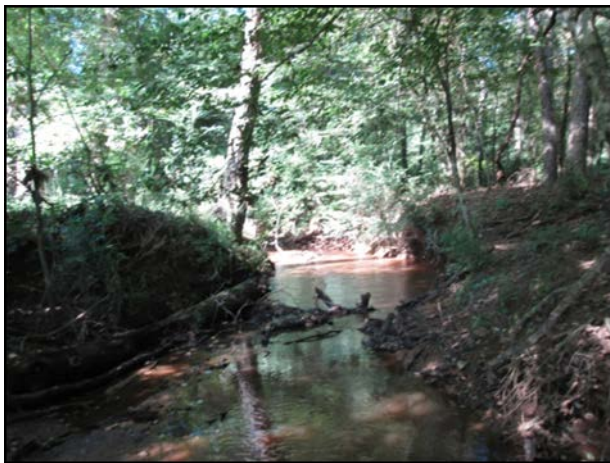
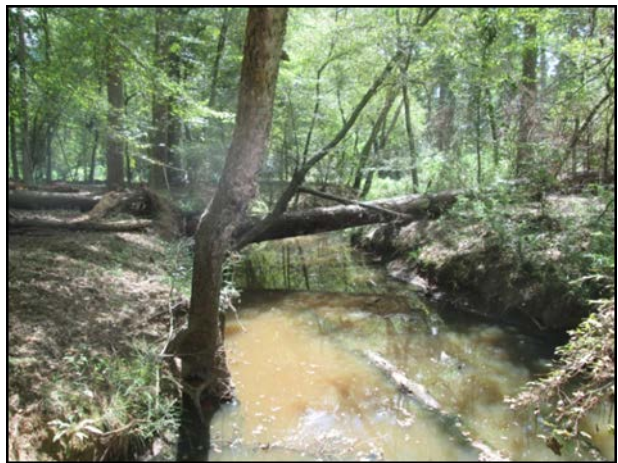
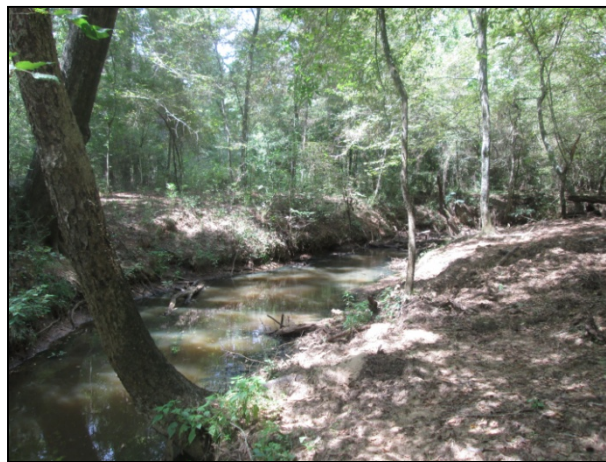
**Photogroup 4-32** Terrapin 2 depicting general stream characteristics. Top left: 30-m transect, downstream, July 2012; Top right: 150-m transect, upstream, July 2012; Middle left: 300-m transect, downstream, July 2012; Middle right: 30-m transect, downstream, August 2012; Bottom: 30-m transect, upstream, August 2012.

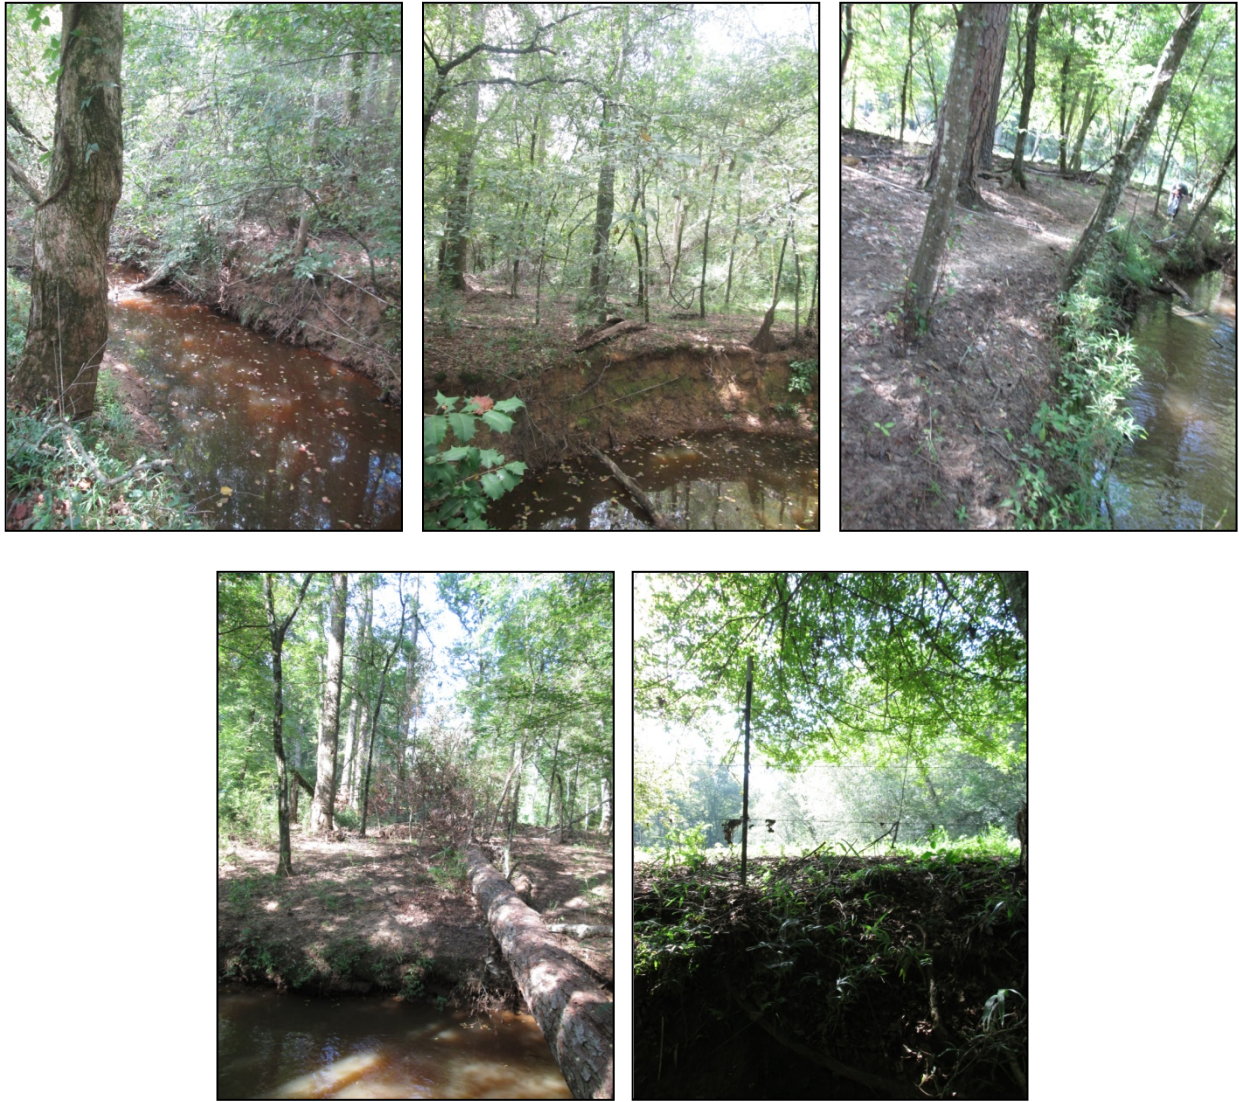
**Photogroup 4-32** Terrapin 2 depicting general bank appearance. Top left: 300-m transect, downstream, August 2012; Top center: 300-m transect, left bank, August 2012; Top right: 30-m transect, left bank, July 2012; Bottom left: 30-m transect, right bank, July 2012; Bottom right: Fenced pastureland, left bank, July 2012.

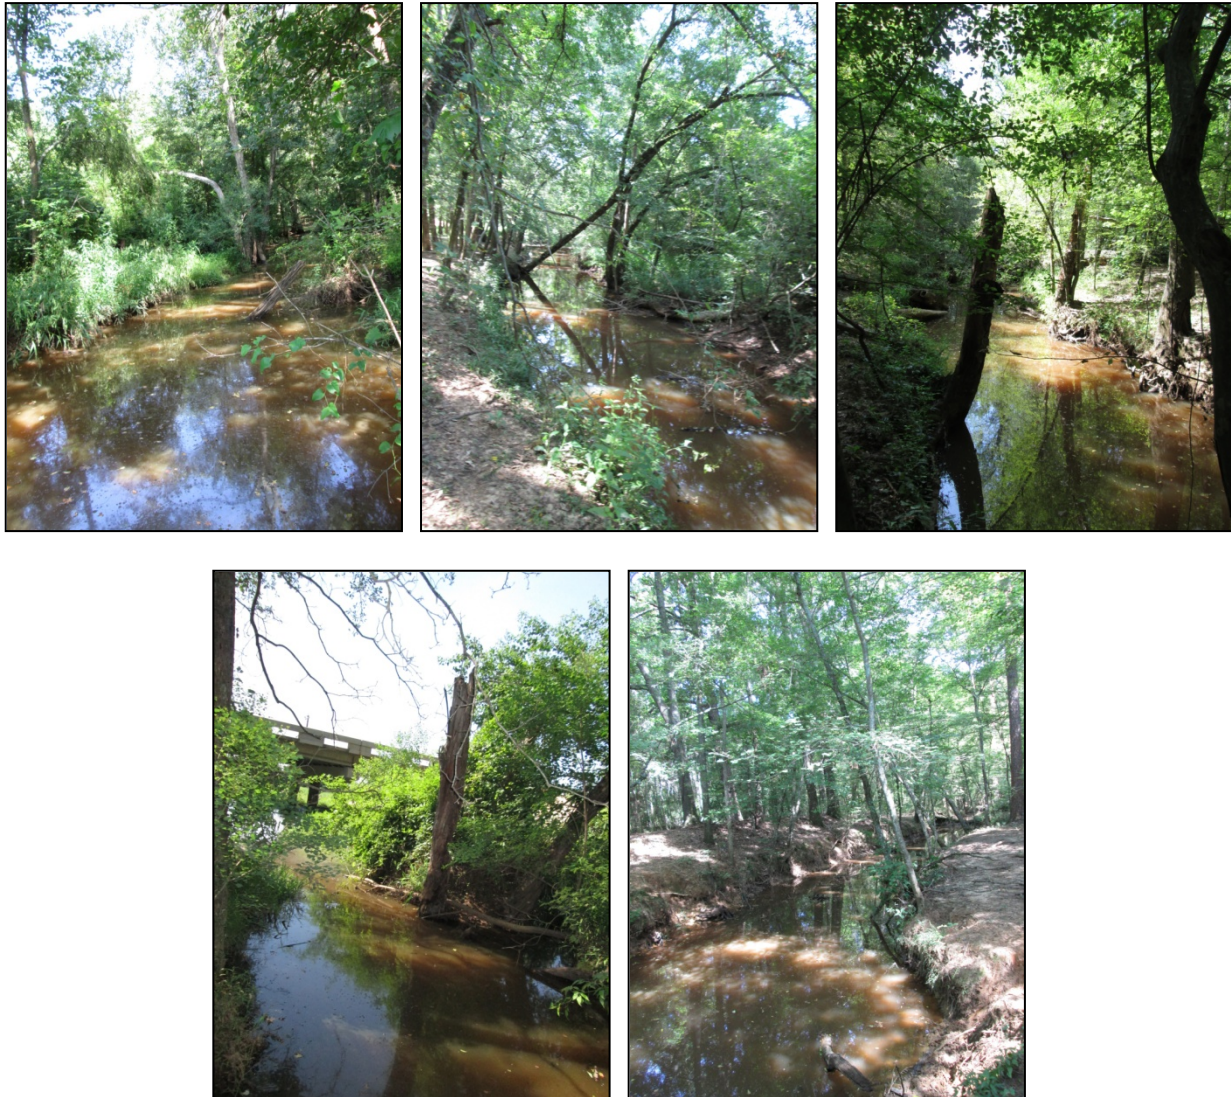
**Photogroup 4-33** Terrapin 3 depicting general stream characteristics. Top left: 30-m transect, upstream, July 2012; Top center: 150-m transect, downstream, July 2012; Top right: 300-m transect, downstream, July 2012; Bottom left: 30-m transect, downstream, July 2012; Bottom right: 300-m transect, upstream, July 2012.

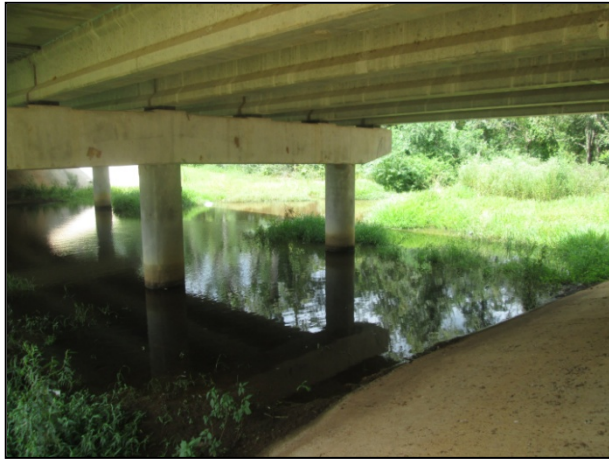
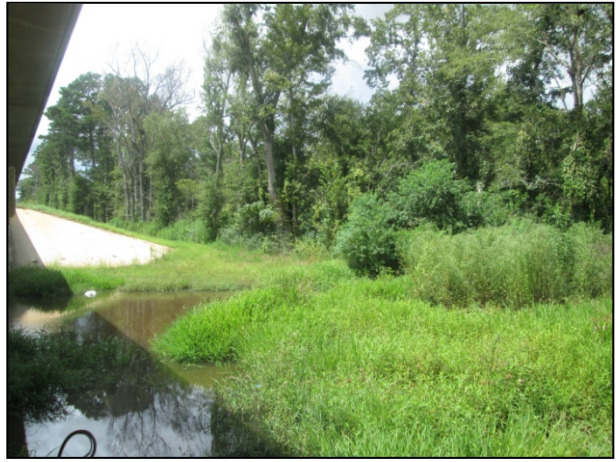
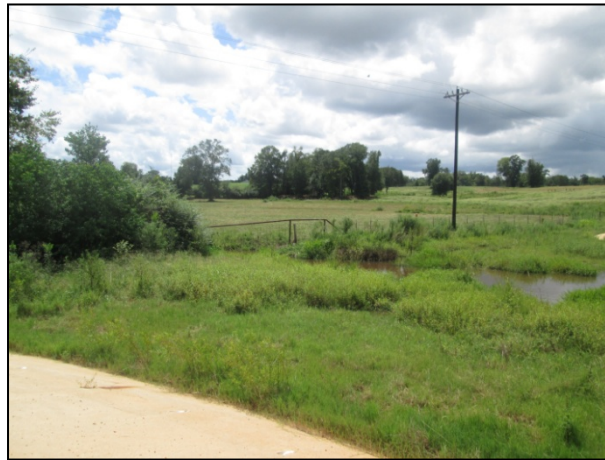
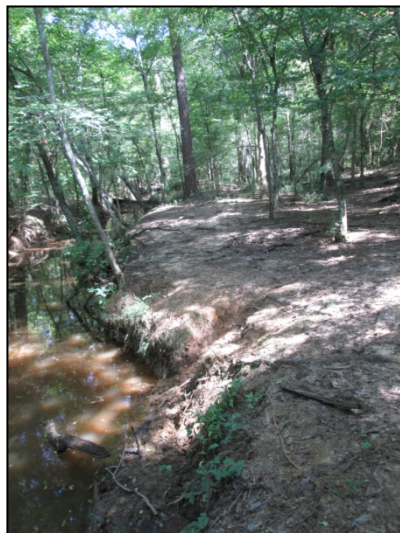
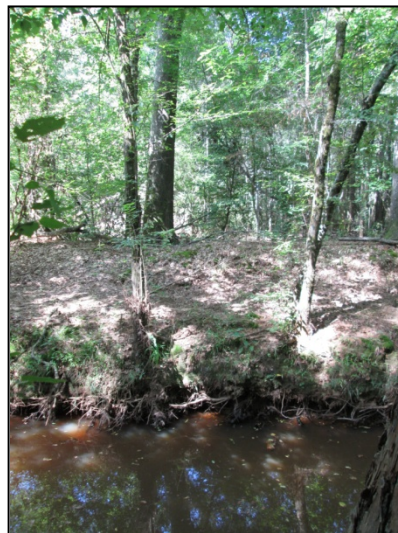
**Photogroup 4-33** Terrapin 3 depicting general bank appearance. Top left: 0-m transect, Highway 7 crossing, flooded banks, August 2012; Top right: 0-m transect, Bank access from Hwy 7, flooded banks, August 2012; Middle: Fenced channel, upstream, August 2012; Bottom left: 300-m transect, left bank, July 2012; Bottom right: 300-m transect, Right bank, July 2012.

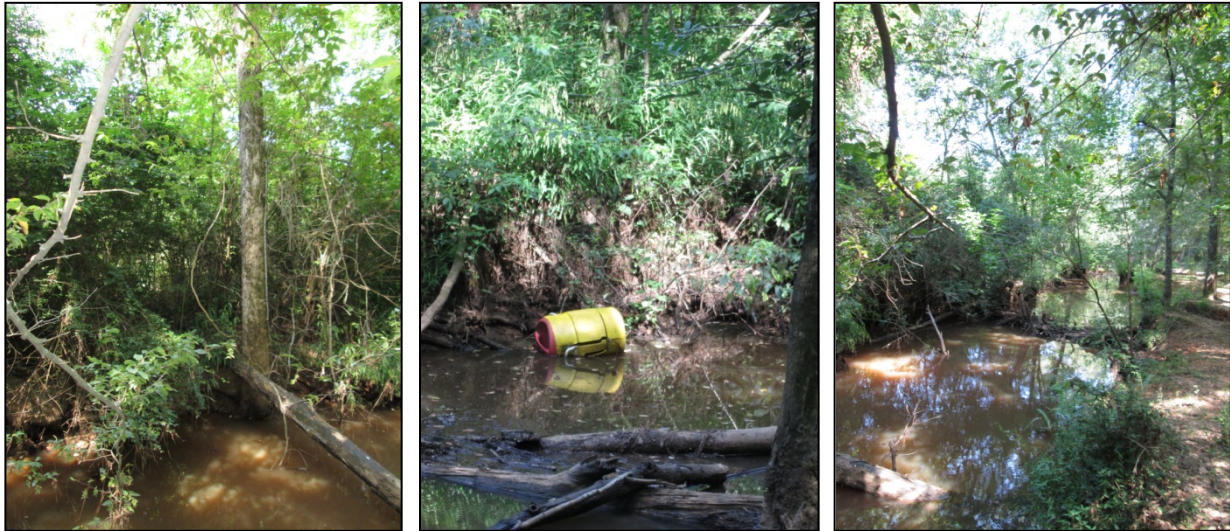
**Photogroup 4-33** Terrapin 3 depicting water surface characteristics. Left: 150-m transect, right bank, July 2012; Center: Large channel litter (cooler), July 2012; Right: 150-m transect, upstream, July 2012.

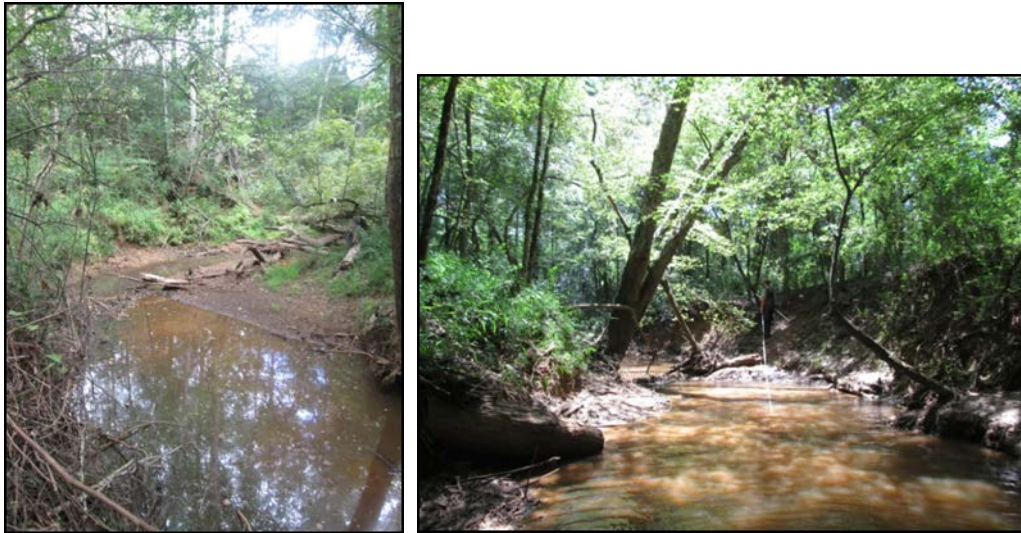
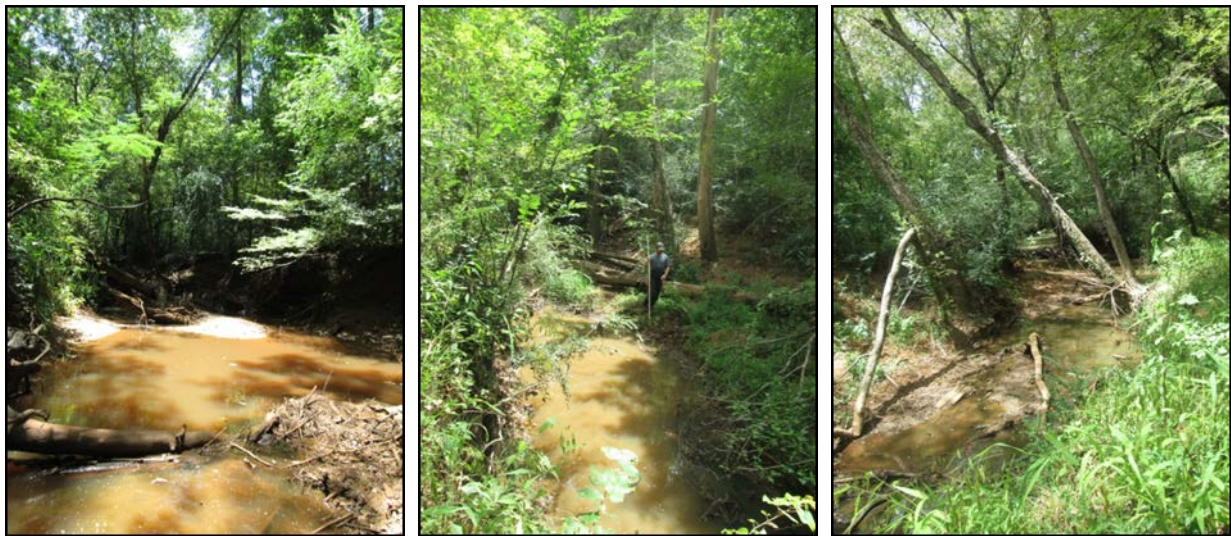
**Photogroup 4-34** Terrapin 4 depicting general stream characteristics. Top left: 300-m transect, downstream, August 2012; Top right: 150-m transect, downstream, July 2012; Bottom left: 300-m transect, downstream, July 2012; Bottom center: 150-m transect, downstream, August 2012; Bottom right: 150-m transect, upstream, August 2012.

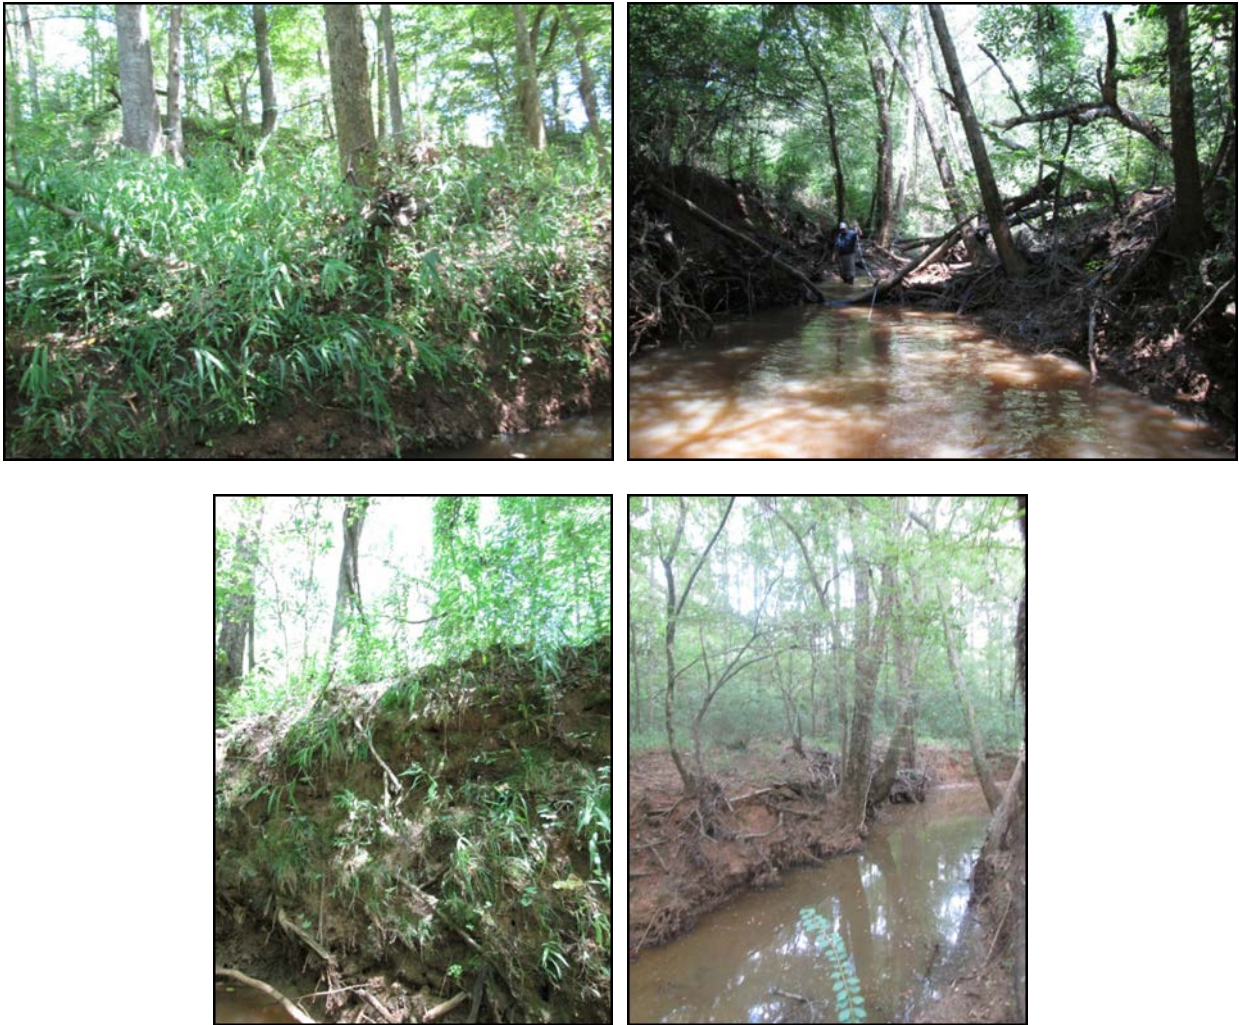
**Photogroup 4-34** Terrapin 4 depicting general bank appearance. Top left: 30-m transect, right bank, July 2012; Top right: 150-m transect, upstream, July 2012; Bottom left: 150-m transect, right bank, July 2012; Bottom right: 300-m transect, upstream, August 2012.
