# Attoyac Bayou Recreational Use Attainability Analysis

**Attoyac Bayou  
Recreational Use Attainability Analysis**

**Texas State Soil and Water Conservation Board  
Project # 09-10**

**October 2012**

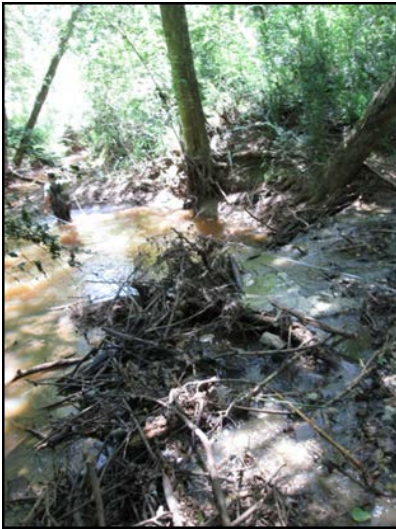
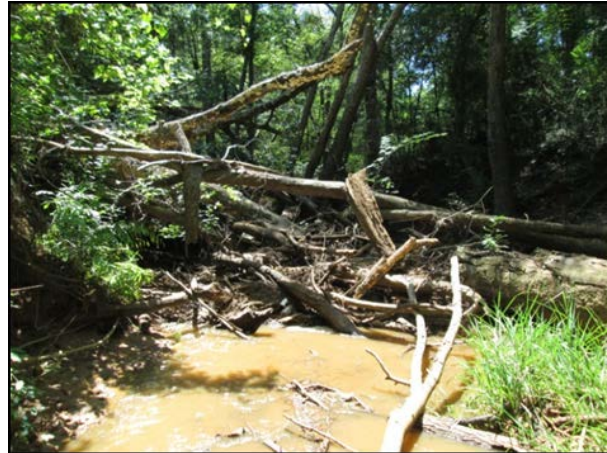
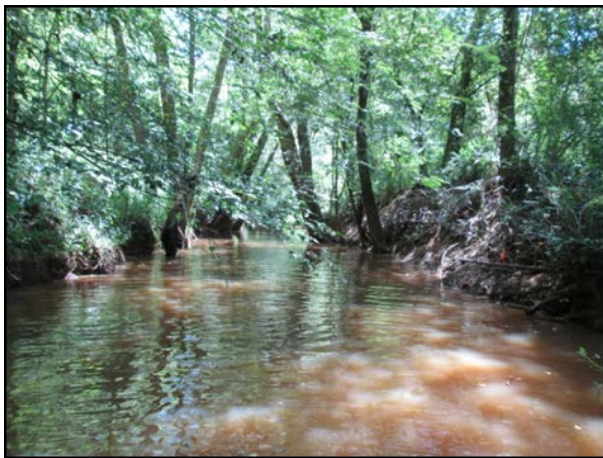
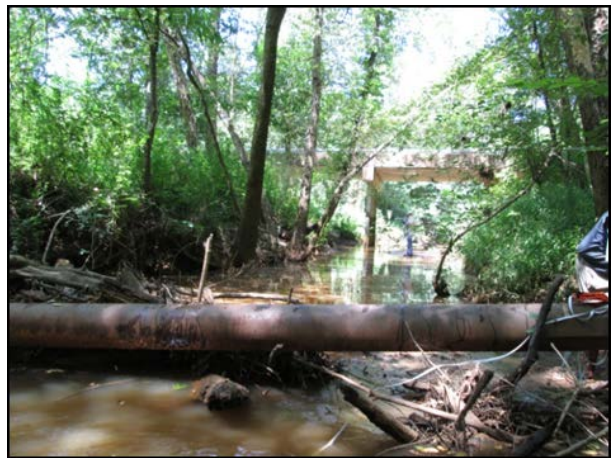
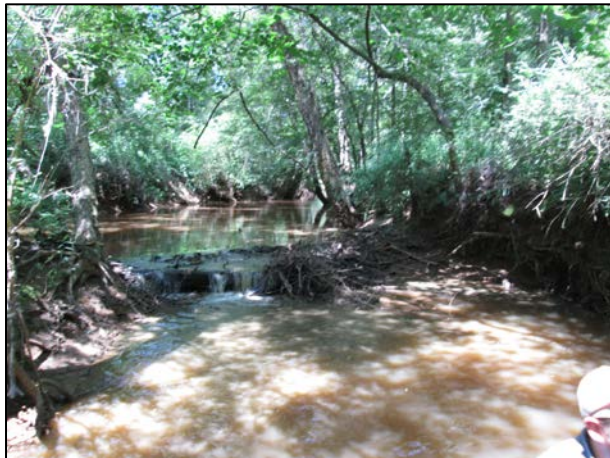
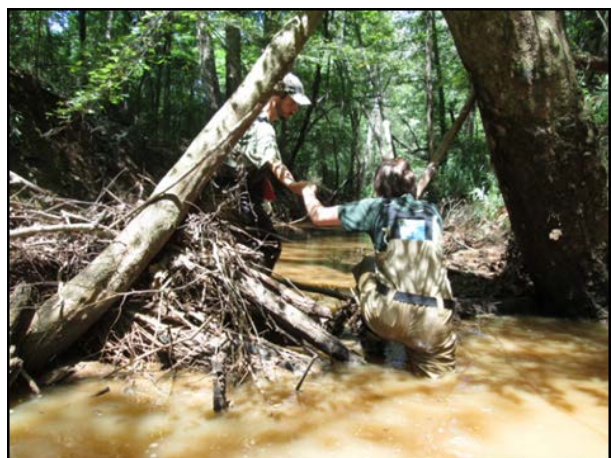
**Photogroup 4-34** Terrapin 4 depicting water surface characteristics. All individuals featured are SFASU and CES staff. Top left: Woody debris within channel, July 2012; Top right: Log jam, July 2012; Middle left: 30-m transect, downstream, July 2012; Middle right: 30-m transect, upstream, July 2012; Bottom left: Log under water surface with woody debris, July 2012; Bottom right: Large woody debris within channel (above and under water surface); July 2012.

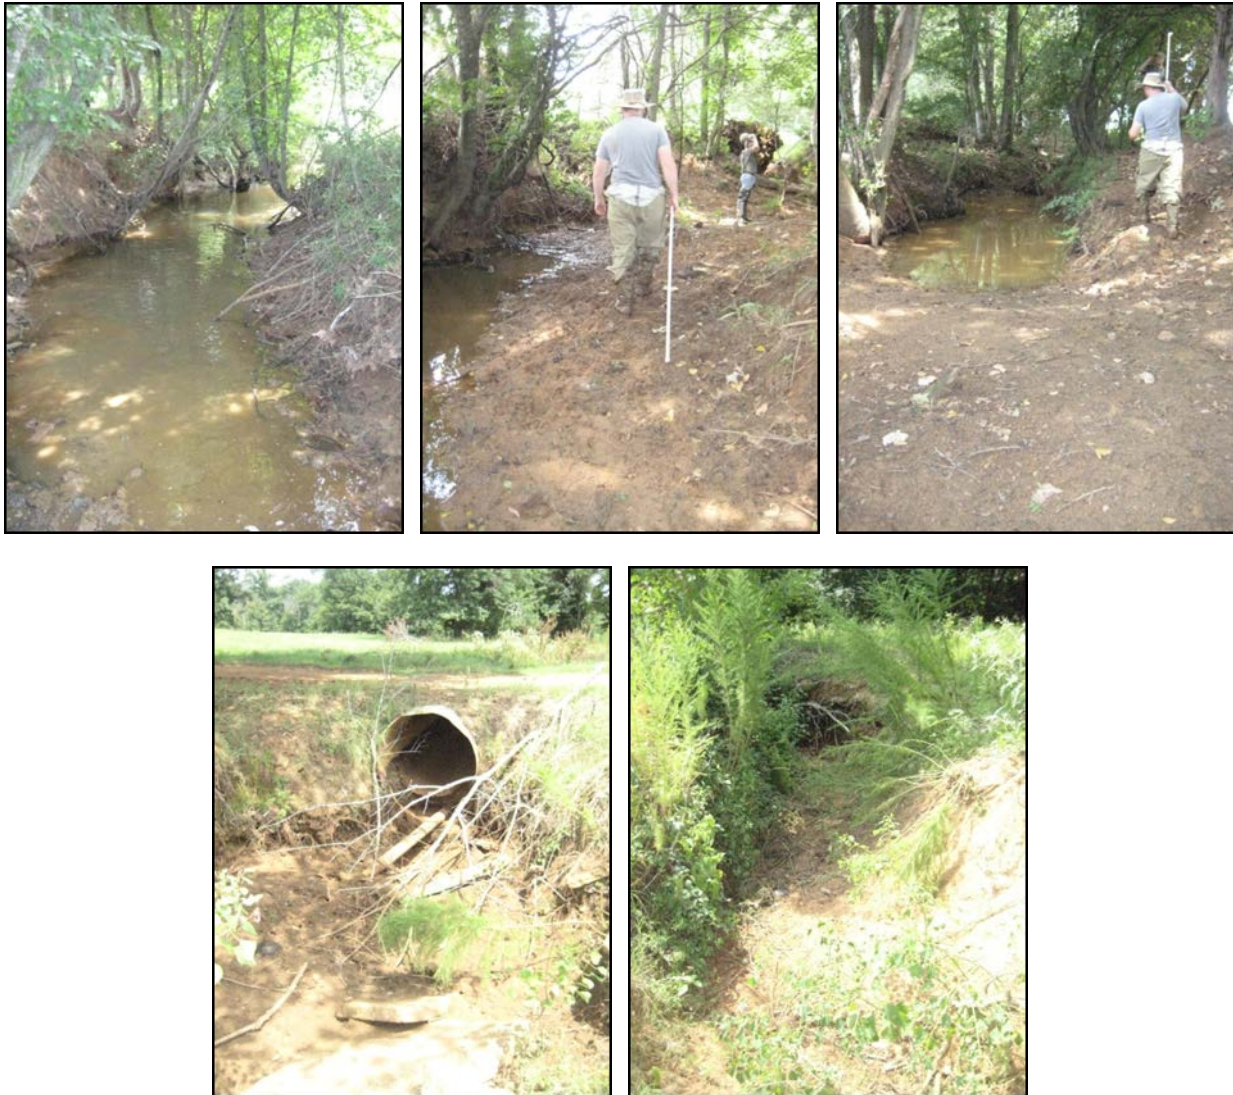
**Photogroup 4-35** Waffelow 1 depicting general stream characteristics. All individuals featured are SFASU and CES staff. Top left: 30-m transect, downstream, July 2012; Top center: 30-m transect, upstream, July 2012; Top right: 150-m transect, upstream, July 2012; Bottom left: 300-m transect, upstream, July 2012; Bottom right: 300-m transect, downstream, July 2012.

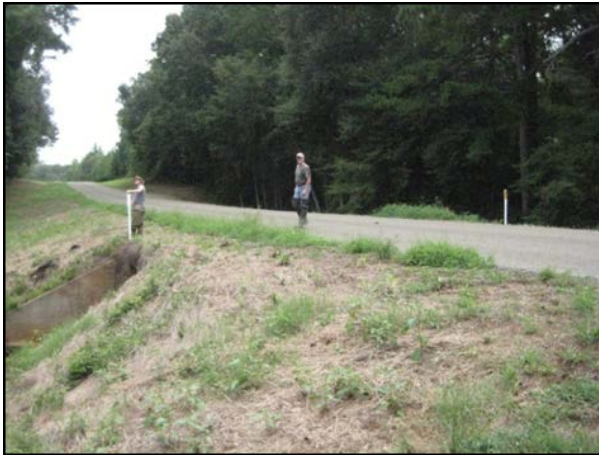
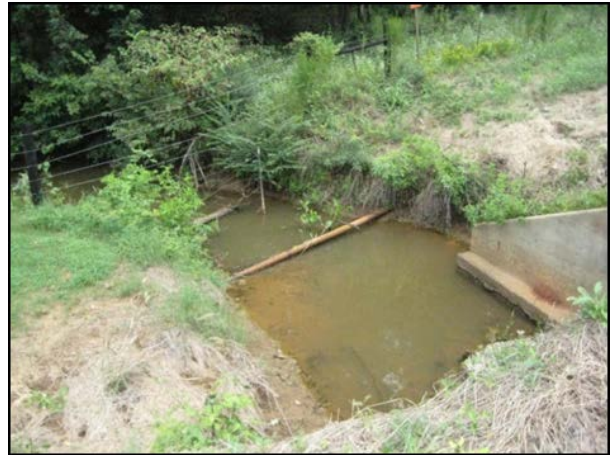
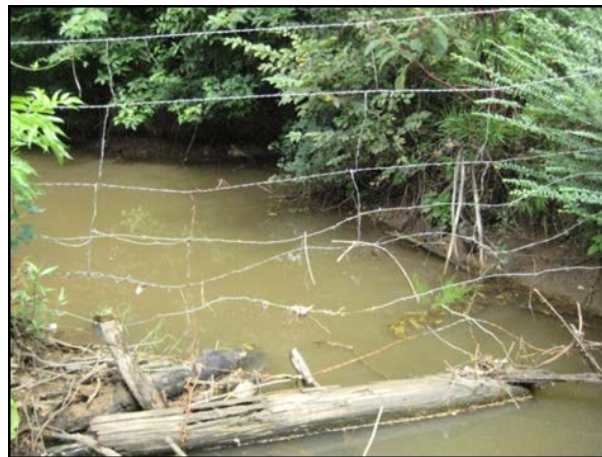
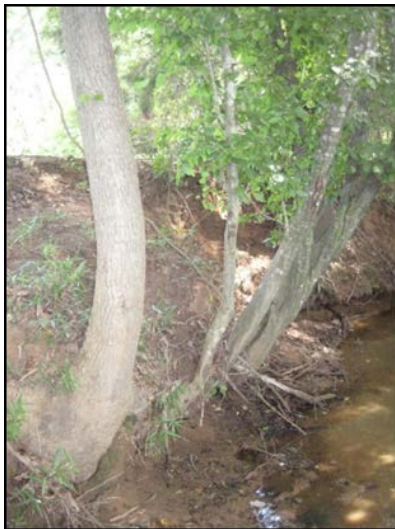
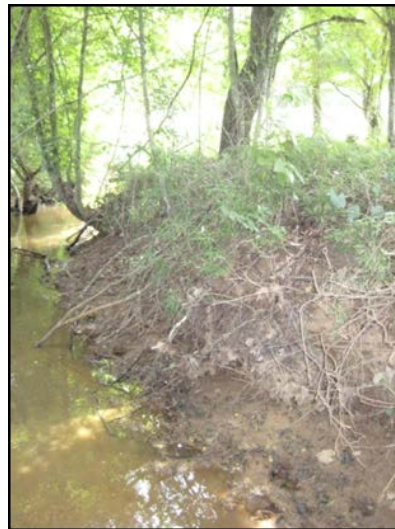
**Photogroup 4-35** Waffelow 1 depicting bank appearance. All individuals featured are SFASU and CES staff. Top left: FM 1878 crossing/access point, July 2012; Top right: 0-m transect, July 2012; Middle: 0-m transect, fenced stream channel, July 2012; Bottom left: 30-m transect, left bank, July 2012; Bottom right: 30-m transect, right bank, July 2012.

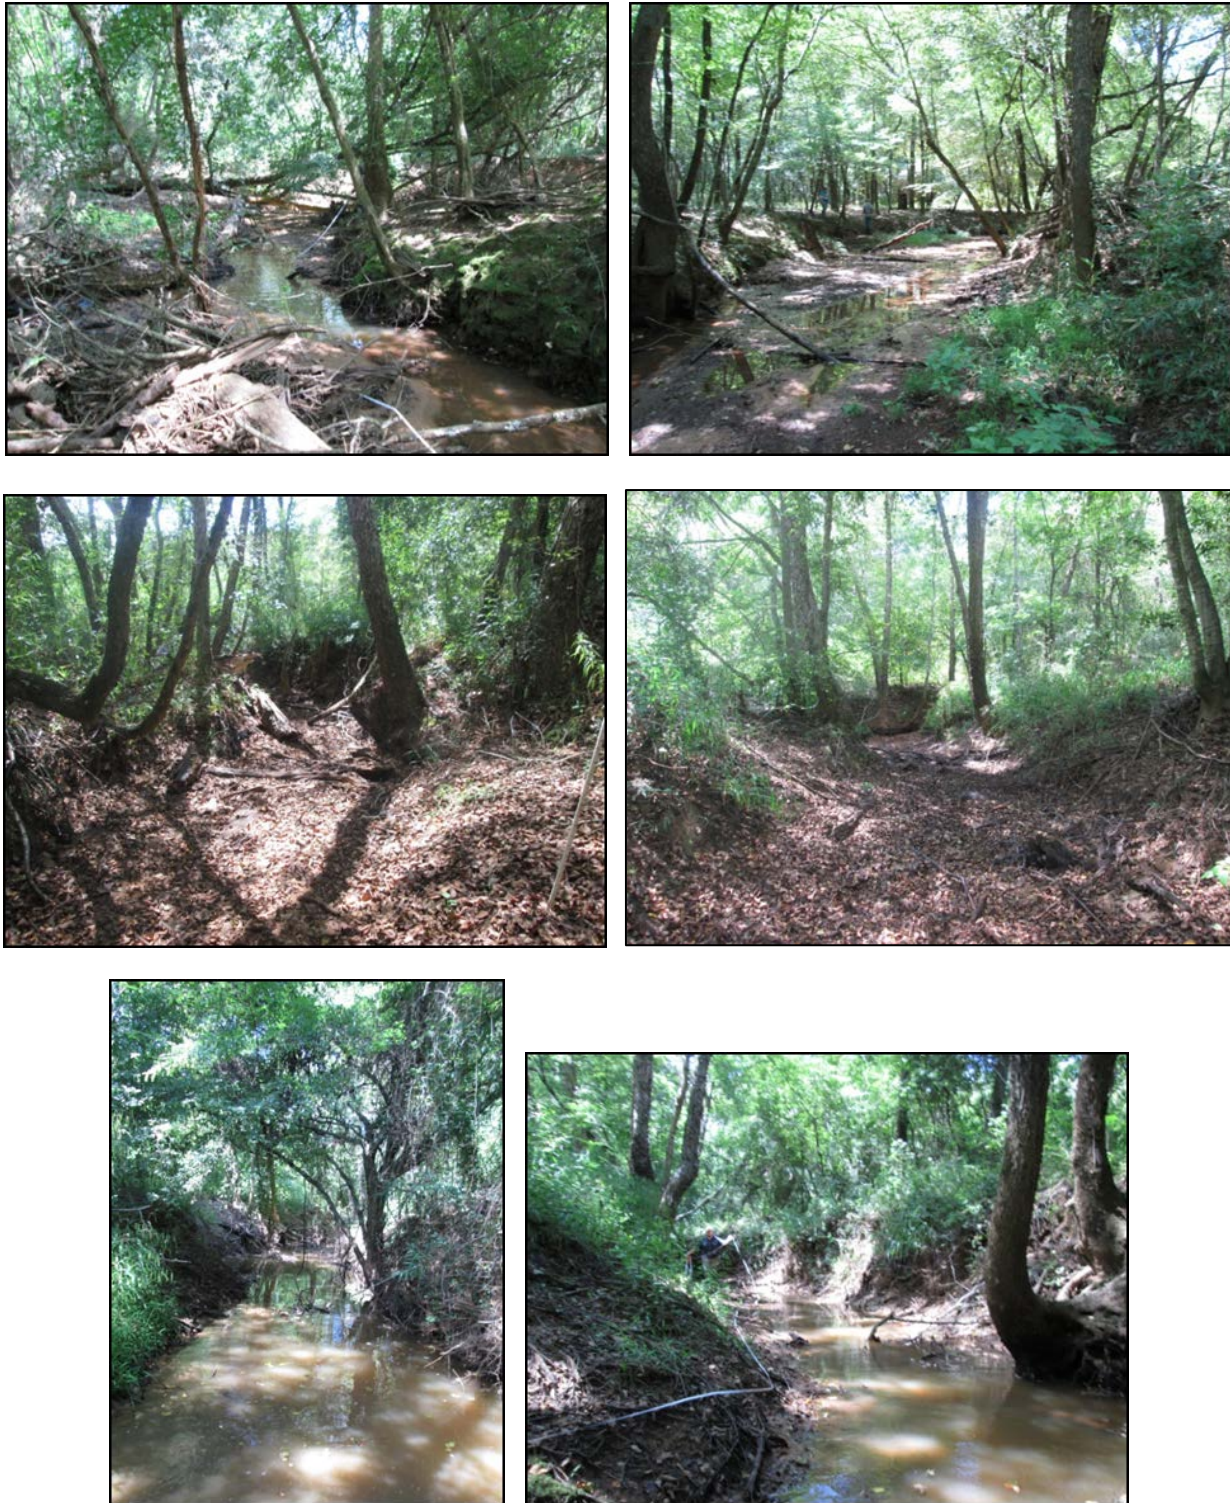
**Photogroup 4-36** Waffelow 2 depicting general stream characteristics. Top left: 30-m transect, upstream, July 2012; Top right: 30-m transect, downstream, July 2012; Middle left: 300-m transect, downstream, August 2012; Middle right: 150-m transect, downstream, August 2012. Bottom left: 300-m transect, upstream, July 2012; Bottom right: 150-m transect, downstream, July 2012.

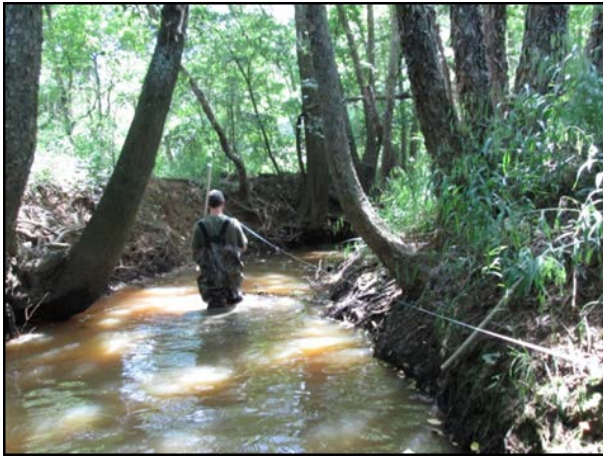
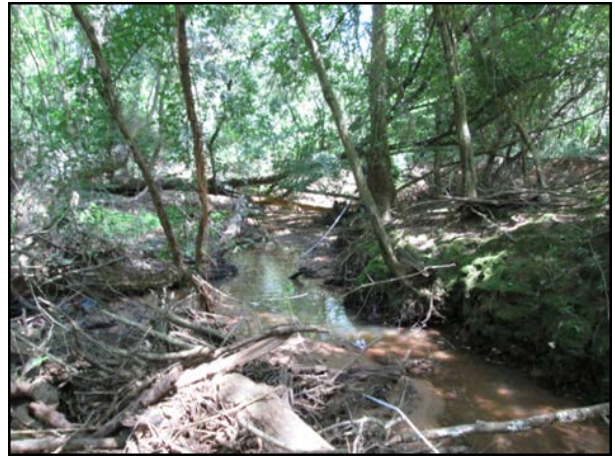
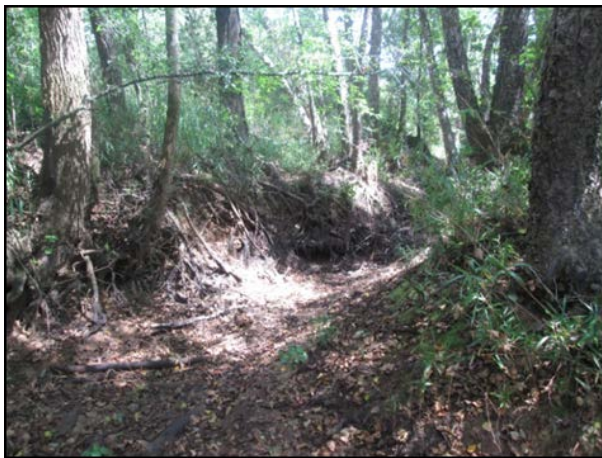
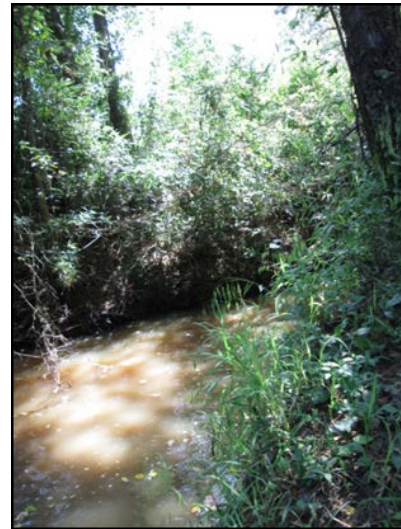
**Photogroup 4-36** Waffelow 2 depicting general bank appearance. All individuals featured are SFASU and CES staff. Top left: 150-m transect, upstream, July 2012; Top right: 30-m transect, upstream, July 2012; Bottom left: 300-m transect, upstream, August 2012; Bottom right: 300-m transect, downstream, July 2012.
