TRAFFIC SAFETY STUDY

OTTUMWA, IOWA

SEPTEMBER, 1980

Prepared by
**HENNINGSON, DURHAM & RICHARDSON
OMAHA, NEBRASKA**

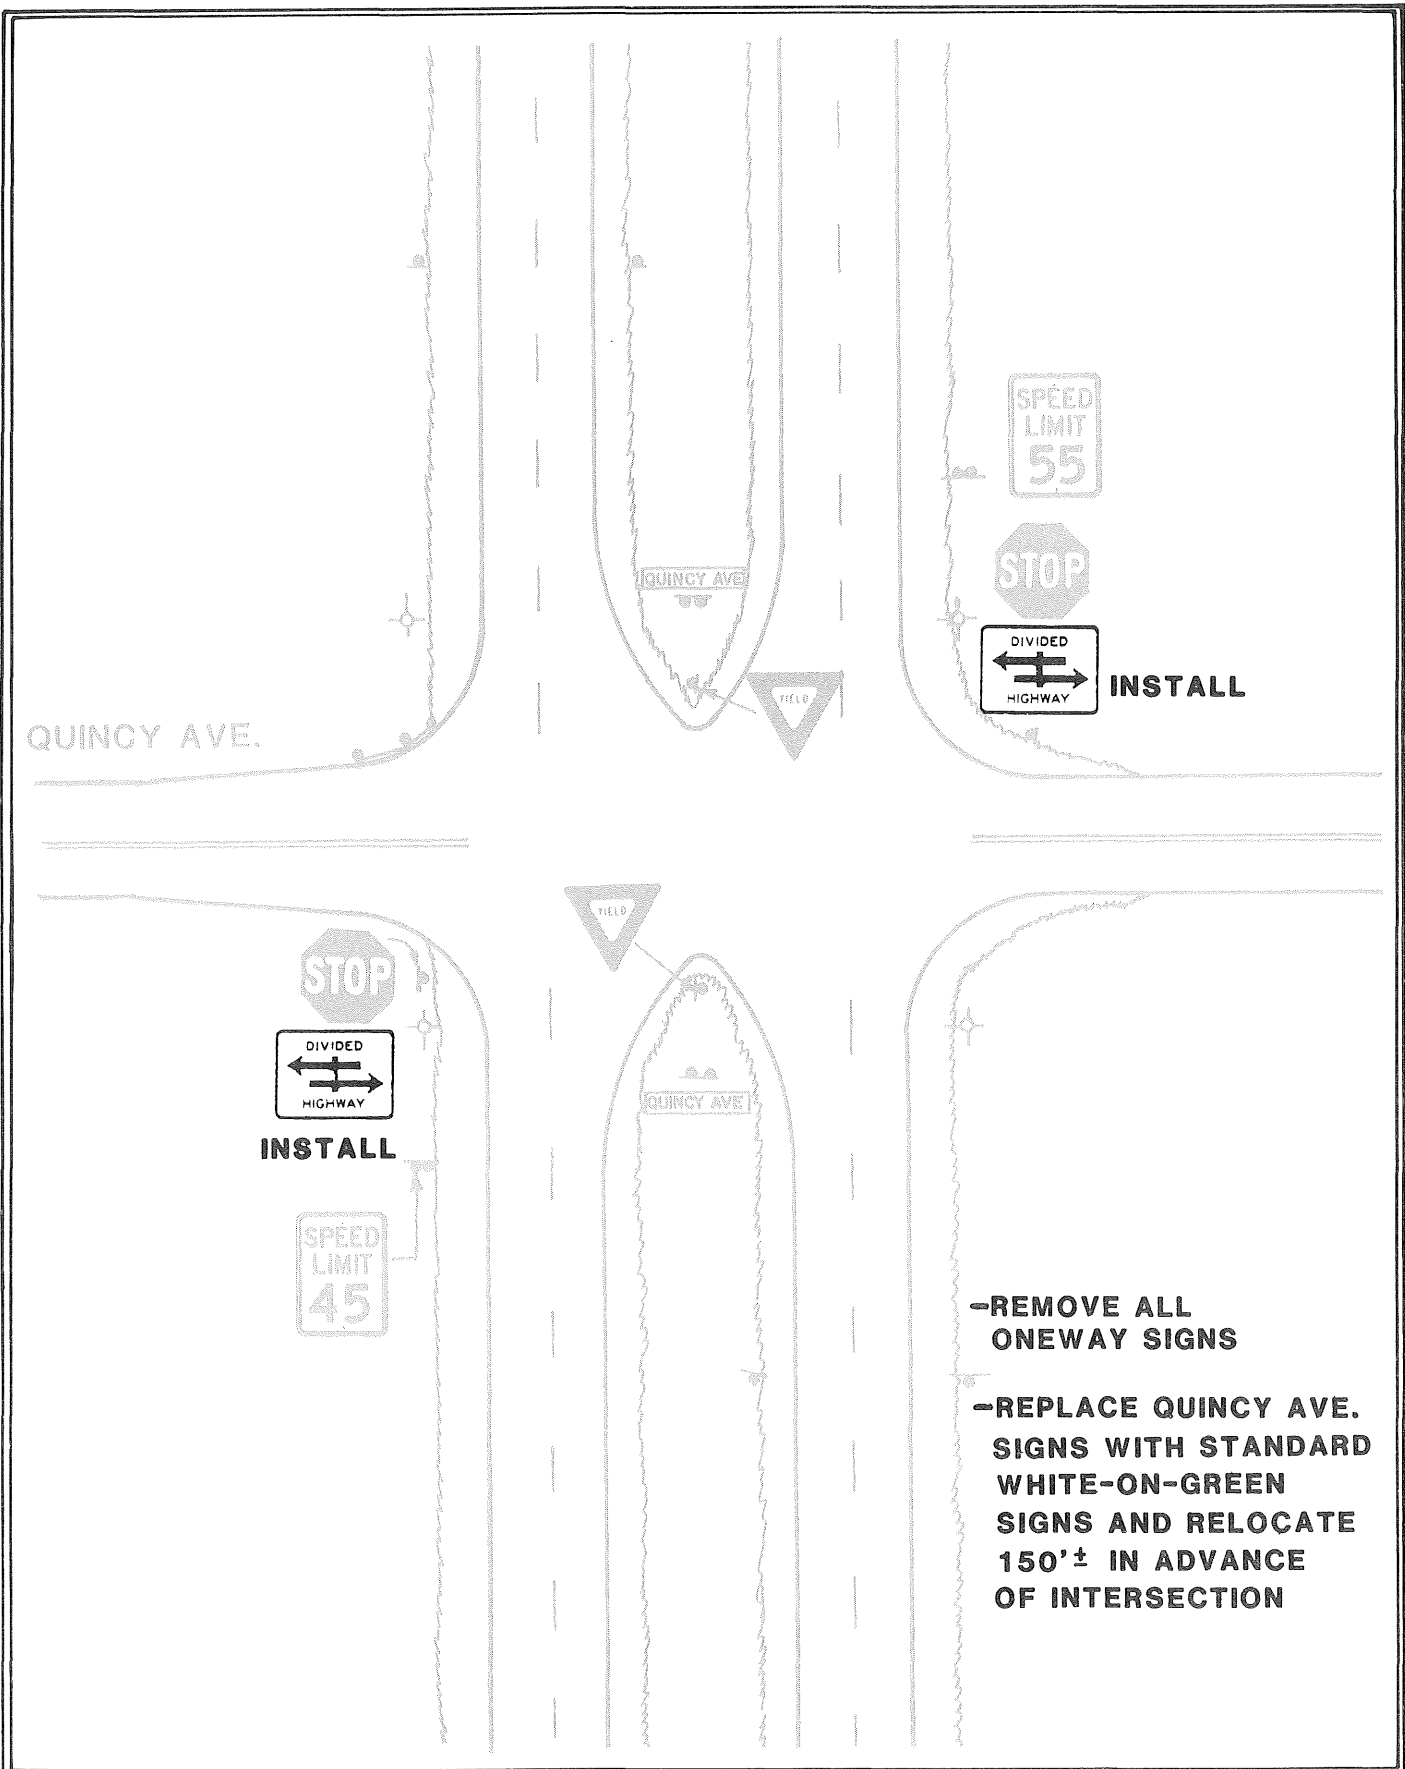
**Figure
2-6**

U.S. 34 & QUINCY AVENUE

- Remove the existing One Way signs and install divided highway (R6-3) signs beneath the Stop signs on Quincy Avenue.*
- Replace the Quincy Avenue street name signs with standard size, white-on-green signs and relocate them 150 feet in advance of the intersection.*
- * Responsibility of Iowa D.O.T.

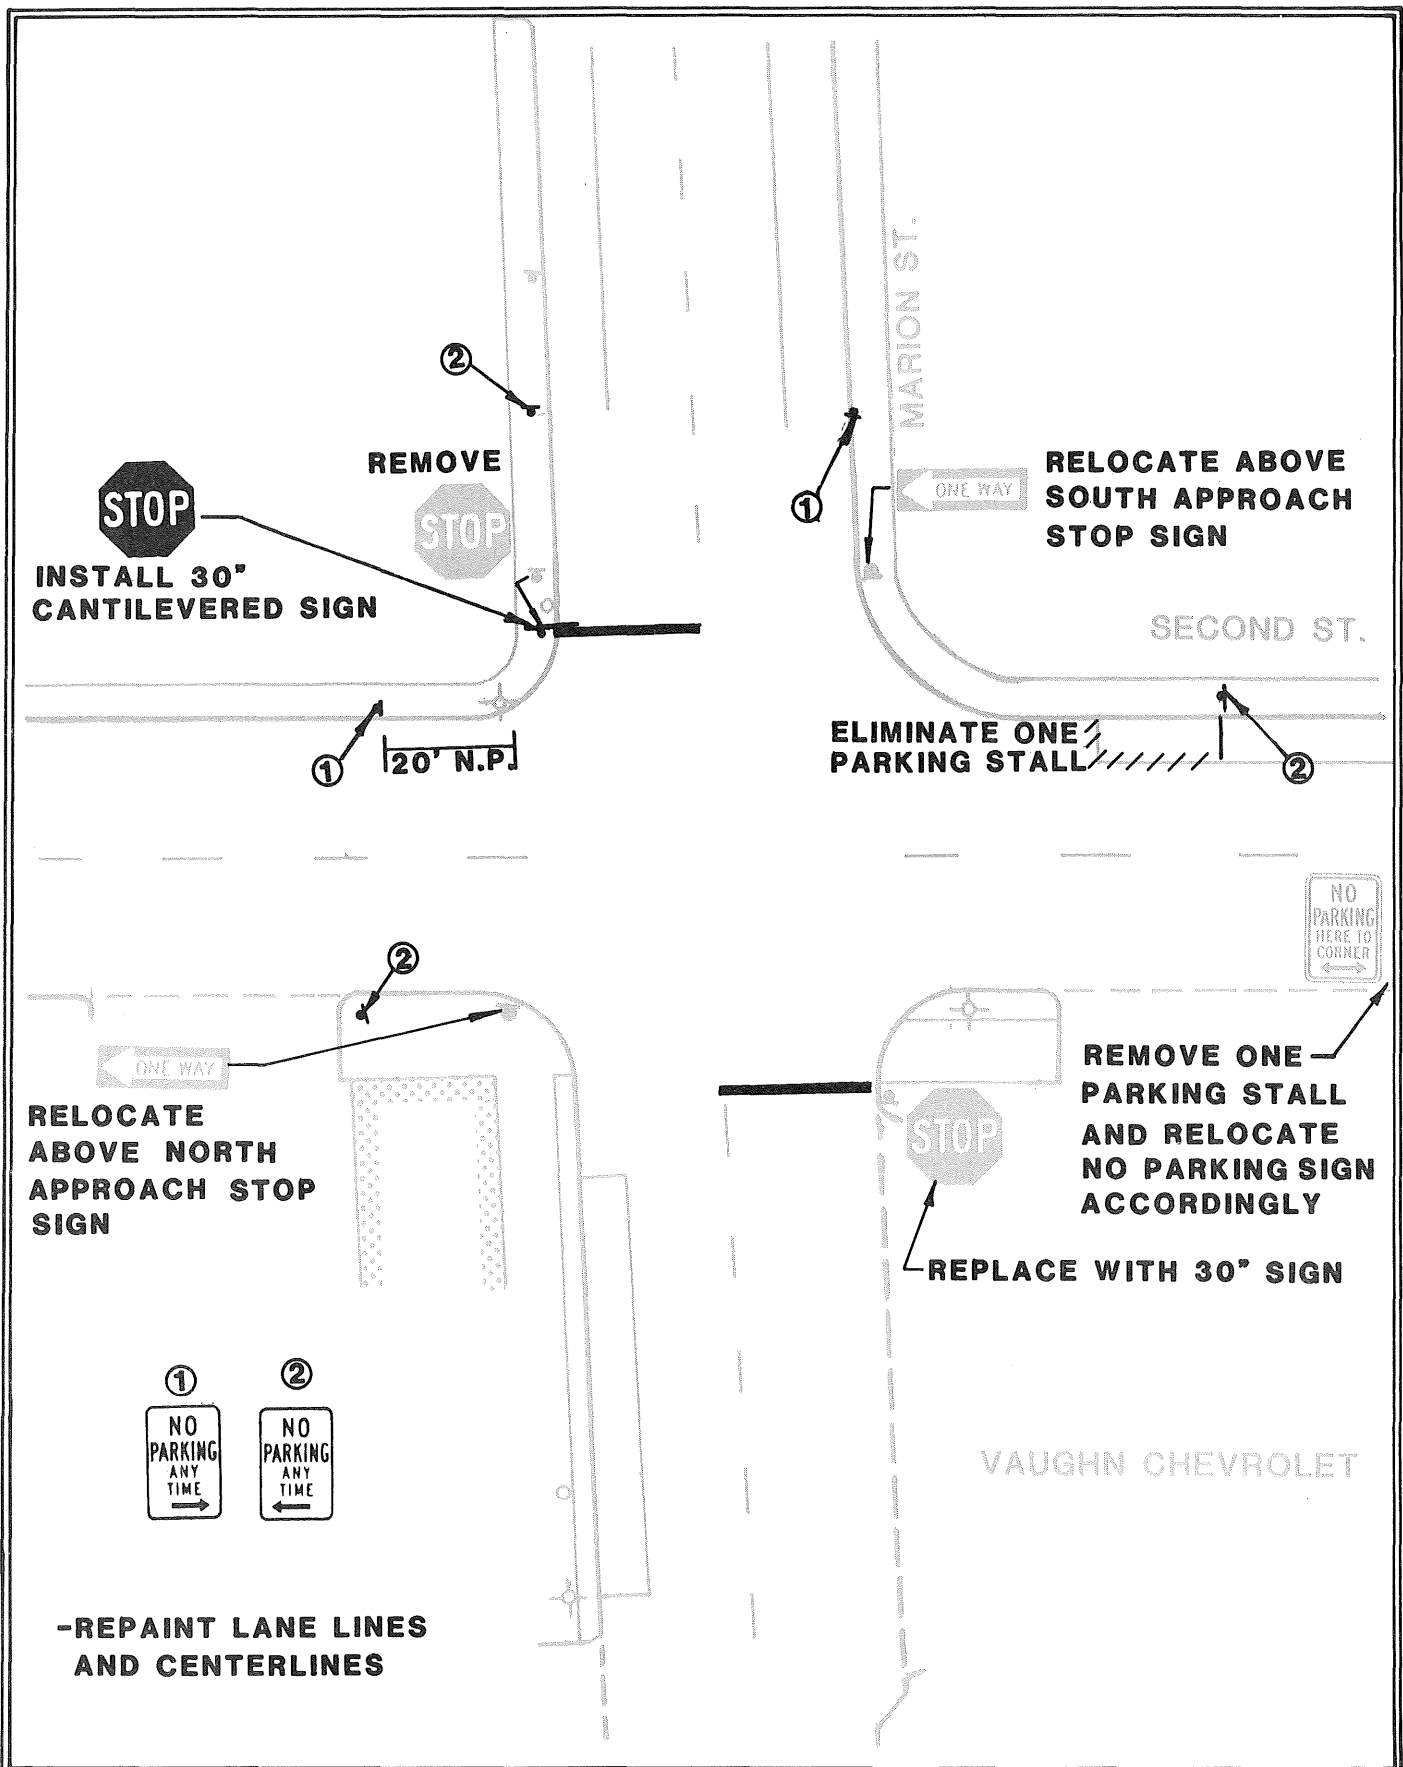
**Figure
2-7**

MARION STREET & SECOND STREET

- Speed enforcement on Second Street.
- Install 30 inch Stop signs on Marion Street.
- Relocate the north approach Stop sign 4 feet from the sidewalk line and cantilever it so the sign is not blocked by the power pole.
- Eliminate one parking stall on both sides of the Second Street east approach and install No Parking signs.

- Relocate the existing One Way signs to the northwest and southeast corners.
- Install stop lines on the Marion Street approaches.
- Repaint existing lane lines and center line.

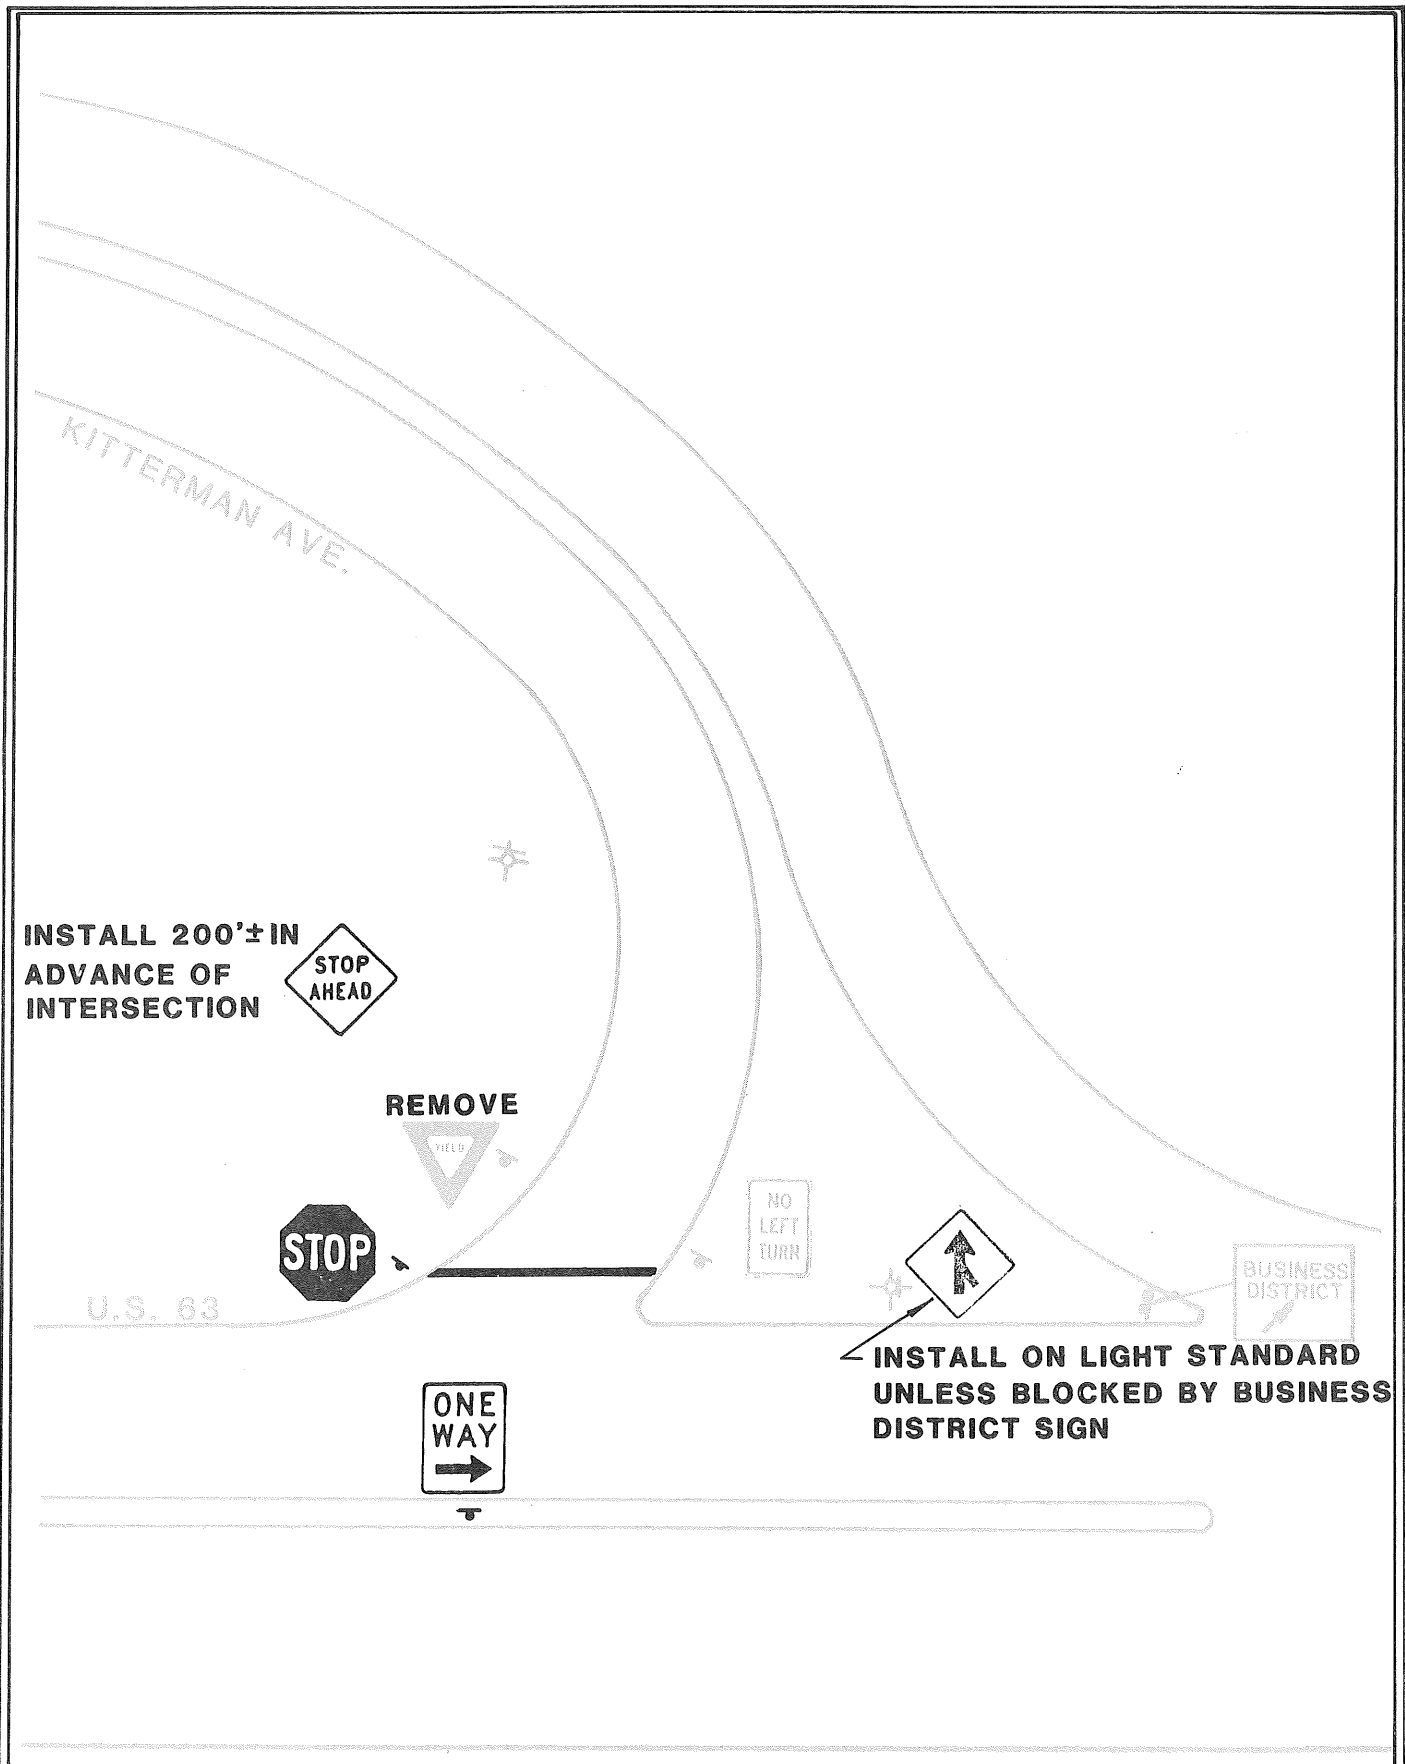
Figure
2-8

U.S. 63 & KITTERMAN AVENUE

- Replace the existing Yield sign on Kitterman with a Stop sign and stop line.
 - Install a Stop Ahead sign (W3-1) on Kitterman approximately 200 feet from the intersection.
 - Install a Merging Traffic sign (W4-1) on U.S. 63.*
 - Erect a One Way sign on the U.S. 63 median opposite the Kitterman entrance.*
- * Responsibility of Iowa D.O.T.

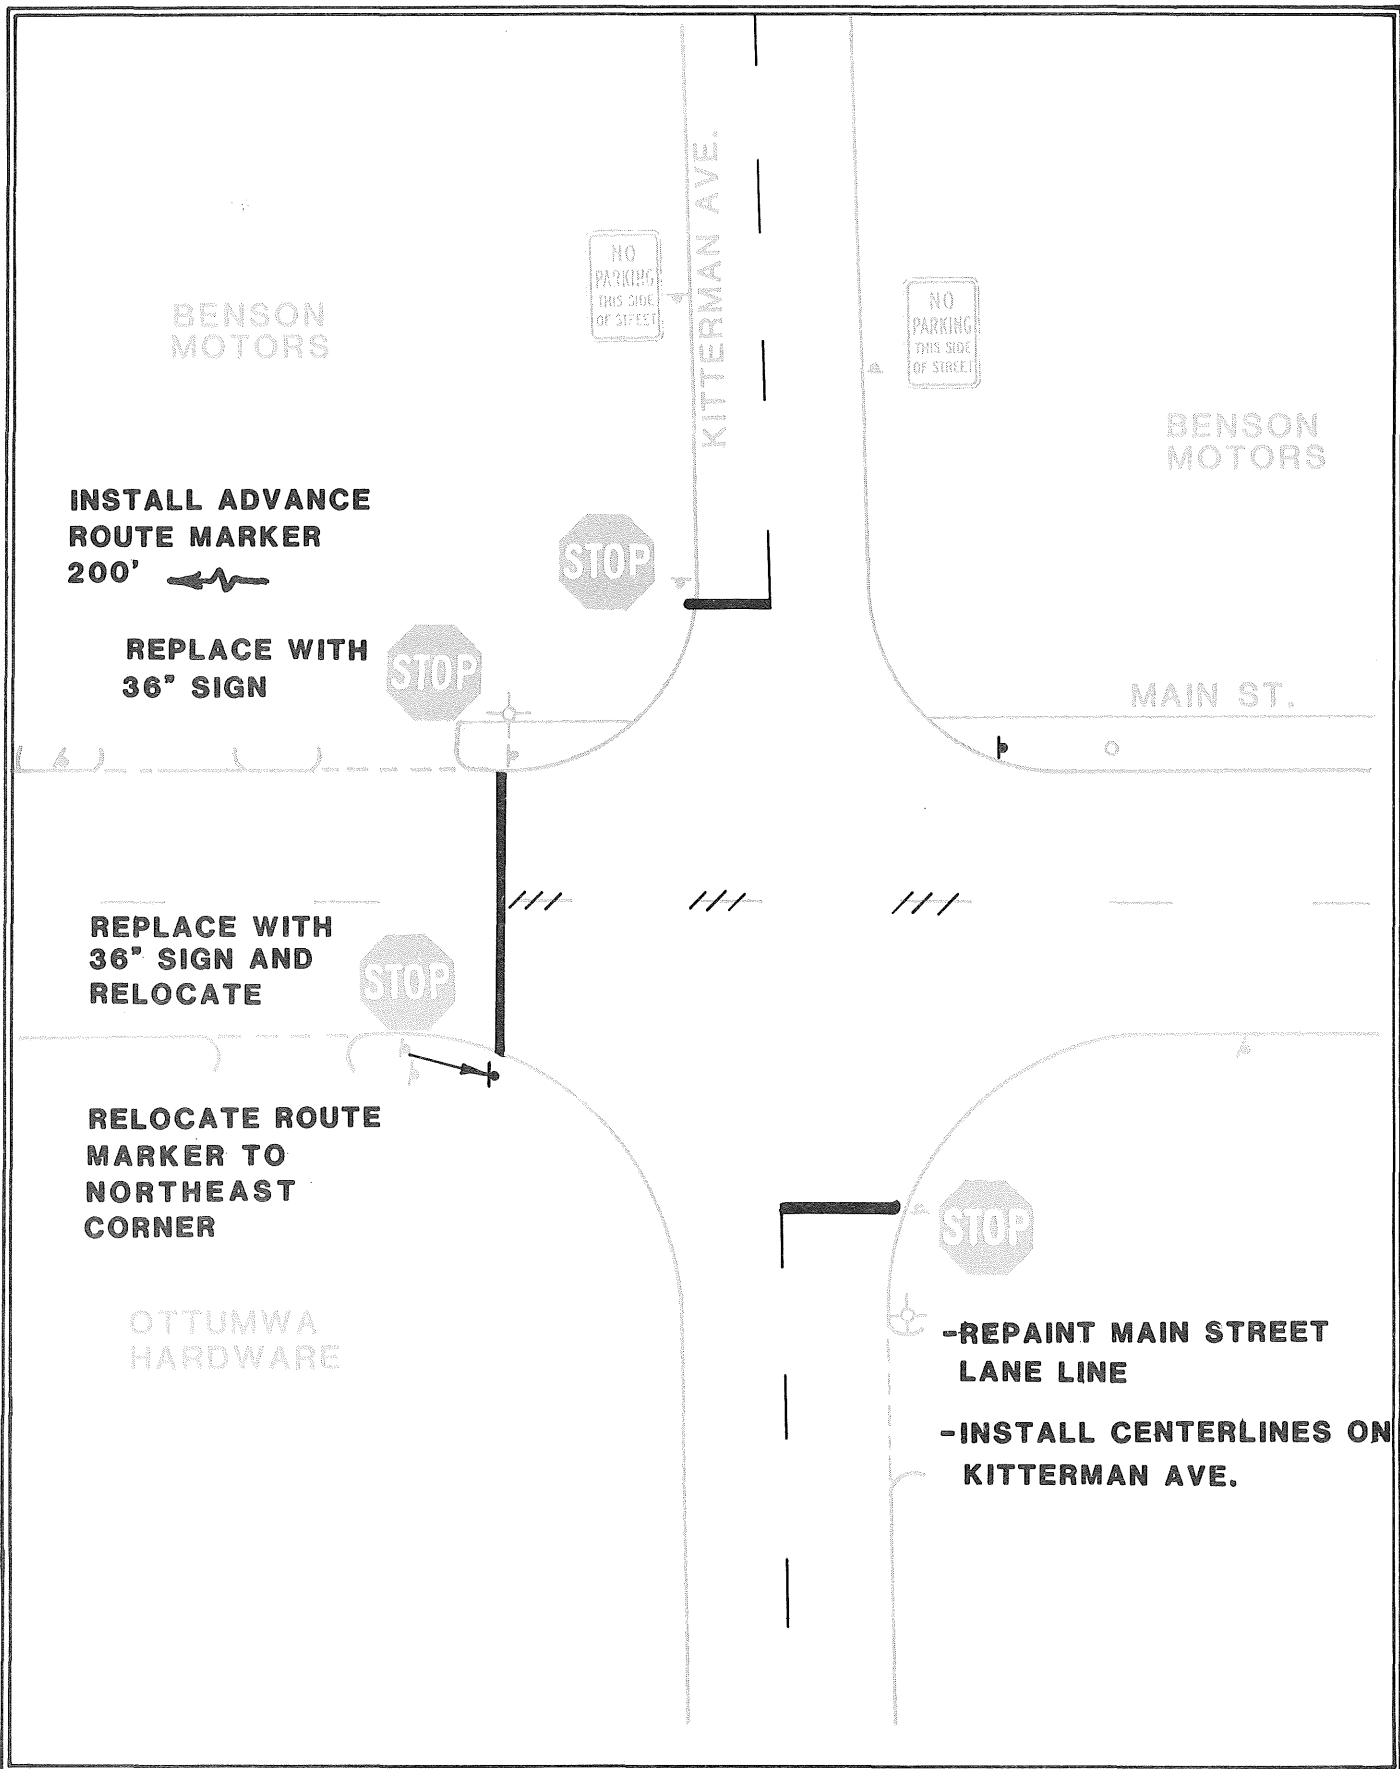
Figure 2-15

KITTERMAN AVENUE & MAIN STREET

- Replace the existing 30 inch Stop signs on Main Street with 36 inch signs.
- Install stop lines on all approaches.
- Install center line striping on the Kitterman Avenue approaches.
- Relocate the southwest corner route marker assembly to the northeast corner.
- Install an advance route turn marker on the north side of Main Street.
- Repaint the Main Street lane line.

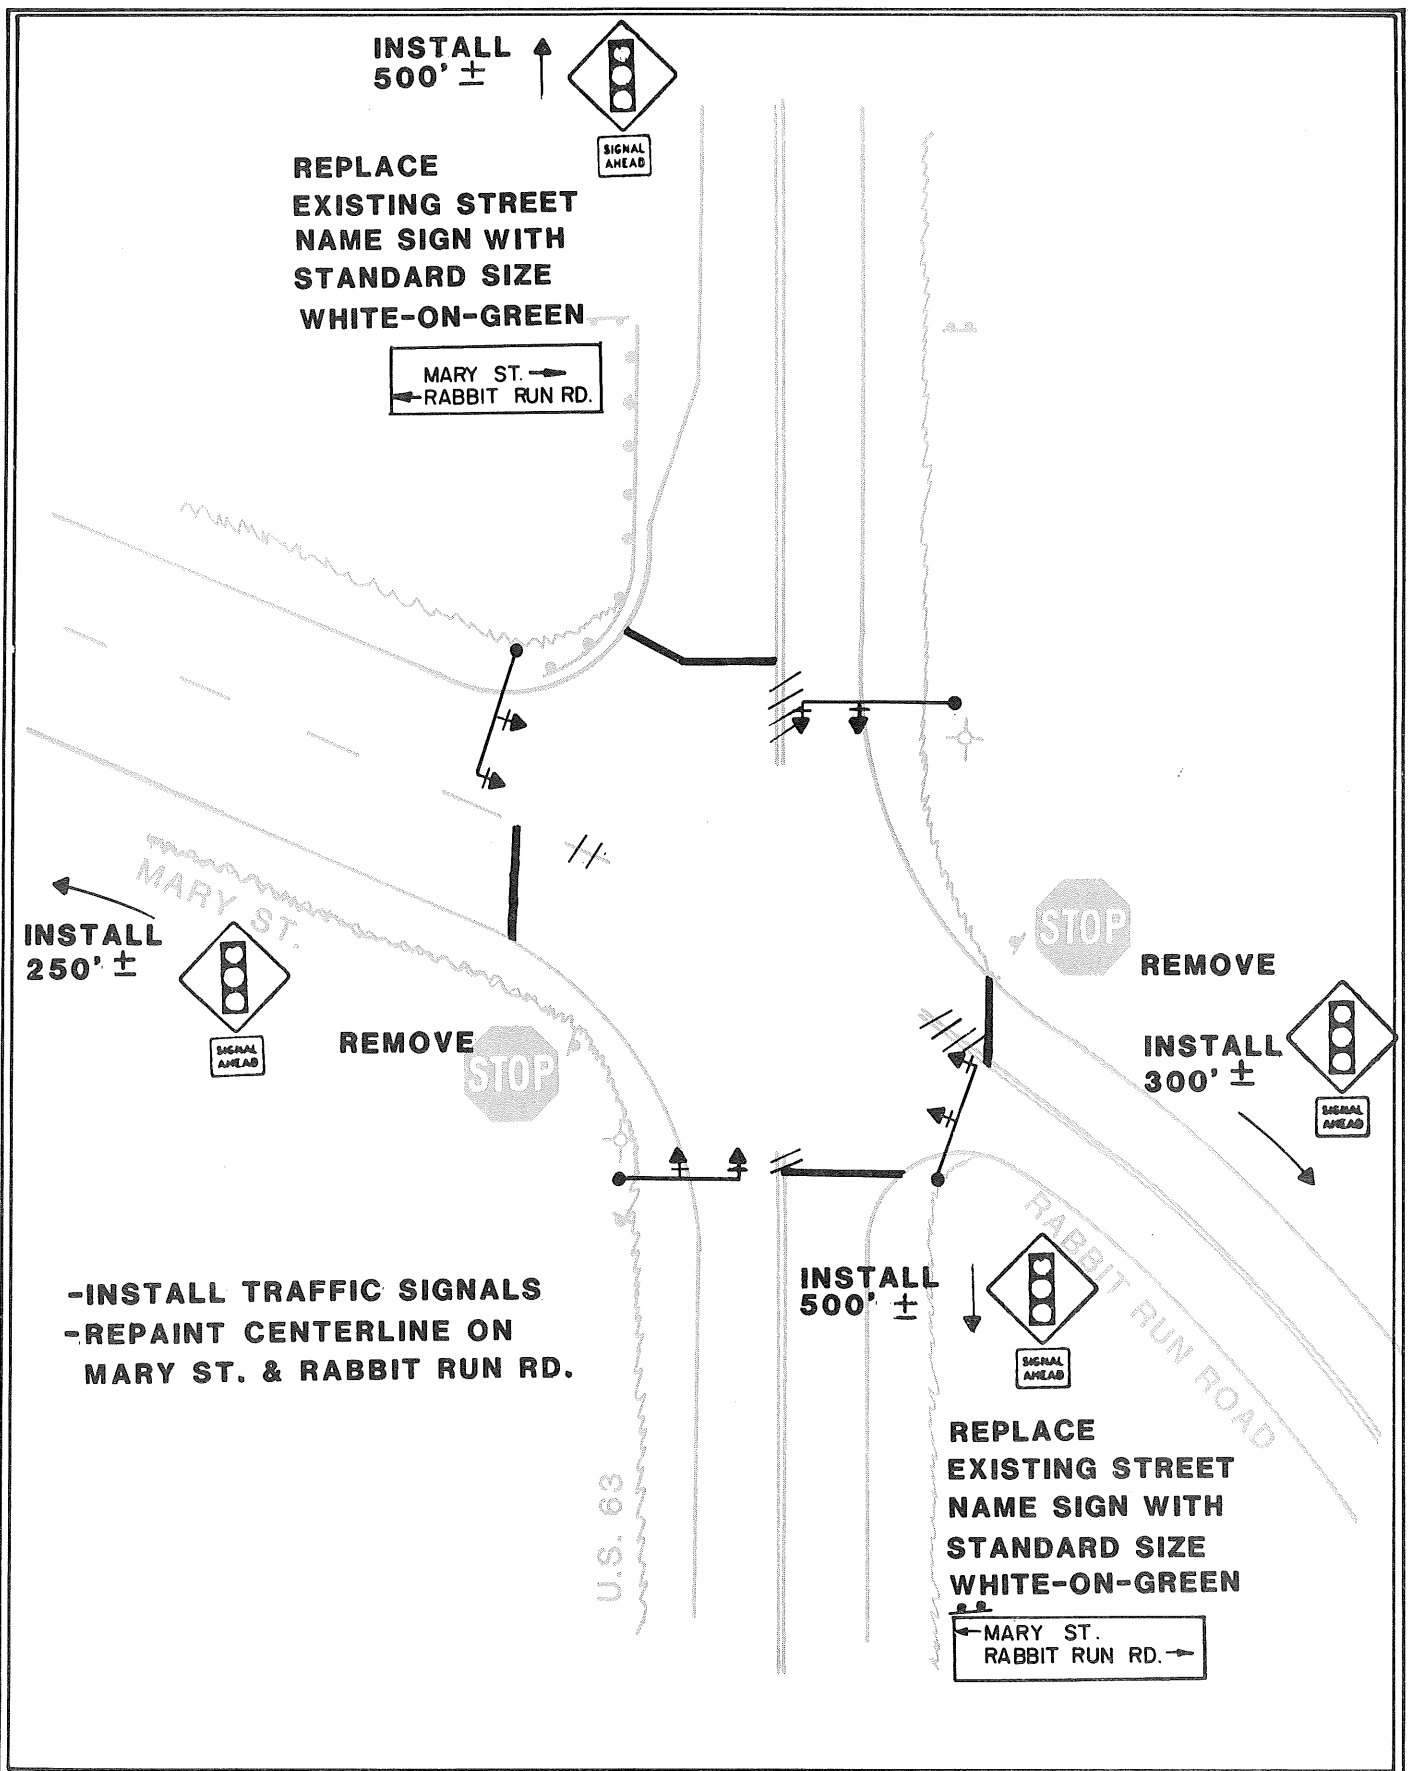
Figure 2-16

U.S. 63, MARY STREET, & RABBIT RUN ROAD

- Repaint the center lines on Mary Street and Rabbit Run Road.
- * Responsibility of Iowa D.O.T.

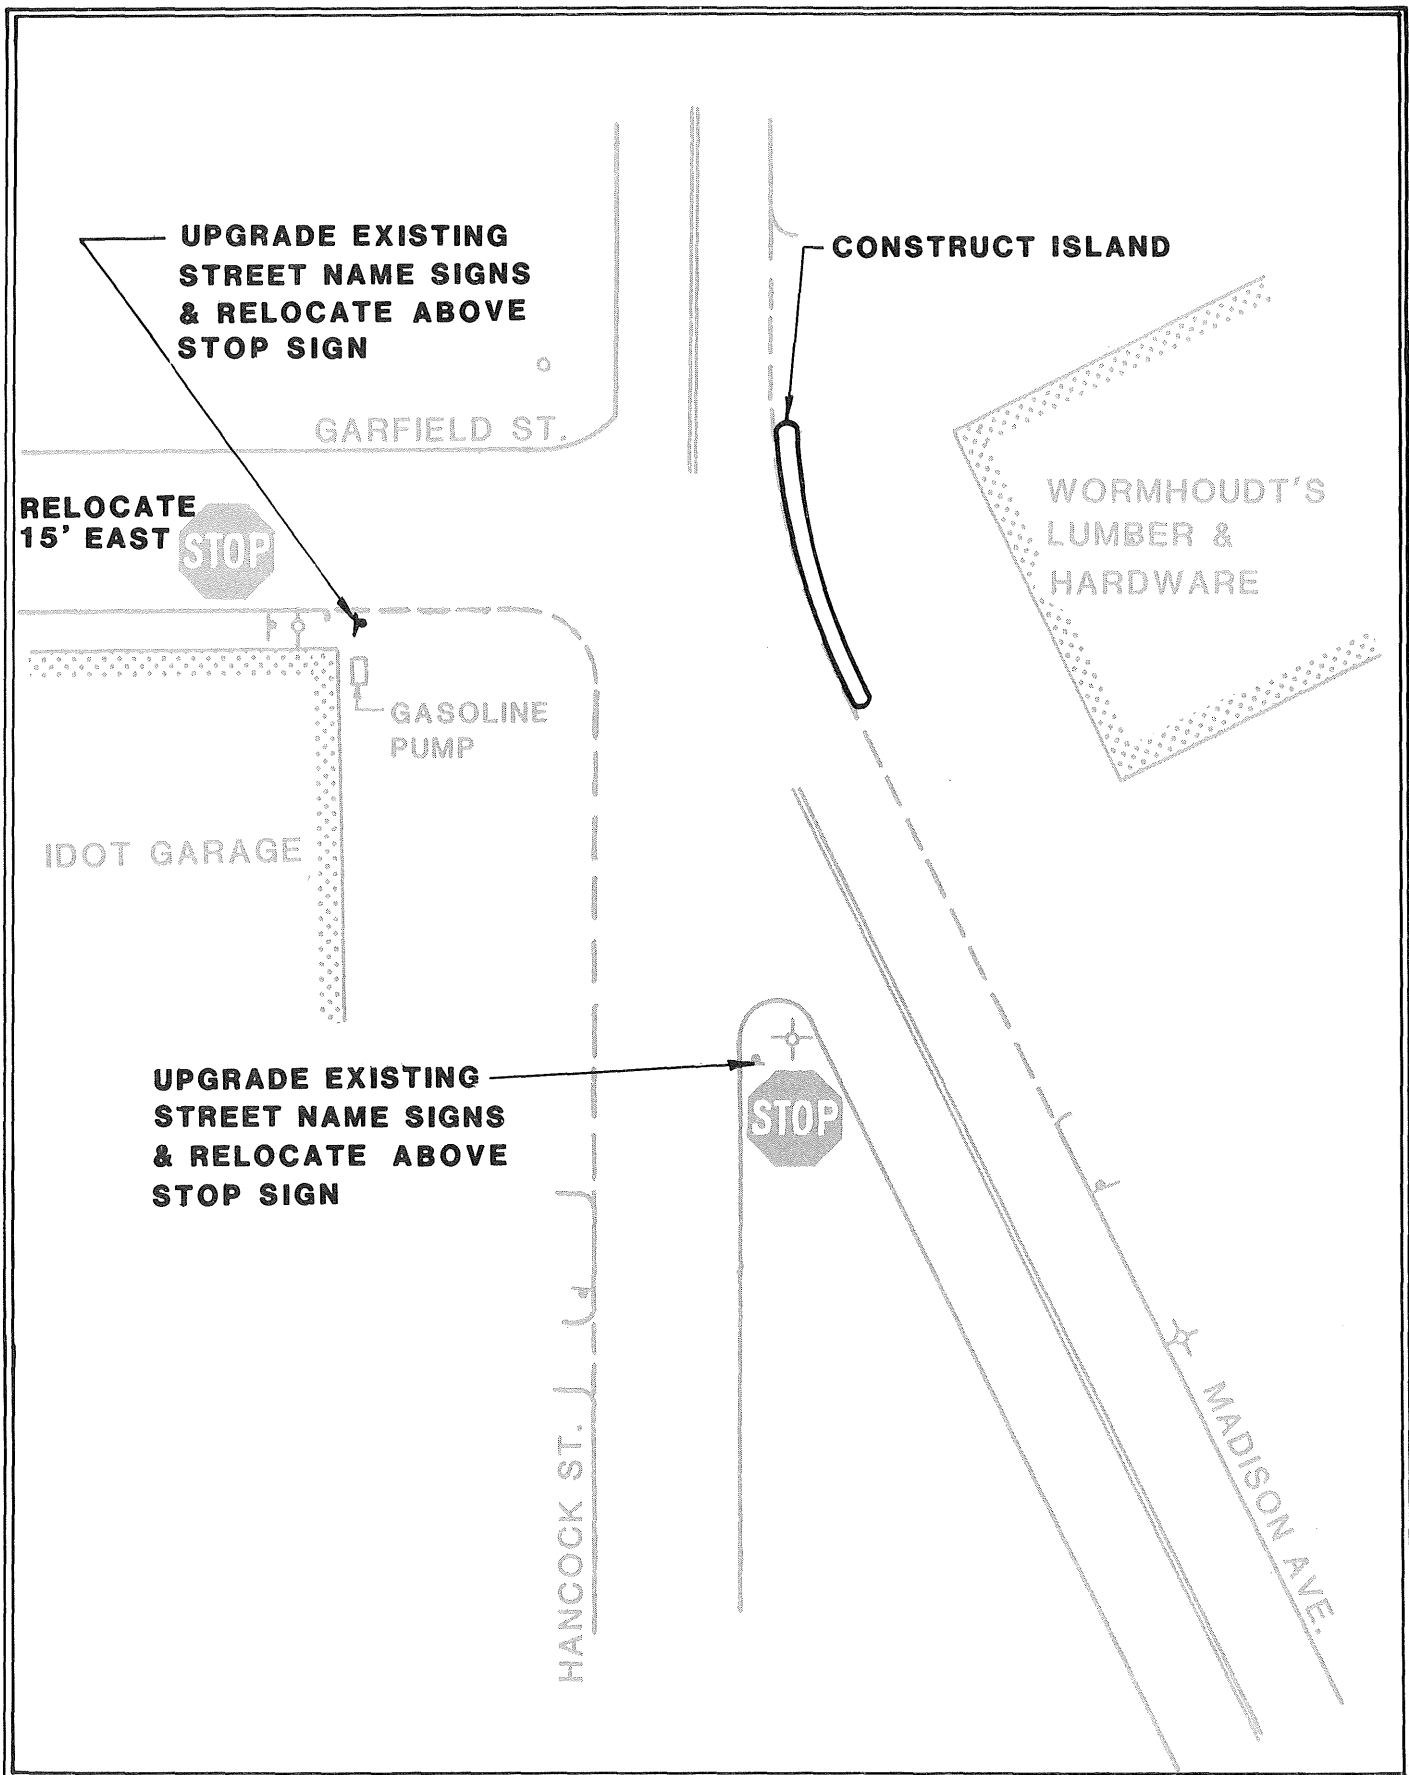
Figure 2-18a

HANCOCK STREET & MADISON AVENUE

- Construct a raised island on the east side of Madison Avenue opposite the Garfield approach.

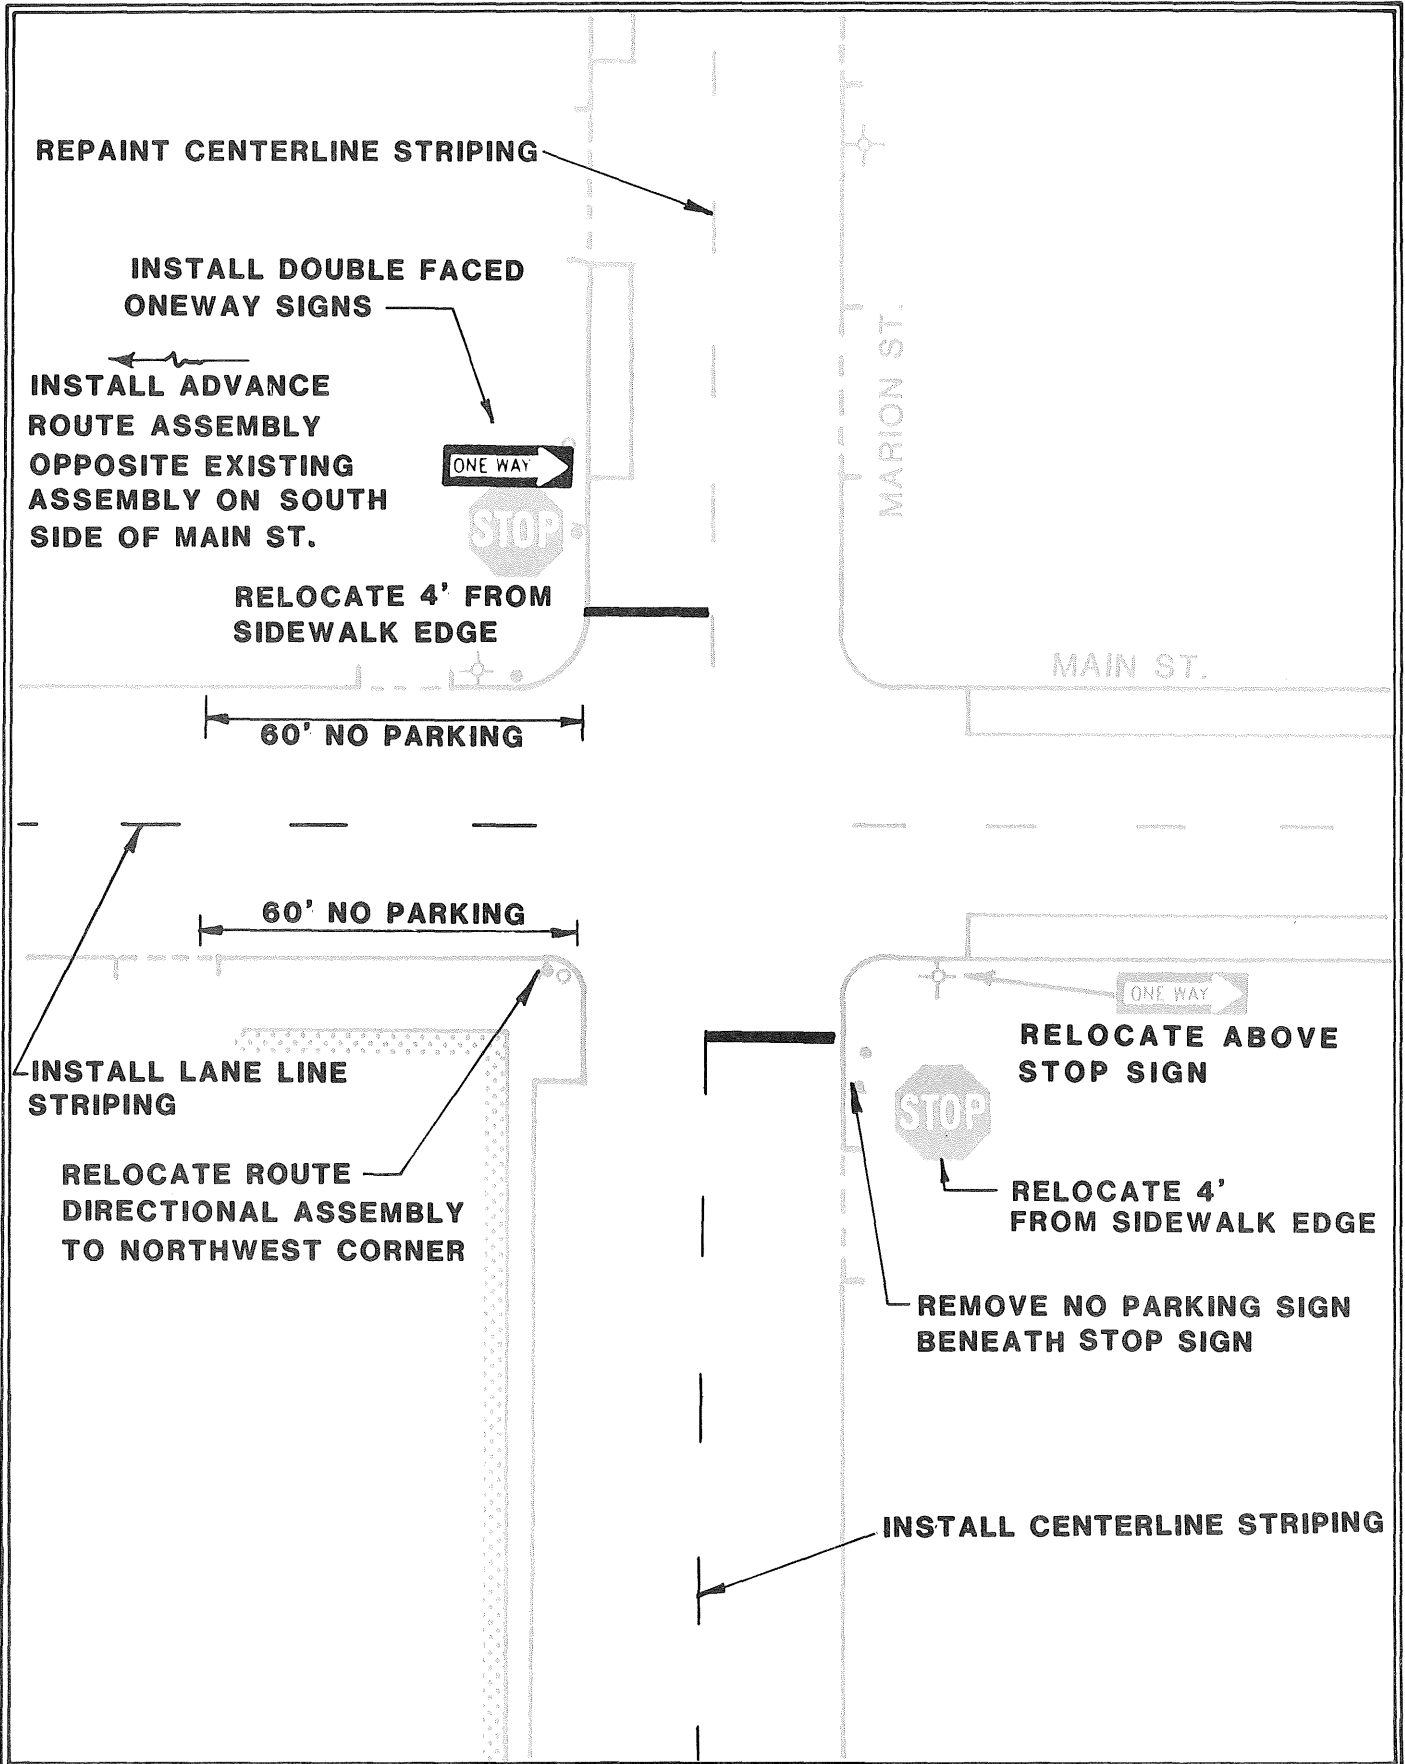
**Figure
2-20**

MARION STREET & MAIN STREET

- Relocate the Marion Street Stop signs to within 4 feet of the sidewalk line.
- Relocate the existing One Way signs on the southeast corner to the Stop sign post and install additional One Way signs above the northwest corner Stop sign.

- Prohibit parking 60 feet from the intersection on both sides of the west approach.
- Remove the No Parking sign beneath the south approach Stop sign.
- Relocate the route directional assembly on the southwest corner to the northeast corner.
- Erect an additional advance route marker at midblock on the north side of Main Street.
- Install lane line striping on the west approach and center line striping on the south approach.

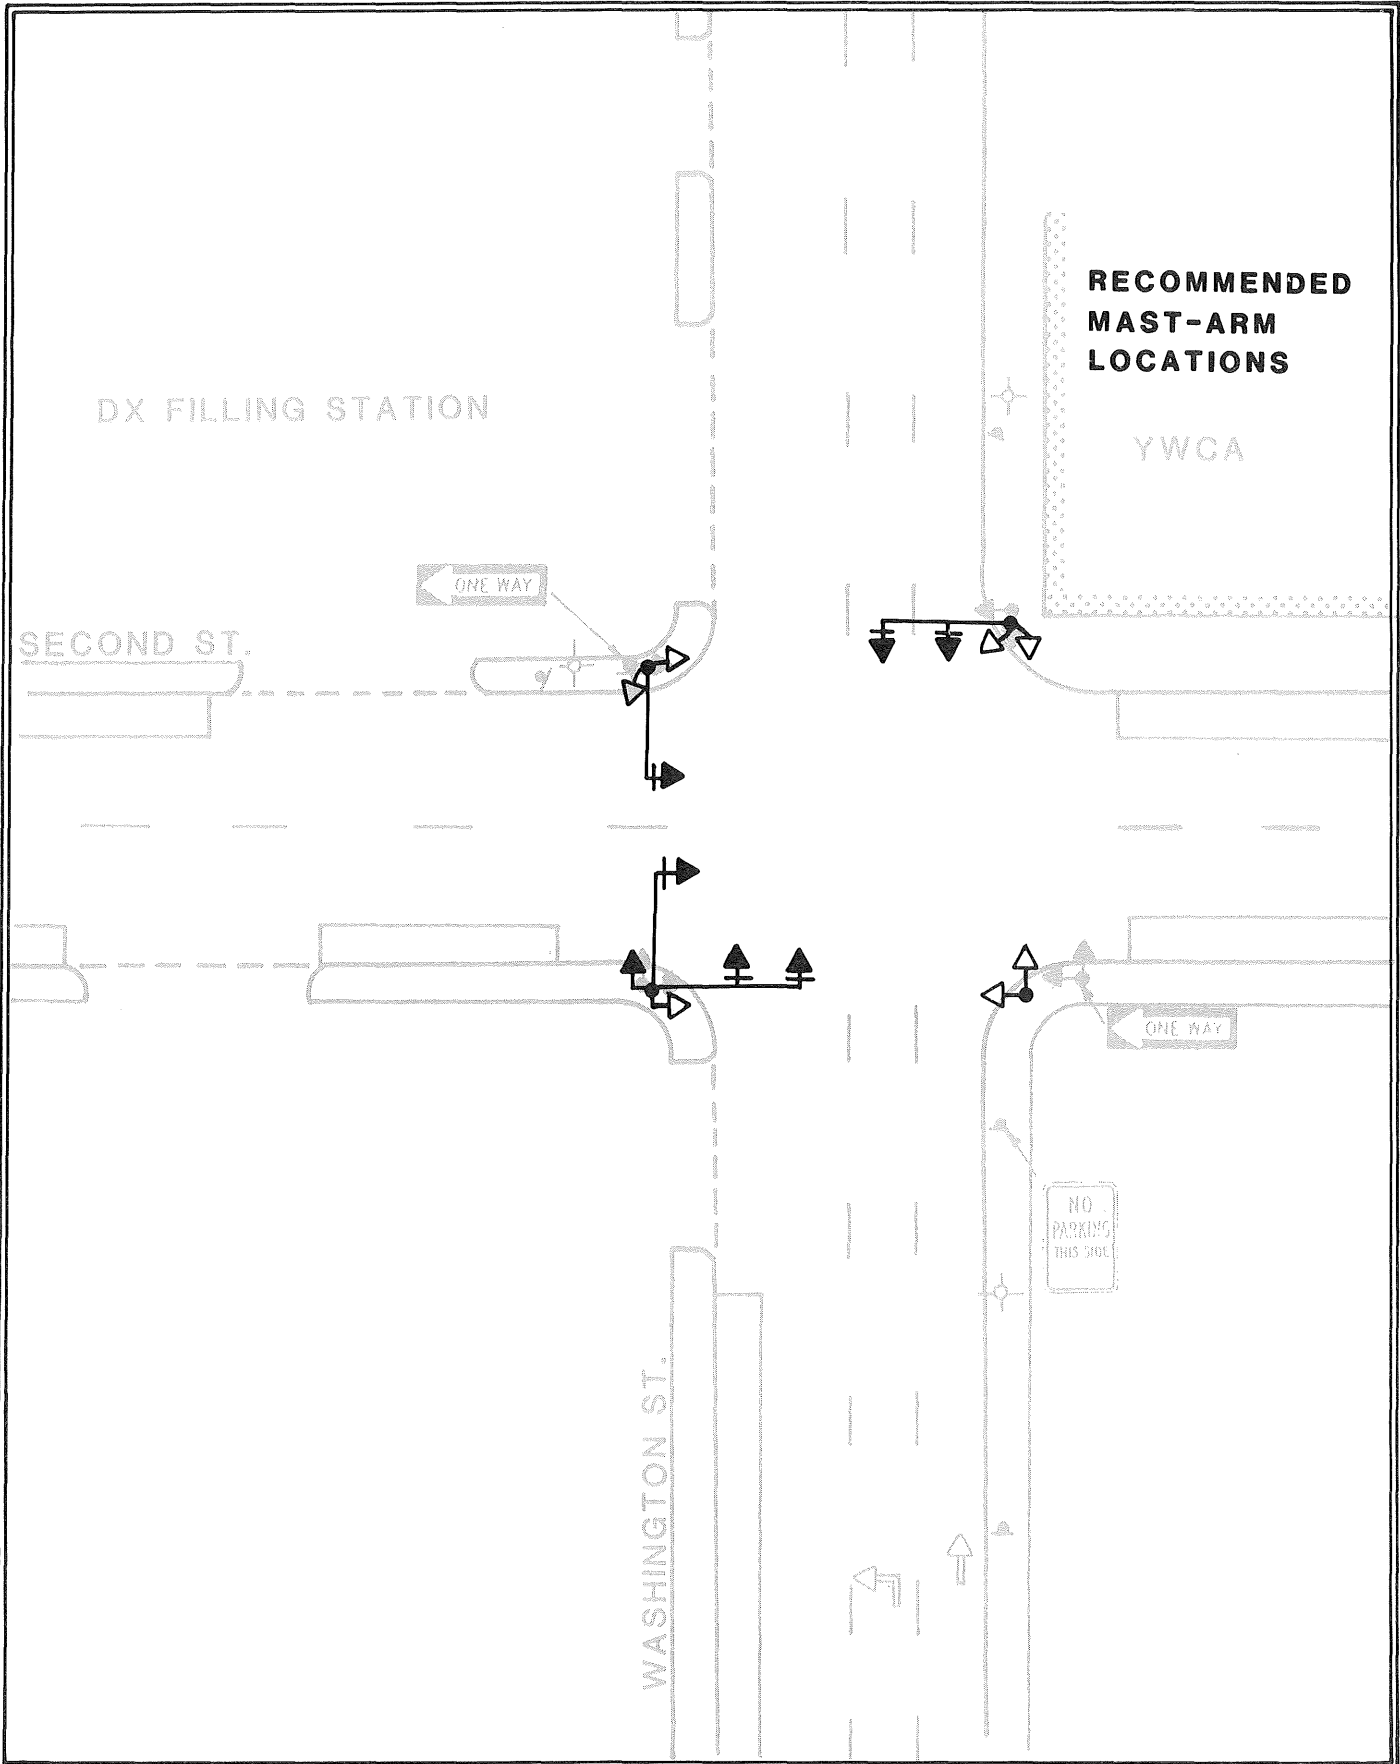
Figure 2-21b

Traffic at Washington and Second is controlled by pedestal-mounted signals that are located on the corners. Each approach is provided with far-left and far-right indications that are equipped with eight inch lenses. Signal visibility is extremely bad at this intersection because the streets are wide and because three of the signal poles are set too far from the corner. Mast-arms are highly recommended to provide the required visibility, however, the existing eight inch signal indications should be replaced by 12 inch indications until mast-arms can be installed. The suggested arrangement of mast-arms is shown on Figure 2-21b.

WASHINGTON STREET & SECOND STREET

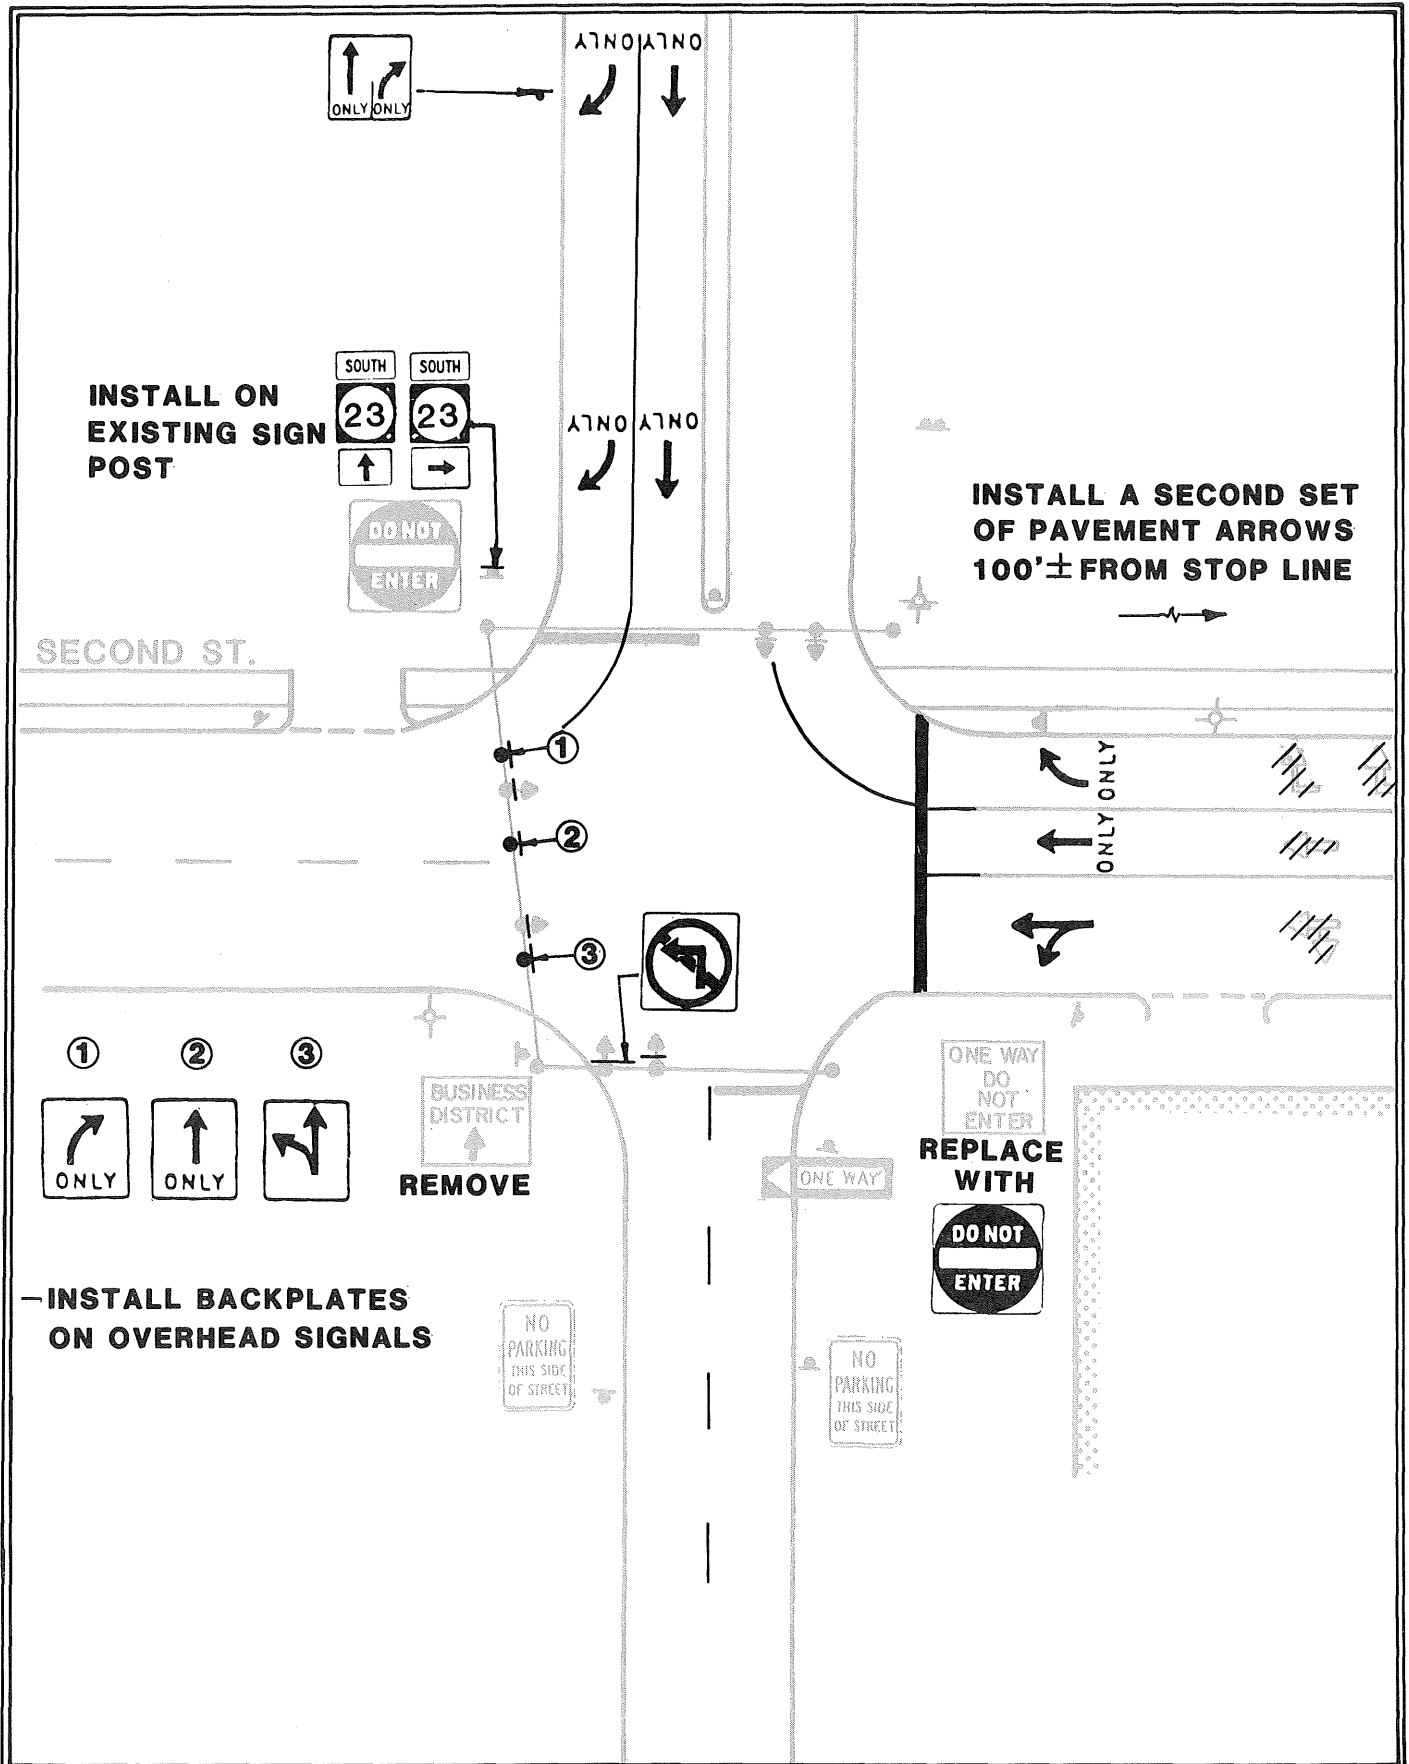
Figure 2-22

KITTERMAN AVENUE & SECOND STREET

- Install backplates on all signal heads.
