TRAFFIC SAFETY STUDY

OTTUMWA, IOWA

SEPTEMBER, 1980

Prepared by
**HENNINGSON, DURHAM & RICHARDSON
OMAHA, NEBRASKA**

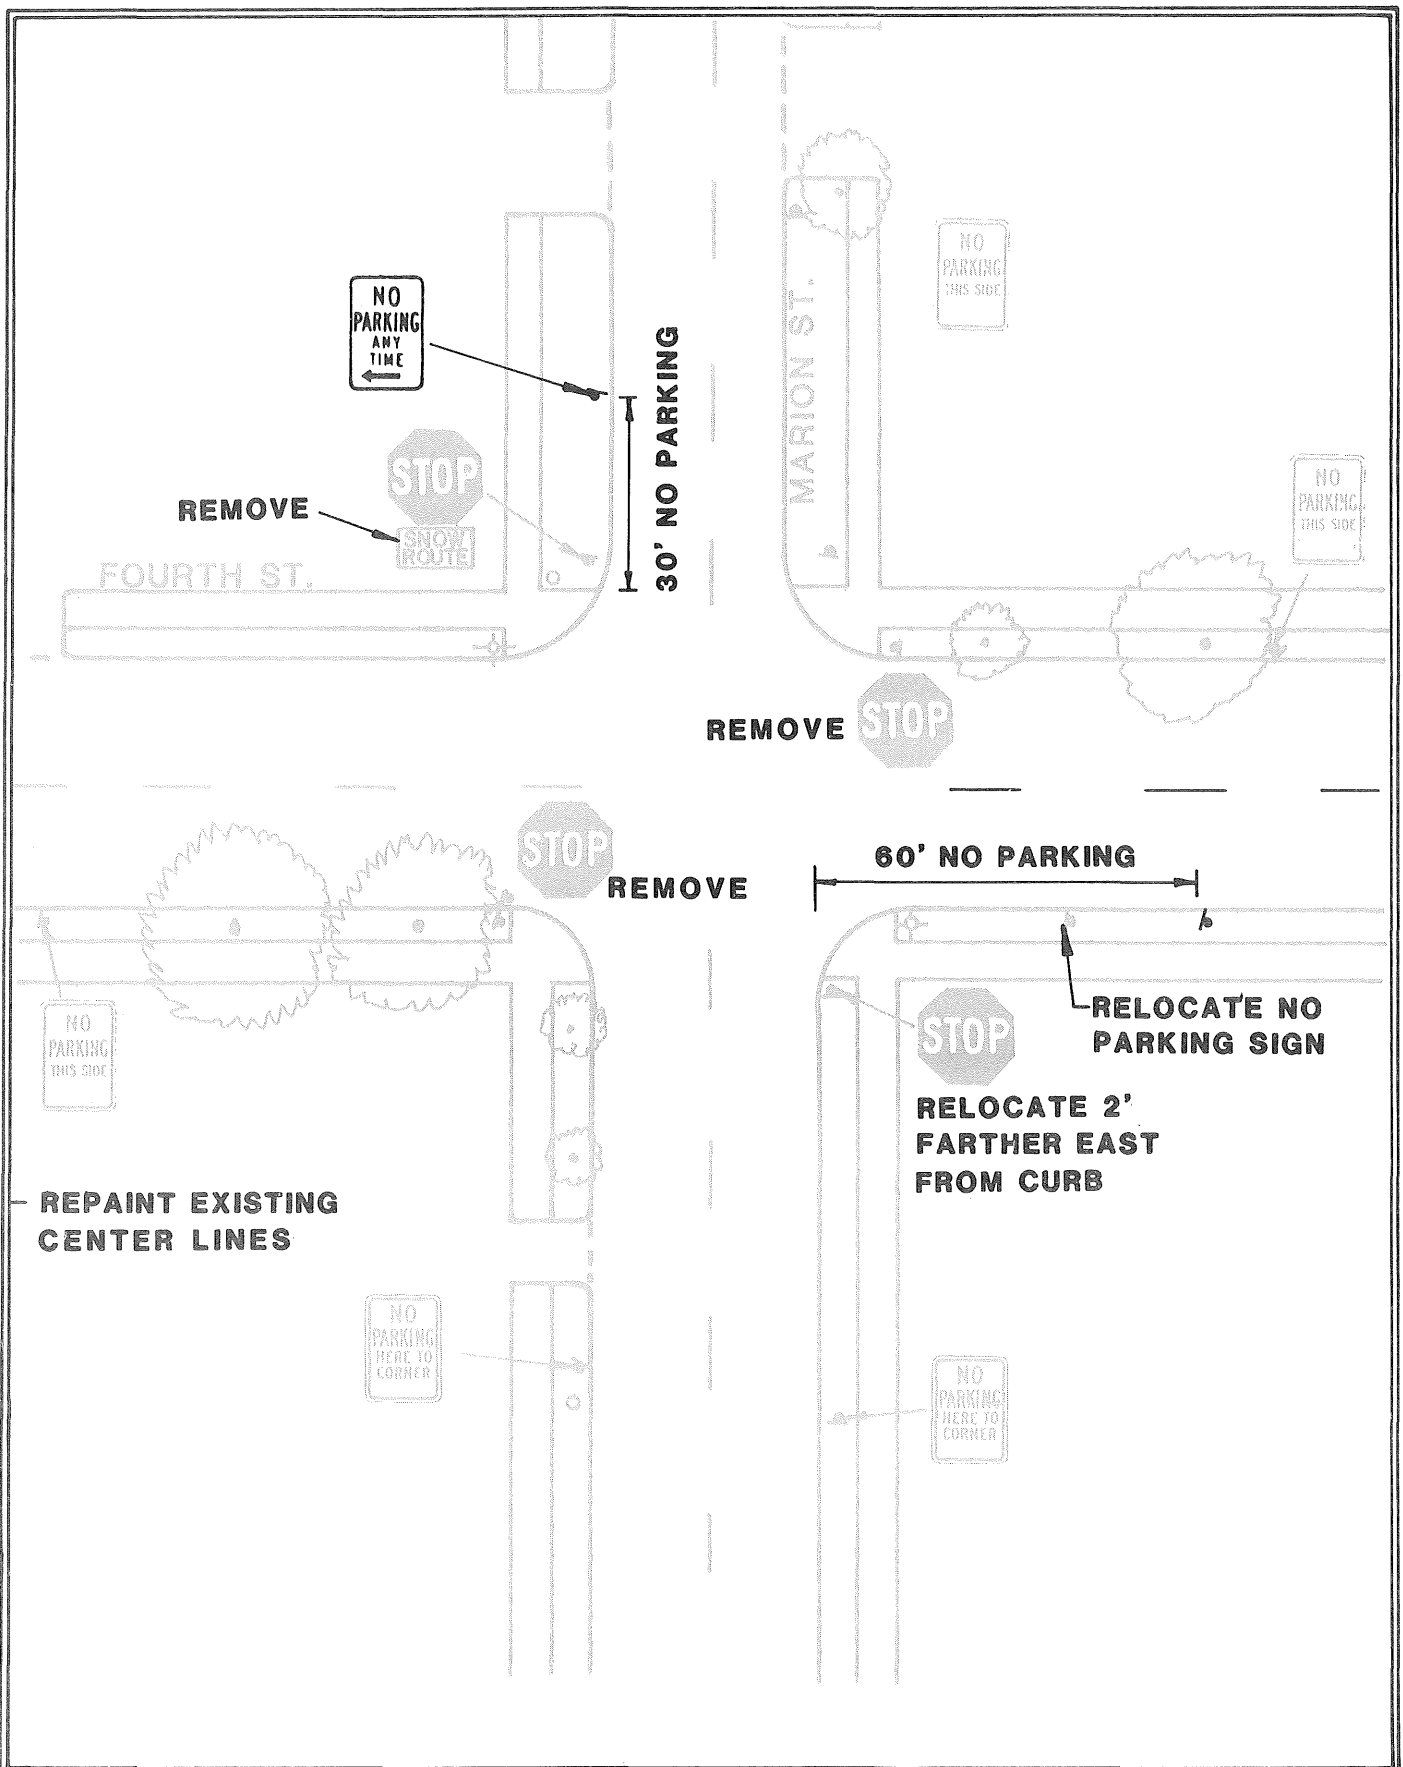
Figure

Note: In January of this year, the City removed the Stop signs on Fourth Street and installed signs on the Marion Street approaches warning motorists that Fourth Street traffic does not stop. The Consultant suggests that such signs carry the more general message: "CAUTION - CROSS STREET TRAFFIC DOES NOT STOP", so they can be reused at other locations.

MARION STREET & FOURTH STREET

- Remove the Stop signs on Fourth Street.
- Relocate the south approach Stop sign 2 feet farther from the curb face.
- Install a No Parking sign 30 feet from the sidewalk line on the north approach.
- Relocate the No Parking sign on the east approach as shown on the improvement diagram to increase sight distance on the southeast corner.
- Install center line striping on the east approach and repaint the existing center lines on the other approaches.

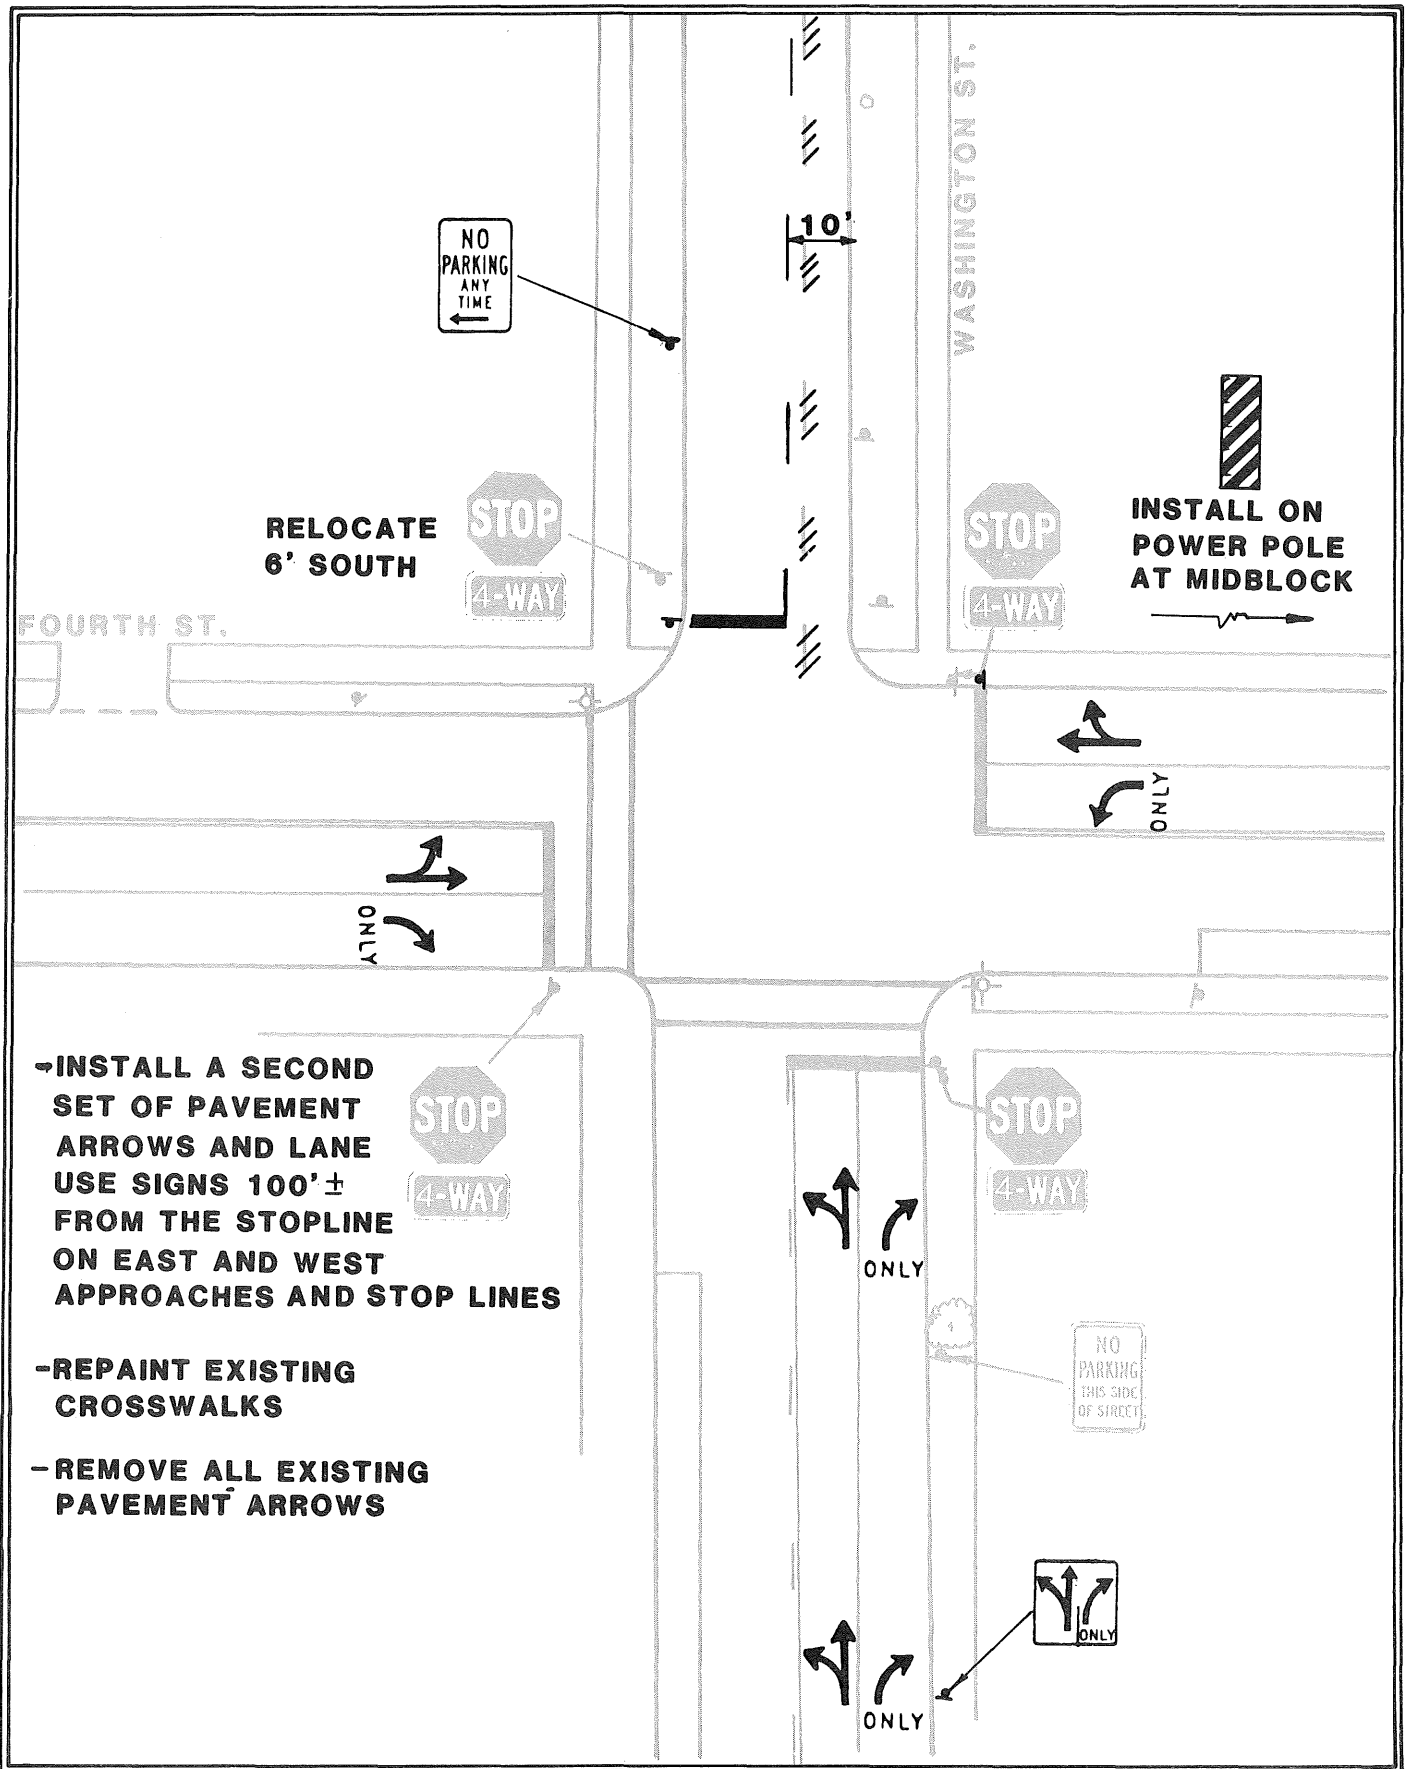
Figure 2-27

WASHINGTON STREET & FOURTH STREET

- Relocate the power poles along the north side of Fourth Street to positions behind the sidewalk.

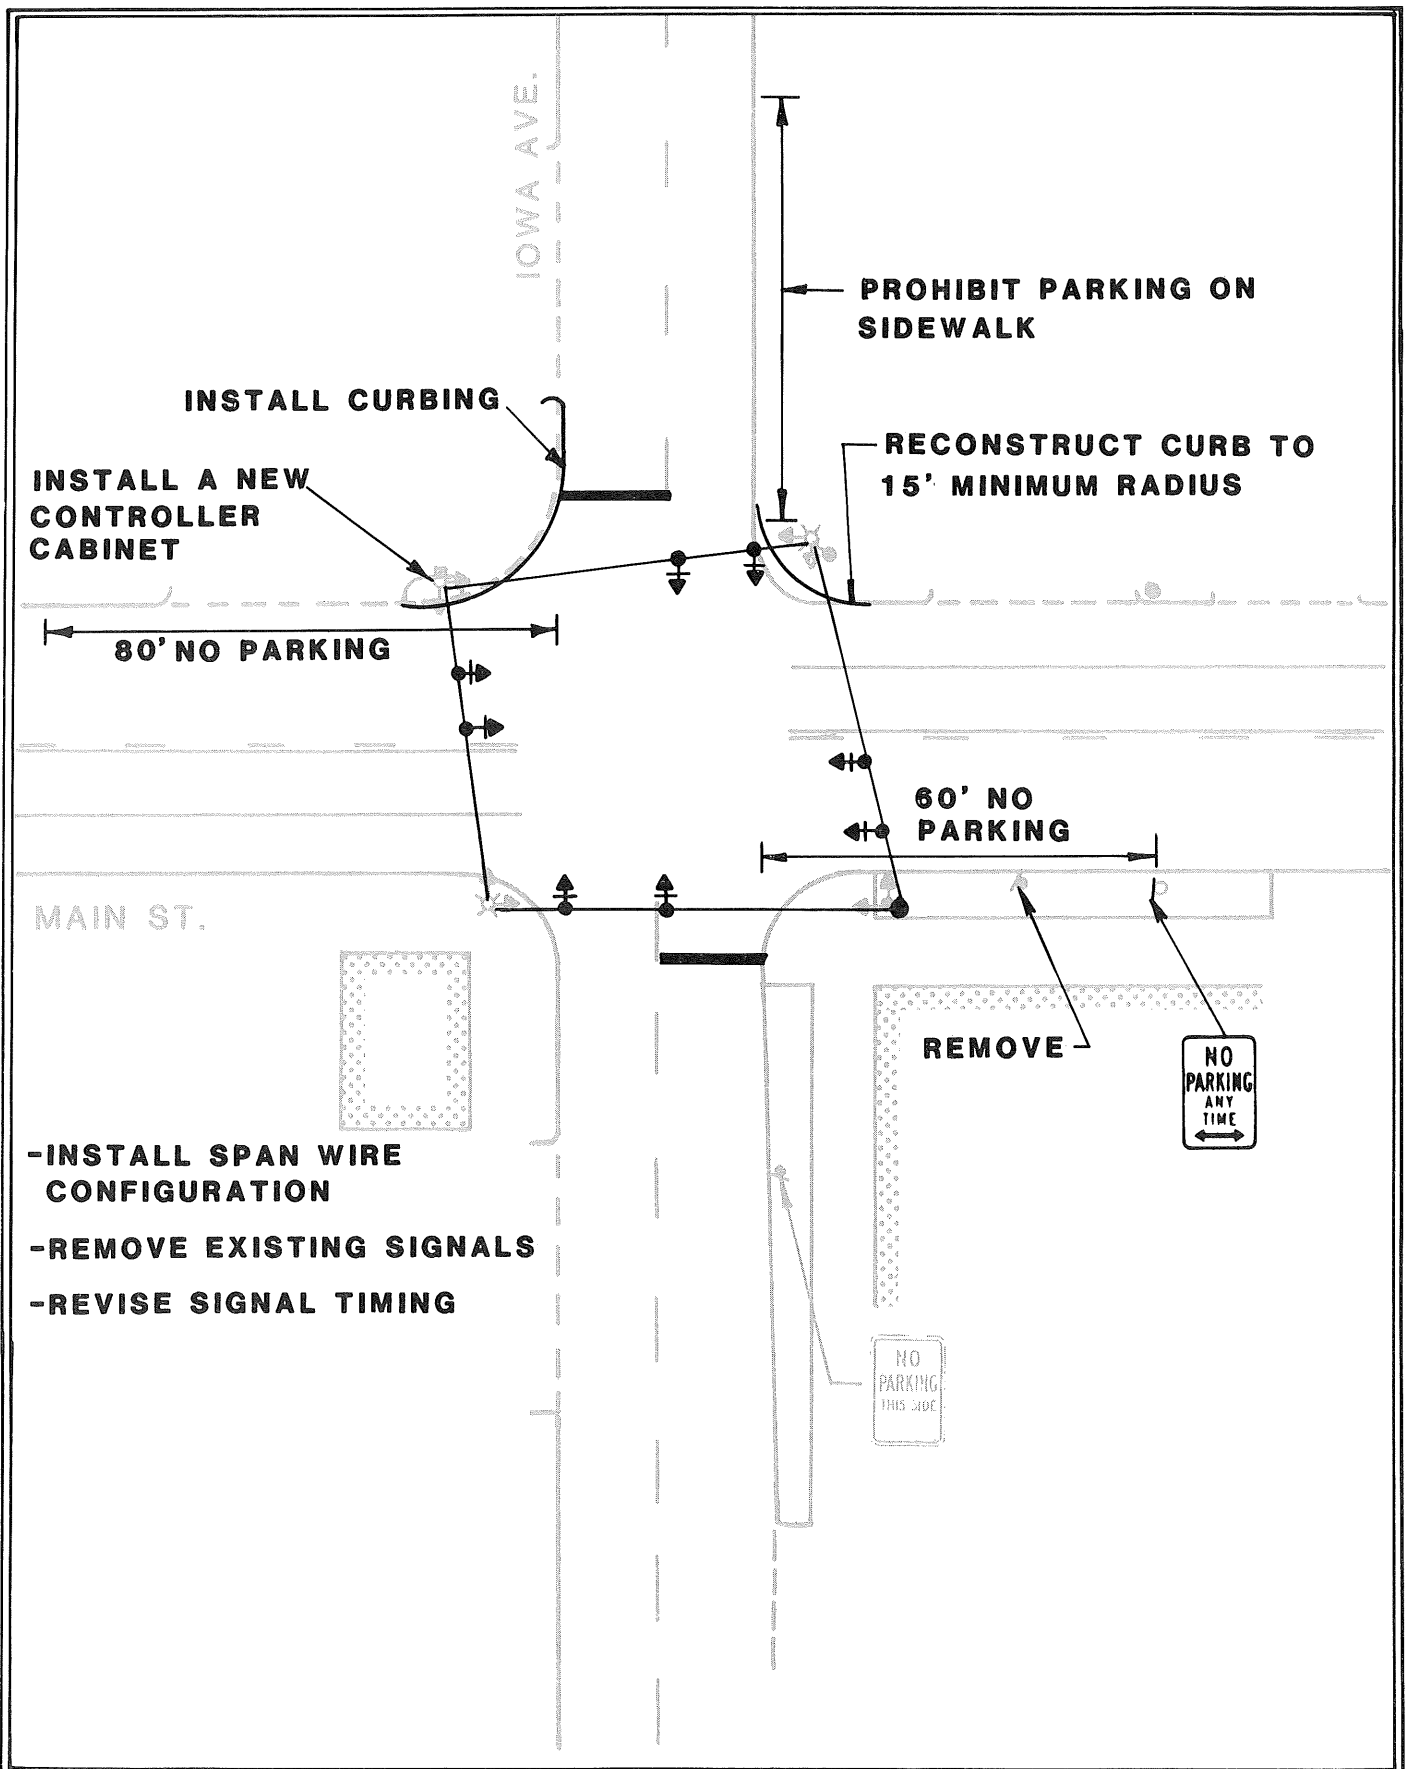
A recent traffic volume count taken by the City indicates that traffic on Iowa Avenue is heavier north of the intersection. On that basis, the Consultant questions the need for a mandatory right turn lane on the west approach, and suggests instead that a left turn lane be provided. Because the Main Street approaches already have offset center lines and should be restriped to provide wider lanes, it is recommended that shadowed left turn bays be painted on the east and west approaches as shown on Figure 2-29b. This improvement should be accompanied by the removal of existing pavement arrows and the installation of left turn arrows and the word message "ONLY" on the left turn lanes.

MAIN STREET & IOWA AVENUE

The no parking zones on Main Street should be increased as shown on Figure 2-29a to promote safer traffic flow through the intersection. It is also recommended that parking on the sidewalk be prohibited on the east side of the north approach, because this practice blocks the sidewalk and breaks down the curb over a period of time. The sidewalk is within City right-of-way so the parking prohibition can be enforced.

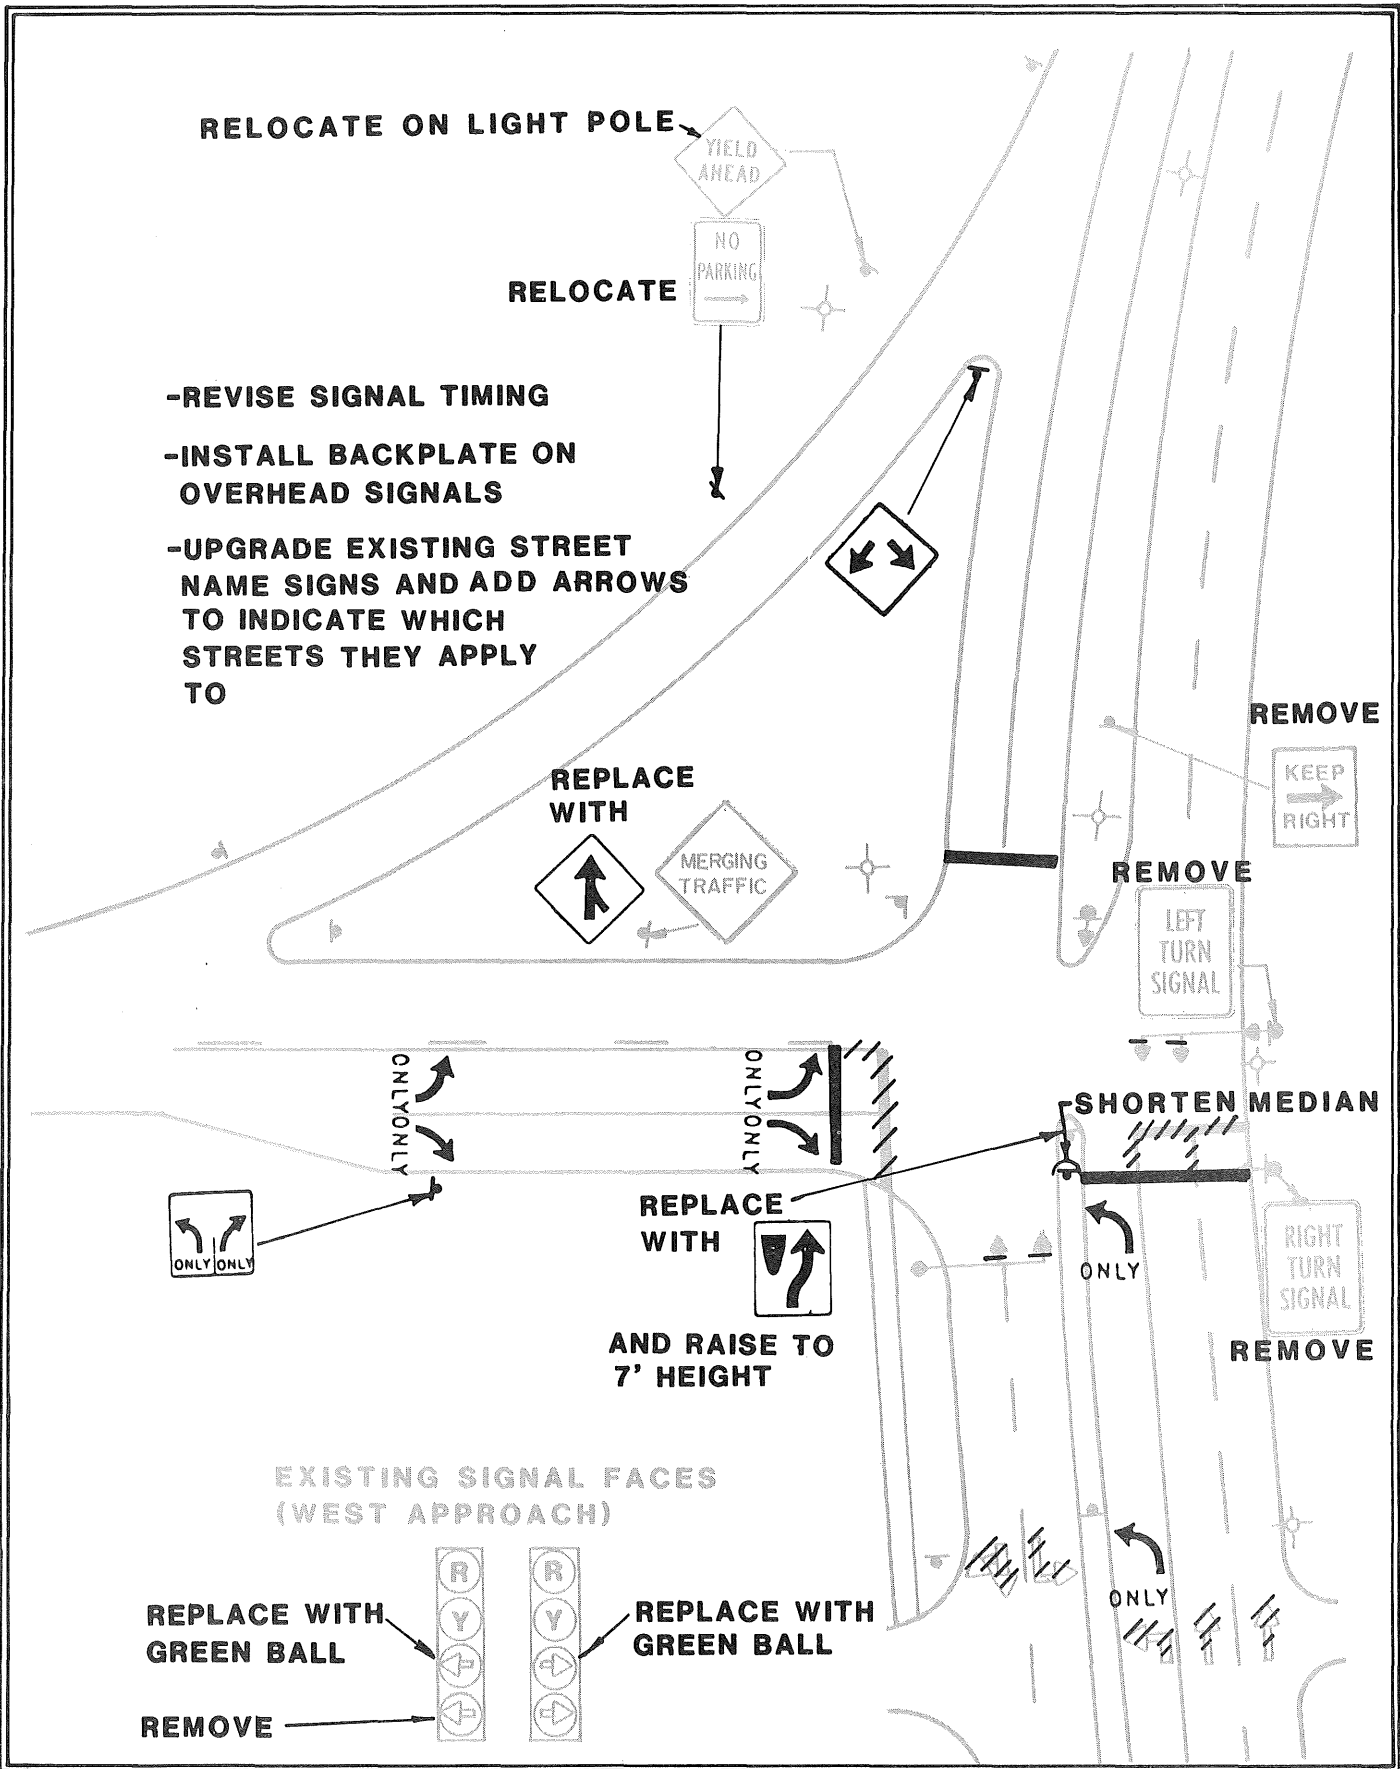
Figure 2-30a

Traffic control is provided by fully actuated signals. The signal heads are mounted on mast-arms for the Wapello and Ferry approaches and are pole-mounted for Albia Road. The Albia signals are signed as right and left turn signals and double green arrows are provided to indicate permitted movements (shown on Figure 2-30a). Separate signal phases are furnished for north and south through traffic, for east bound traffic, and for left turns from Ferry and right turns from Albia. Clearance intervals currently range from 5 to 7.5 seconds with an all-red phase. Pavement arrows are located only on the Ferry Street approach and stop lines are provided on Ferry and Albia.

WAPELLO STREET, ALBIA ROAD, & FERRY STREET

- Reconstruct the median nose on Ferry Street.
- Install backplates on the overhead signals.

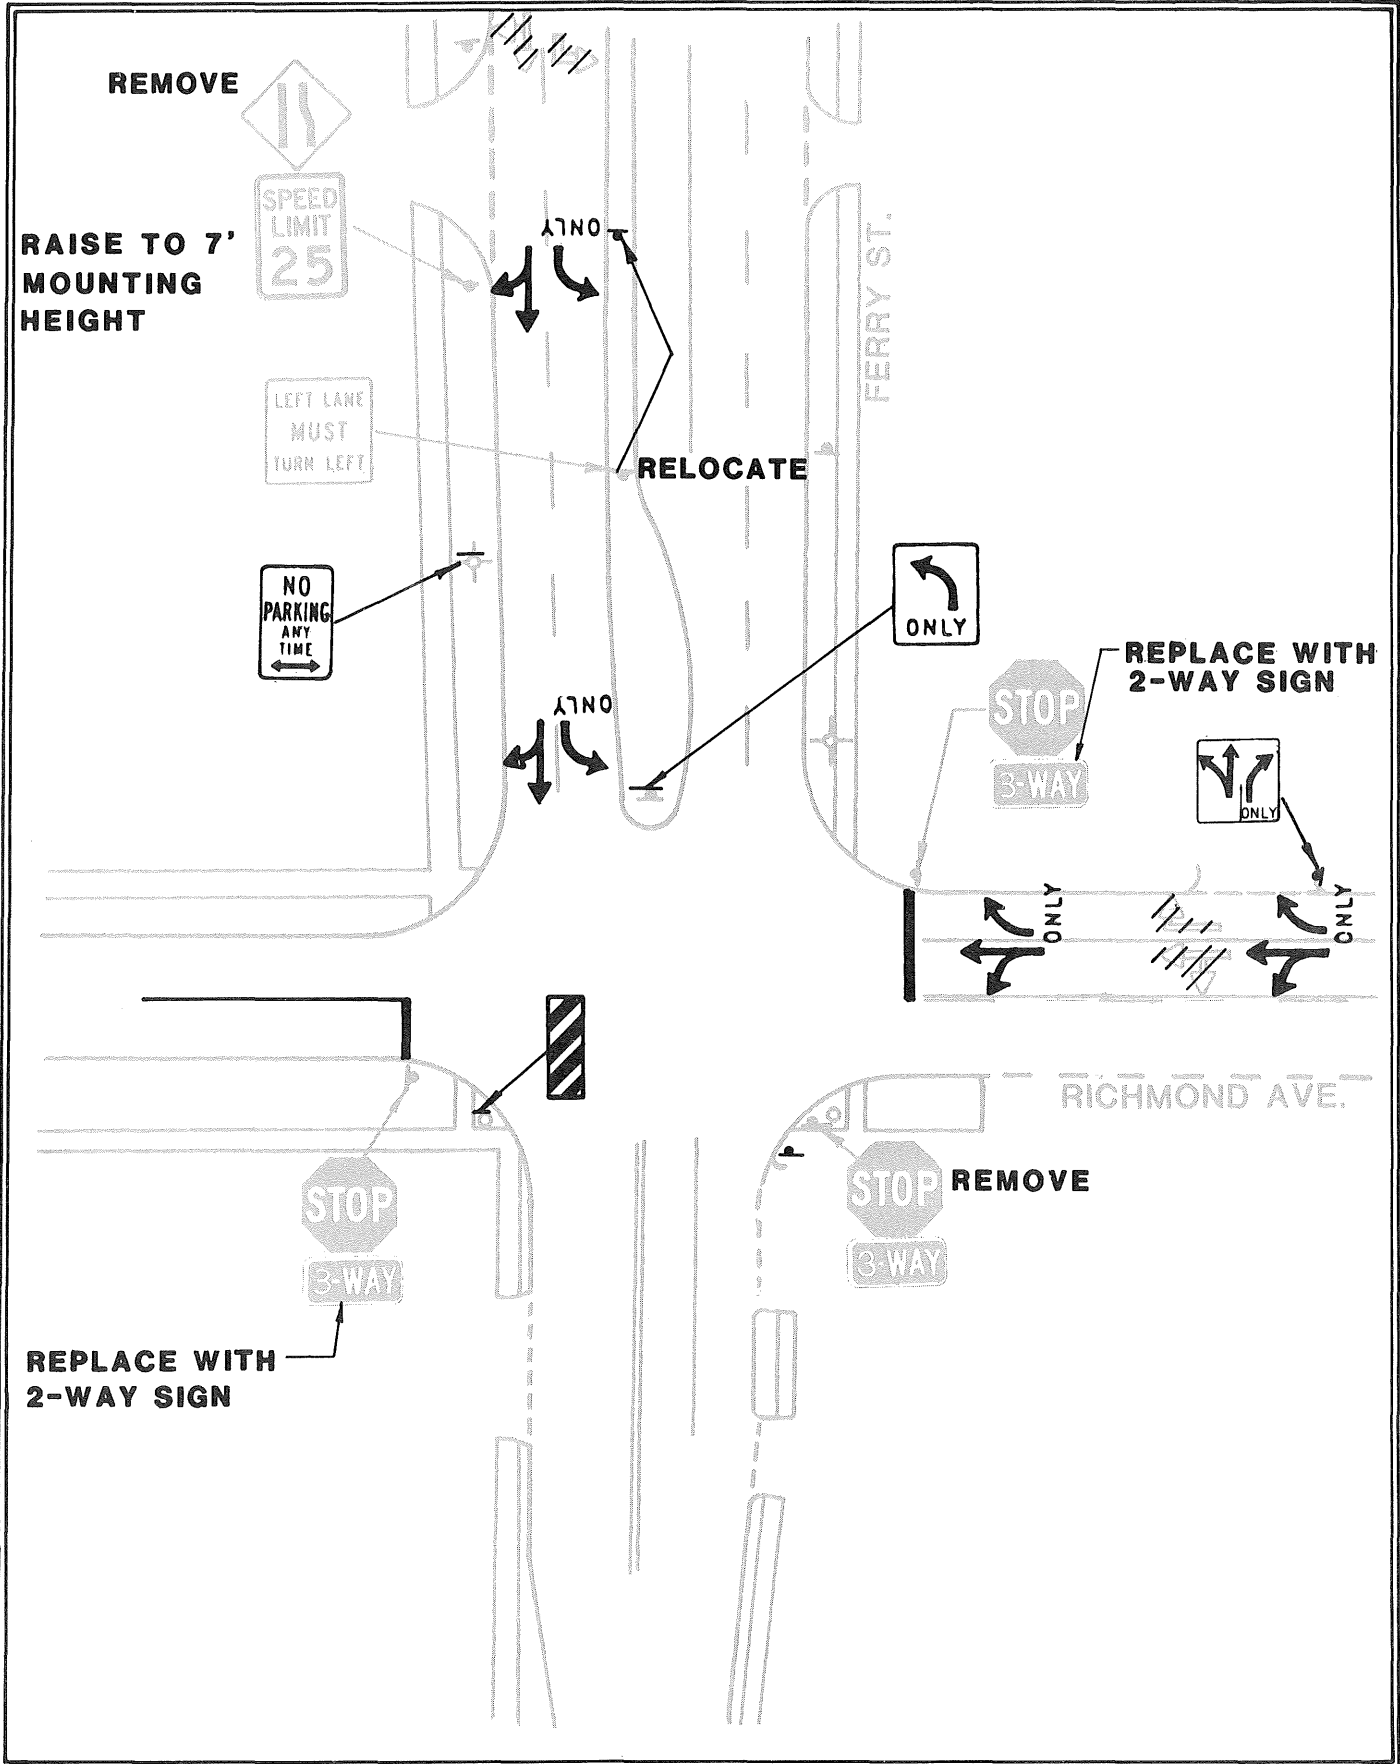
Figure 2-31

FERRY STREET & RICHMOND AVENUE

- Install stop lines on the east and west approaches.
- Remove the existing pavement arrows and install conforming arrows and lane assignment signs.
- Remove the Stop sign on the south approach.
- Install an Object Marker (OM-3R) on the southwest corner power pole.
- Install a No Parking sign on the north approach to supplement the painted curb.
- Remove the Pavement Transition sign on the north approach and raise the Speed Limit 25 sign to a 7 foot mounting height.
