Investigation and Rehabilitation of Lining Imperfections and cracks in an Operating Railway Tunnel

Investigation and Rehabilitation of Lining imperfections and cracks in an Operating Railway Tunnel

The X.Z.Y. tunnel is a curved tunnel with single-rail track for the railway in southwest China. The construction was started in April 2003 and completed in August 2004. The tunnel crosses a hills area where the excavation was in a stratum of mudstone mixed with sand stone. The stratum was formed horizontally with developed joints. The tunnel was constructed using the conventional tunnelling method with an integral lining system.

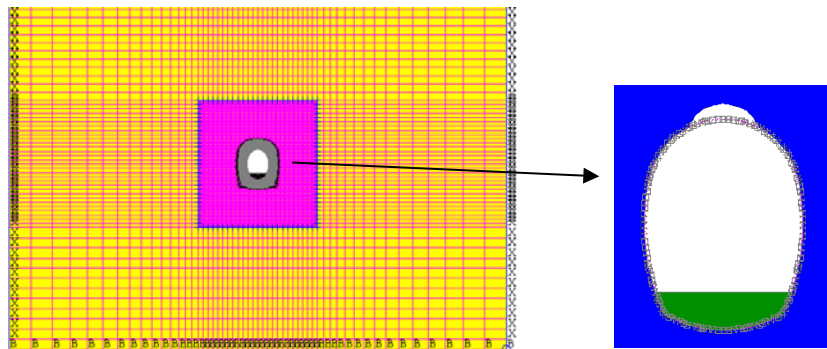
Figure 9 FLAC 2D Numerical model

Simple FLAC2D numerical analysis was carried out to investigate the influence of void behind the lining on the lining mechanical performance, as shown in Figure 9. Generally tunnel damages may be influenced by many factors such as ground condition, imperfections in design and construction. Numerical analysis show that the insufficient lining thickness and void behind the lining are major causes of the lining crack. This is shown in Figure 10 that if a void at the corwn, the lining bening moment reverse at the crown. The computed results of the stress at the different position of the tunnel lining was presented in table 4. It found that at the shoulder of the intrados of the tunnel arch the bending moment change from compression to tensile, which is

very easy to cause a tensile crack due to the low tensile strength of the lining concrete. This results highly coincides with observed result in Figure 3 and Figure 5.
