ADVANCED MASTERS IN STRUCTURAL ANALYSIS  
OF MONUMENTS AND HISTORICAL CONSTRUCTIONS

# Master's Thesis

**Investigation of damage and repair  
of masonry piers affected by fire in  
the church of Santa Maria del Mar  
in Barcelona**

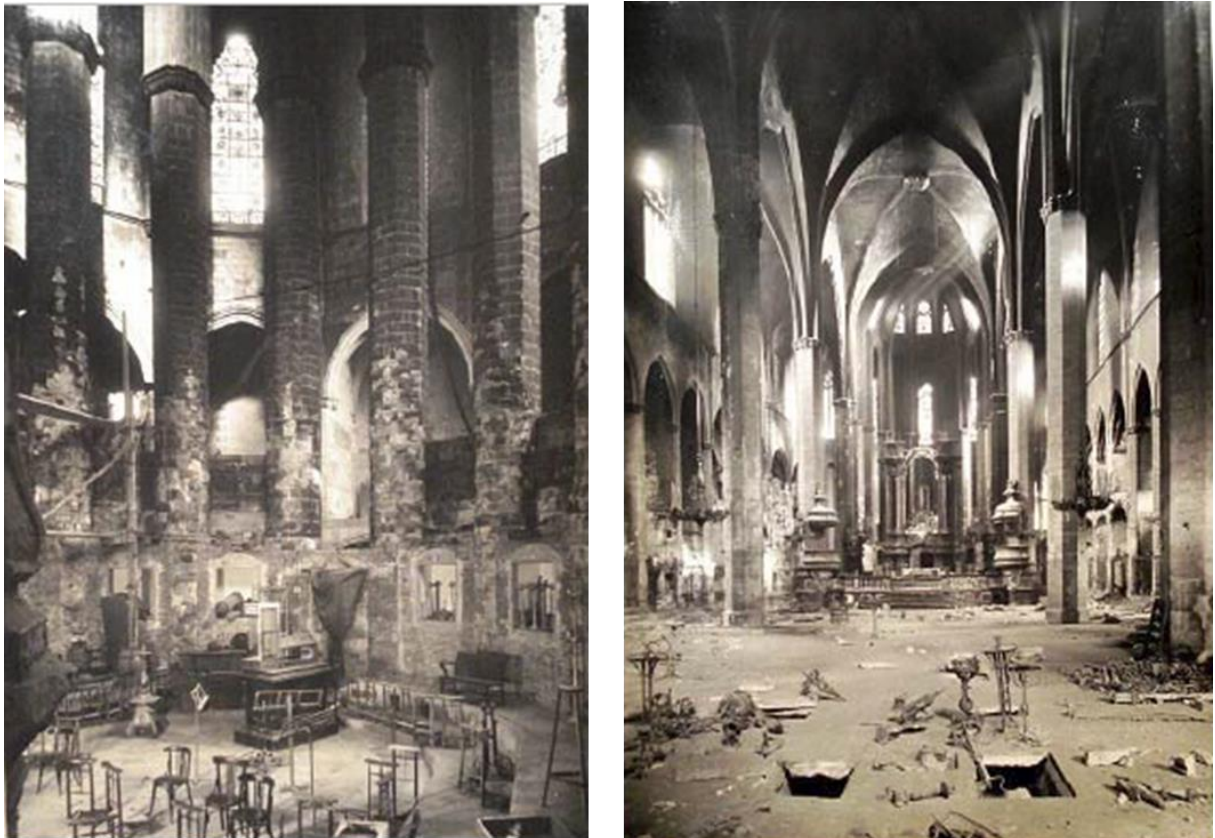
burn for eleven days. The fire caused damages in the piers, arches, and keystones. This paper will seek to further evaluate and characterize the damages in the piers due to the fire and hypothesize their true current condition.

Figure 6: Historic photographs after 1936 fire (left) choir, (right) nave (Roca, 2017)

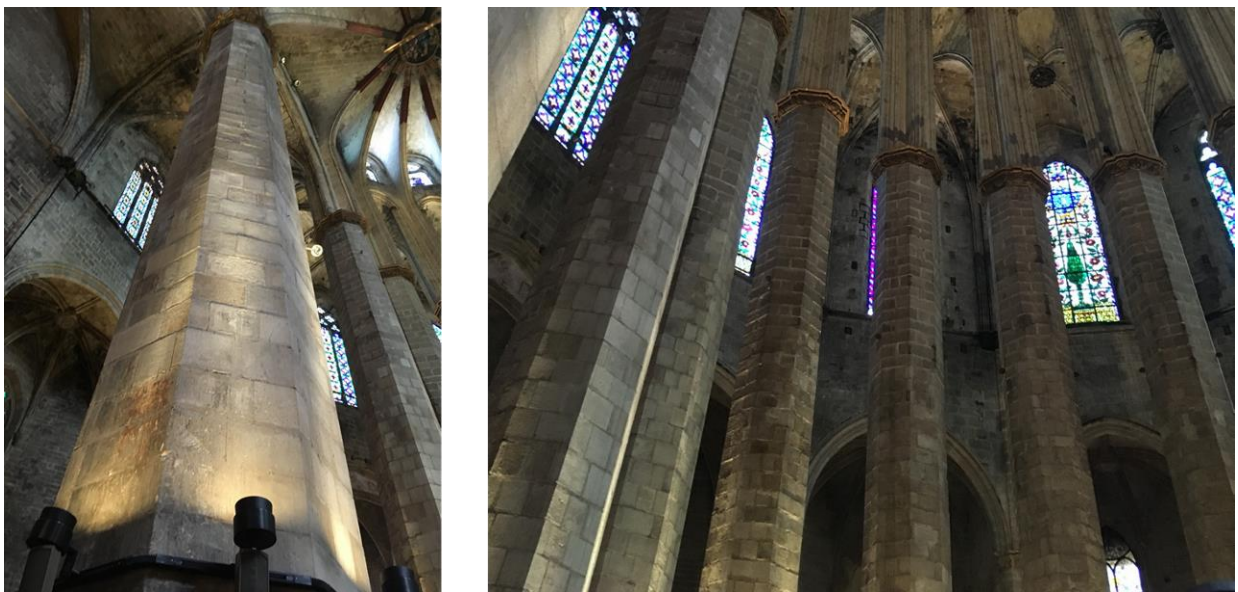
Due to the nature and distribution of the damage patterns found on the piers in the choir, their condition has been documented differently. Because each column shows the same trends, Piers 9-16 will be described by a representative example. It is obvious that interventions have been performed on the choir columns after the fire, therefore most of the damage is not visible. The bases of the columns have been rebuilt. The lower two-thirds of the columns have many replacement stones; these are easily seen as a change in the typical stone pattern shown in Figure 5. The piers of the choir have also been almost completely repointed. Aside from some stones with a pitted texture, the piers of the choir appear in very good condition with no spalls, sheeting, or cracks visible. However, this could be misleading because the extend of interventions indicates they suffered a lot of damages.

Figure 25: Piers of the choir
