INLET FOGGING AND OVERSPRAY IMPACT ON INDUSTRIAL GAS TURBINE LIFE AND PERFORMANCE

Klaus Brun, Ph.D.
Manager
Southwest Research Institute®
San Antonio, Texas, USA

Rainer Kurz, Ph.D.
Manager
Solar Turbines, Inc.
San Diego, California, USA

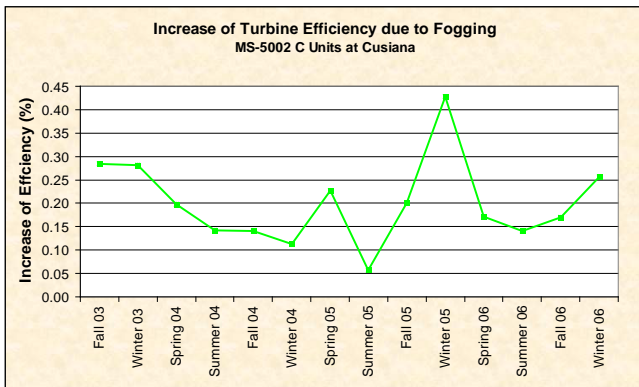
Figure 10. Percentage of Gas Turbine

conditions) is achievable with dry fogging versus no fogging. However, the overspray fogging is seen to only provide a marginal benefit of less than 0.8 percent additional output power over dry fogging. Figure 10 shows the gas turbine's efficiency increase of fogging versus no-fogging. A very marginal (less than 0.5 percent) power increase is seen. Namely, fogging and overspray do provide a power boost but do not significantly improve efficiency. Also, the small relative benefit of overspray versus dry fogging operation should be evaluated in light of the significant amount of blade corrosion and, thus, performance degradation, the overspray is causing.
