Unstable Reading of Accelerometers in Cryogenic Service

RasGas

Project Engineer
Ebara International Corp
Cryodynamics Division

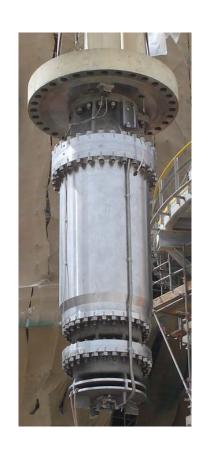
- RasGas operates over 100 pieces of cryogenic submersible equipment. Approximately 80 % are on pumping service and the rest on expansion service.
- These units use two vibration transducers to provide protection and diagnostic capability. The signal from the accelerometer is conveyed to the external signal conditioner (inside field junction box) them to a monitoring system
- Since commissioning vibration signals tend to be spiky (that is, random in nature) they may OEM recommended alert limits. This may mask potential real problems to the machine.

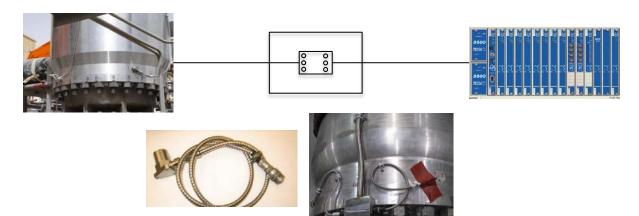
- A multidisciplinary team, was formed to investigate root cause and possible mitigation actions, including OEM of system involved; Turbine, Transducer, monitoring system
- More than 20 tests on different component were performed to isolate the source of unstable vibration readings that can be summarized as follows:
 - Monitoring System
 - Signal Cable (from JB to Monitoring System)
 - Input Module (field junction box)
 - Transducer and/or Transducer cable (submerge unit)

- –Data collector was used to record raw acceleration signal at the buffered output of the vibration monitor at the instrument housing and at the Accelerometer Input Module (AIM) located on the unit platform.
- -Data confirmed the presence of low frequency components in the vibration signal which is being amplified by the integrating circuitry.
- –No significant difference between data collected at Monitoring System and the AIM
- -Test confirmed Signal cable monitoring system (I/O, Safety barriers) are not inducing errors in the signal.
