# RESOLVING STRUCTURAL VIBRATION ISSUES ON A WATER FLOOD PUMP

Nicolas Péton, Sergey Drygin,  
Dmitry Leonov

This case study is designed to outline how the high vibration issue of two Water flood modules was successfully diagnosed, the root cause for the high vibration and finally how it was mitigated using some structural analysis techniques.

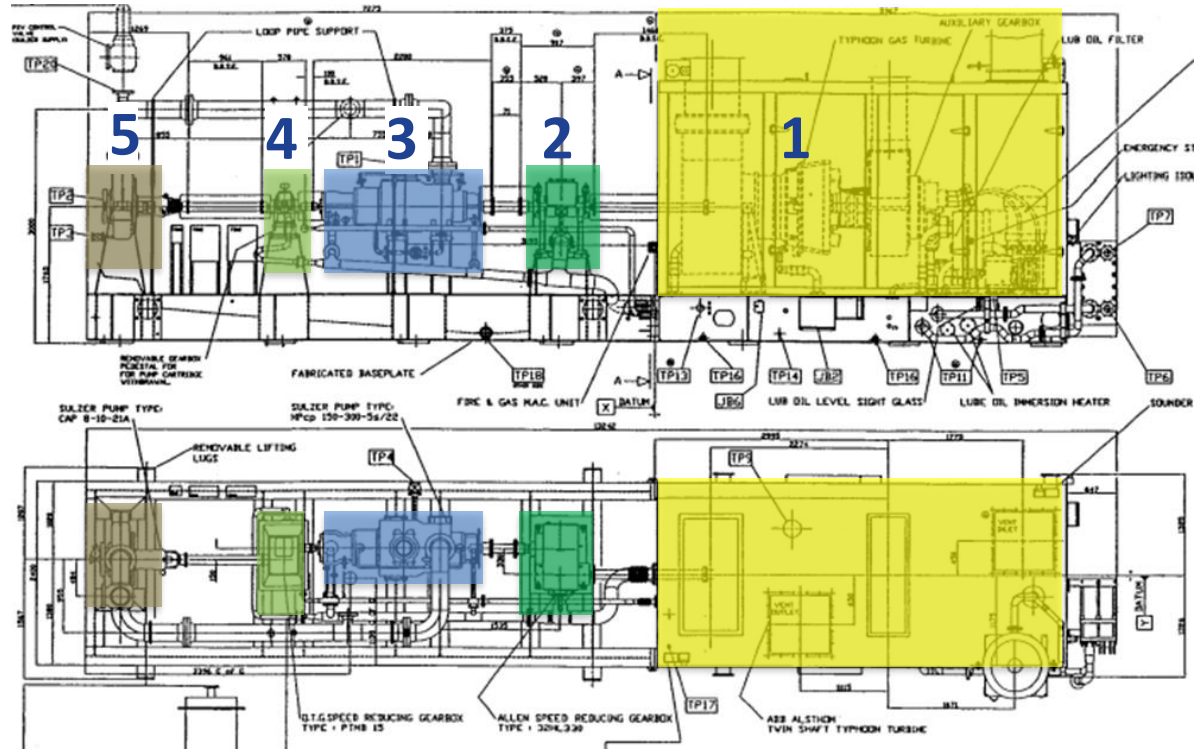
# Two identical water flood modules

1. Gas turbine and enclosure
2. Main gearbox
3. Pump
4. Booster gearbox
5. Booster pump

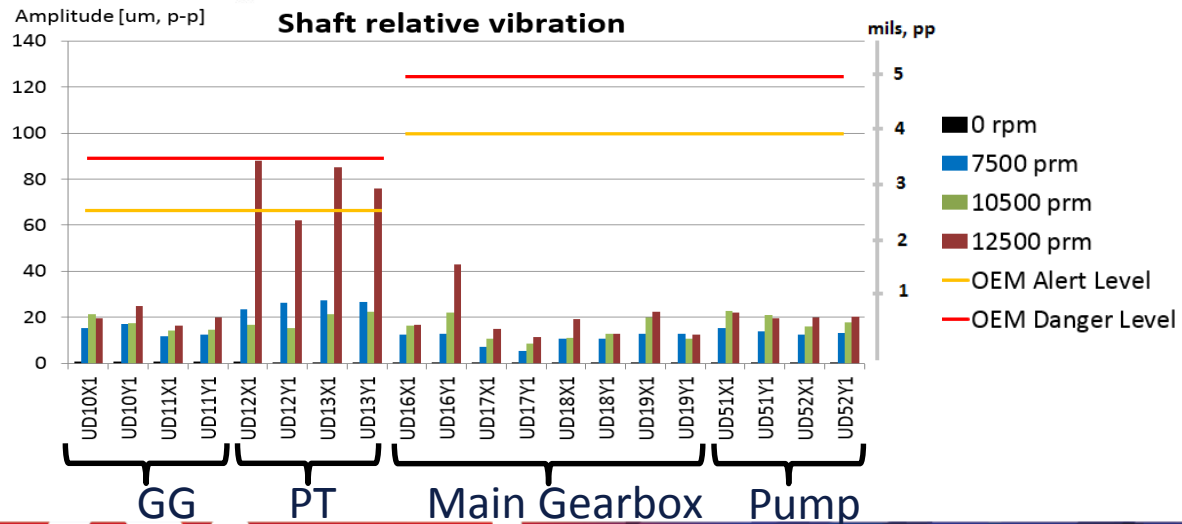
**Power Turbine**  
 High level of Shaft  
 relative vibration  
 > 90 um pp (3,5 mils)

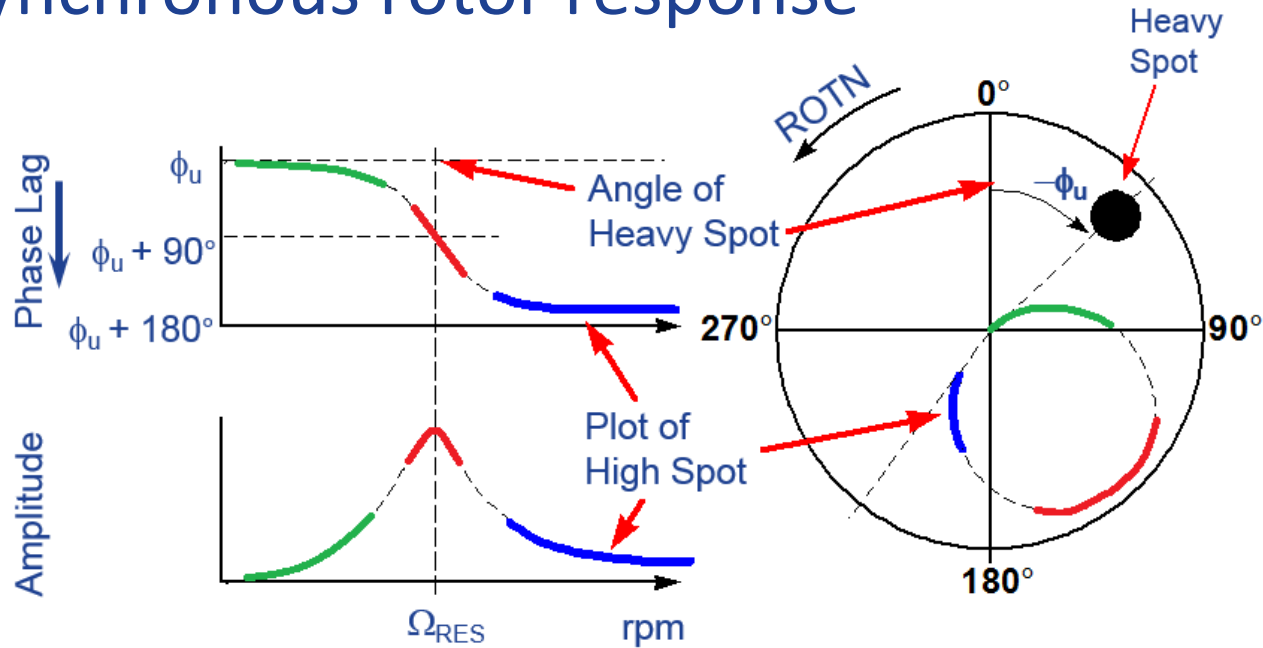
# Synchronous rotor response

Green line - well below resonance, red line - on resonance, blue line – well above resonance.

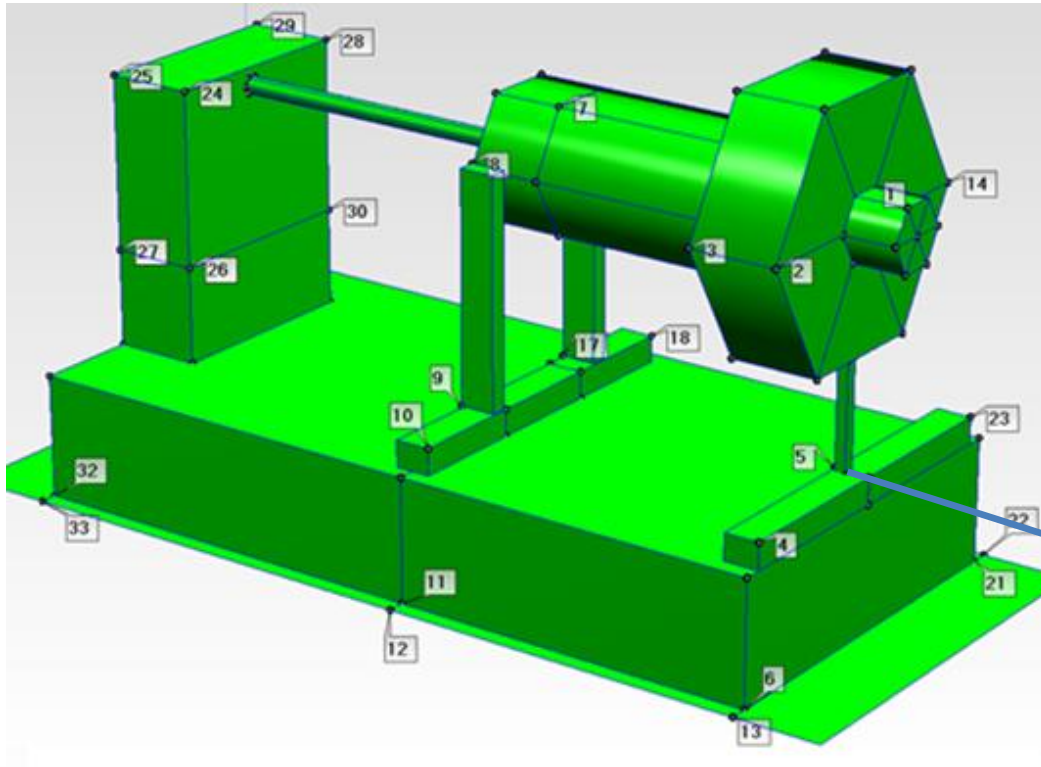
Roved Triaxis  
accelerometer  
(points 1-35)

Reference probe (point 5)

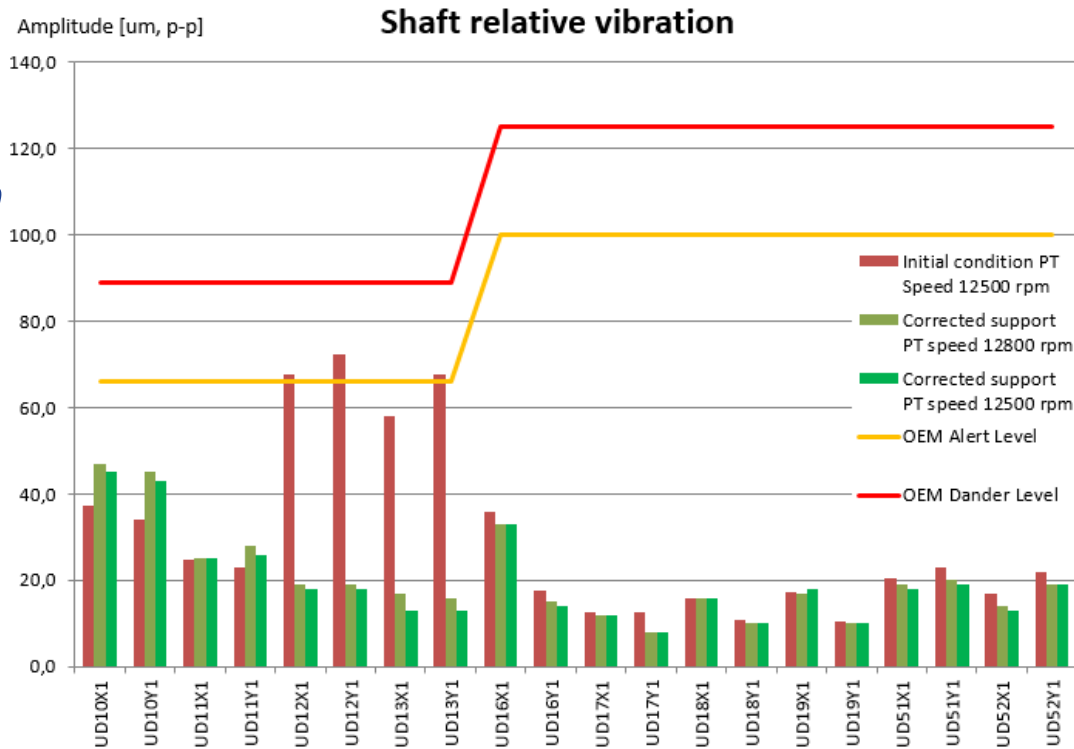
# Outcome

*After supporting system modification it was possible for Unit A to reach maximum designed speed, maximum flow with acceptable vibration level.*

*Unit B modification done during next planned overhaul.*
