ASIA TURBOMACHINERY & PUMP SYMPOSIUM  
MARCH 2018 | SUNTEC SINGAPORE

# Resolving High Vibration On a Vertical Pump

Baker Hughes, a GE Company

Saudi International Petrochemical Company

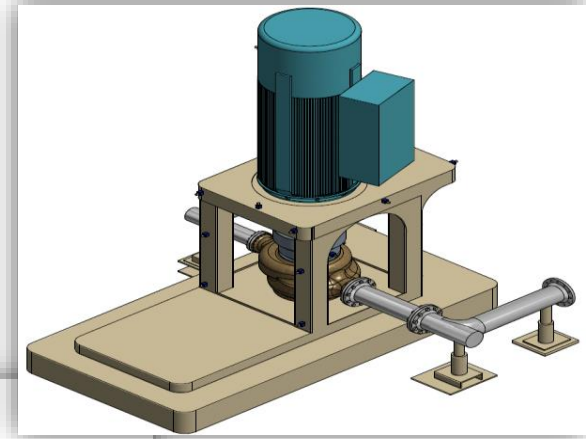
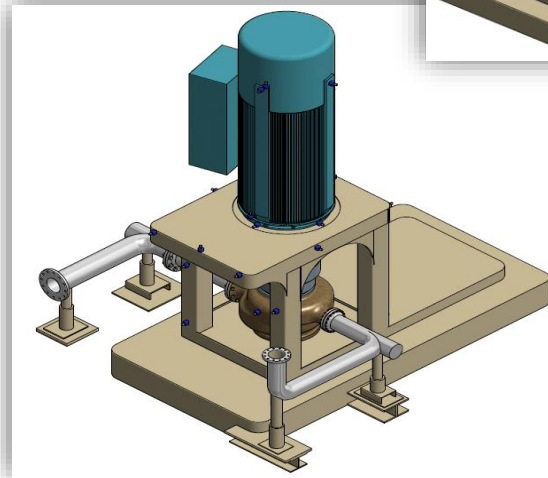
# Machine Details

- The unit is vertical HP reactor feed pump
- Single stage, 230 kW, 12338 rpm & 3.444 gear ratio
- Driven by induction motor (260 kW, 3585 rpm, ball bearings)
- Flexible shim pack coupling

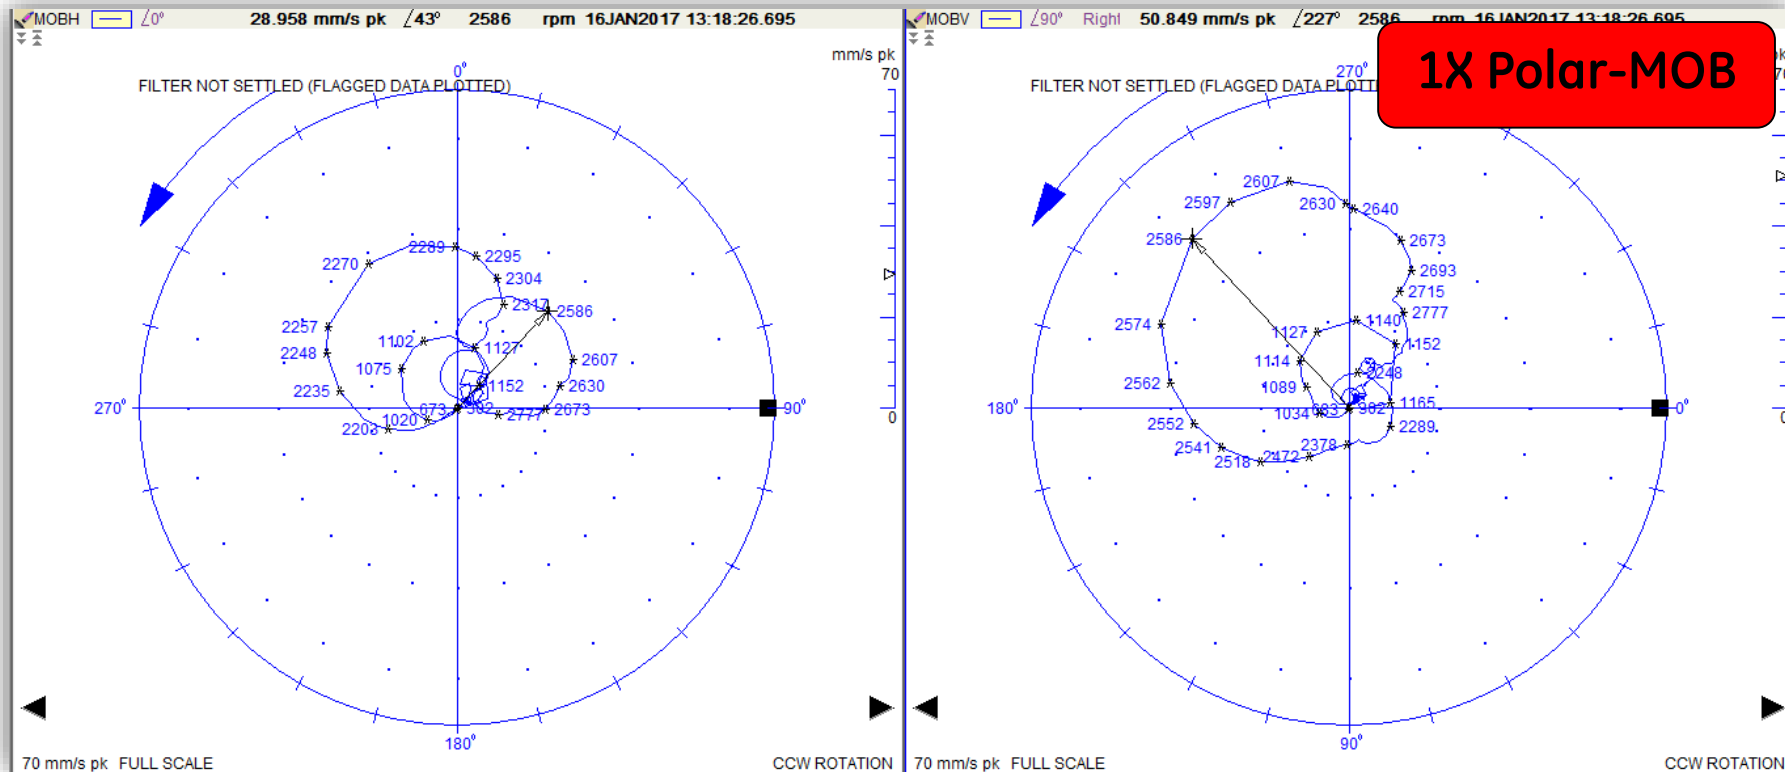
# Data Analysis– Coupled Run “cont’d”

- High overall vibration levels with 1X motor dominant frequency
- Transient Start-Up / Shut-Down data showed that the unit is running well above the 2nd critical speed
- **The highest amplitude while passing the 2<sup>nd</sup> critical frequency (70 mm/sec Peak)**

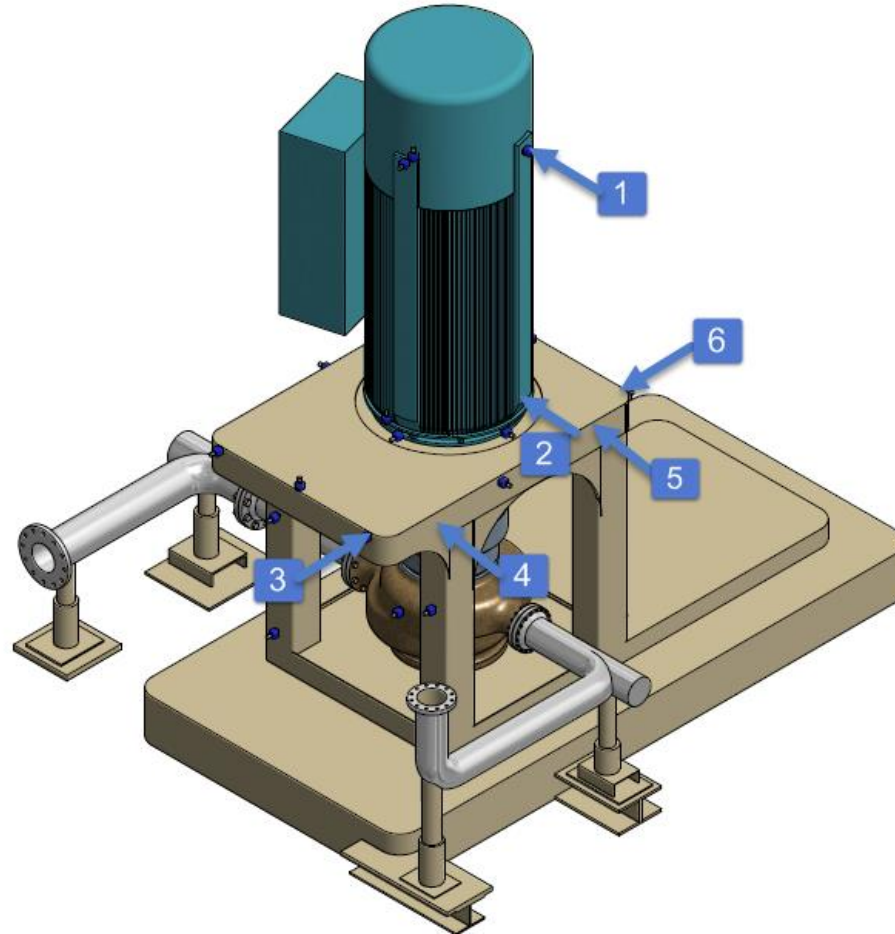
# Data Analysis-Impact Test

Point#5 Showed Natural Frequency Close to The Running Speed  
Other Points Showed Natural Frequency BUT Away from The Forcing Frequencies

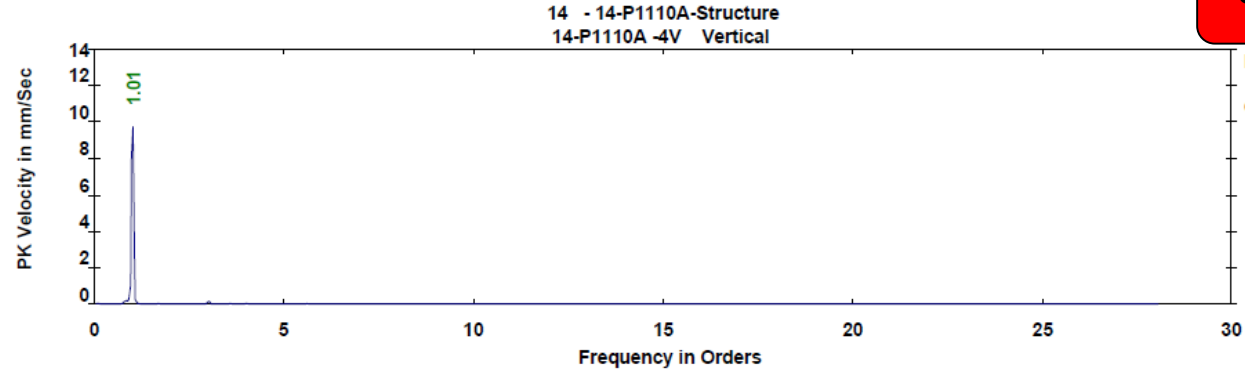
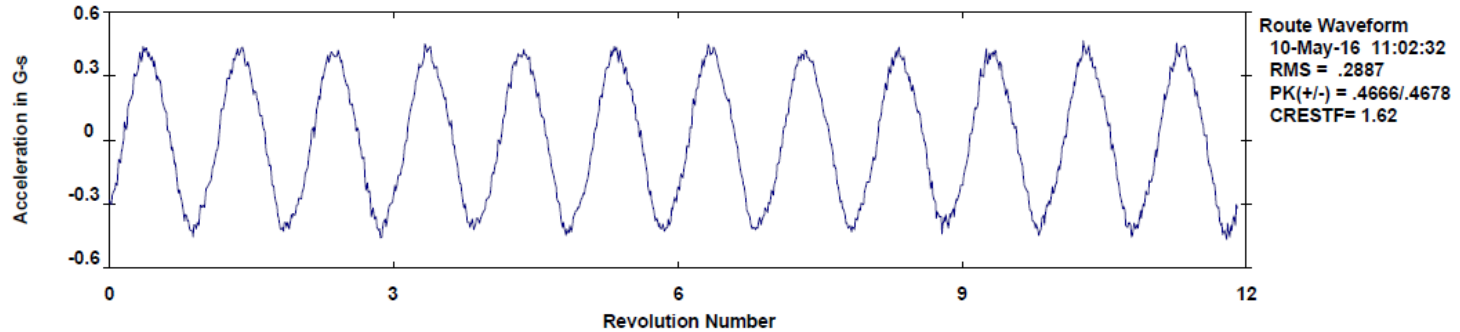
Spectrum- 1X

- High vibration levels on the motor, pump and structure for more than 2 years (11 mm/sec Peak at steady state)

1X motor dominant vibration component.

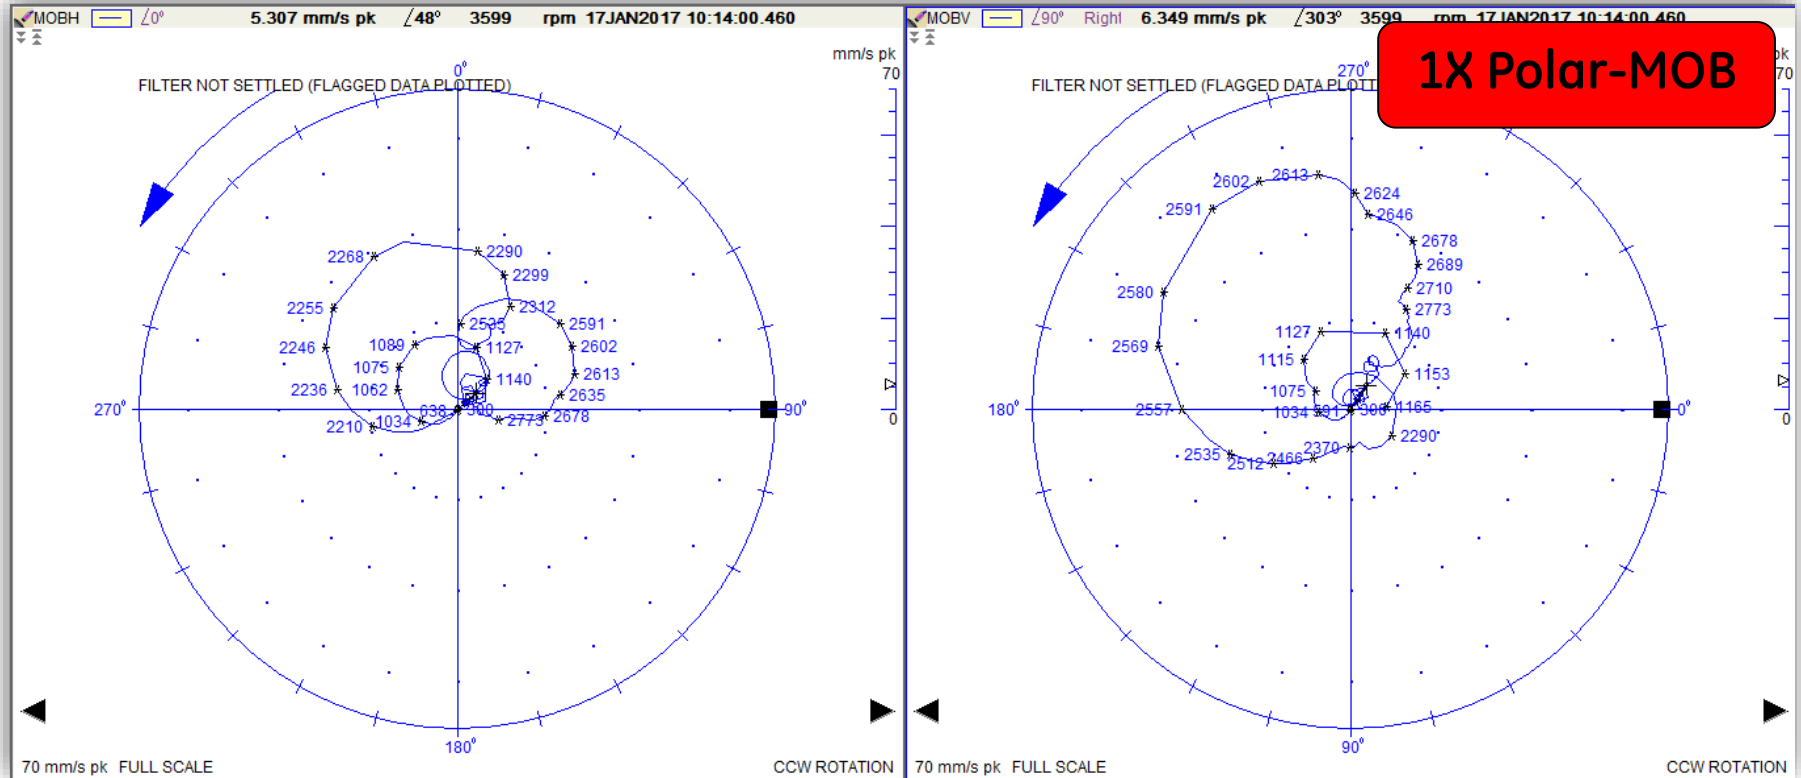
# Data Analysis— Solo Run “cont’d”

- High vibration at same locations as in coupled run
- **High residual unbalance response on the motor while passing 2<sup>nd</sup> critical frequency**
- **Bode & polar plots confirmed the residual unbalance response**

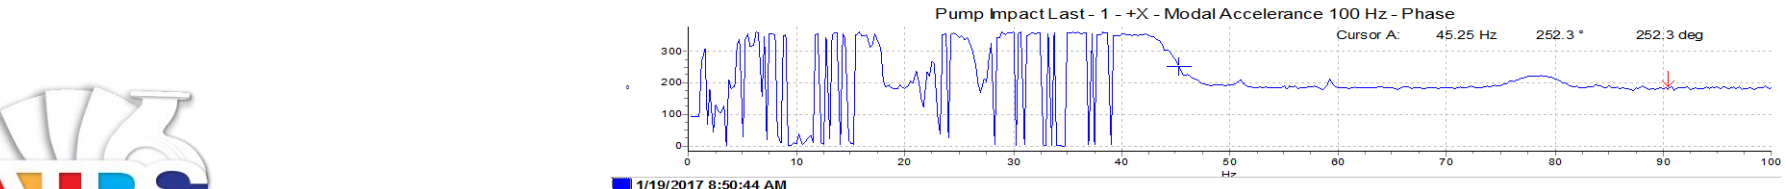
Other Points Showed Natural Frequency BUT Away from The Forcing Frequencies
