ASIA TURBOMACHINERY & PUMP SYMPOSIUM
MARCH 2018 | SUNTEC SINGAPORE

Large Vibrations on Centrifugal Compressor Caused by Inappropriate Operation During Mechanical Running Test

Y. Bidaut, MAN Diesel & Turbo Schweiz AG

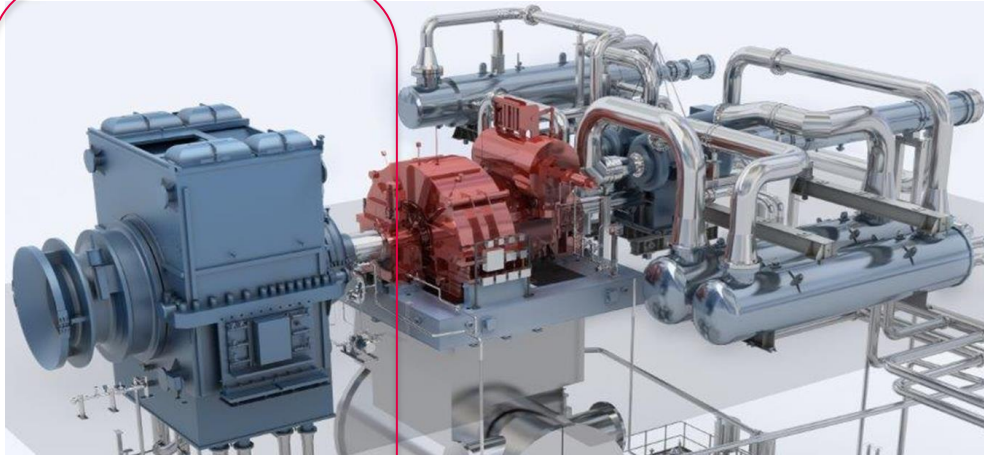
Background – Train Arrangement, Compressor

- Air Separation Unit
- Steam Turbine (ST) Driven
- Main Air Compressor (MAC):
 - 3 stages, in-line
 - Internal cooling

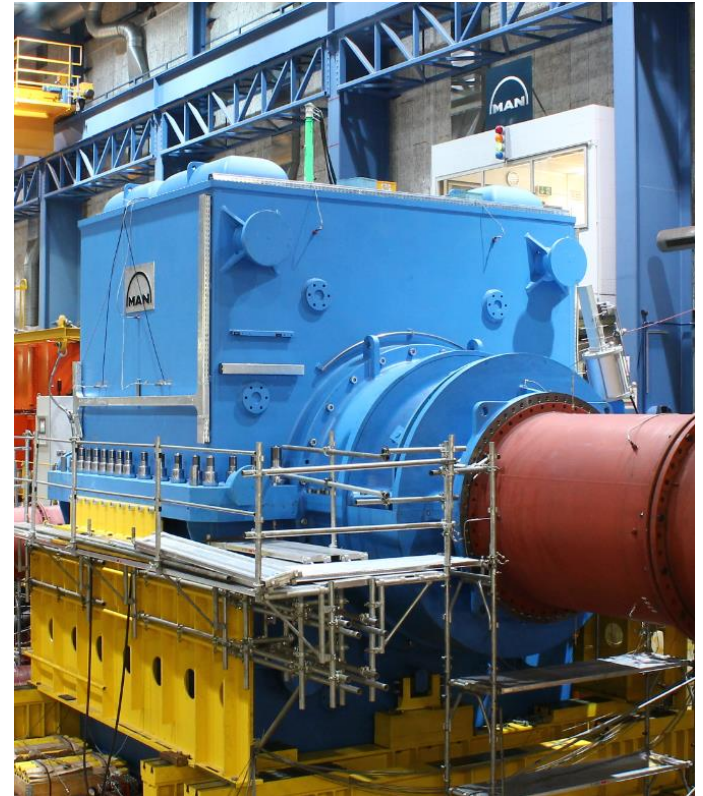
- In house mechanical test in facility test
- Sudden increase of radial vibrations on DE bearing probes → shut-down
- After shut-down
 - Compressor started again
 - Excessive vibration levels

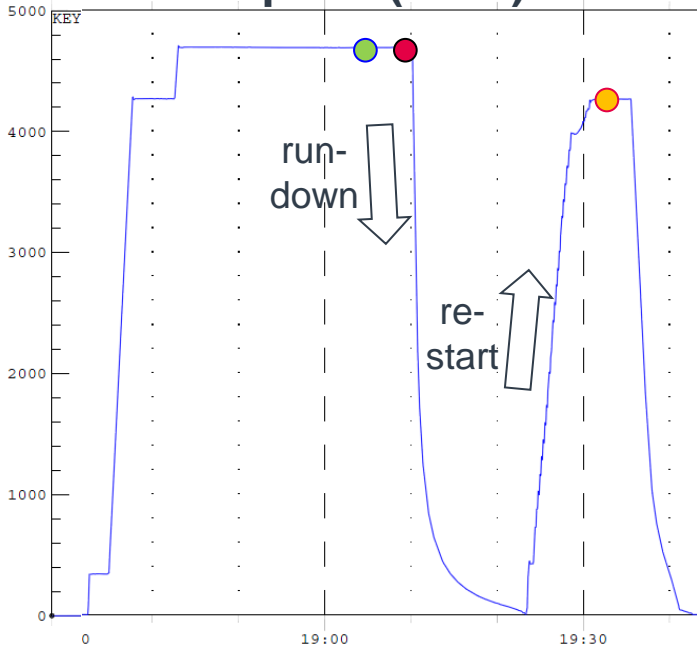
Findings – Lateral Vibrations (MAC – DE)

→ Vibration levels too high after re-start

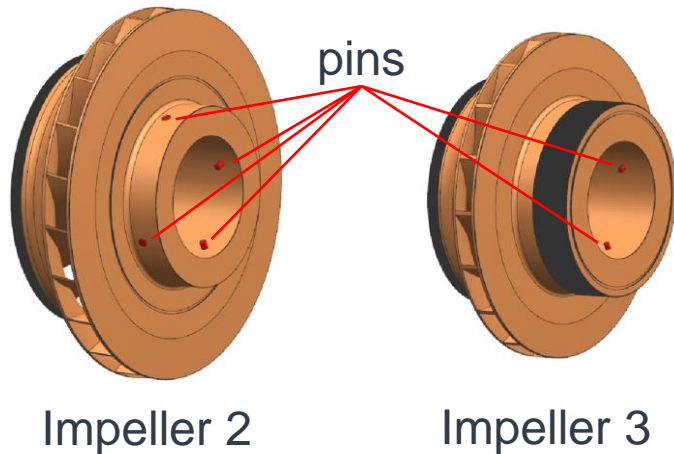
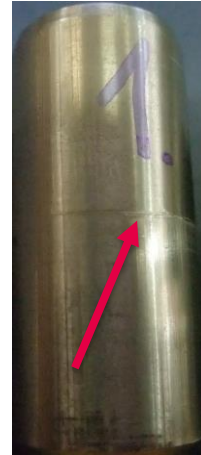
Removed pins from impeller 3

Impellers 2 & 3 are mounted onto the shaft by an interference fit along with pins.

- Clear traces of shear on pins of impeller 3
- This confirms the impeller had moved on the shaft during the test

1. Shrink increased from 1.22 ‰ to 1.40 ‰
2. Mechanical test run carried out at trip speed for 15 minutes duration and well outside the stability limit

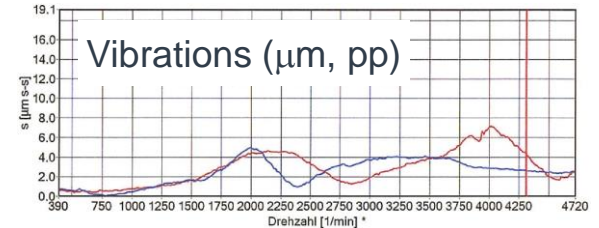
Measurements after modification

- After modification, this rotor was successfully balanced and delivered to site.
