ASIA TURBOMACHINERY & PUMP SYMPOSIUM MARCH 2018 | SUNTEC SINGAPORE

Case Study on resolving high vibration issue of a centrifugal compressor at an offshore platform

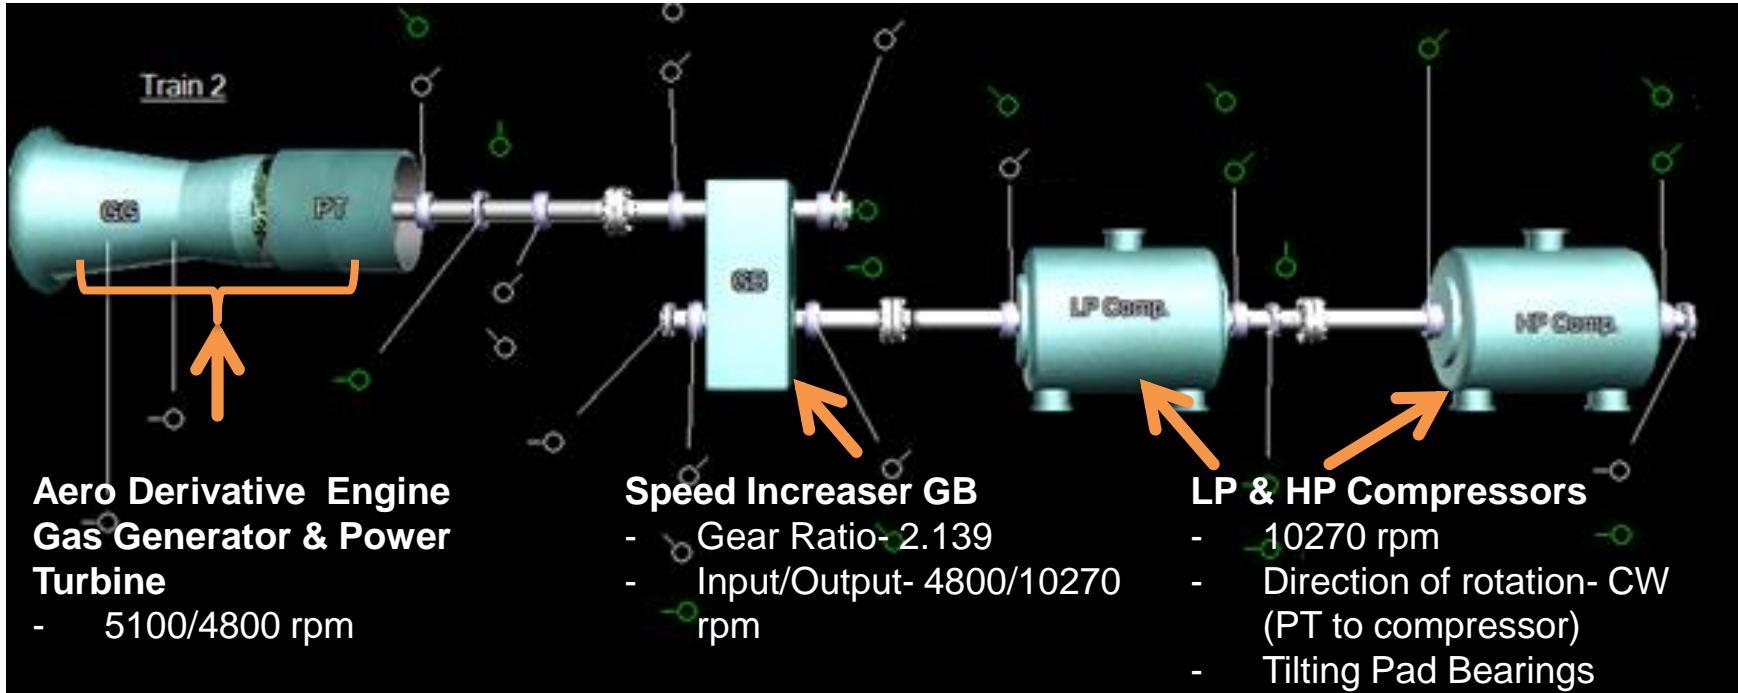
Machine Details

- 26th July 2015 The gradual rise in shaft vibration towards Non-Drive End (NDE) bearing began from startup onwards
- October 2015 Readings on Gas Injection Compressor Train were observed touching vibration alarm limits, 51 μm pp (microns peak to peak) towards LP compressor NDE bearing at higher speed/load condition.
- October 2015 From here onwards, the vibration amplitudes of LP onwards Compressor NDE bearing intermittently reached alarm limits & Machine availability became a concern for the customer.
