ASIA TURBOMACHINERY & PUMP SYMPOSIUM
MARCH 2018 | SUNTEC SINGAPORE

Steam Whip phenomenon in Steam turbine

GE D11 180MW 3,600RPM

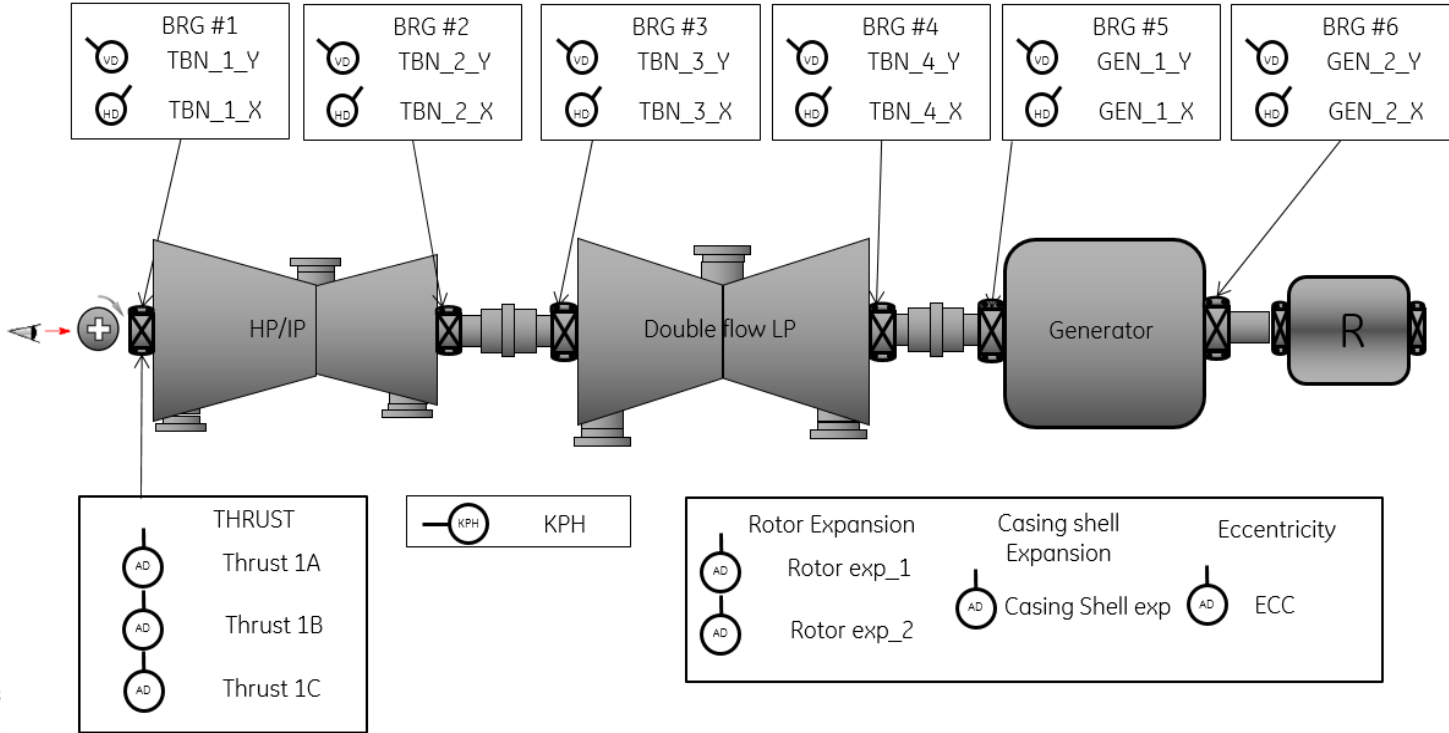
Historical background

- HP #1, 2, 3, 4 stages: Processed to remove cracks from wheel heat grooves & steam balance holes.
- 10 visually identified cracks: 11.2 mm of maximum crack depth (HP 1 stage front)
- Estimated growth speed of cracks of $8.75 \mu\text{m}/\text{cycle}$ (trend analysis)
- Correction of HIP TBN rotor bending: 0.30 mm max.
→ 0.05 mm based on mid-span

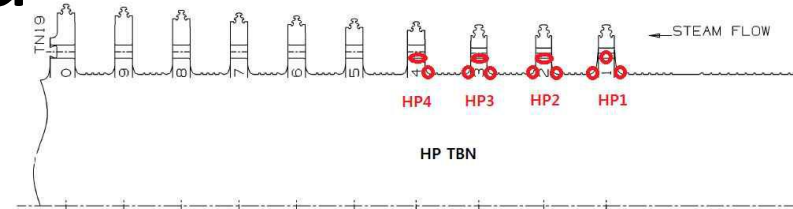
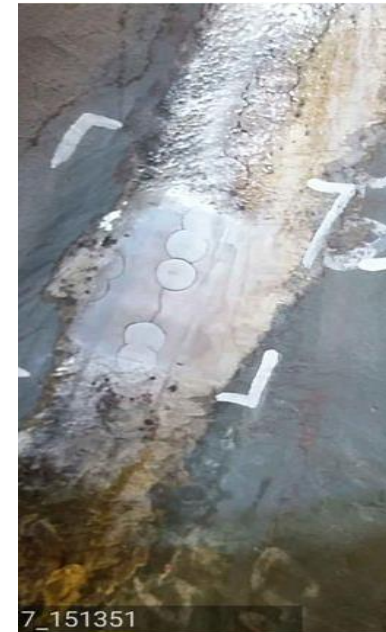
Historical background

- Replace to HIP retractable packings (1 anti-swirl conv./14 retr./2 brush) and N2 conventional packings.
- Structural change and removal of sound-absorbing materials to reduce vibrations related to axial resonance of the LP hood
- The vibration values of BRG#2 raised up till 11mils with the 22.5Hz component in first operation test 1 Nov.

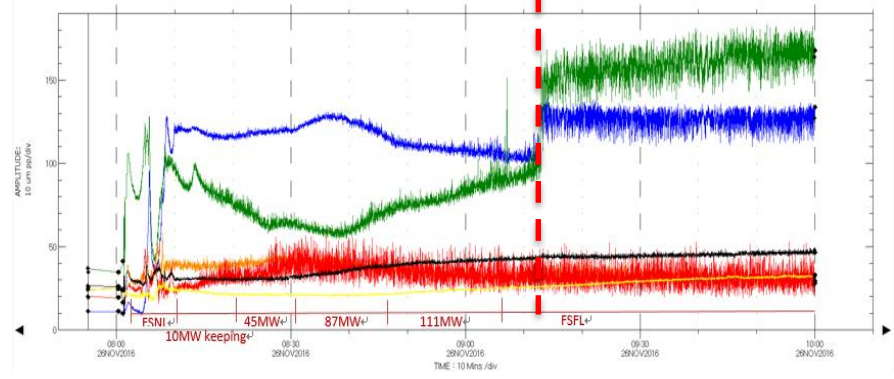
While the load kept Full load, the high vibration situation was suddenly occurred. The vibration amplitude of BRG#2 was raised up 63um and BRG#1 also was observed raised 22um.

The 1X component did not change any vibration value at same time with this situation.
