46TH TURBOMACHINERY & 33RD PUMP SYMPOSIA
HOUSTON, TEXAS | DECEMBER 11-14, 2017
GEORGE R. BROWN CONVENTION CENTER

Thrust Balance Line Bolts Failure

Felix Cestari, Compressor Design Engineer, Siemens
Robert Briggs, Pipeliner Product Line Manager
Regis Fowler, Head of Product, MTO
Ge Jiangang, Production Manager, PWPC PetroChina

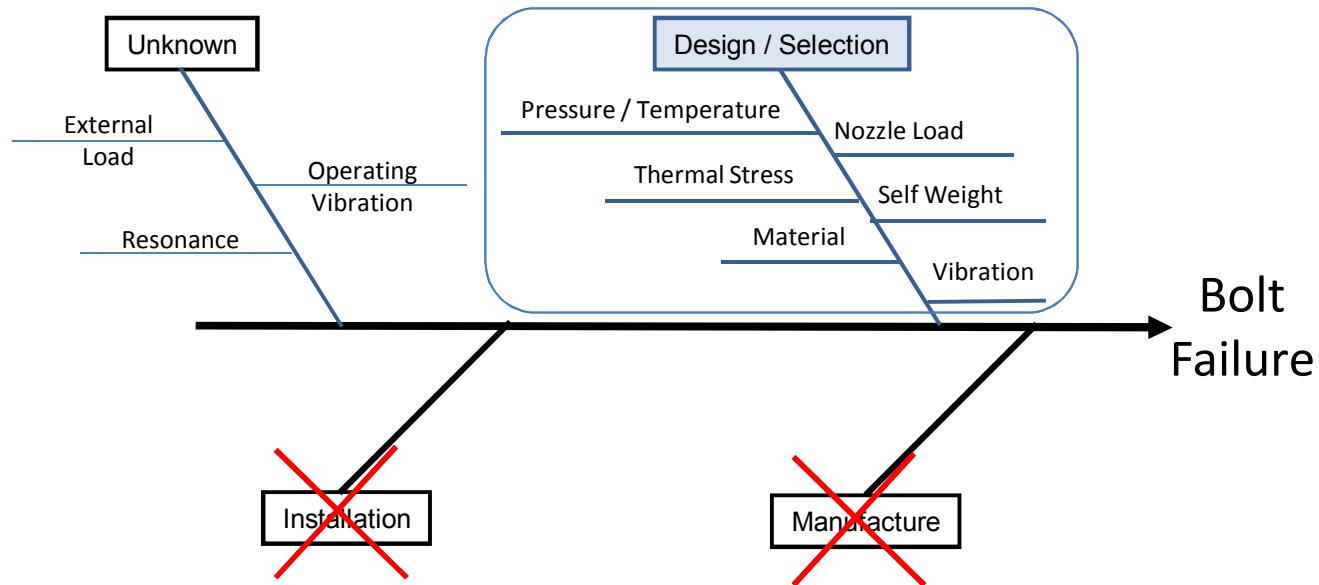
Cause – Effect: Fishbone Diagram

- No bolt quality issues (material, manufacturing, etc.).
- No problems with thrust balance line installation (bolts torque, TBL alignment, flange gap, etc.).
- Customer vibration survey useful but inconclusive.
- Low rotor vibration.
- Bolt size / material selection correct for the application.
- Calculated bolt stress below material fatigue limit.

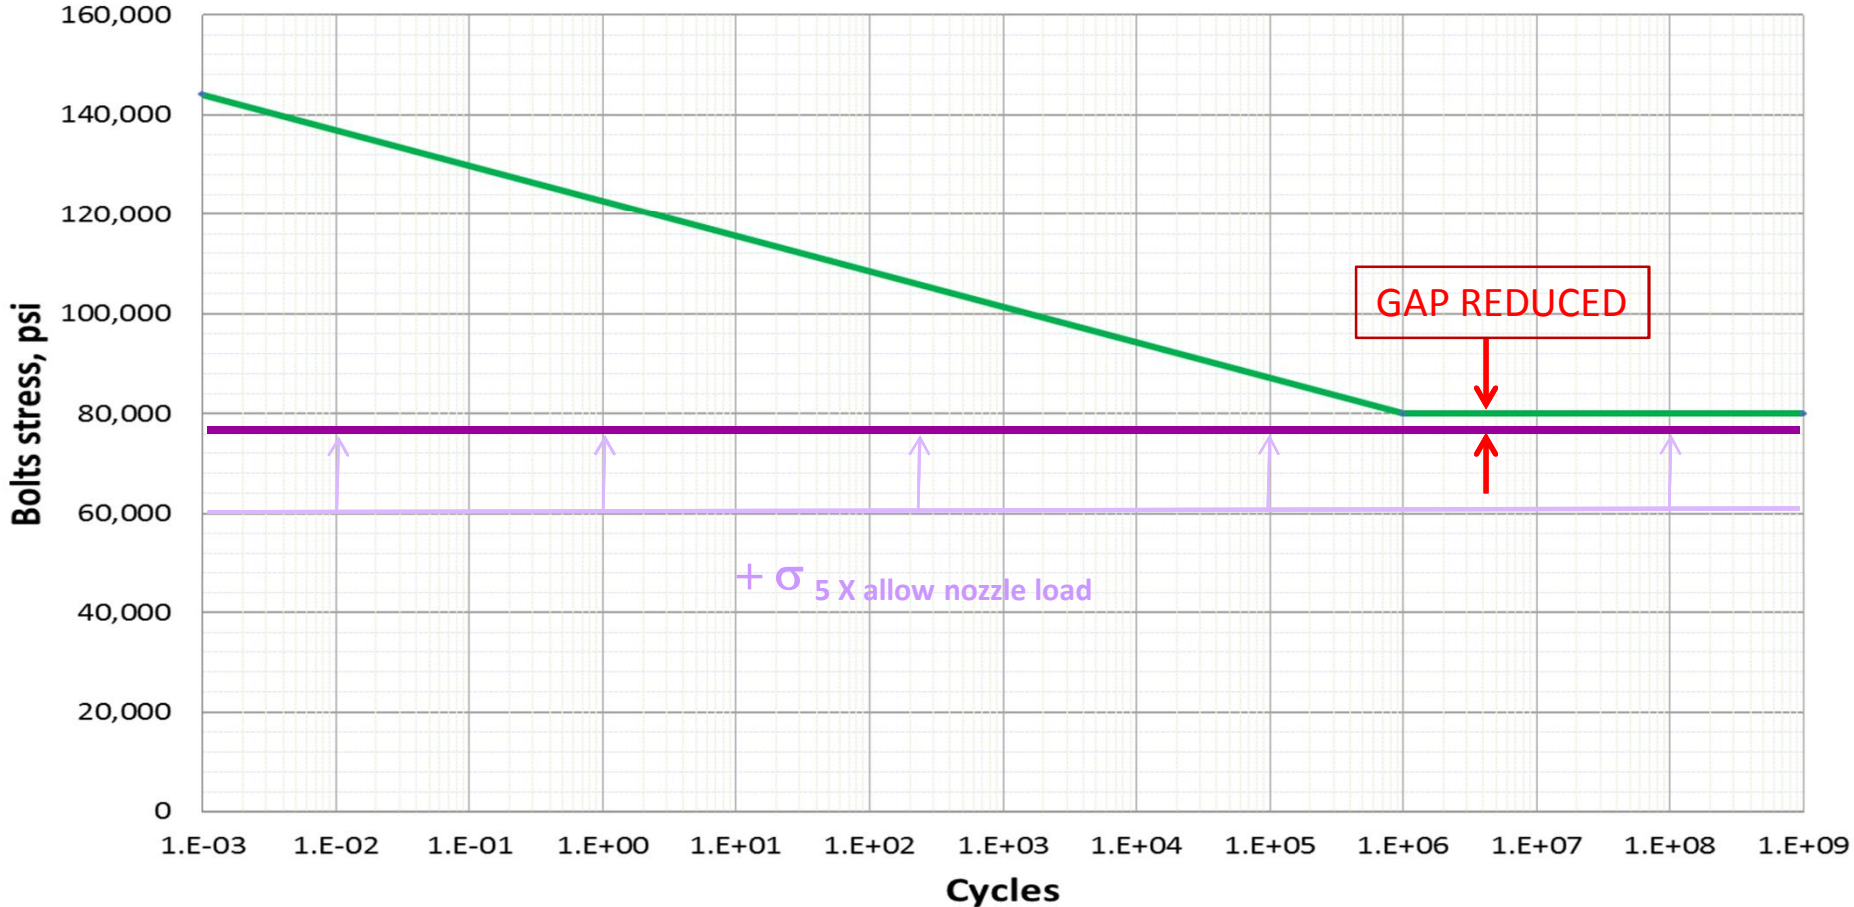
Thrust Balance Line Flange Bolts Fatigue Life

Calculated stress equivalent to five (5) times allowable nozzle load.

- Restore and secure the piping support system.
- Inspect periodically the piping support system for cracks, looseness of nuts, piping movements.
- Keep existing damper at the thrust balance line.

- Provide solid foundation for the station piping system.
- Assure the piping supports system are at design conditions.
- Inspect the piping support system integrity.
 - ✓ Check nozzle flange-to-flange alignment.
 - ✓ Remove existing damper at the thrust balance line.
