ASIA TURBOMACHINERY & PUMP SYMPOSIUM  
MARCH 2018 | SUNTEC SINGAPORE

# Failure, Repair and Overhaul of 5 MW Right Angle Reduction Gear Box

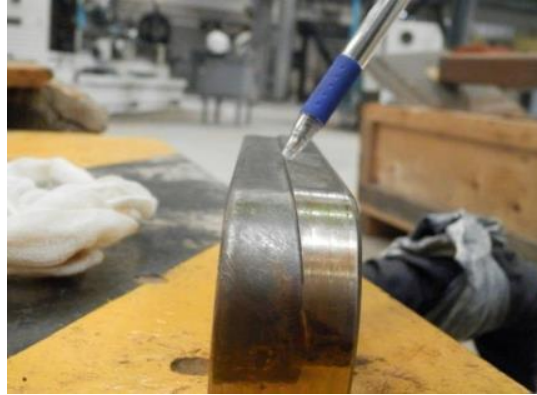
Bevel Pinion sitting Collar

Extruded Keys – High Torque
