ASIA TURBOMACHINERY & PUMP SYMPOSIUM  
MARCH 2018 | SUNTEC SINGAPORE

# Case Study:

## Recip Pump on Unstable Condensate

# Two (2) API 674 Quintuplex Plunger Power Pumps

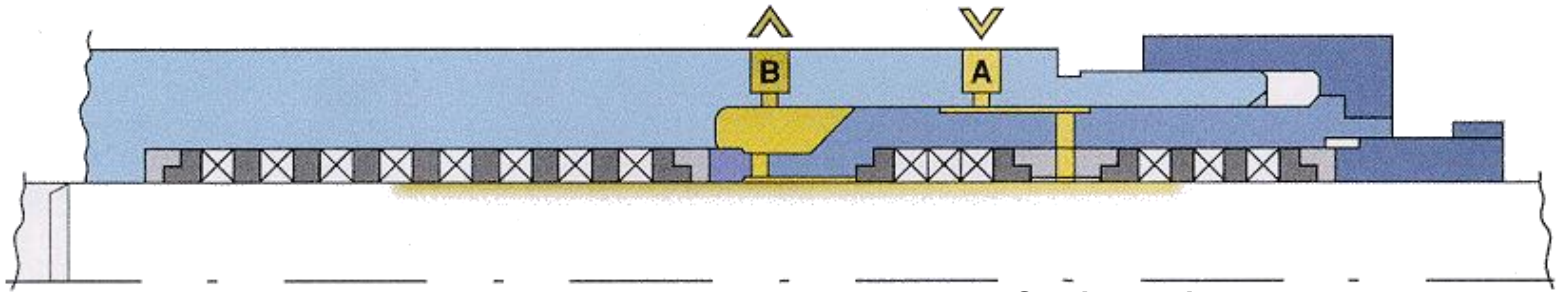
# Sealing/Packing System Design

- Triple packing arrangement
- Seal oil system using mineral oil at low pressure
- Sealing oil lubricated packings and prevented emissions
- Recovery back to process fluid

A: Inlet Sealing Fluid  
B: Outlet Leakage Recovery

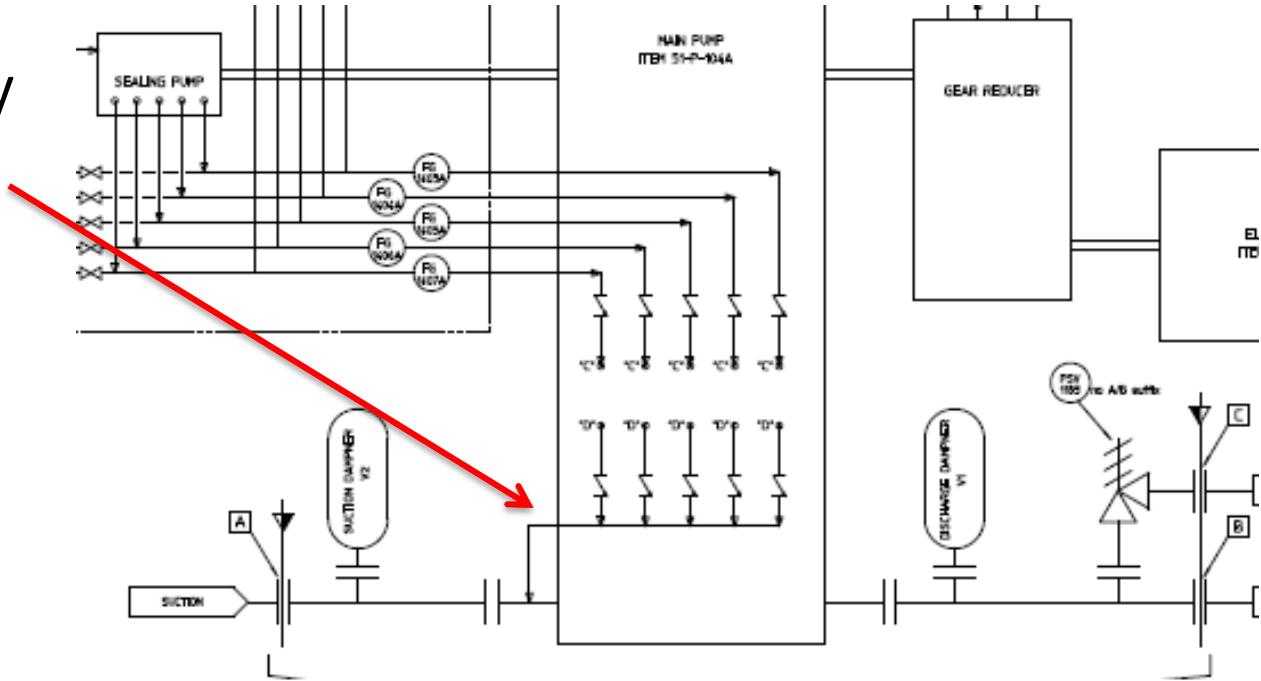
# Sealing/Packing System Design

Seal oil recovery  
back to main  
pump suction
