ASIA TURBOMACHINERY & PUMP SYMPOSIUM
MARCH 2018 | SUNTEC SINGAPORE

Cooling water pump gearbox diagnostics, failure and remedial actions

Failure of an industrial scale bevel gear assemble in 2.5 years of its commissioning. The gear box drives a pumps rated at 16240m³/h at 47.5 meter of head. The unit developed an abnormal noise with slightly higher impacting (vibration waveform) on the gearbox. However upon inspection, increased back-lash (still in recommended limit) was observed on the unit and the machine was kept in operation.

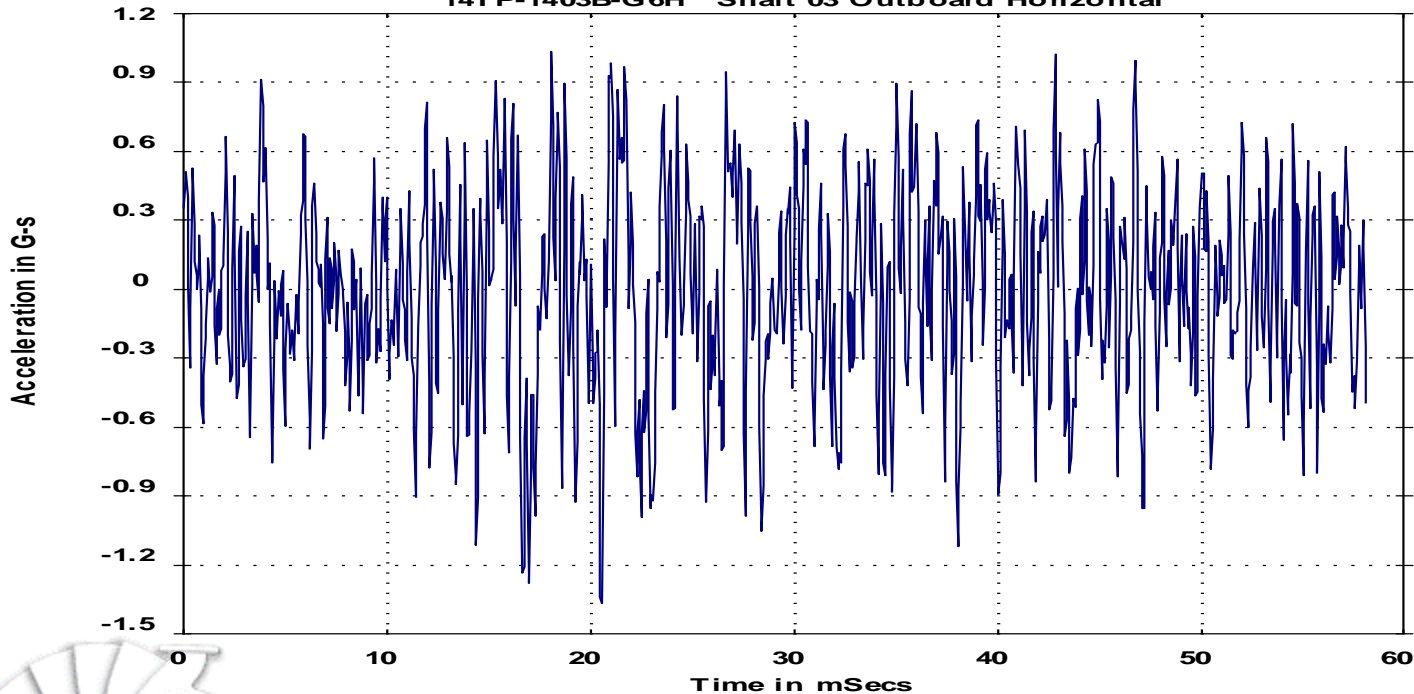
Apr 2014 data of 3rd shaft

Route Waveform
23-Apr-14 20:47:46

P-P = 1.21
LOAD = 100.0
RPM = 5100. (85.00 Hz)

PK(+) = 1.04
PK(-) = 1.37
CRESTF = 3.20

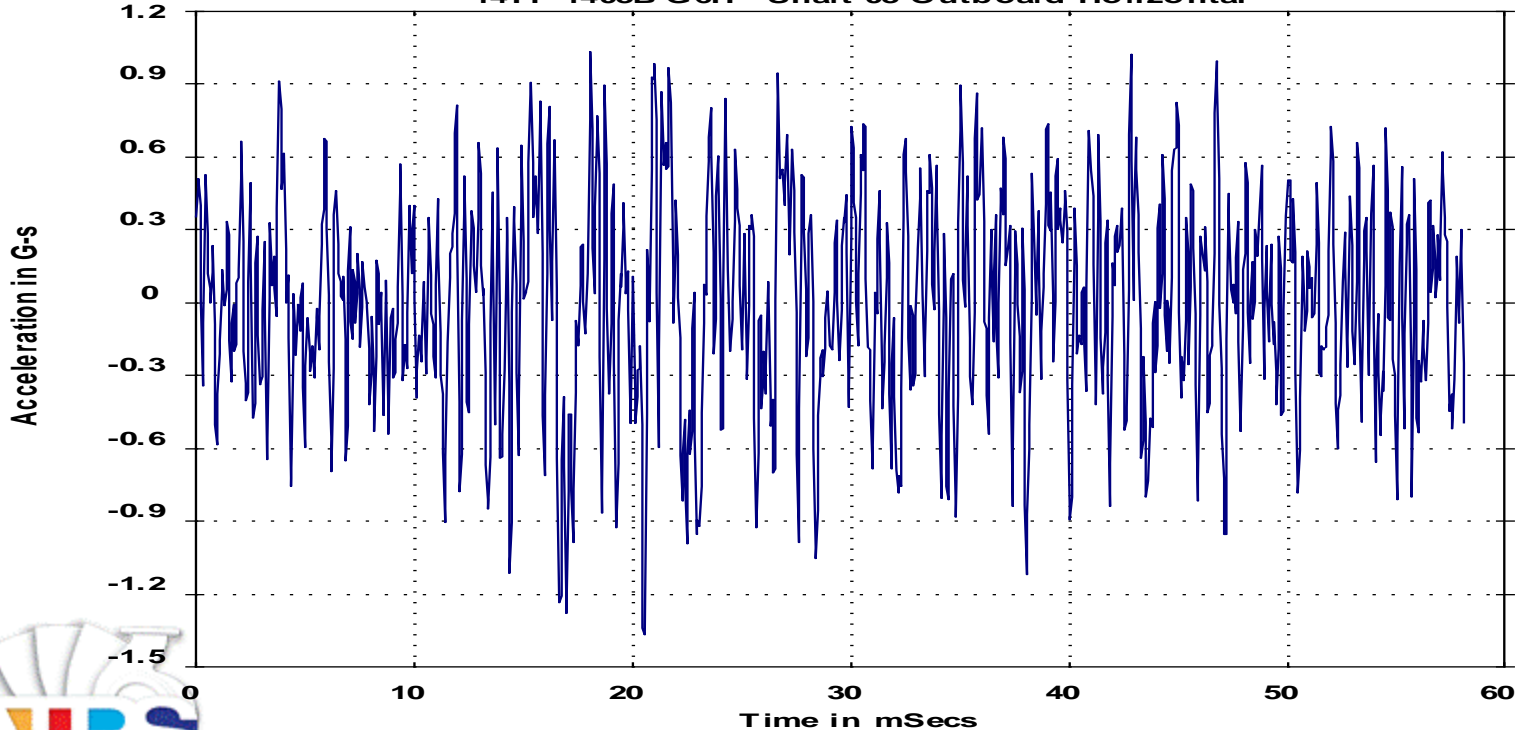
After repair data of 3rd shaft

Route Waveform
23-Apr-14 20:47:4

P-P = 1.21
LOAD = 100.0
RPM = 5100. (85.0)

- Polishing of broken tooth area and wear on other gear teeth with fine emery paper.
- Re-adjusting mounting distance as per the original drawing.
- Ensure best possible backlash figure (which was hard to attain due to varying backlash).
- Contact check was performed to bring the gear contact area back to the middle of teeth (~40% from the toe).
