ASIA TURBOMACHINERY & PUMP SYMPOSIUM
MARCH 2018 | SUNTEC SINGAPORE

Dry Gas Seal (DGS) Separation Seal Failure

Case Study from ExxonMobil Singapore

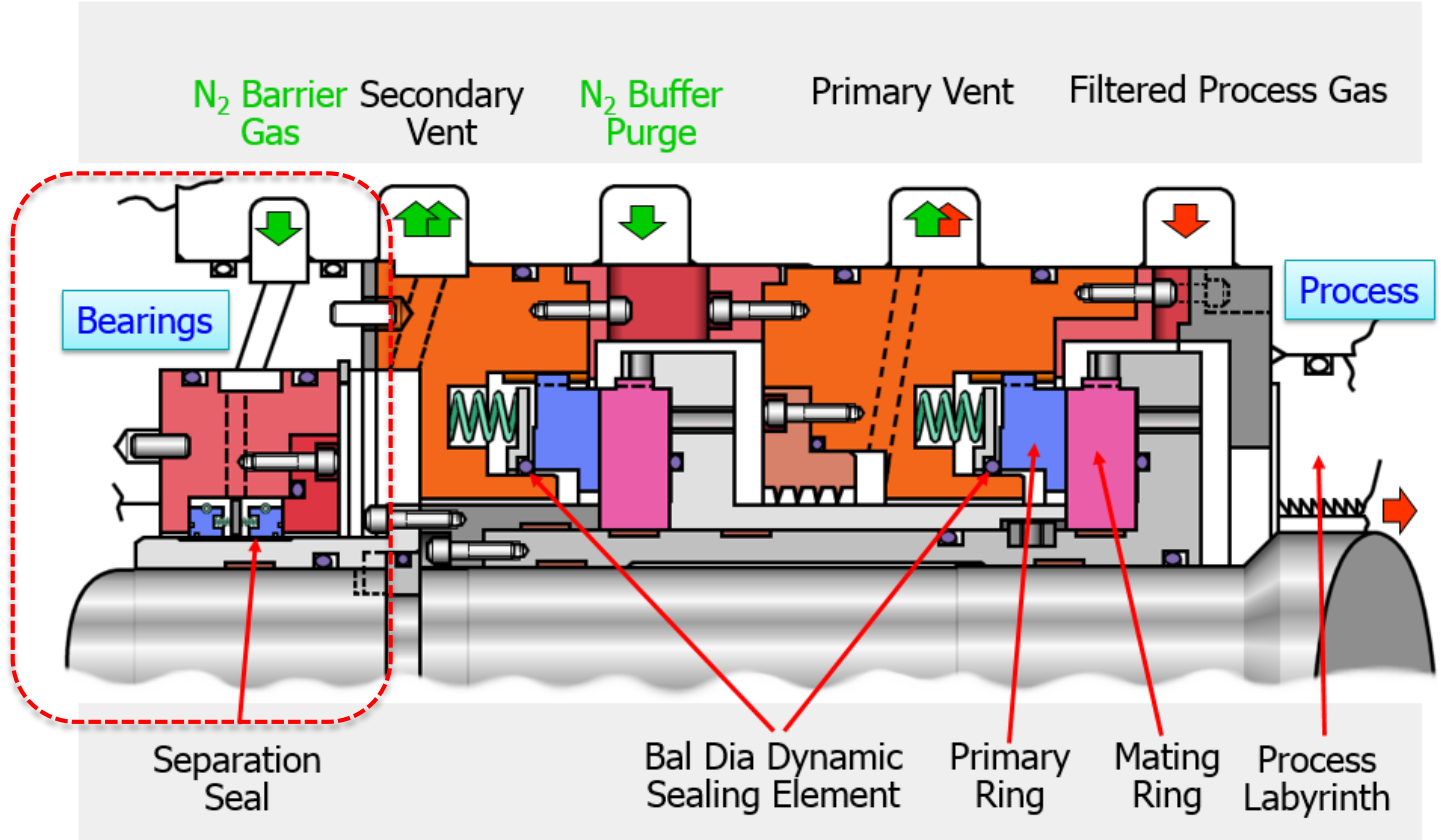
Dry Gas Seal & Barrier Seal Arrangement

Contact type segmented carbon bush barrier seal

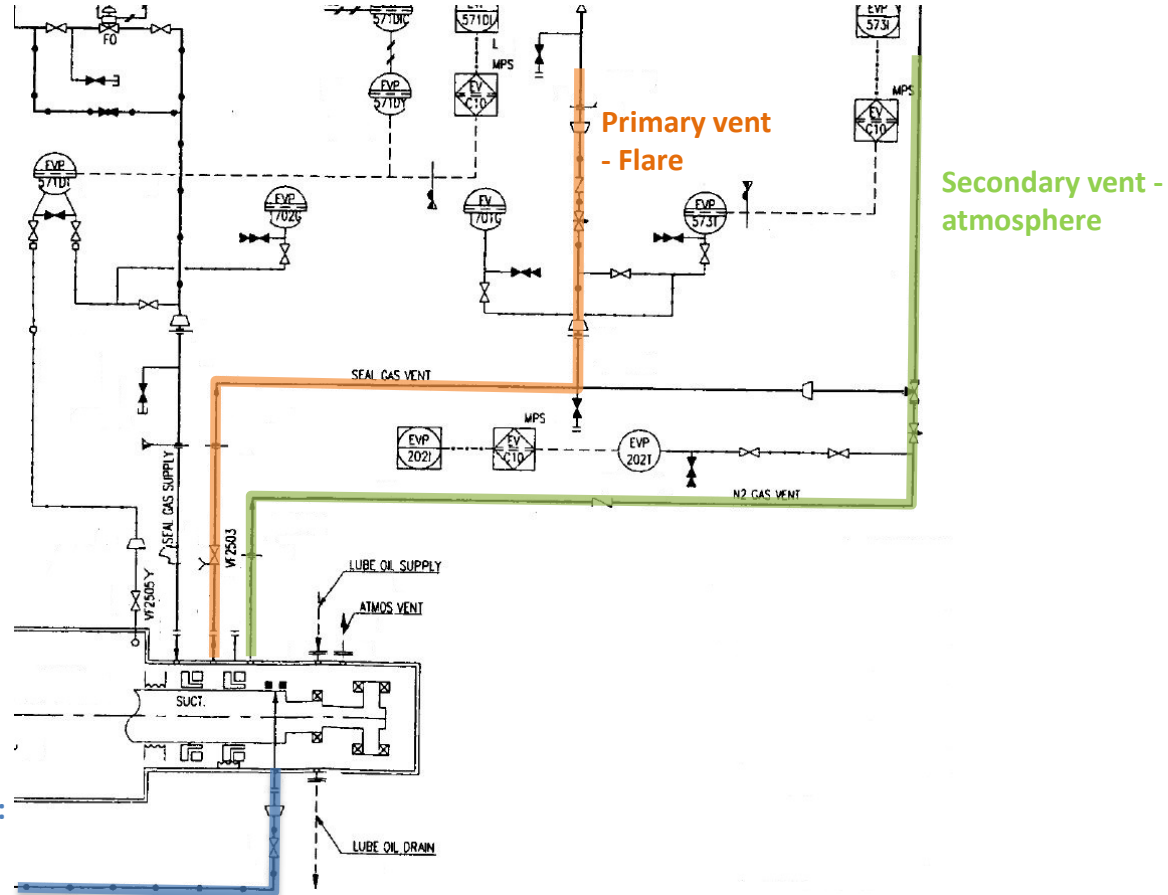
Dry Gas Seal System Overview – Plant 1

- Tandem arrangement dry gas seal
- Contact type carbon bushing separation seals installed
- Use of cryogenic nitrogen used as separation gas
- No secondary seal gas supplied

- Pressure = 45 kPag
- Flow = 1 ~ 4 Nm³/hr

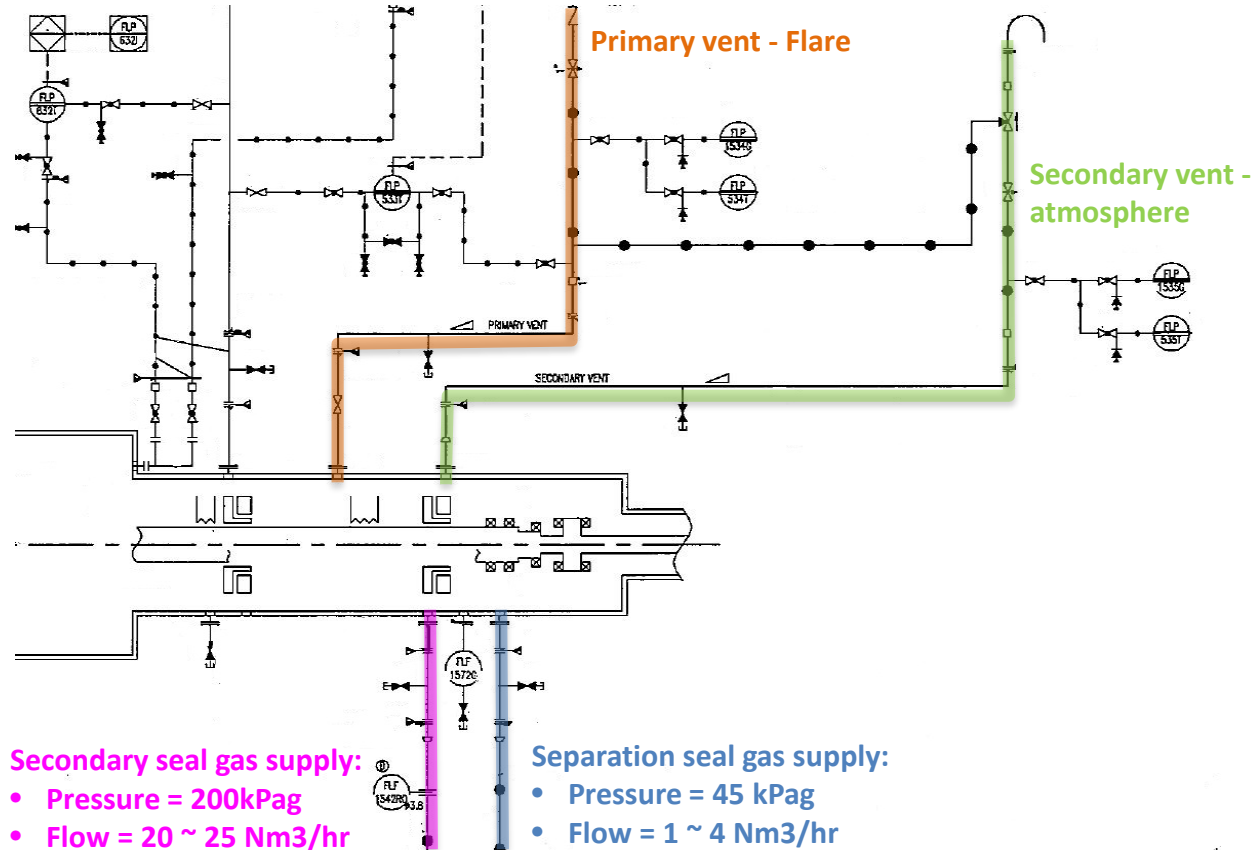
Mitigation Steps To Prevent Oil Migration in Plant 2

- Availability of secondary seal gas

- Use of needle valve in secondary vent to maintain low pressure of 5 – 15kPag in secondary vent line
- Primary vent pressure maintained at about 20 ~ 50kPag

- All 10 units have been in service since 2013 and no oil has been observed in the secondary drain sight glasses.

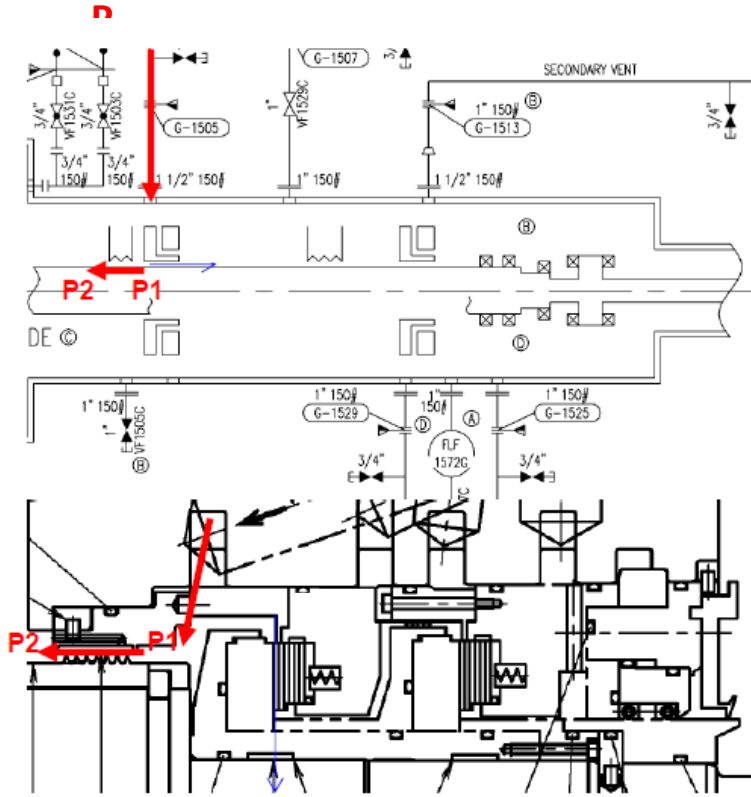
Site Pressure Survey for Case Labyrinth Pressure Drop

Casing	P _{supply} (kPag)	P1 (kPag)	P2 (kPag)
PGC LP	100	90	70
PGC MP	455	440	420
