# Lessons learned on the diagnosis of pathologies in concrete dams: 30 years of research and practice

A. Blanco<sup>1</sup>, F. Pardo-Bosch<sup>2</sup>, S. Cavalaro<sup>1</sup>, A. Aguado<sup>3</sup>

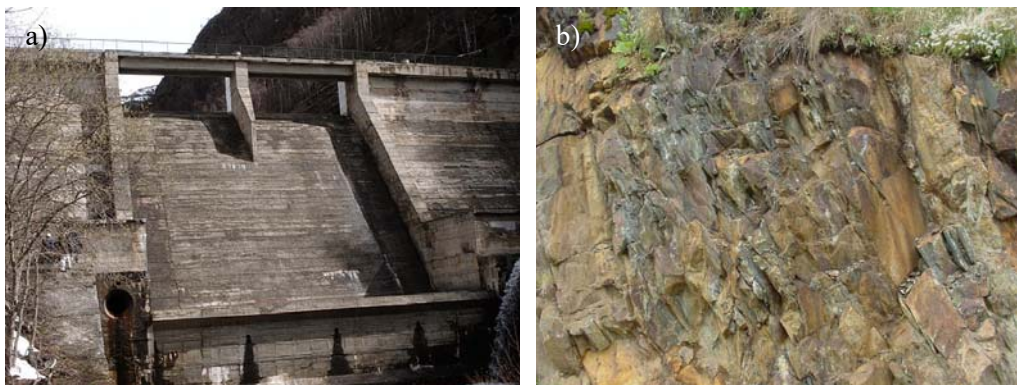
Case study I (Figure 1a) was selected due to the magnitude of the non-recoverable displacements and the singularity of the pathology - a combination of two expansive reactions with different kinetics. This concrete-made, gravity dam was built from 1968 to 1971 and presents a straight shape in the top view, with a crest length of 102.4 m and a height of 28.9 m. The dam is divided into 1 block (number 1) that is 12.4 m wide and 6 blocks that are 15.0 m wide (numbers 2 to 7). The dam presents one gallery and the reservoir has a capacity of 0.33 hm<sup>3</sup>. Slate and phyllites are the predominant surrounding geologic formation (Figure 1b), which is also the most likely source of the aggregates to produce the concrete used in the dam. This hypothesis was later confirmed by the historical construction records and by the microstructural analyses performed.

Figure 1. a) General view of the downstream face in 2005 and b) slates found near the dam.

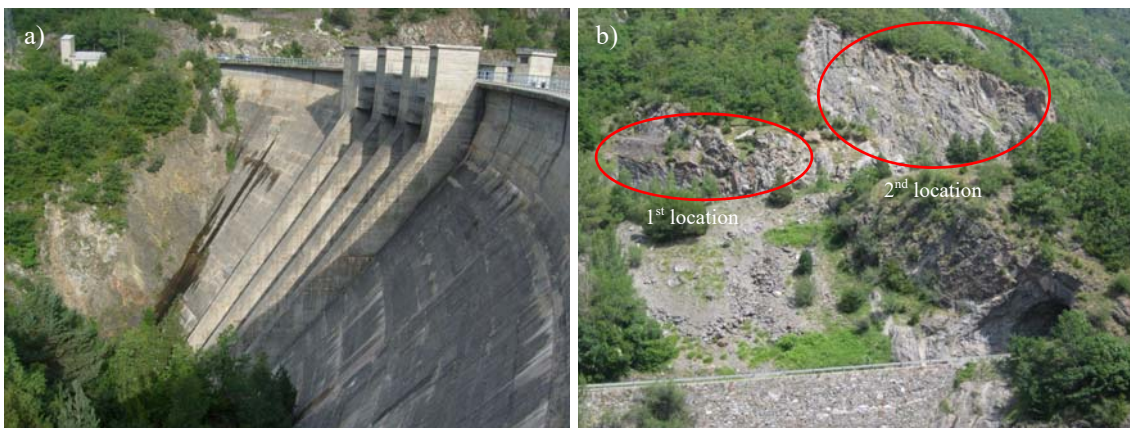
Case study III was selected given the peculiarities of the internal sulfate attack in the dam, which is not generalized in the downstream face but localized in certain areas where a specific type of aggregate was used. This study corresponds to an arch-gravity dam (see Figure 10a) built in 1969 that is 72,6 m high and whose crest is 195 m long. The dam is divided into 12 blocks containing 4 main longitudinal galleries connected by an additional perimeter gallery. The reservoir has a capacity of 3 hm<sup>3</sup>. The dam is in an area with sedimentary and metamorphic rocks such as slate and limestone (in some cases with calcite veins or quartz). The historical records indicate that the concrete was produced with aggregates from the area, extracted from 2 different locations of the same quarry (see Figure 10b).

Figure 10. a) General view of the downstream face in 2008 and b) view of the quarry and locations for the extraction of aggregates.

This dam is an example of the importance of reviewing “clinical history” to reach a successful diagnosis (see Table 1). Historical records indicate that the aggregates used in the concrete were obtained from two locations at the quarry near the dam (see locations in Figure 10b). Figure 14 depicts the areas of the dam constructed with aggregate from each location and the position of the most significant damage found in the visual inspection conducted in 2008. The aggregates extracted from the first quarry location shown in Figure 10b were used to produce the concrete for the first stage of construction (hatched areas in Figure 14). Aggregates from the second quarry location shown in Figure 10b were used in the following construction stages (white area in Figure 14). Interestingly, all signs of damage were detected in areas corresponding to the initial stage of construction.
