# Phase III Development of a Short-Radius Guardrail for Intersecting Roadways

*Midwest States' Regional Pooled Fund Research Program  
Fiscal Year 2001-2002 (Year 12)  
Research Project Number SPR-3 (017)  
NDOR Sponsoring Agency Code RFPF-02-02*

MwRSF Research Report No. TRP-03-183-07

December 6, 2007

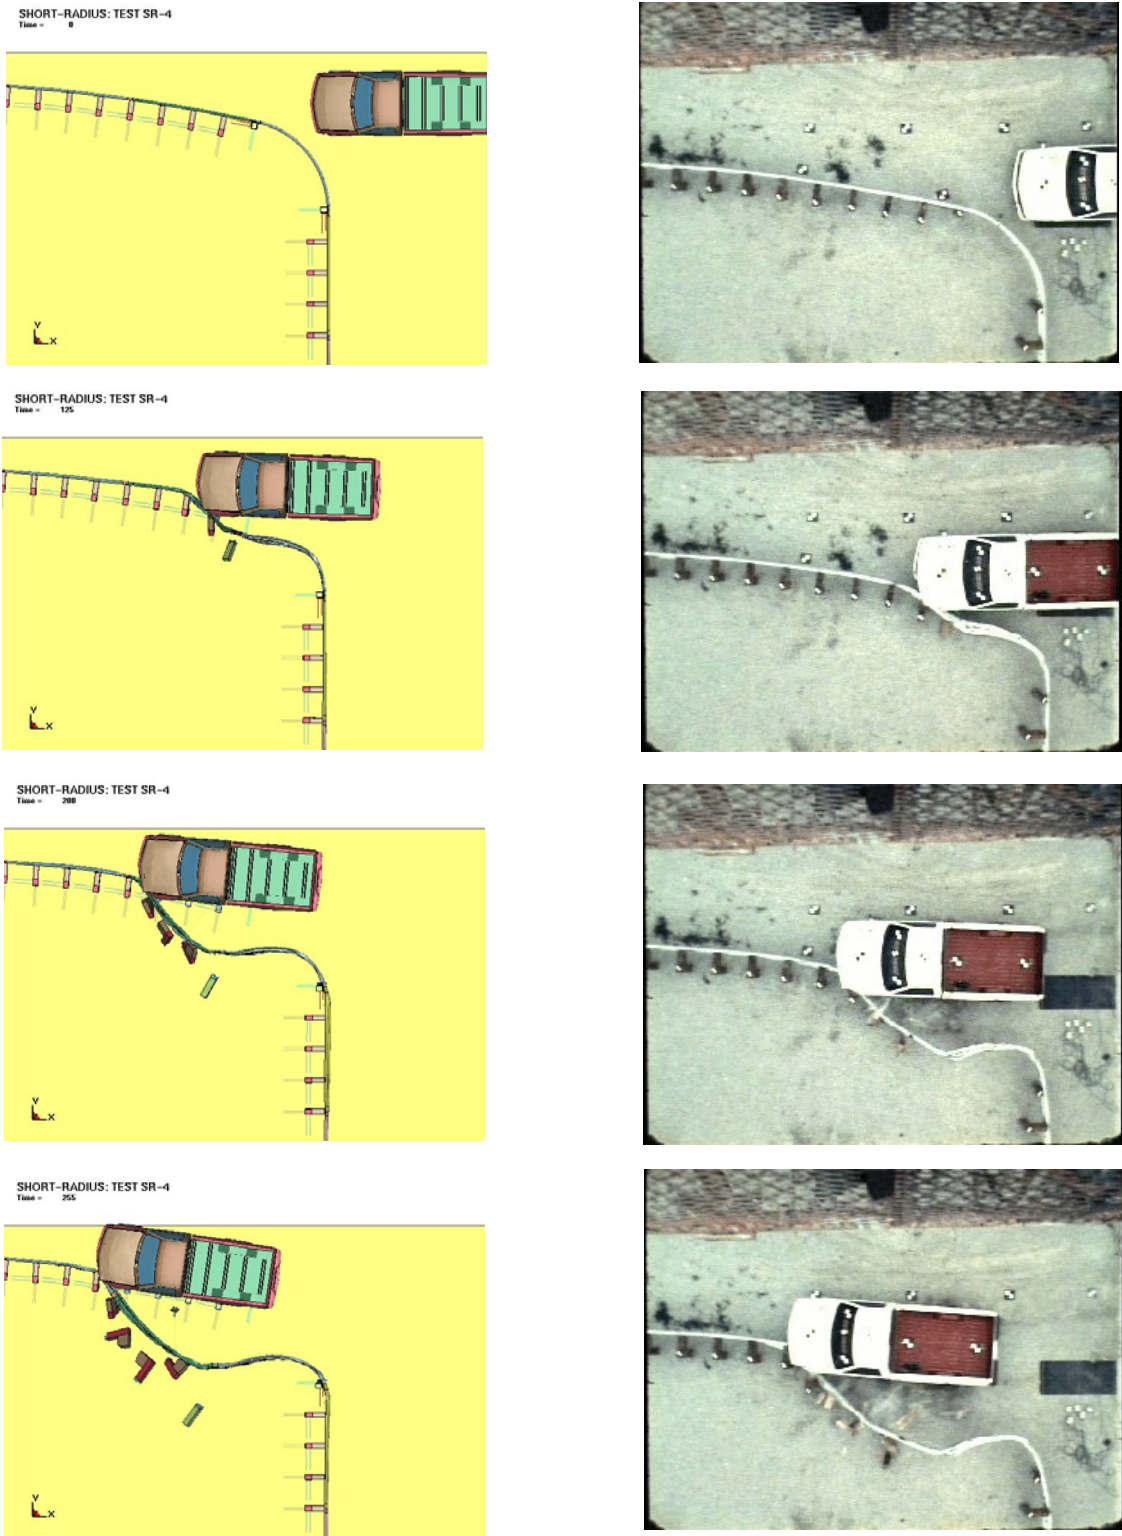
Figure 10. Comparison of Full-Scale Test and LS-DYNA Simulation Model, Test No. SR-4

Prior to conducting full-scale test no. SR-5, the researchers reviewed the results of the previous failed test, test no. SR-4, in order to determine design changes that would improve the performance of the system. The failure of test SR-4 to meet the safety performance criteria was directly attributed to the intrusion and snagging of the thrie beam guardrail into the wheel well region of the pickup truck. Through the initial portion of the impact, the thrie beam guardrail was impacted by the left-front corner of the vehicle and deflected toward the inside of the short-radius guardrail system. After approximately 0.300 sec, the leading edge of the impacted guardrail slid past the left-front corner and into the wheel well. The intruding guardrail punched a large hole in the floor pan of the occupant compartment, thus causing a rapid deceleration and yaw of the vehicle. The intrusion of the thrie beam was caused by the combination of the orientation of the impact vehicle, the geometry of the system, and the lack of upstream tension in the guardrail. Because the cable anchorage at post no. 1P was disengaged almost immediately, there was little or no upstream tension in the flared guardrail section. Therefore, the vehicle moved downstream along the system with very little redirection. This in turn led to the intrusion of the thrie beam into the wheel-well region.

LS-DYNA computer simulation was conducted in order to evaluate the potential effectiveness of a redesigned anchorage that developed upstream tension throughout the impact event. The first step in that analysis was to conduct a simulation of test no. SR-4 and compare the simulation results with the physical test. Sample results from that analysis are shown in Figure 10. The results showed that the simulation model compared well with the physical test in terms of the system deformation and truck redirection. The model captured the loss of tension and the vehicle pocketing within the guardrail that was observed in test no. SR-4. The model became unstable prior to the time in the impact where the guardrail knee entered the wheel well and impacted the firewall in the test, but the results demonstrated that the model could effectively reproduce the correct behavior of the short-radius system with the existing anchorage design.

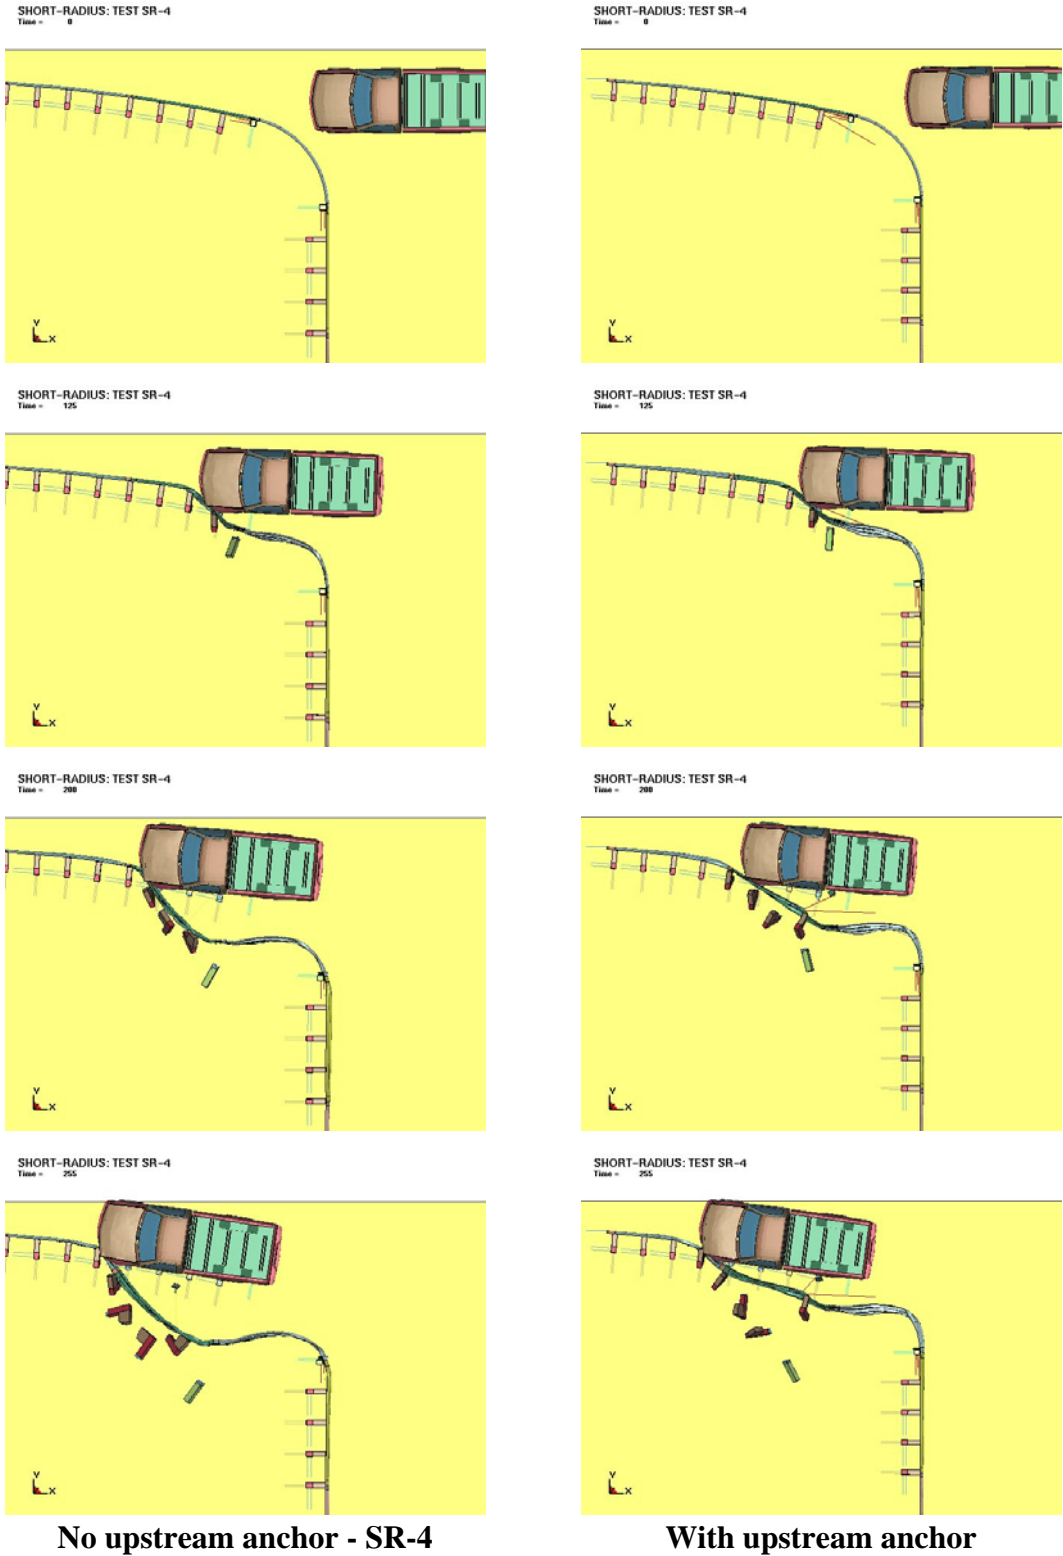
Figure 11. LS-DYNA Simulations of Test SR-4 and SR-5

The second step in the analysis was to compare the results from the SR-4 simulation with the results from a computer simulation where the upstream anchorage remained intact. Thus, a second model was simulated with an upstream anchorage on the primary side that would not release when post no. 1P fractured. The results of that simulation and comparison with the simulation of test no. SR-4 are shown in Figure 11. The comparison of the two computer models showed a clear improvement in the behavior of the system with the anchorage remaining intact. The model with the intact anchorage demonstrated improved upstream tension in the rail and much lower evidence of the pocketing that caused the failure in test no. SR-4.

primary side of the short-radius system that was connected to a release lever placed in front of the nose of the system. The design allowed the anchor to be released during impacts on or near the nose of the system while remaining in place during impacts on the side of the system. Full-details for the secondary anchor are provided in a subsequent section.

The researchers also decided to lower the top height of the thrie beam rail in the short-radius system from 854 mm (31.625 in.) to 787 mm (31 in.). The thrie beam rail height had been raised to 854 mm (31.625 in.) prior to test no. SR-4 in order to improve the capture of the pickup truck and to aid the pickup truck in smoothly redirecting near the splice in the thrie beam at post no. 1P. However, review of the results of test no. SR-4 showed that the increased height did not significantly improve the capture of the pickup truck, and that the addition of the flare to the primary side of the system eliminated any issue with the redirection and/or interlock of the pickup truck with the splice at post no. 1P. In addition, it was believed that returning the height of the system to a more standard 787 mm (31 in.) would improve the compatibility of the system with the recently developed MGS system and existing 813-mm (32-in.) high bridge rail designs.

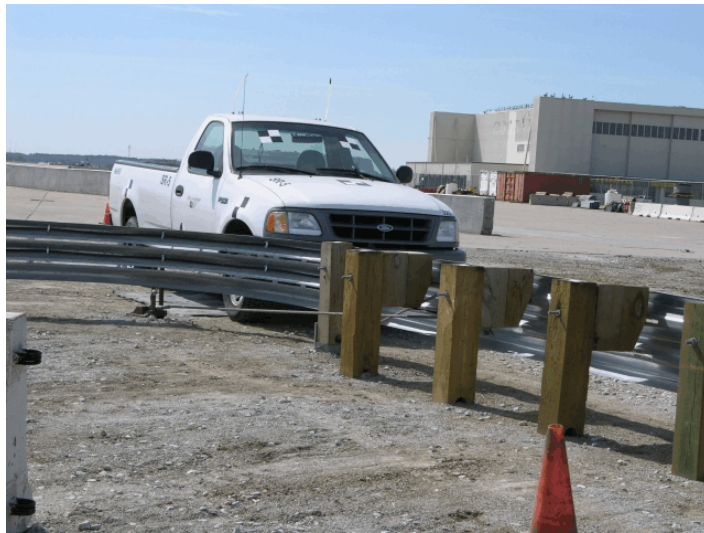
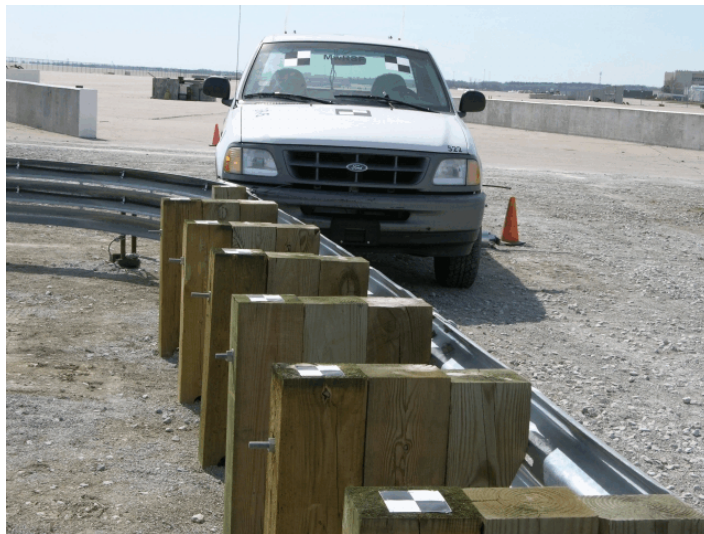
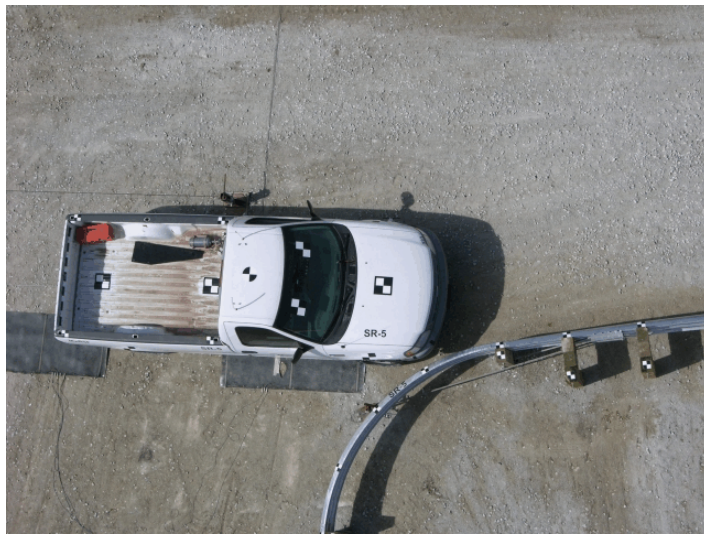
Figure 49. Impact Location, Test SR-5

The right-front corner of the test vehicle impacted the curved nose section of the short-radius guardrail system just upstream of post no. 1P, as shown in Figure 49. Upon impact, the front of the pickup truck deformed the curved nose section inward. At 0.034 sec, the thrie beam guardrail around the right-front corner of the bumper deformed upward and wrapped around the front of the pickup truck. At this same time, the right-front quarter panel crushed inward due to rail contact. At 0.062 sec, the right-front corner of the pickup truck contacted post no. 1P which fractured at the ground. At 0.086 sec, the guardrail continued to capture the pickup truck's front bumper. At this same time, post no. 2P deflected backward. At 0.102 sec, the pickup truck contacted post no. 2P which fractured at the ground. By 0.120 sec, the right-front corner of the pickup truck's hood deformed upward, and the quarter-panel continued crushing below it. At this same time, the pickup truck began to redirect. At 0.156 sec, the pickup truck contacted post no. 3P which deflected backward. At this same time, post no. 1P was still attached to the rail. At 0.170 sec, the hood's right-front corner, the right-front

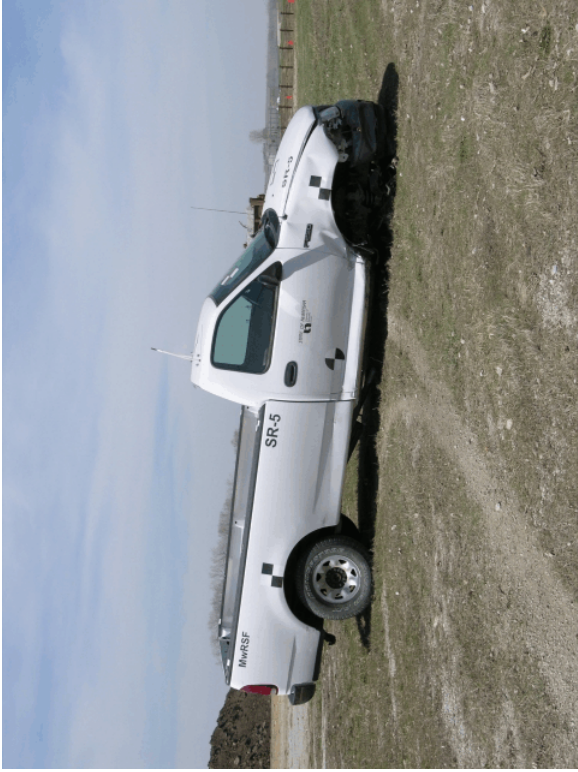
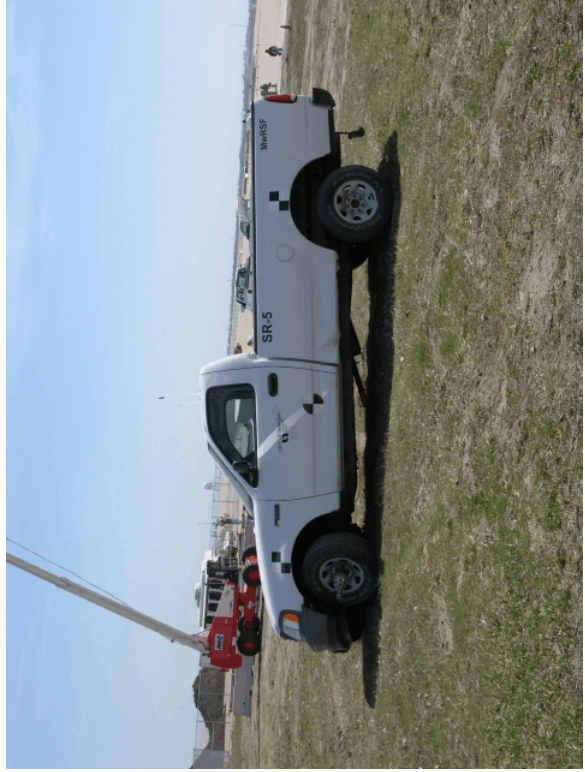
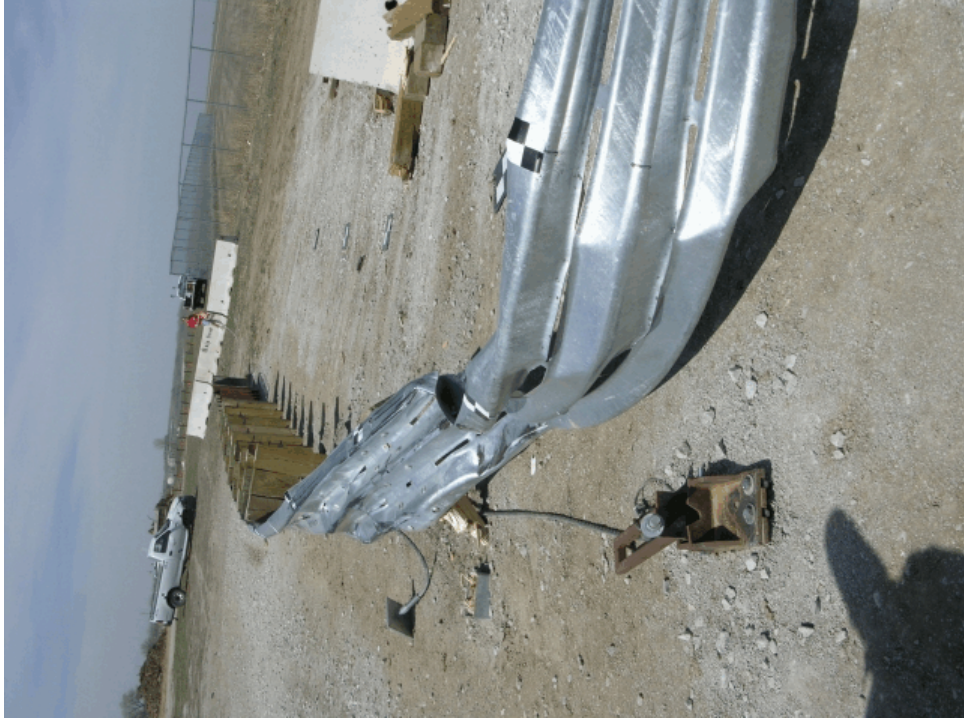
Figure 50. Vehicle Trajectory and Final Position, Test SR-5

quarter panel, and the right-front corner of the bumper continued to deform as the rail continued to flatten. At 0.182 sec, the pickup truck contacted post no. 4P which rotated slightly backward in the soil. At 0.190 sec, a gap between the right-front corner of the hood and the quarter panel formed, and the pickup truck rolled slightly counter-clockwise away from the system. At 0.216 sec, the top of the right-side door separated from the frame and bent outward at the door trim. At 0.276 sec, vehicle continued to be redirected, and the front bumper was located at post no. 7P. At 0.468 sec, the pickup truck exited the system with a resultant velocity of 85.4 km/h (53.1 mph) and at an angle of 12.6 degrees. The pickup truck came to rest 41.9 m (137 ft - 6 in.) downstream from impact and 10.8 m (35 ft - 6 in.) laterally away from the primary side, as shown in Figure 42. It should be noted that the secondary anchor remained in place throughout the vehicle contact and successfully developed upstream tension necessary to redirect the vehicle. The trajectory and final position of the pickup truck are shown in Figure 50.

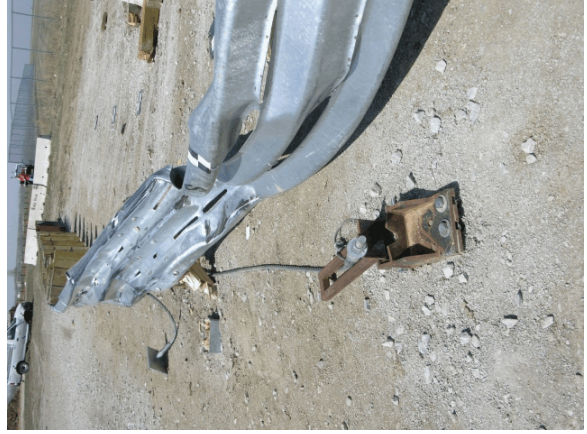
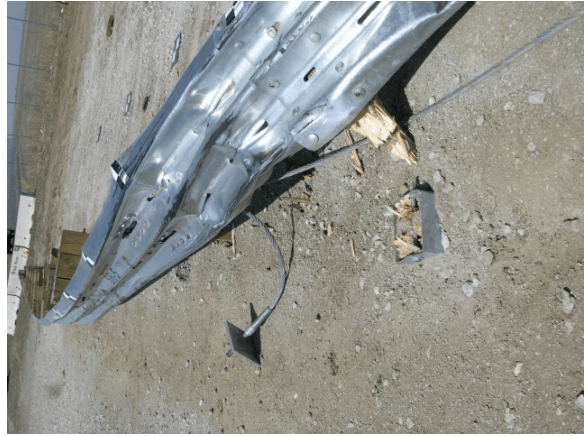
Figure 52. System Damage, Test SR-5

Damage to the short-radius system was moderate, as shown in Figures 51 through 61. Post no. 1P fractured at the foundation tube but remained attached to the rail. Post nos. 2P through 3P fractured at ground level and disengaged from the rest of the system. The tapered blockout at post no. 2P disengaged from the post. Post no. 4P fractured approximately 178 mm (7 in) below the groundline and disengaged from the system. Post no. 5P cracked at the groundline and rotated backwards in the soil. Post no. 6P sustained a 229-mm (9-in.) long crack through the transverse hole and rotated backward in the soil. Post no. 7P also rotated backward in the soil.

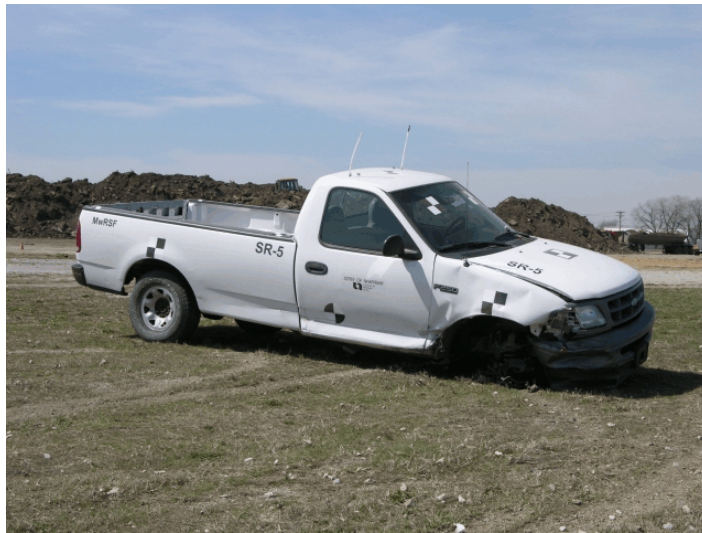
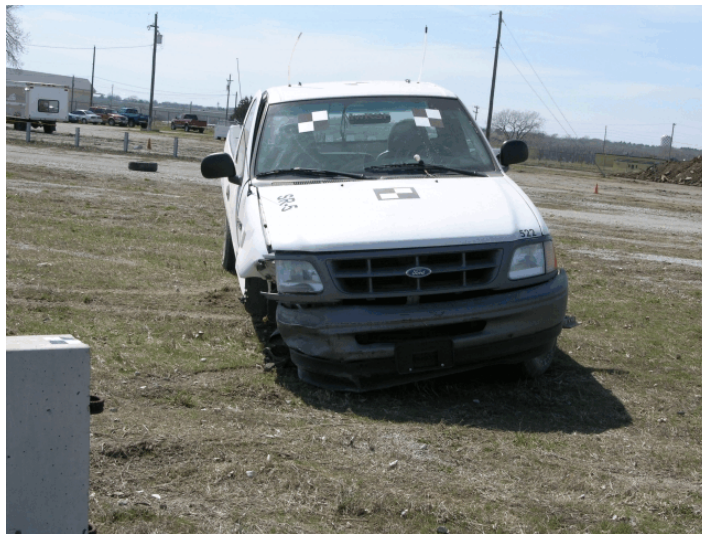
Figure 62. Vehicle Damage, Test SR-5

Exterior vehicle damage was minimal, as shown in Figures 62 through 64. Occupant compartment deformations to the right side and center of the floorboard were judged insufficient to cause serious injury to the vehicle occupants. Maximum longitudinal deflections of 13 mm (0.5 in.) were located near the left side of the right-side floorboard. Maximum lateral deflections of 25 mm (1 in.) were located near the right-front corner of the right-side floor pan. Maximum vertical deflections of 38 mm (1.5 in.) were located near the center of the right-side floorboard. Complete occupant compartment deformations and the corresponding locations are provided in Appendix C.

The right-front bumper corner was deformed inward and encountered significant dents and scratches. The right side of the grill was also deformed inward and fractured around the headlight.

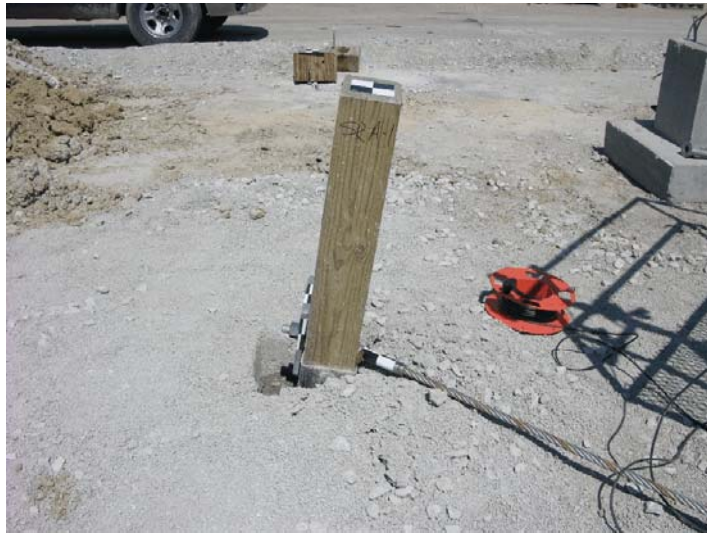
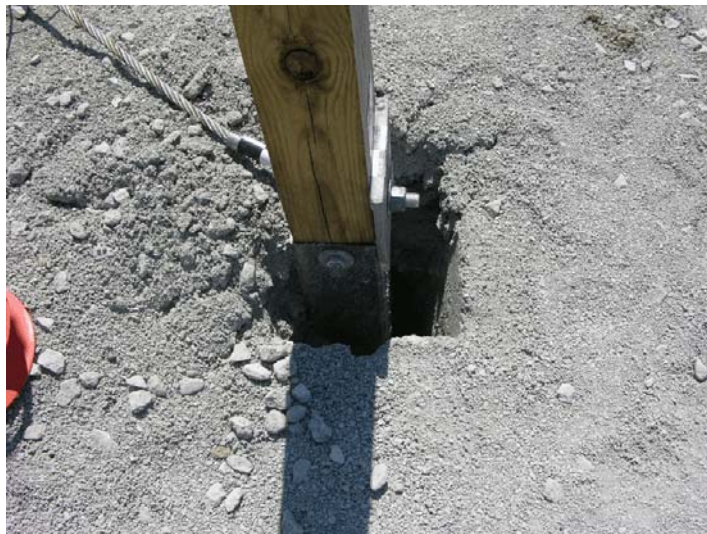
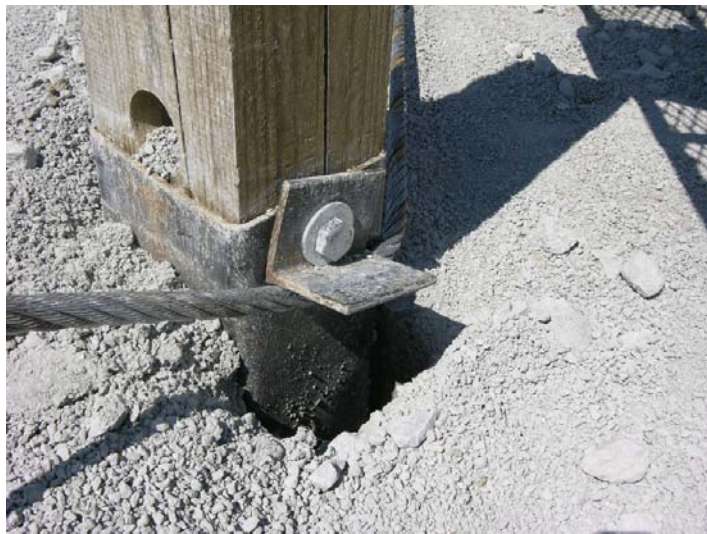
Figure 66. Bogie Test Results, Test No. SRA-1

The 2,082-kg (4,589-lb) bogie, attached to the cable, was pulled away from the installed posts to determine the maximum load the system could withstand and the amount of deformation imparted to the cable anchor bracket at the bottom of the primary-side post. The bogie speed was 34.66 km/h (21.54 mph). The posts experienced moderate movement in the soil as shown in Figure 66. In addition, the cable anchor bracket did not experience any deformations. The maximum load was found to be approximately 35 kips as shown in the load curve in Figure 67. Previous experience and testing of guardrail cable anchorages has demonstrated that the loads found for the new SR anchorage were consistent with past guardrail anchorage loads in the 35 kip range. This suggested that the revised short-radius anchorage would be sufficient for redirective impacts on the primary side of the system. Test results are shown in Table 2.

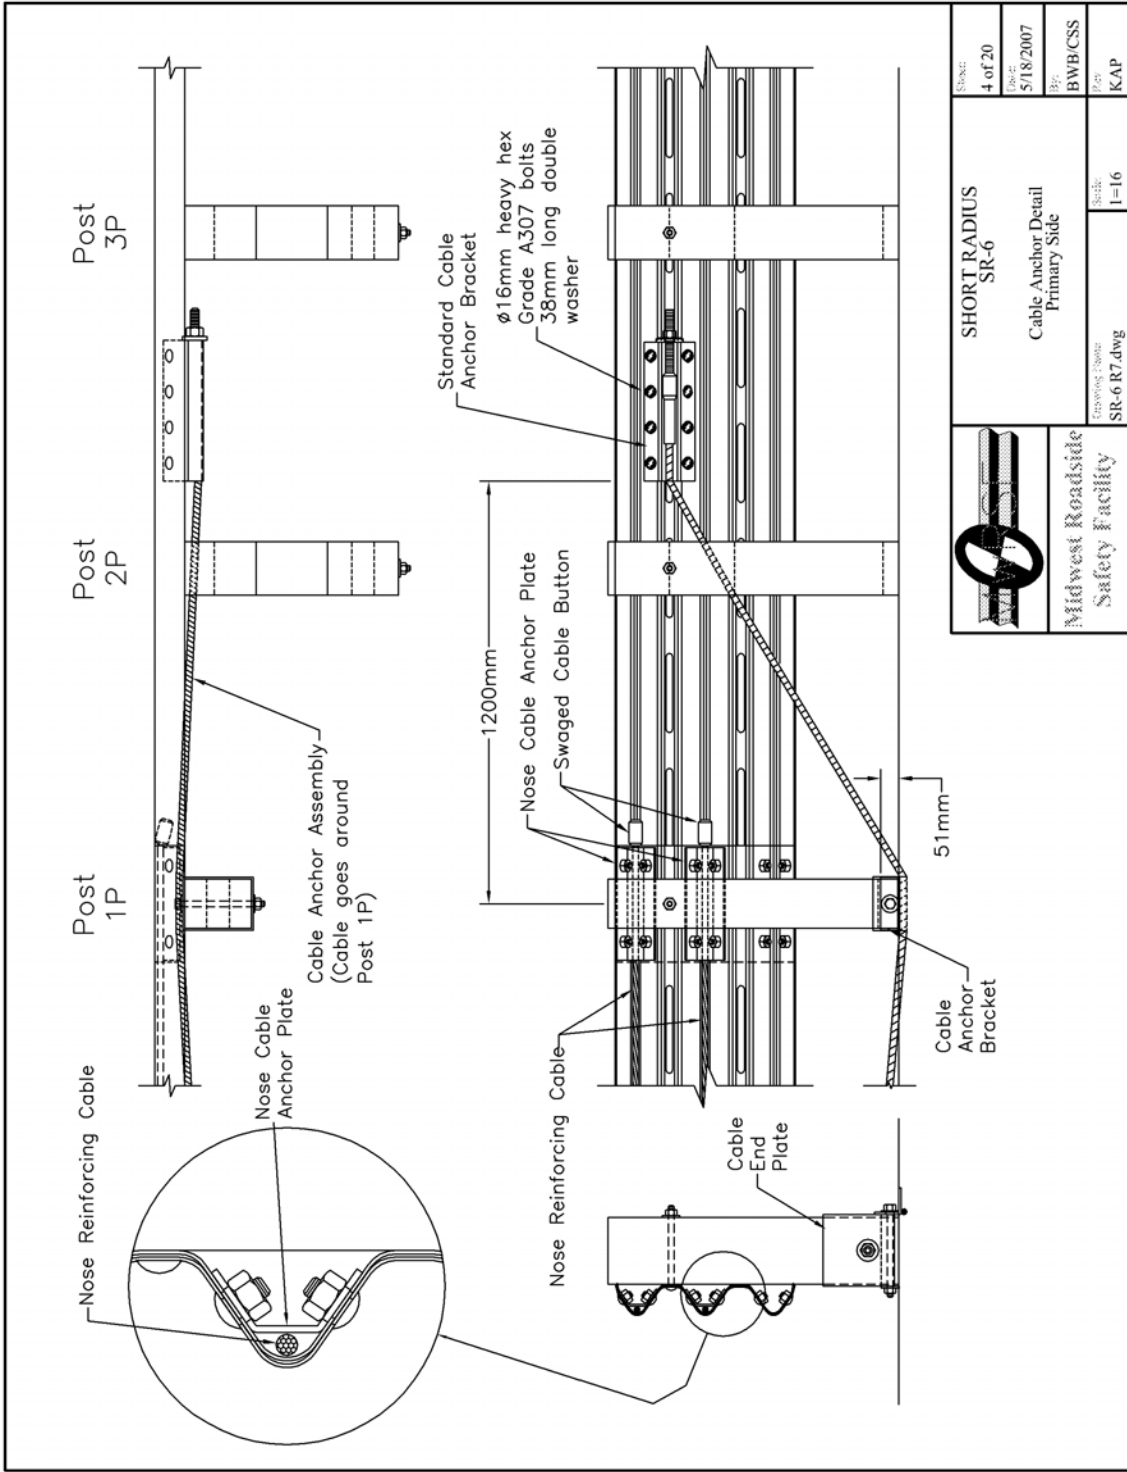
Figure 71. Primary Side Cable Anchor Detail, Test SR-6

The modified short-radius guardrail system was identical to the previous system except for the method used to develop the tensile strength of the three beam guardrail downstream from the nose section. The cable anchor assembly on the primary side was lengthened and oriented differently within the system thereby removing the cable release mechanism from the traffic side of the system. The cable came around the traffic face of the first post on the primary side and then terminated in the first post on the secondary side, as shown in Figures 68 through 72. The existing anchorage on the secondary side was located at post no. 2S. This change shifted the location of the anchorage one post downstream on the secondary side. A cable bracket was located at the ground line of post no. 1 on the primary side which held the cable down and developed the necessary tensile strength, as shown in Figures 71 and 74. Photographs of the modified system are shown in Figures 76 and 77.

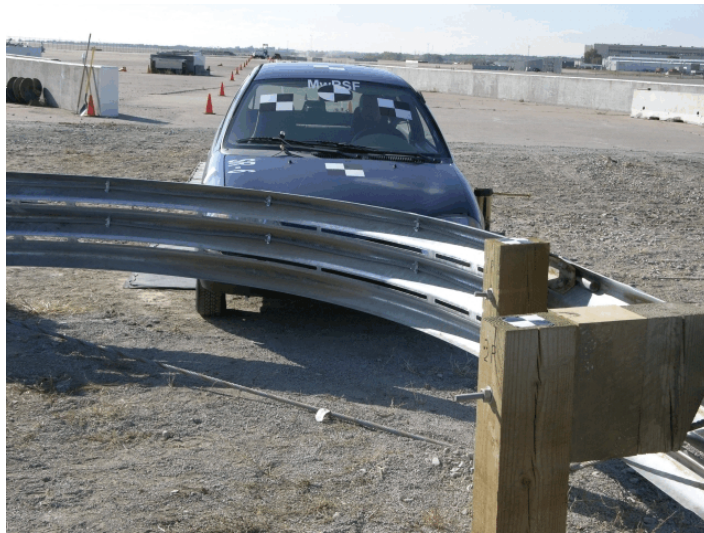
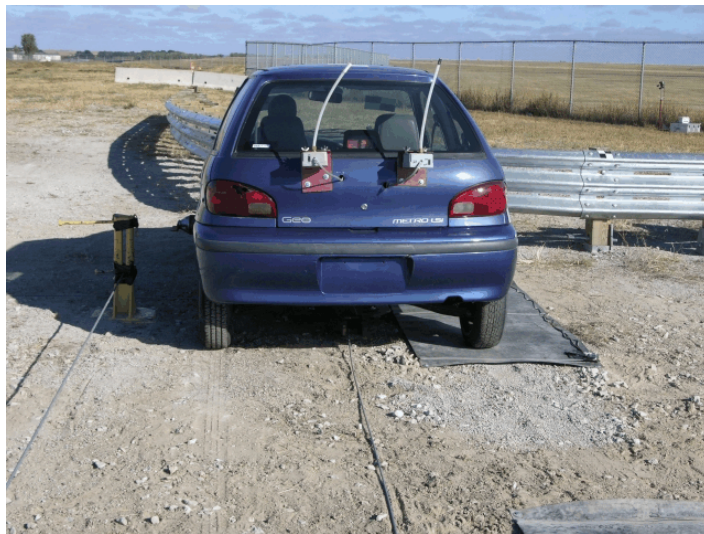
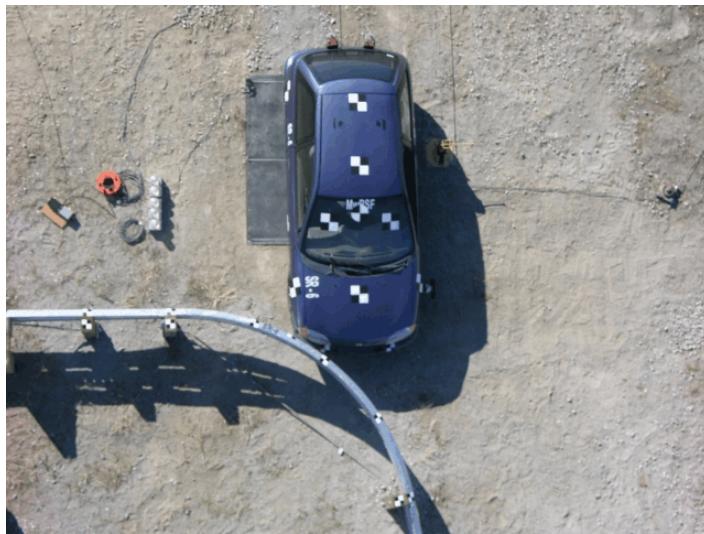
Figure 86. Impact Location, Test SR-6

The test vehicle impacted the curved nose section of the short-radius guardrail system, as shown in Figure 86. Upon impact, the right-front corner of the small car deformed as well as the curved nose section. At 0.022 sec, a buckle point formed at the quarter point on the secondary side of the curved nose section. At 0.032 sec, the curved nose section buckled near its midpoint, and the front of the hood was pushed up. At this same time, post no. 1S bent back in the sleeve. At 0.044 sec, the right-front corner of the hood deformed inward. As the vehicle continued downstream, a tear propagated through one of the slot tabs of the nose section, and the rail continued to crush and flatten. At 0.052 sec, buckle points occurred at both quarter points of the first section of rail on the primary side and at post nos. 1P and 3P. At 0.070 sec, the hood deformed, and a crease formed near the middle of the hood. At this same time, buckle points formed at post nos. 1S and 1P. At 0.082 sec, post no. 1P fractured at ground level and rotated downstream. At 0.104 sec, post no. 1S fractured at ground level, and the primary side cable anchor was released. At 0.124 sec, the front bumper of

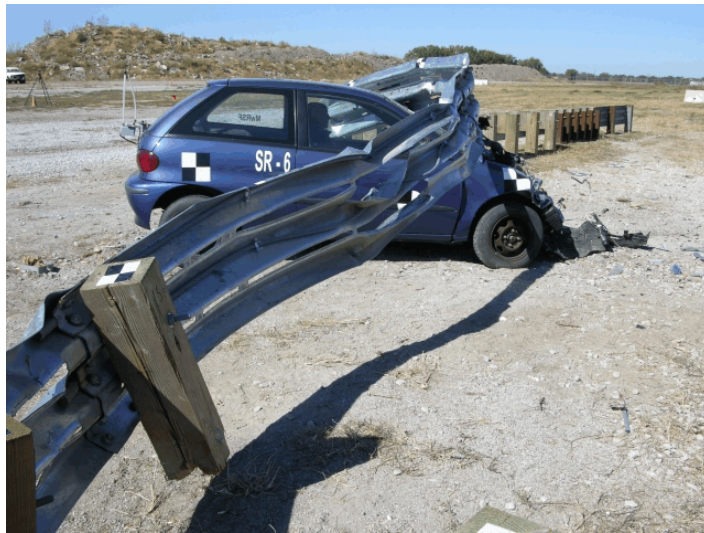
Figure 88. System Damage, Test SR-6

Damage to the short-radius system was moderate, as shown in Figures 88 through 92. Post nos. 1P and 1S fractured at the foundation tube. Post no. 1P disengaged from the rest of the system and post no. 1S remained attached to the rail. Post no. 2P fractured at ground level and disengaged from the rest of the system. Post nos. 3P and 4P also fractured at ground level and disengaged from

the rest of the system. Post no. 5P twisted downstream and encountered a small crack at ground level. The blockout at post no. 5P disengaged from the rail, but remained attached to the post.

Contact marks were found between the center of the nose section and post no. 3P. The rail was flattened and deformed between post nos. 1S and 3P. Rail buckling was found along the curved nose section. Additional rail buckling was found at post nos. 1P through 5P and between post nos. 5P and 8P. The post bolt released from the rail at post nos. 6P through 8P. The lower corrugation encountered a 178-mm (7-in.) long tear 2,134 mm (3 ft) downstream from the impact point. Another 178-mm (7-in) long tear occurred on the middle corrugation of the nose section between the primary-side quarter point and the center of the rail. All rail slots were bent and deformed on the primary side. Minor post bolt slot deformation occurred at post nos. 3P through 7P. The galvanization was removed the nose section.
